U. S. NUCLEAR REGULATORY COMMISSION

Docket Nos.: 50-348 and 50-364  
License Nos.: NPF-2 and NPF-8  
Report Nos.: 50-348/97-09 and 50-364/97-09  
Licensee: Southern Nuclear Operating Company, Inc.  
Facility: Farley Nuclear Plant (FNP), Units 1 and 2  
Location: 7388 North State Highway 95  
Columbia, AL 36319  
Dates: September 8 - 12, 1997  
Team Leader: B. Crowley, Reactor Inspector  
Maintenance Branch  
Division of Reactor Safety  
Inspectors: W. Bearden, Reactor Inspector, Maintenance Branch, RII  
R. Bernhard, Senior Reactor Analyst, RII  
R. Caldwell, Resident Inspector, Farley Site  
W. Kleinsorge, P.E., Reactor Inspector, Maintenance Branch,  
RII  
W. Scott, Senior Operations Engineer, Quality Assurance and  
Maintenance Branch - NRR

### Farley Nuclear Plant NRC Inspection Report 50-348,364/97-09

This inspection included a review of the licensee's implementation of 10 CFR 50.65, "Requirements for Monitoring the Effectiveness of Maintenance at Nuclear Power Plants" [the Maintenance Rule]. The report covers a one-week period of inspection.

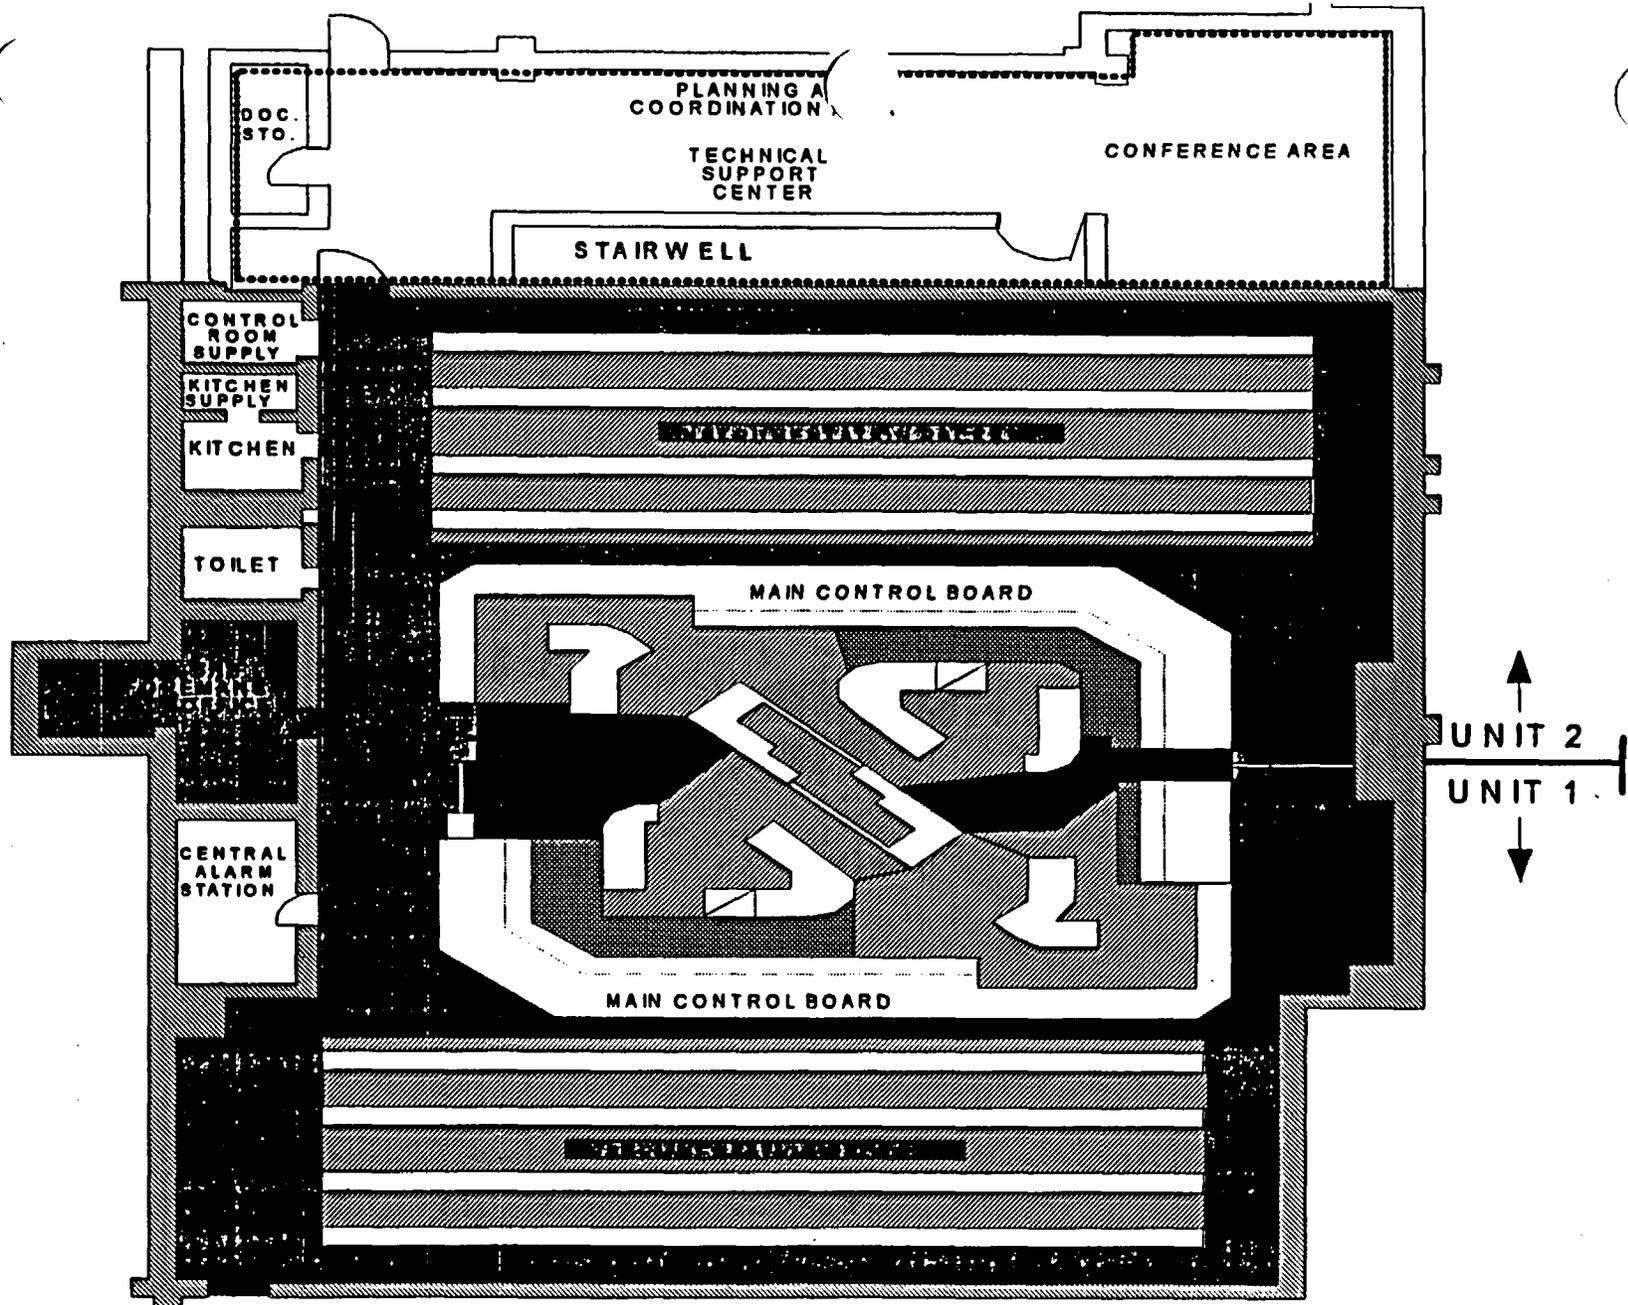
- GENERAL ACCESS AREA**  
 LIGHT GREY CARPET
- RESTRICTED AREA**  
 REDISH GREY CARPET
- ATC ENTRANCE - HOLD POINT**  
 DARK BLUE CARPET

- TECHNICAL SUPPORT CENTER**
- CONFINES OF CONTROL ROOM**

NOTE: ONE DUAL UNIT LICENSED  
 SRO SHALL BE PRESENT IN  
 THE CONTROL ROOM BETWEEN  
 THE TWO SECURITY DOORS  
 AT ALL TIMES.
