APPLICANT: Omaha Public Power District

FACILITY: Fort Calhoun Station, Unit 1

SUBJECT: SUMMARY OF MEETING WITH OMAHA PUBLIC POWER DISTRICT (OPPD) TO DISCUSS DRAFT RESPONSES TO REQUESTS FOR ADDITIONAL INFORMATION (RAIs) FOR THE RENEWAL OF THE OPERATING LICENSE FOR FORT CALHOUN STATION, UNIT 1 (FCS)

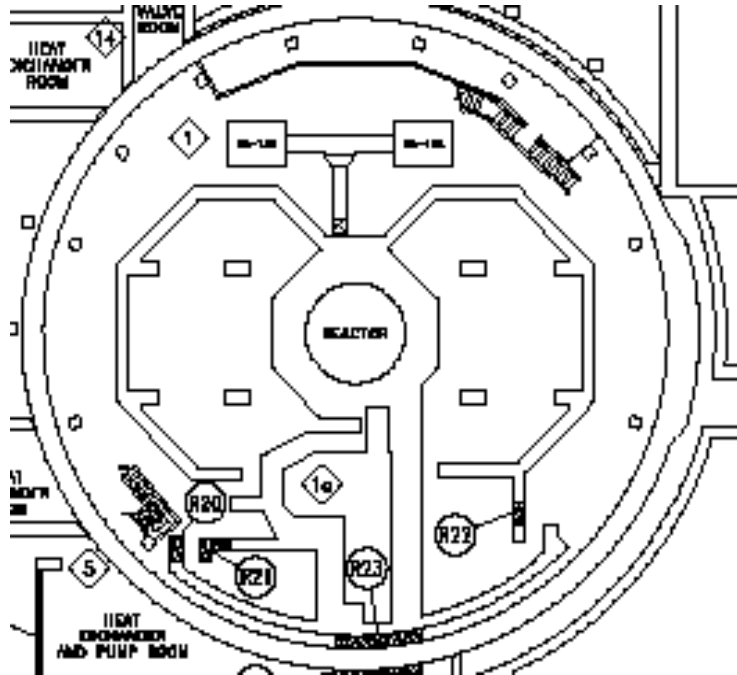
1. The masonry walls in containment are identified as R20, R21, R22, and R23 in the following figure of the 989' elevation level of containment.

2. Temperature – 120°F  
Humidity – 20 to 100%  
Radiation – 10R/hr averaged over a 40-year life.
3. The masonry walls in containment are inspected during performance of the containment inspection surveillance test which is performed every other refueling outage.
4. Containment inspections performed in 1996, 1999, and 2002 did not identify any degradation of the masonry walls.

Based on the information in LRA Table 3.5-3, row number 3.5.3.04, and in FCS AMP B.2.10, the applicant plans to inspect and review the masonry walls in accordance with enhanced GALL program XI.S5, "Masonry Wall Program." As the ungrouted masonry walls in containments are subjected to higher sustained temperatures (> 110°F), humidity, and radiation, please provide the following information for the staff to make a reasonable conclusion regarding the adequacy of these walls during the extended period of operation:
