APPLICANT: Omaha Public Power District

FACILITY: Fort Calhoun Station, Unit 1

SUBJECT: SUMMARY OF MEETING WITH OMAHA PUBLIC POWER DISTRICT (OPPD)  
TO DISCUSS DRAFT RESPONSES TO REQUESTS FOR ADDITIONAL  
INFORMATION (RAIs) FOR THE RENEWAL OF THE OPERATING LICENSE  
FOR FORT CALHOUN STATION, UNIT 1 (FCS)

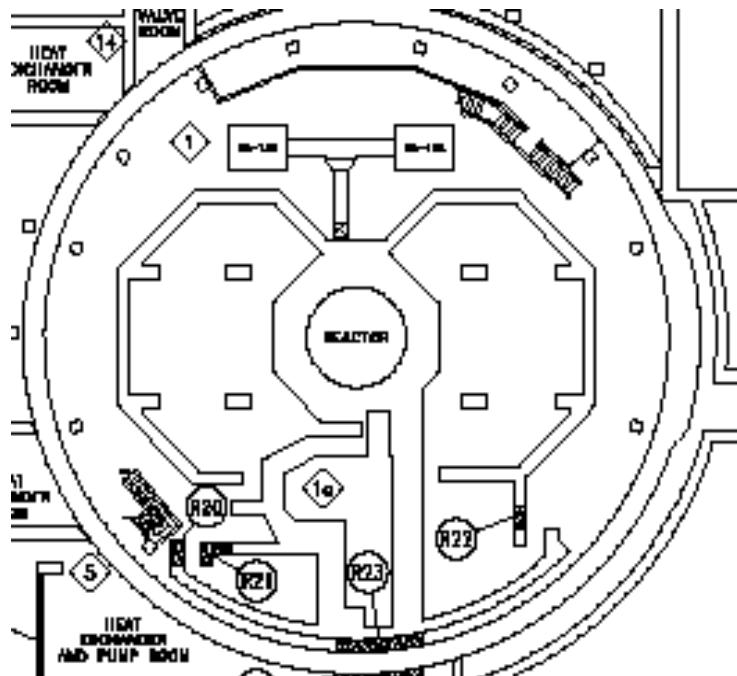
1. The masonry walls in containment are identified as R20, R21, R22, and R23 in the following figure of the 989' elevation level of containment.

2. Temperature – 120°F  
Humidity – 20 to 100%  
Radiation – 10R/hr averaged over a 40-year life.
3. The masonry walls in containment are inspected during performance of the containment inspection surveillance test which is performed every other refueling outage.
4. Containment inspections performed in 1996, 1999, and 2002 did not identify any degradation of the masonry walls.

- 3.5.3-D1      Based on the information in LRA Table 3.5-3, row number 3.5.3.04, and in FCS AMP B.2.10, the applicant plans to inspect and review the masonry walls in accordance with enhanced GALL program XI.S5, "Masonry Wall Program." As the ungrouted masonry walls in containments are subjected to higher sustained temperatures (> 110°F), humidity, and radiation, please provide the following information for the staff to make a reasonable conclusion regarding the adequacy of these walls during the extended period of operation:
