~~ATS-773~~

HYDROLOGY DOCUMENT NUMBER 133

As part of LLNL's program on radionuclide migration through fractured rock, major geologic discontinuities have been mapped and characterized at the 420 m level in the Climax Stock, adjacent to LLNL's Spent Fuel Test. Persistence or continuity of features was the principal sampling criterion, and ninety major fractures and faults were mapped in the main access and tail drifts. Although the purpose and nature of this study was different from previous fracture surveys in the Climax Stock, the results are generally consistent in that three predominant fracture sets are identified: NW strike/vertical, NE strike/vertical, NW strike/subhorizontal. The frequency of major features in the main access drift is somewhat higher than in the tail drift. Those mapped in the main access drift are generally braided, stepped, or en echelon, while those in the tail drift appear to be more distinct and planar. Several of the fractures in the tail drift lie in the NE/vertical set, while most form an entirely different set oriented N5E/55NW. Sub-horizontal fractures were common to both drifts. An area of seepage associated with some of these low-angle features

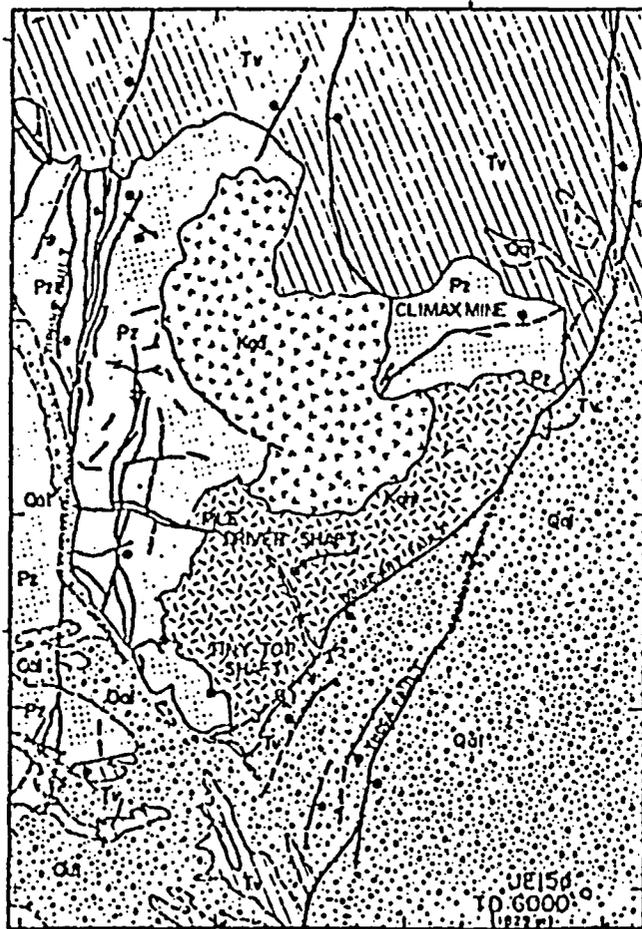
Figure 1. Geologic map of the Climax Stock.
(Modified after Barnes et.al., 1963).

Figure 1 is a generalized geologic map of the Climax Stock and its surroundings. The geologic setting is a composite stock of Cretaceous age that intrudes paleozoic sediments and metasediments. The majority of the exposed wall rocks are Ordovician limestones and dolomites of the Pogonip Group. The stock also intrudes the Eleana Formation, a series of argillites,

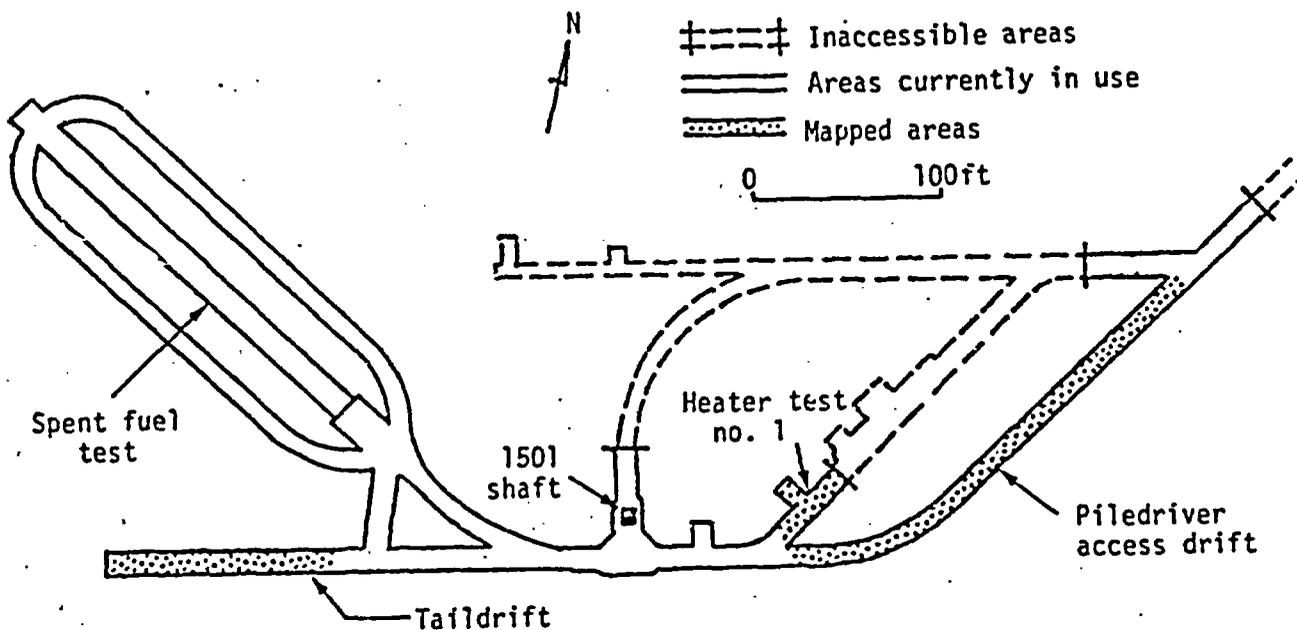
Fig. 2. Layout of drifts at 420 meter level of Climax Stock, NTS, showing areas included in the reconnaissance mapping.

The field project is located in the Climax Stock at the Nevada Test Site (Fig. 1), near LLNL's Spent Fuel Test (Ramspott, et al. 1979). Preliminary hydrologic testing is in progress for several fractures intersecting the main access drift, and additional sites are being considered in the areas shown in Fig. 2. Maps of the major discontinuities in these drifts are included in the report and pertinent geologic information is provided. Some comparison with previous mapping projects in the Climax Stock is made.

Detailed fracture mapping has recently been done in the tail drift and the drifts being used for the Spent Fuel Test (Fig. 2). Preliminary results have been published by Wilder and Patrick (1980) and Carlson, et al. (1980), and a more complete report is in preparation. Based on strike frequency diagrams given by Wilder and Patrick for joints mapped in the tail drift, boundaries of the principal pole directions are shown by the dashed lines in Fig. 3. The low-angle joints correlate well with low-angle sets given by Maldonado. Nearly half of the high-angle joints strike roughly northeast and dip between 65SE and vertical. About thirteen percent of the high-angle fractures strike northwest and dip to the northeast. As shown by Fig. 3, these two joint sets correspond in orientation to the main sets in the Climax Stock. However, the predominance of northeast-striking joints in the tail drift is opposite from Maldonado's data, in which the northwest-striking fractures are the most numerous. Wilder and Patrick (1980) indicate that this difference in frequency is probably due to sampling bias caused by the direction of the tail drift.

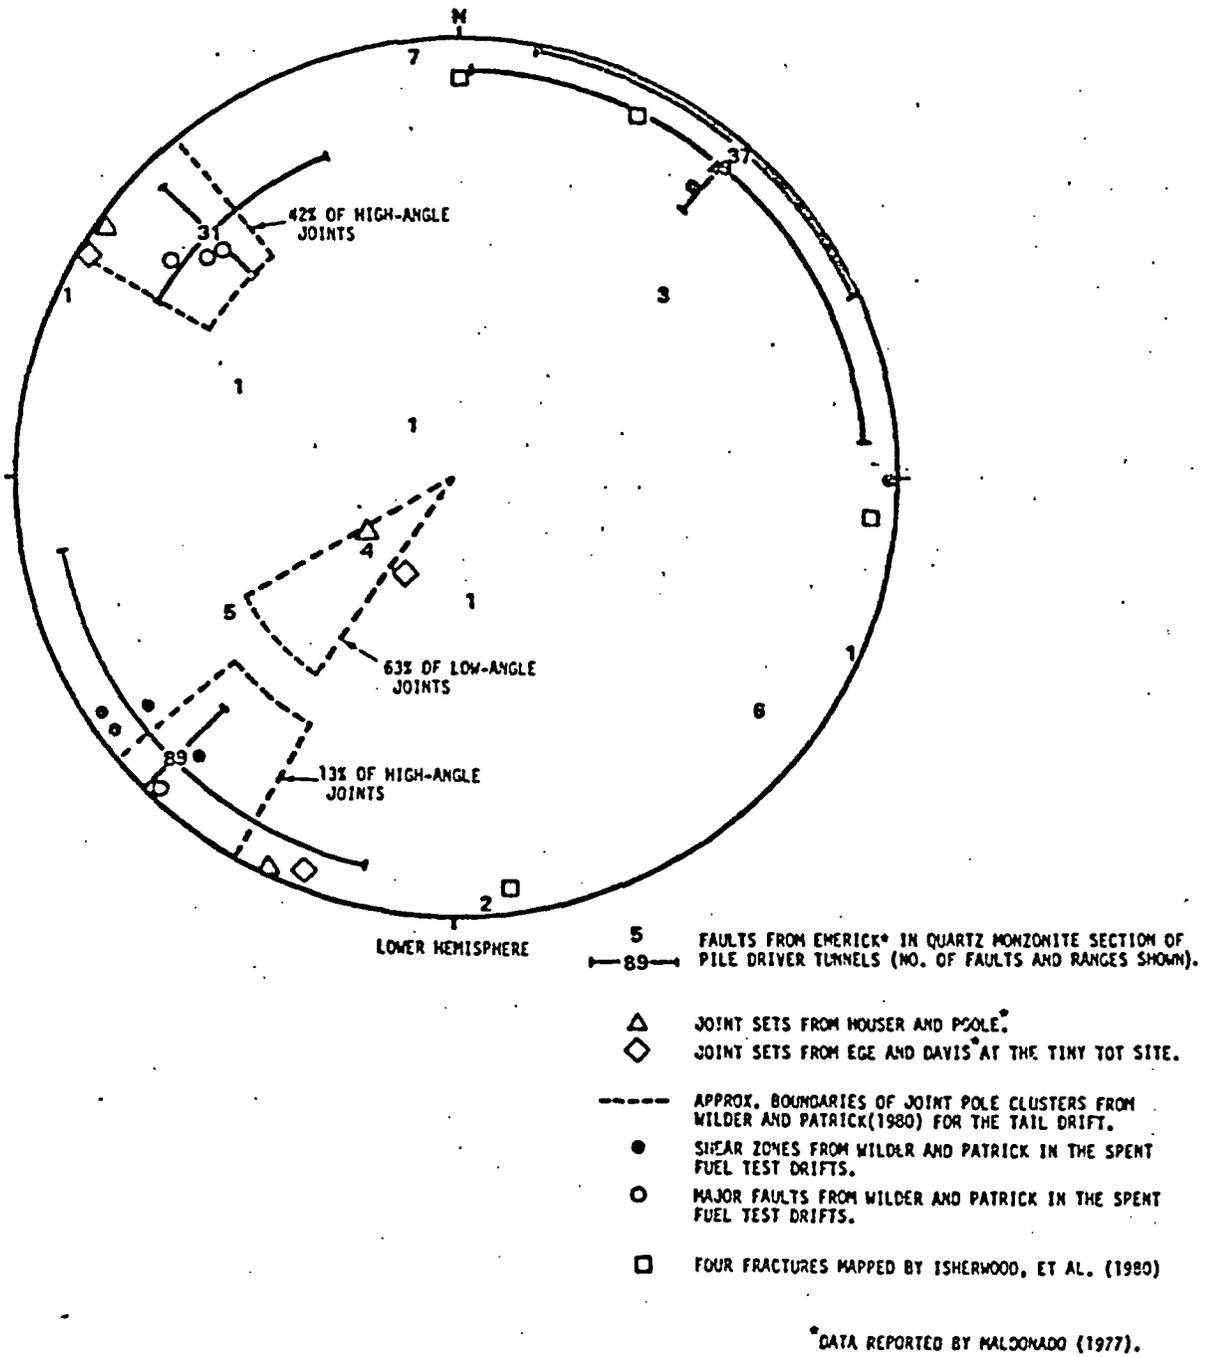
Fig. 3. Equal-area pole plot summarizing fracture orientations found in previous surveys of the Climax Stock.

Several different fracture surveys have been conducted in the Climax Stock. Maldonado (1977) states that three prominent joint sets were mapped by Houser and Poole (written communication to Maldonado, 1962) with mean orientations N32W/22NE, N64W/vertical, and N35E/vertical. He also reports similar sets found by Ege & Davis (written communication to Maldonado, 1964) at the surface of the Tiny Tot site (Fig. 1). Their orientations are N62W/20NE, N30E/vertical, and N69W/85NE. Figure 3 shows the mean pole orientations for these six joint sets plotted on an equal-area stereographic projection.

For the quartz-monzonite portion of the Pile Driver tunnel complex, Maldonado gives the average orientations of 239 faults, based on unpublished data by W. L. Emerick (1966). These data are also plotted in Fig. 3, and the ranges in strike and dip (from Maldonado's Table 10) around the dominant pole directions are indicated. The diagram shows that most of the mean fault orientations in the quartz-monzonite, which includes the area of the present study, are within 25° of the three joint sets cited above. Considering the usual scatter of poles about a mean, the correlation is fairly strong.

The spent fuel test mapping also identified a number of high-angle shear zones and faults throughout the experiment drifts. Based on a map of these features in Wilder and Patrick (1980, Fig. 8), we have plotted the orientations as the open and solid dots in Fig. 3. The general correlation with Maldonado's fault sets is readily apparent.

In the preliminary stages of the radionuclide migration project, four prominent, high-angle fractures were mapped and characterized on the southeast rib of the main access drift (Isherwood, et al., 1980). Three sets of boreholes were drilled to intersect these fractures, and initial flow tests have been performed on two of the 3 sets of boreholes in preparation for later radio-nuclide migration experiments. Our mapping includes these four fractures, and their pole orientations are plotted in Fig. 3. Only one of these falls into the major joint sets for the stock.

A third set of discontinuities was observed in the access drift with a mean orientation of N35W/25NE. This sub-horizontal set is apparently pervasive in the Climax Stock, according to the data in Fig. 3. Most of these features are planar and healed by quartz up to 10 mm thick. They typically contain pyrite in either continuous veinlets or discontinuous stringers. As sketched in Fig. 8, they tend to break or be open where the pyrite is continuous. Some of these low-angle fractures in the vicinity of Sta. 1+50 (Section A-A' of Fig. 5) are apparently open and seeping groundwater. Collection of groundwater in this area is in progress as part of the geochemical characterization task (Isherwood, et al., 1980). An additional low-angle fracture with an orientation of N38E/52NW and several high-angle fractures are also seeping water; however, it is not clear which of these features is the dominant flow path.

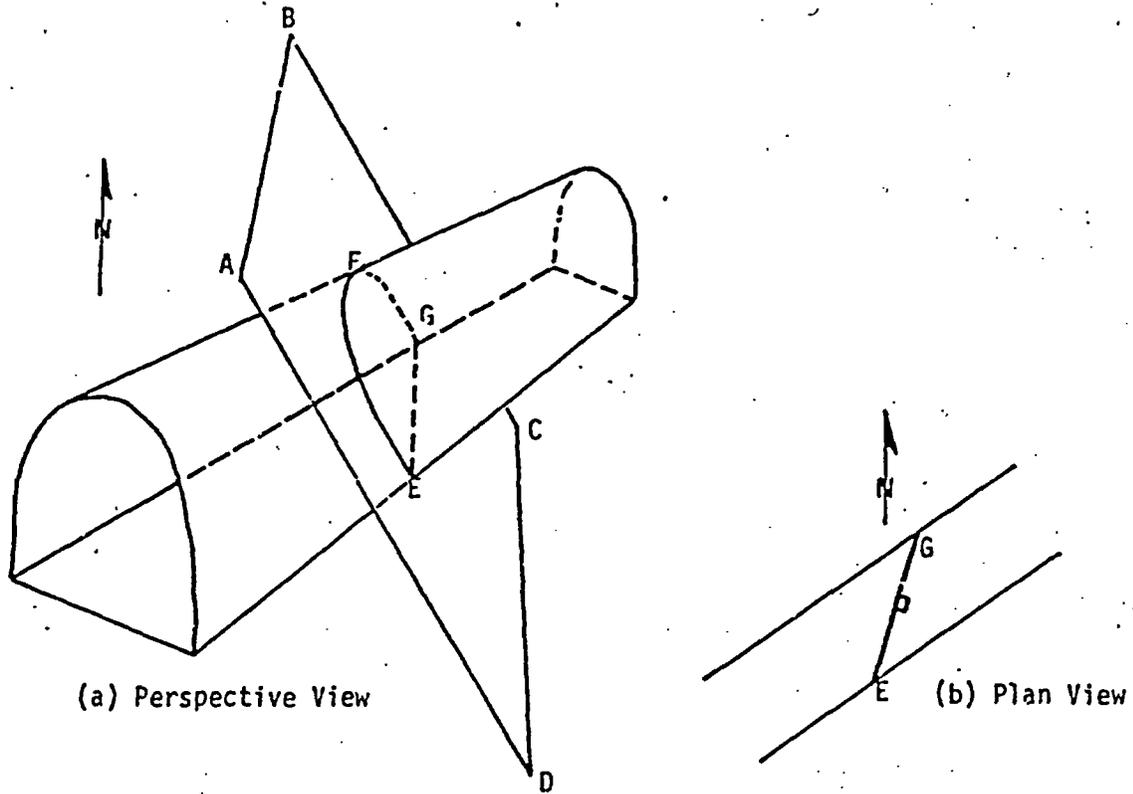
Fig. 4. Schematic diagram of mapping technique. Fracture plane ABCD in (a) strikes NNE and dips steeply to the east. Its intersection with the drift is the trace line EFG, and the mapped representation of the fracture in plan view is shown in (b).

Figure 4 schematically shows how the fractures were projected onto the floor map. Continuous features were mapped in plan view according to their intersection with the floor of the drift. Since the floors of the drifts are not exposed, the intersections were inferred by extrapolating between traces in the ribs. For fractures that are continuous and well-defined, the technique is quite reliable; however, it is less reliable for major features that are truncated, parallel to the drift or otherwise not visible in opposite ribs. In these cases the traces in the floor must be extrapolated from outcrops in only one rib or in the roof of the drift. Uncertainty arising from such measurements or extrapolations were noted in the mapping.

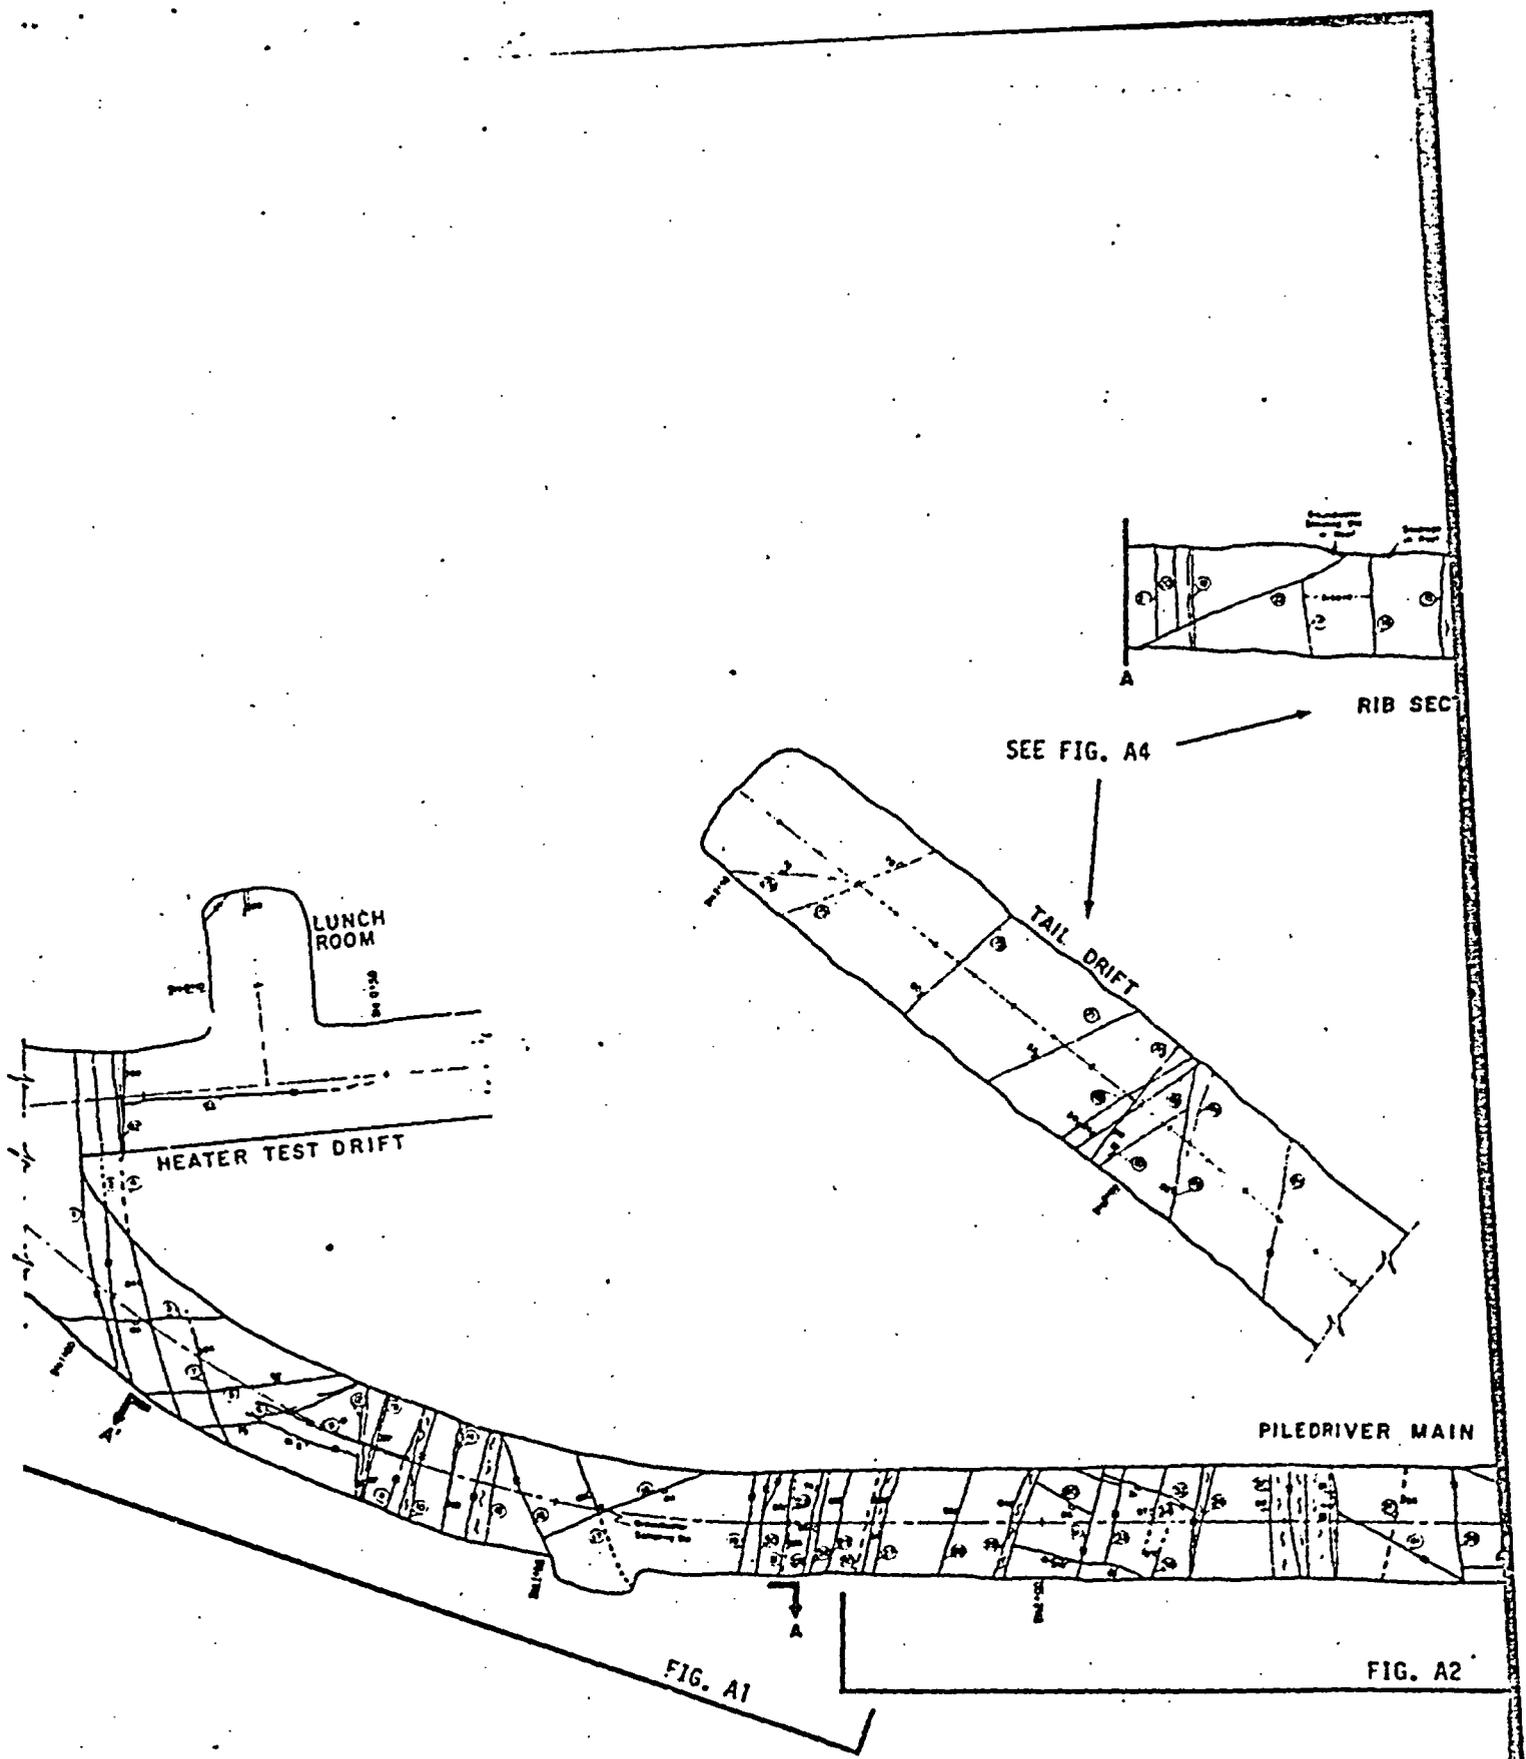
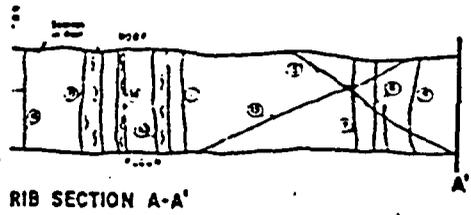
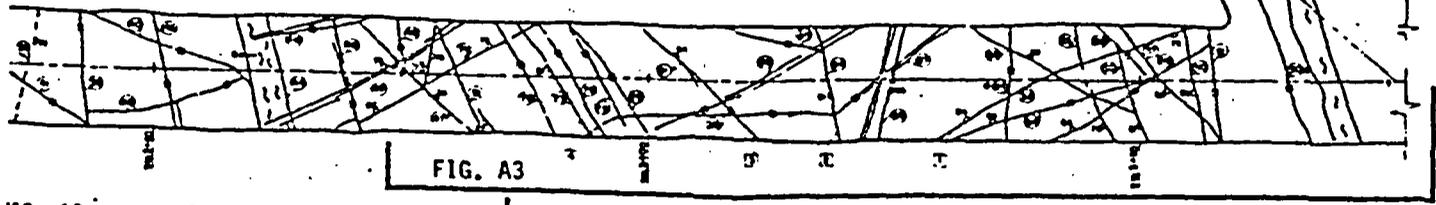
Fig. 5. Floor map of major discontinuities in Tail and Main Access Drifts at 420m level of Climax Stock, NTS.

Results of the mapping are summarized by Fig. 5, which has been reduced from its original 1:60 scale. In order to provide maps suitable for future field work, enlargements of the composite portions indicated in Fig. 5 are given at a scale of 1:120 in Appendix A. A total of ninety features were sampled in the heater test alcove, access drift, and tail drift; and each is described in Appendix B according to its assigned number. Fig. 6 is an equal-area contour diagram of poles to the ninety fractures. Comparing this with the previous results reported for the Climax Stock in Fig. 3, there is general agreement in the predominant fracture or fault orientations. There appears to be some dissimilarity, however, in results for the tail and main access drifts, which is discussed further below.

In many places, the northeast-dipping, low-angle features are observed to truncate high angle fractures. Examples of this can be found in the rib map (Section AA') of Fig. 5. Evidence of faulting along the low-angle fractures is absent, and therefore would be an unlikely cause for the truncation. Our tentative explanation is that the low-angle discontinuities, either open or healed at the time, effectively blocked the propagation of the later high-angle fractures. Our data on such a relationship is indeed limited, and further detailed mapping would be needed to substantiate this explanation.

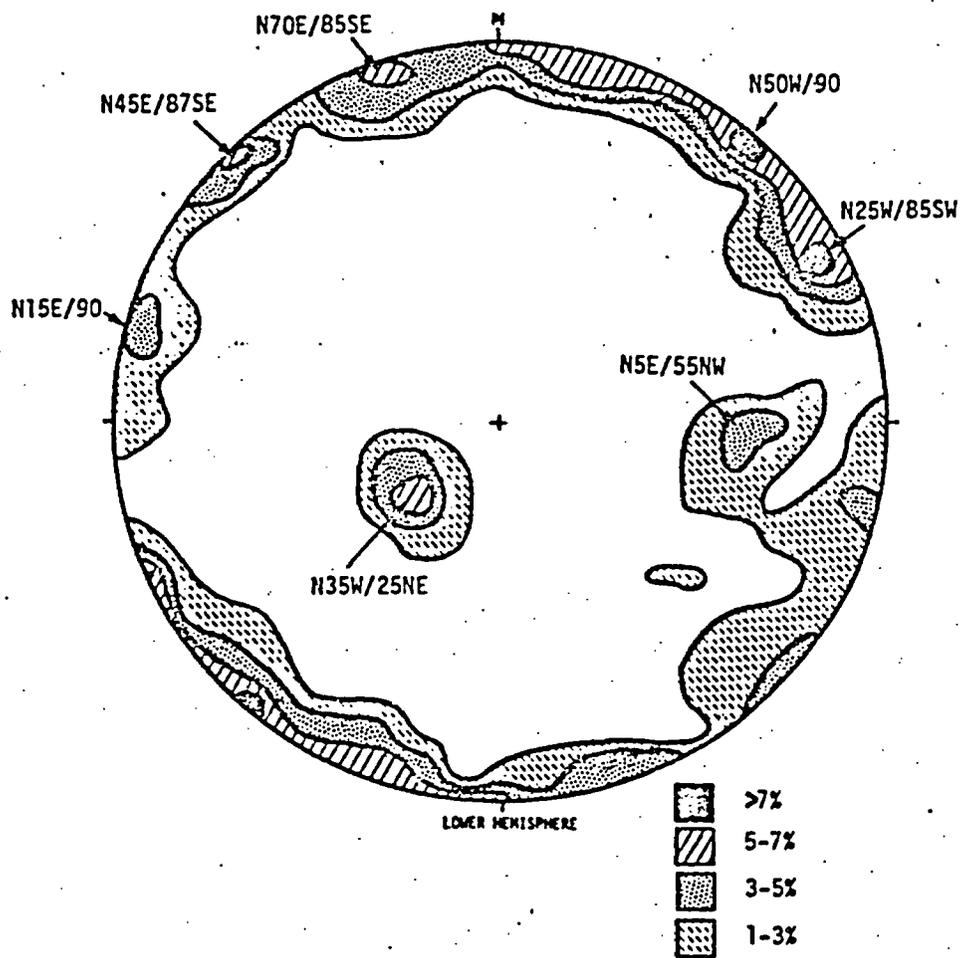
Fig. 6. Equal-area contour diagram of poles to 90 fractures mapped in the main access and tail drifts, based on data from Figs. 7 and 9. (Concentrations in percentage of points within on percent area counting circle).

Another prominent grouping in Fig. 6 is oriented N45E/87SE and corresponds to the NE-striking set of high-angle fractures reported by Maldonado (1977) and Wilder and Patrick (1980). Two lesser modes occur near this set at N70E/85SE and N15E/90, however these do not correlate with previous mappings. Throughout most of the area mapped in the main access

drift these fractures can be observed striking nearly parallel to the drift. Clearly, the sampling is geometrically biased against them, plus it is difficult to accurately measure orientations when the traces are in the roof of the tunnel. For the most part, fractures of this set were found to be quite variable in orientation (wavy) and discontinuous, which was not strictly in accordance with our sampling criteria. Therefore, a more detailed mapping effort in this area probably would yield a stronger clustering in Fig. 6.

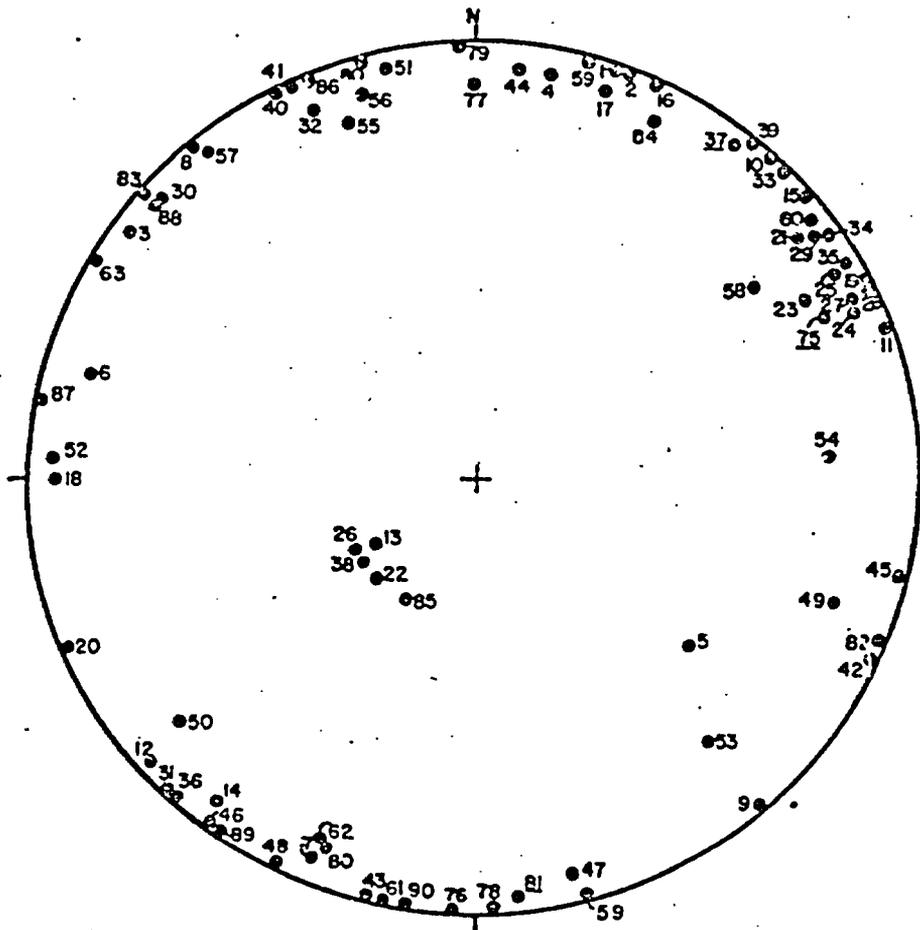
Fig. 7. Lower hemisphere Schmidt plot of poles to fractures mapped in the main access drift. Numbers correspond to features on base map; those underlined indicate average measurements on curved surfaces.

Seventy-nine of the fractures mapped are located in the main access drift, and an equal-area pole plot of these is given in Fig. 7. In cases where a fracture is curved, the average of several different measured orientations was plotted. The predominant orientation of the fractures in the access drift is N50W/90 as indicated by Fig. 6. A somewhat lesser peak within this clustering is oriented N25W/85SW. These correspond roughly to the NW-striking fault and joint sets reported by Maldonado, as well as to some of the shear zones and joints given by Wilder and Patrick (1980). Typical mineralization of fractures in the main access drift is mostly calcite, with some iron oxide and chlorite. The wall rock is sometimes altered to clay. Thickness of filling varies widely both on a given fracture and among fractures, but for single, unsheared features it is typically one to three millimeters.

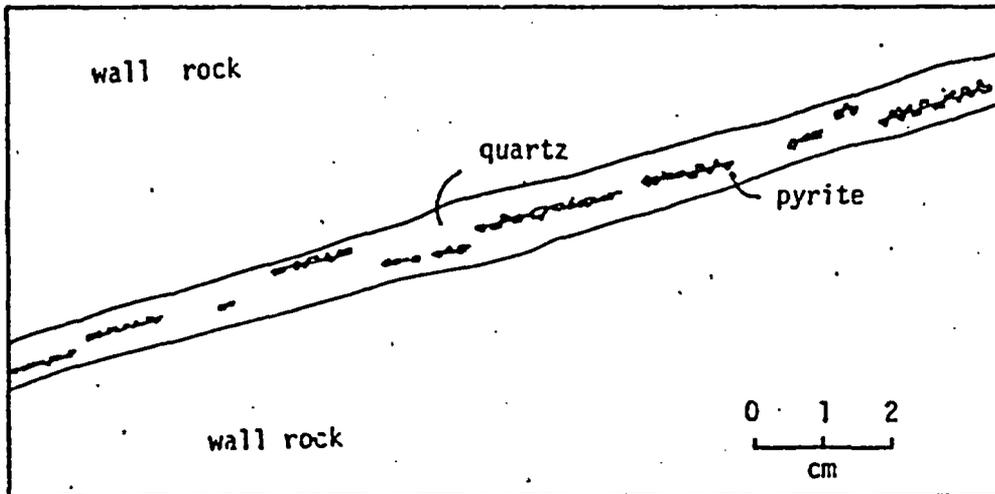
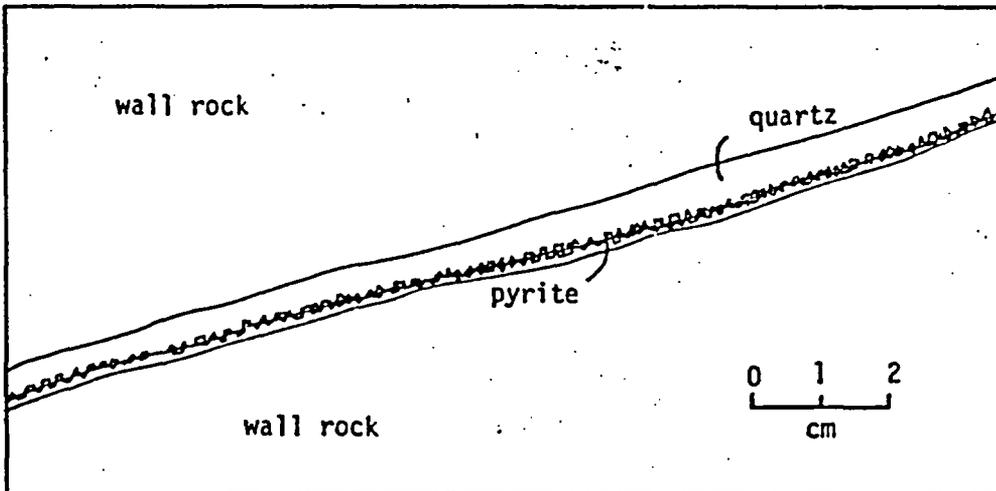
Fig. 8. (a) Low-angle healed fracture with discontinuous pyrite stringers. (b) Low-angle healed fracture with pyrite as a continuous layer. Open breaks or fissures tend to be along the continuous portions of the pyrite.

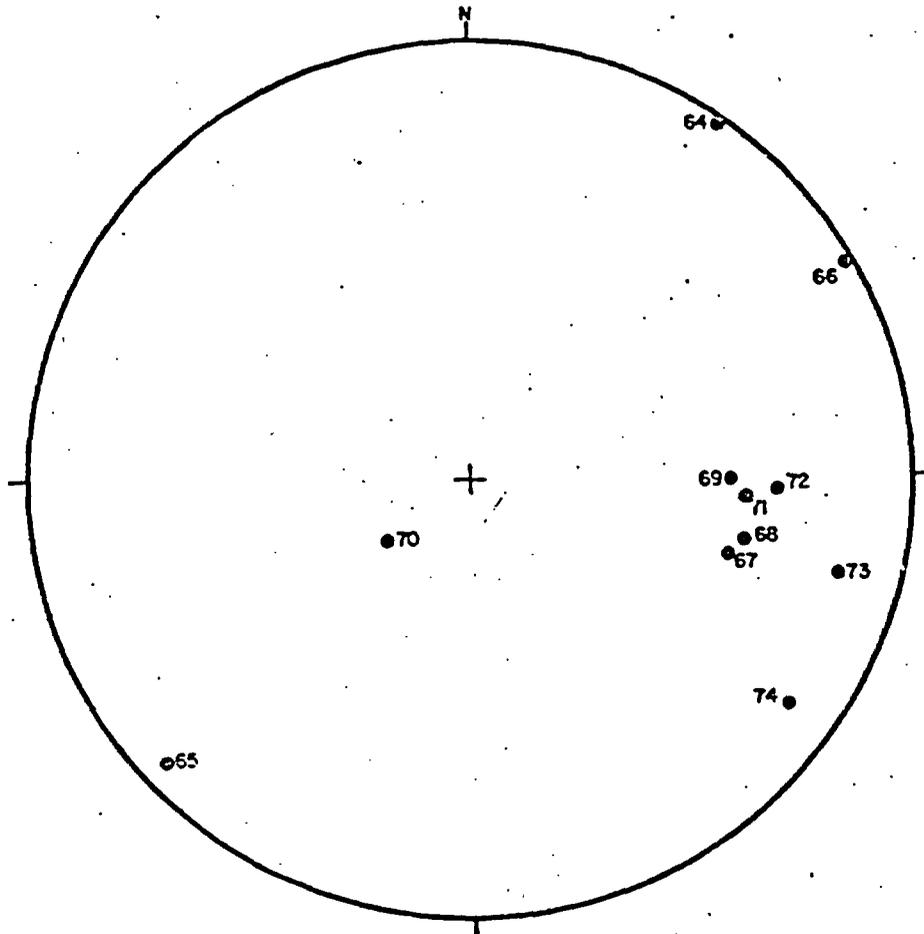
Fig. 9. Lower hemisphere Schmidt plot of poles to fractures mapped in the tail drift.

Far fewer major fractures were found in the tail drift than in the main access drift. Only eleven were identified over a distance of about 30 meters (frequency = 0.37 fracture/m), whereas the main access drift yielded a frequency of 79/85 m = 0.93 fracture/m. Three of the major fractures fall into the NW-striking, high-angle set, and one belongs to the low-angle NE-dipping set of the Stock (Fig. 9). The remaining seven fractures have a mean orientation of about N5E/50NW, which lies outside the major NE-striking set described earlier. However, Wilder and Patrick (1980) report the latter as the dominant joint orientation in the tail drift, which would indicate that none of those joints apparently met the continuity or persistence criteria for our mapping. Orientation of the drift with respect to the NE-striking set would be of lesser importance in causing this bias.

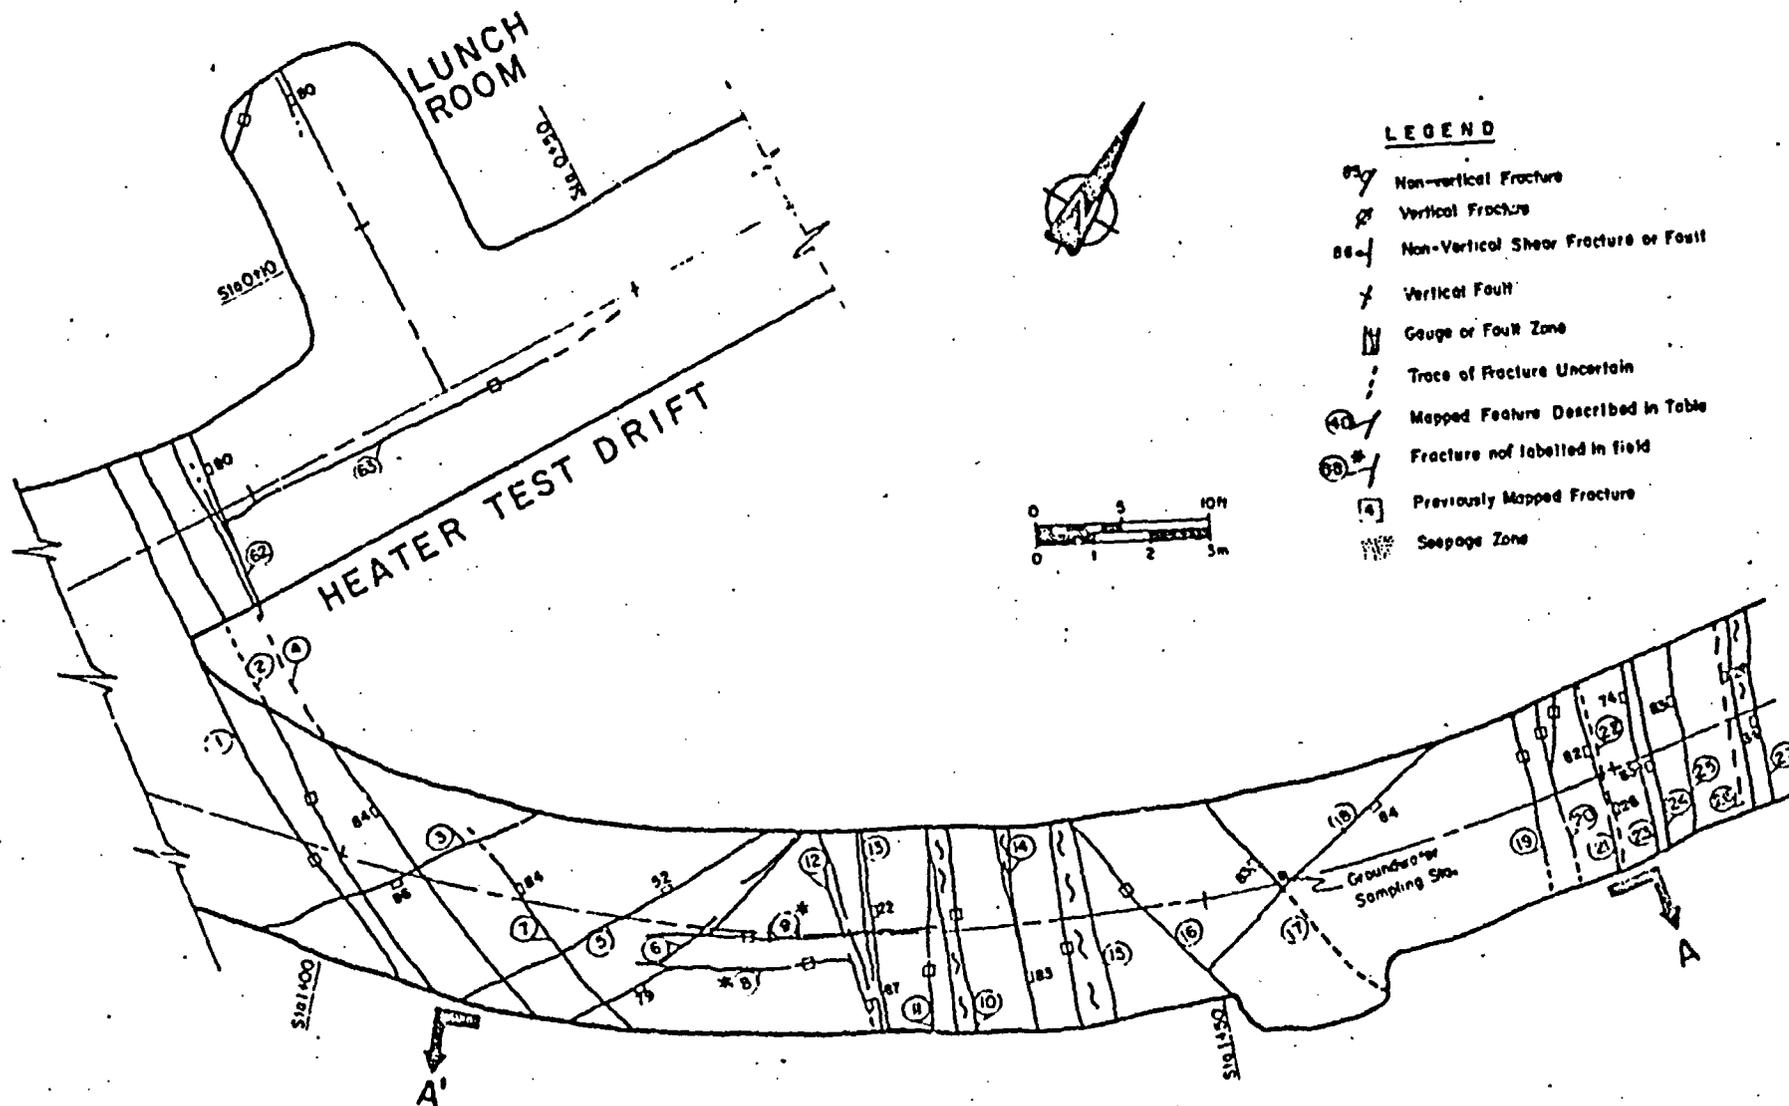
Fig. A1. Floor map of Heater Test Drift and Main Access Drift from station 0+90 to 1+85.

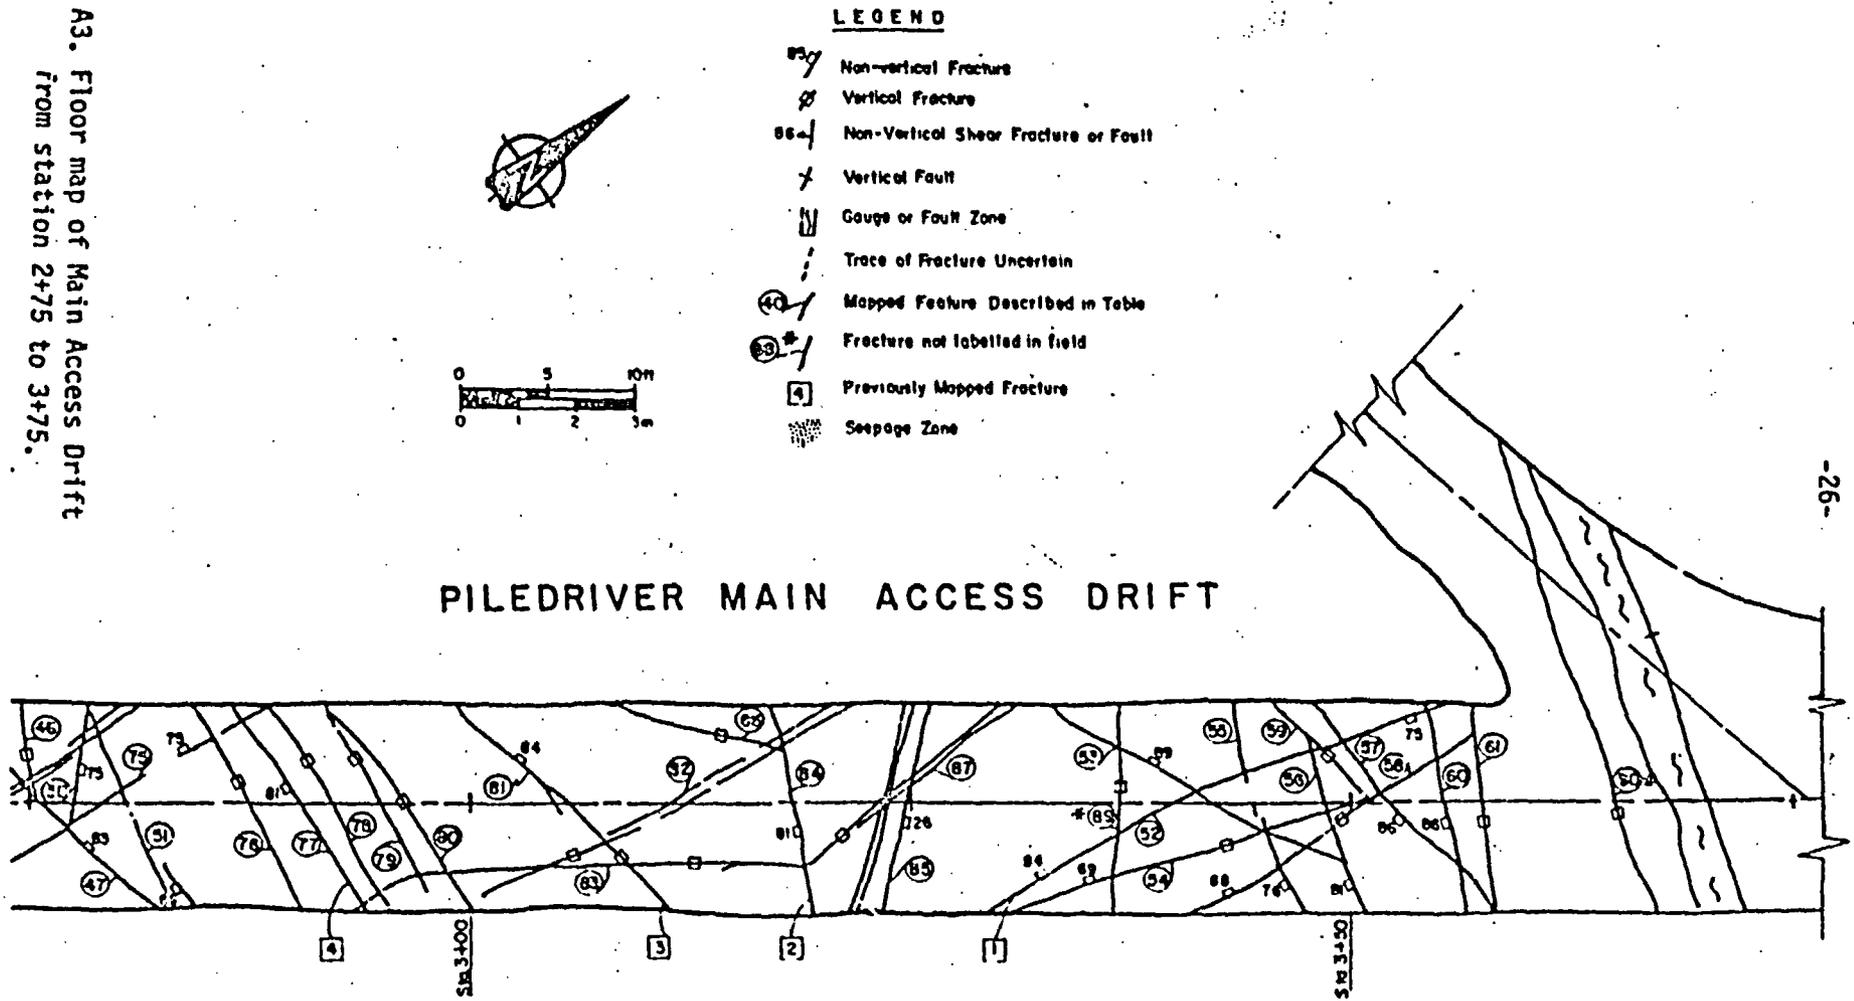
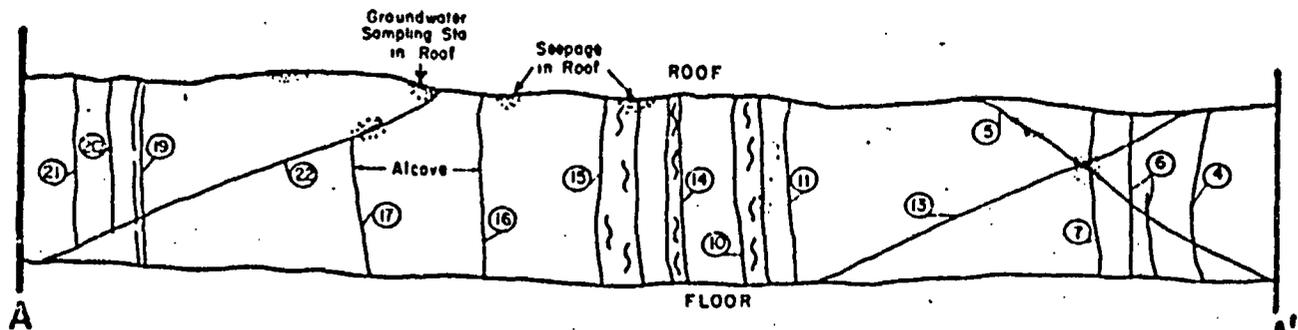
RIB SECTION A-A'

Fig. A4. Tail Drift floor map and south rib map in vicinity of station 1+50.

Along the access drift from station 1+10 to station 1+85 water can be seen seeping from low-angle discontinuities. In order to show the relation of the wet and dry features in this area, an additional map of part of the southwest rib was prepared. This appears as section A-A' on the fracture map which is discussed in the following section.
