BNP - USNRC Region II Update

Neil Gannon
November 25, 2003

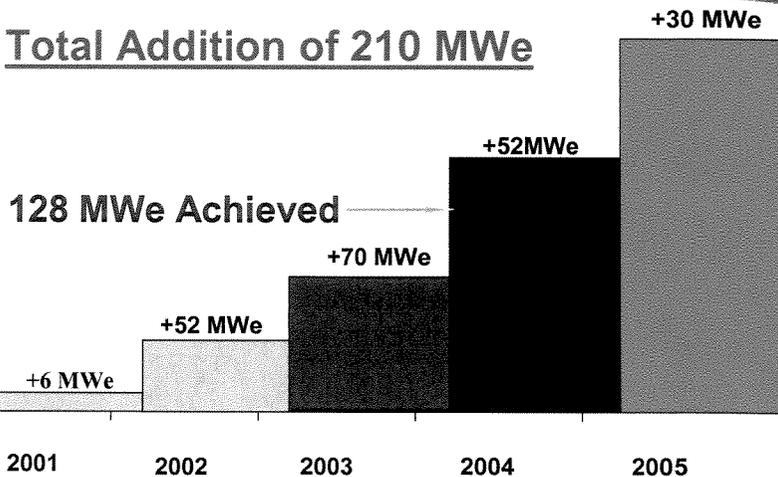
2001 – 2005 BNP Power Uprate

Total Addition of 210 MWe

- MELLLA+ License Implementation
- Main Transformers
- Moisture Separator Reheater (MSR)
 - Relief Valve Upgrade
 - Tube Bundle and Reheat Section
- Feedwater Heaters (3)
- Isophase Cooling
- Condensate & Feed Pump Upgrades

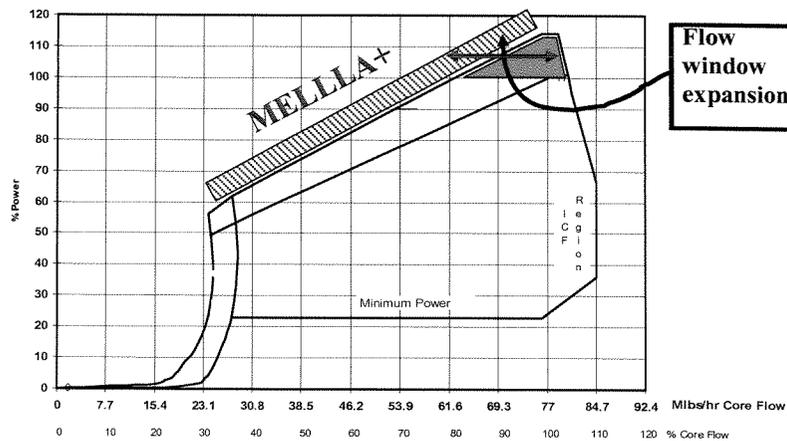
Expanded Power-Flow with MELLLA+

- MELLLA+ Is an Extension of the Existing Power Flow Map
- At Full Uprate Conditions, the Existing Flow Window Is Very Restrictive
 - ▶ 3.0% Unit 2
 - ▶ 5.5% Unit 1
- MELLLA+ Provides Flow Window for Sustained Operation at 120% OLTP

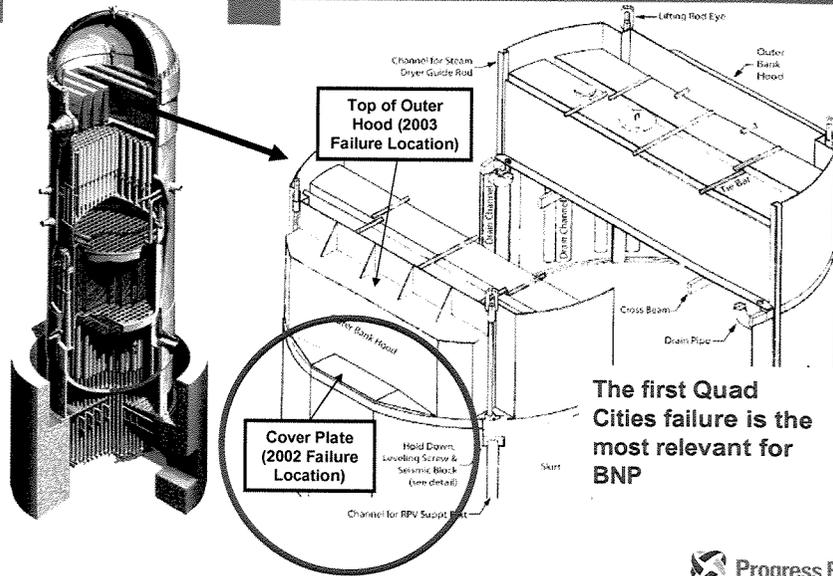
Quad Cities Dryer Failures

- MELLLA+ License
 - Needed for full power base load operation
 - BNP is Lead Plant
- Reactor Core Design
 - 120 % Original Licensed Power
 - 2-year operating cycle
 - 97% capacity factor
- Reactor Dryer Structural Design
 - Quad Cities failures (BWR-3)
 - BNP evaluation in progress

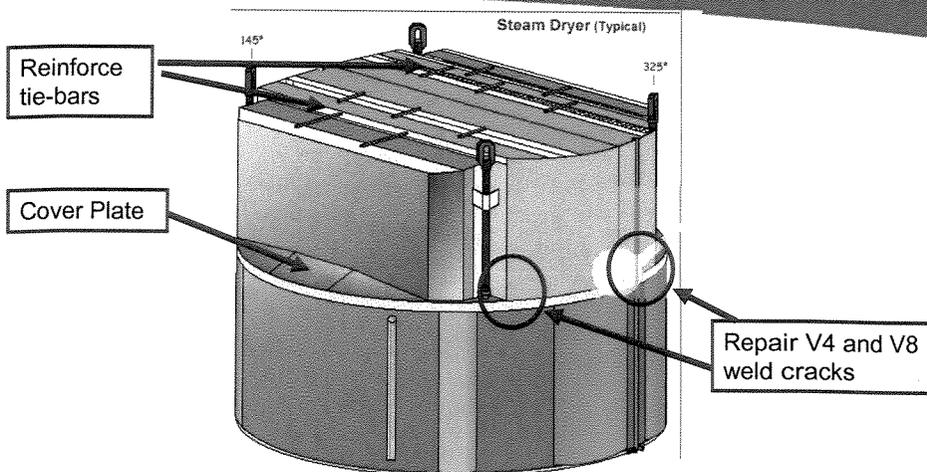
BNP Dryer Modifications & Repairs

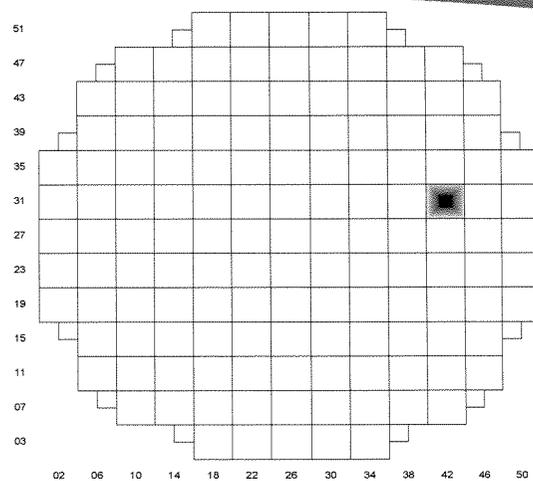
U2 Fuel Leak – Core Location

- Unit 2 Fuel Leak detected 5/27/03 (7 weeks into new cycle).
- Promptly suppressed with one control rod.
- Second suppression rod inserted 8/22/03.
- Leak believed to be GE-14 (most likely first cycle)

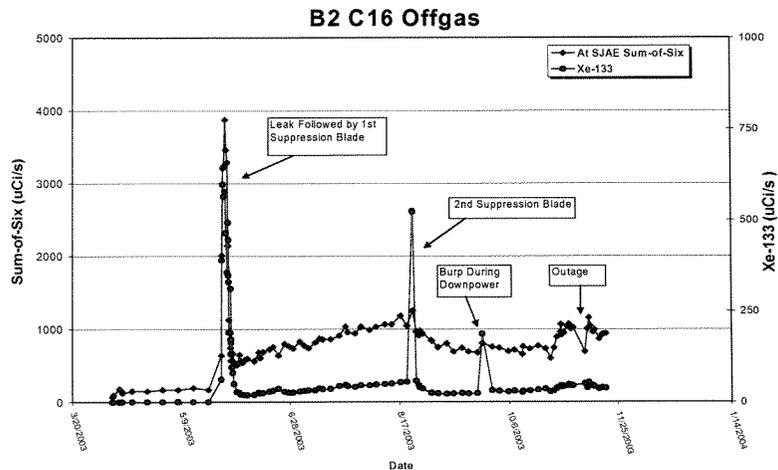
U2 Fuel Leak – Off-gas Trend

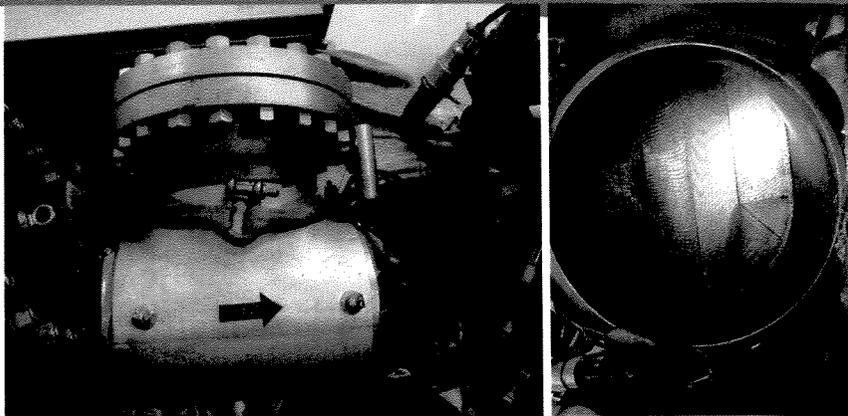
HD Strainer Assembly

- High flow T-strainers with removable stainless steel basket screens were installed in the discharge piping of the Unit 2 Heater Drain Pumps during B216R1
- Strainers of the same design will be installed in Unit 1 during B115R1
