RS-03-232

Dresden Nuclear Power Station, Units 2 and 3
Facility Operating License Nos. DPR-19 and DPR-25
NRC Docket No. 50-237 and 50-249

Quad Cities Nuclear Power Station, Units 1 and 2
Facility Operating License Nos. DPR-29 and DPR-30
NRC Docket Nos. 50-254 and 50-265

Subject: Additional Information for the Review of the License Renewal Applications for Dresden Nuclear Power Station, Units 2 and 3 and Quad Cities Nuclear Power Station, Units 1 and 2

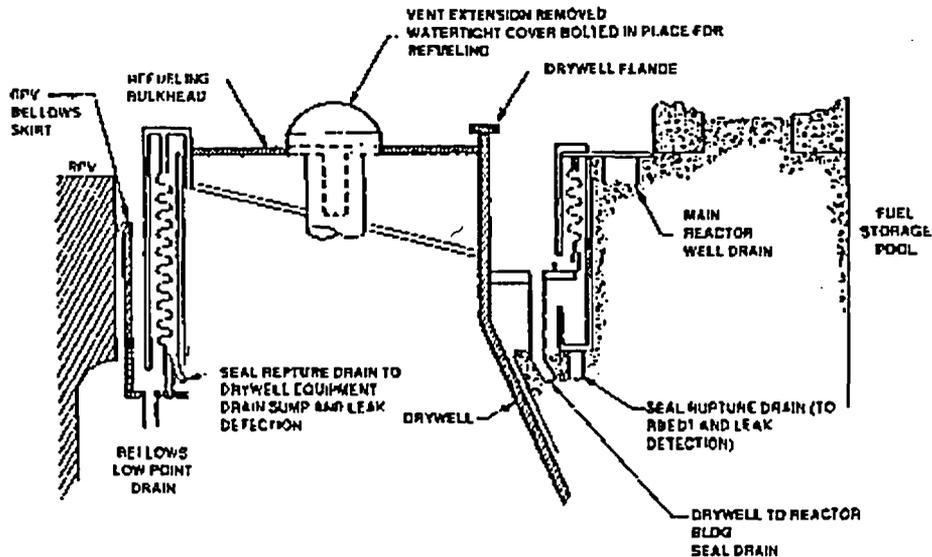
Leakage past the RPV-to-drywell refueling seal is collected and directly piped by design to the drywell equipment drain sump. Refer to the following drawing.

A high flow switch in the drain line to the equipment drain sump provides an alarm in the control room if flow >1 gpm is detected (there is an additional high level alarm on the sump itself). The annunciator response procedure directs actions to quantify/mitigate the leakage, since excessive flow through the drain line could eventually result in leakage into the drywell.

It should be noted that inspection of the condition of the drywell interior coating is periodically performed under approved procedures. In the extremely unlikely event of leakage through the RPV-to-drywell refueling seal sufficient to overwhelm the hard-piped drain system and enter the drywell, periodic inspection and maintenance of the coating will prevent corrosion that could eventually impact drywell structural adequacy. There is no operating experience of leakage through the RPV-to-drywell bellows ever bypassing the drain system.
