NUREG/CR-4692
ORNL/NOAC-233

**Operating Experience Review
of Failures of Power Operated
Relief Valves and Block Valves
in Nuclear Power Plants**

Engineering Technology Division
Nuclear Operations Analysis Center

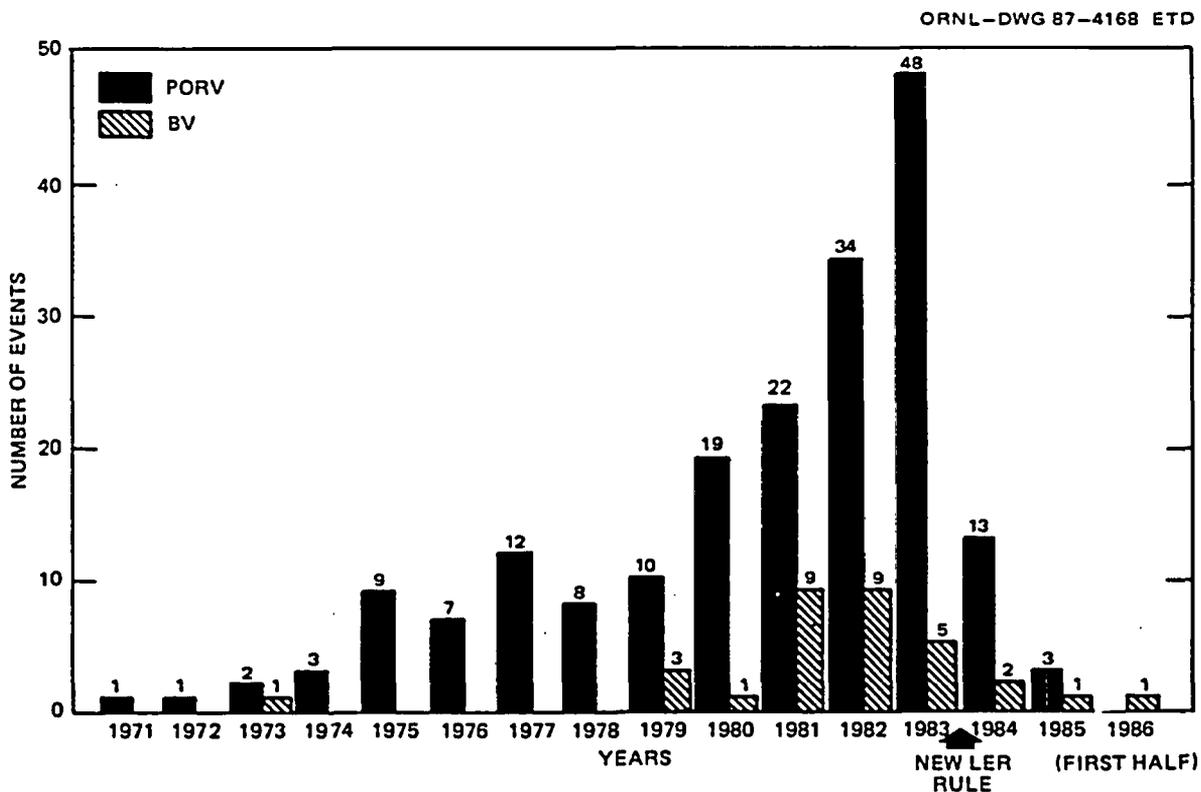
Fig. 1. Reported PORV failure events 1971-1986

Note that because PORVs are not classified as safety related, their failures were not always reported, especially in earlier years (before 1979) (see Fig. 1). Consequently, PORV failures may have been more prevalent than indicated. However, after the Three Mile Island Unit 2 (TMI-2) accident, increased sensitivity to PORV (and BV) operability problems probably led to increased reporting of such events. Nonetheless, a revised LER reporting rule, which went into effect Jan. 1, 1984, did not specifically require reporting of all PORV or BV failures; hence, the number of LER-reported failures of these components has decreased sharply from post-TMI levels. In both cases, the actual number of PORV and BV failures may actually be higher than shown on Fig. 1. One purpose of the new LER rule was to shift reporting of single failures to the INPO NPRDS system. In time, NPRDS should have better PORV failure data, provided that the utilities accurately and consistently report such failures.

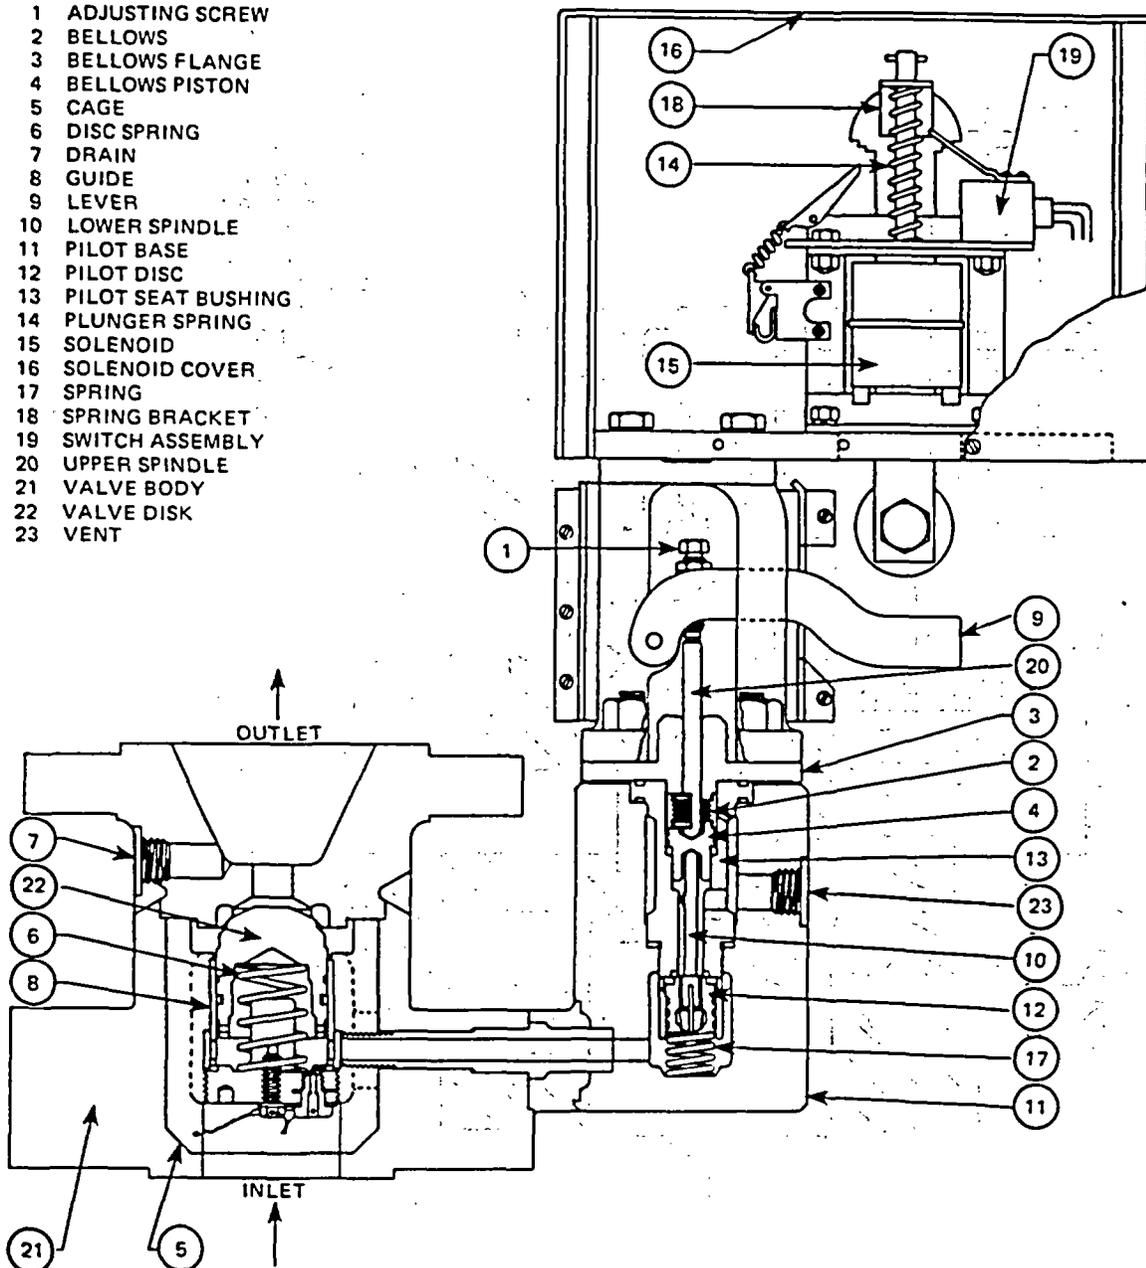
- 1 ADJUSTING SCREW
- 2 BELLOWS
- 3 BELLOWS FLANGE
- 4 BELLOWS PISTON
- 5 CAGE
- 6 DISC SPRING
- 7 DRAIN
- 8 GUIDE
- 9 LEVER
- 10 LOWER SPINDLE
- 11 PILOT BASE
- 12 PILOT DISC
- 13 PILOT SEAT BUSHING
- 14 PLUNGER SPRING
- 15 SOLENOID
- 16 SOLENOID COVER
- 17 SPRING
- 18 SPRING BRACKET
- 19 SWITCH ASSEMBLY
- 20 UPPER SPINDLE
- 21 VALVE BODY
- 22 VALVE DISK
- 23 VENT

Fig. 2. Pilot-operated relief valve (Courtesy of Dresser Industries)

The pilot-operated relief valve consists of a main valve with piston- or diaphragm-operated disk and a pilot (Figs. 2-5). Under normal operating conditions, the pilot allows system pressure into the piston chamber. Because the piston area is greater than the disk seat area, the disk is held closed. When the set pressure is reached, the pilot is actuated to vent the piston chamber, which allows the disk to open. Some valve designs also shut off system fluid to the piston chamber.

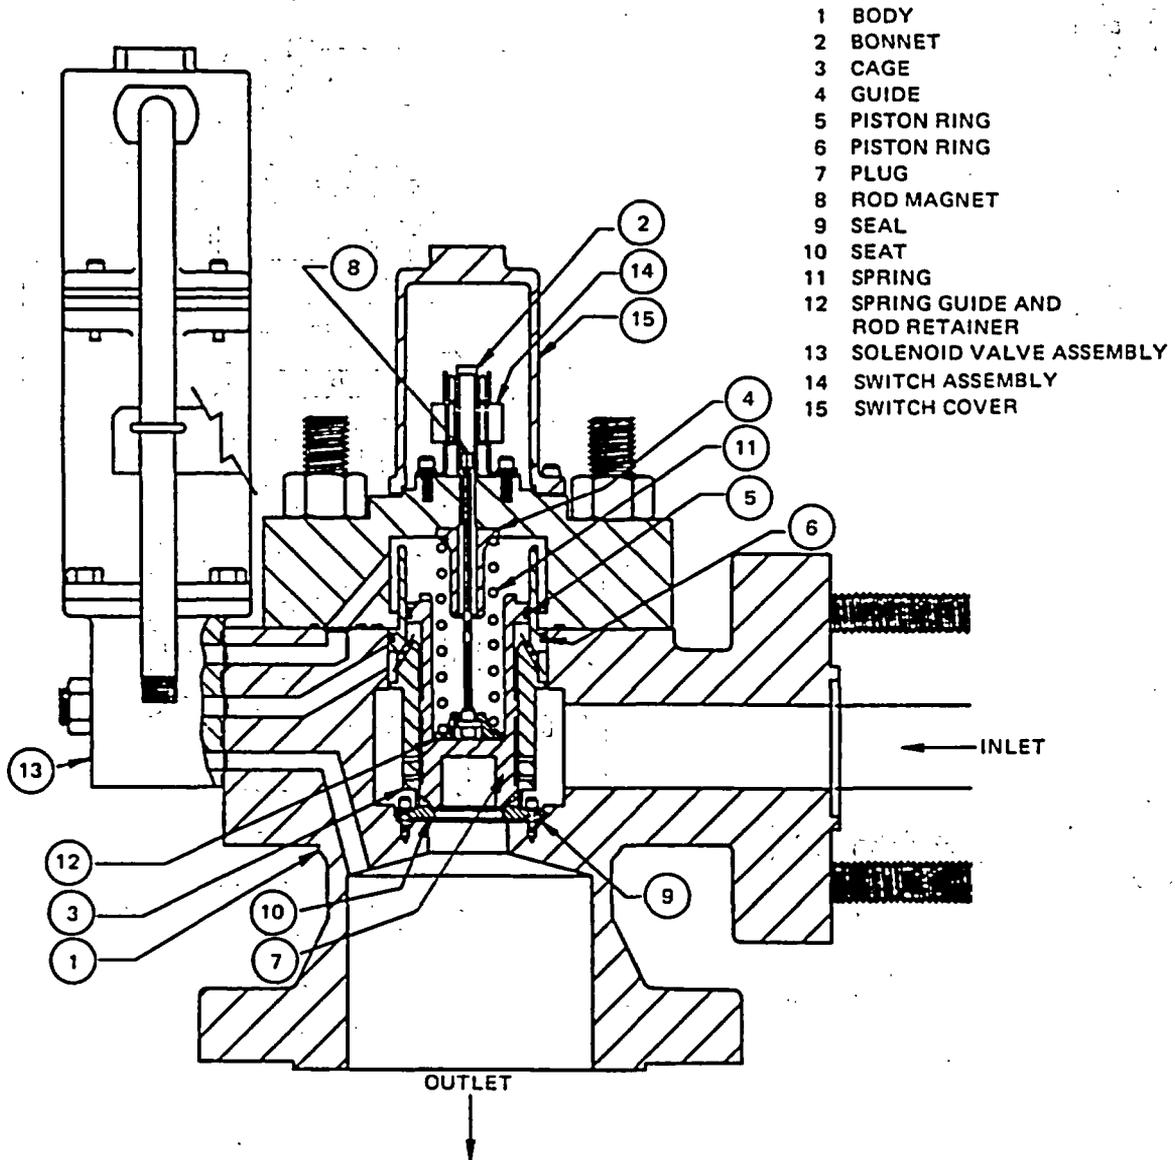
Fig. 3. Pilot-operated relief valve (Courtesy of Crosby Valve and Gage Company)

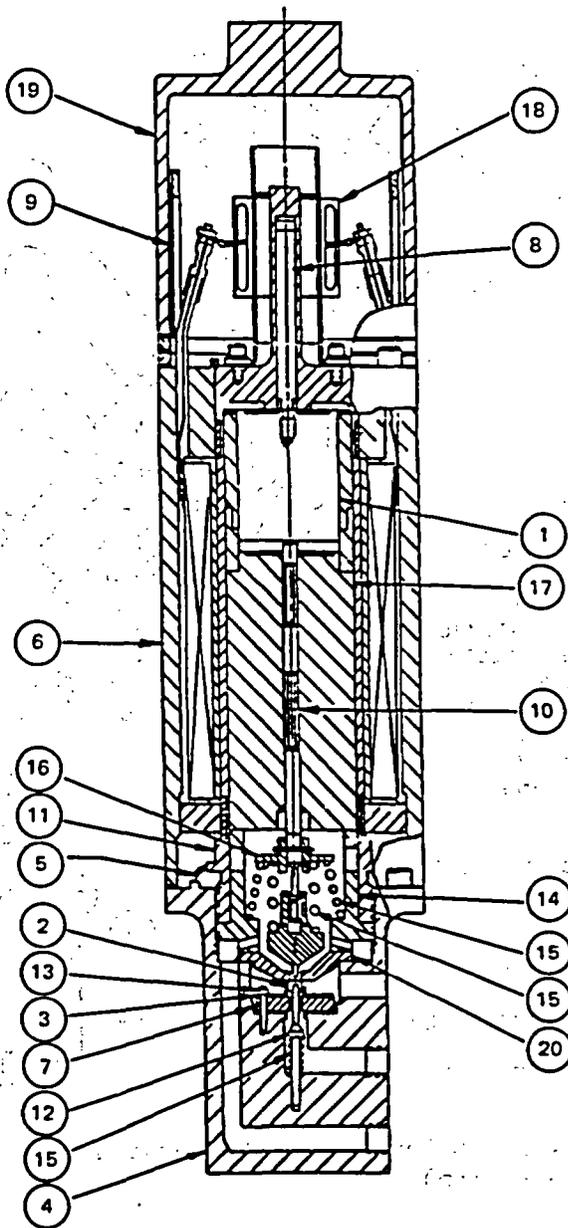
- 1 ARMATURE ASSEMBLY
- 2 BALL
- 3 BALL GUIDE
- 4 BODY
- 5 CANOPY
- 6 ELECTROMAGNET ASSEMBLY
- 7 LOWER SEAT
- 8 MAGNET ROD ASSEMBLY
- 9 MAGNETIC SHUNT
- 10 OVERRIDE ASSEMBLY
- 11 PRESSURE VESSEL
- 12 RETURN STEM
- 13 SCREW
- 14 SEAT RETAINER
- 15 SPRING
- 16 SPRING RETAINER
- 17 STOP ASSEMBLY
- 18 SWITCH ASSEMBLY
- 19 SWITCH COVER
- 20 UPPER SEAT

Fig. 4. Solenoid valve assembly for Crosby PORV — part No. 13 on Fig. 3 (Courtesy of Crosby Valve and Gage Company)

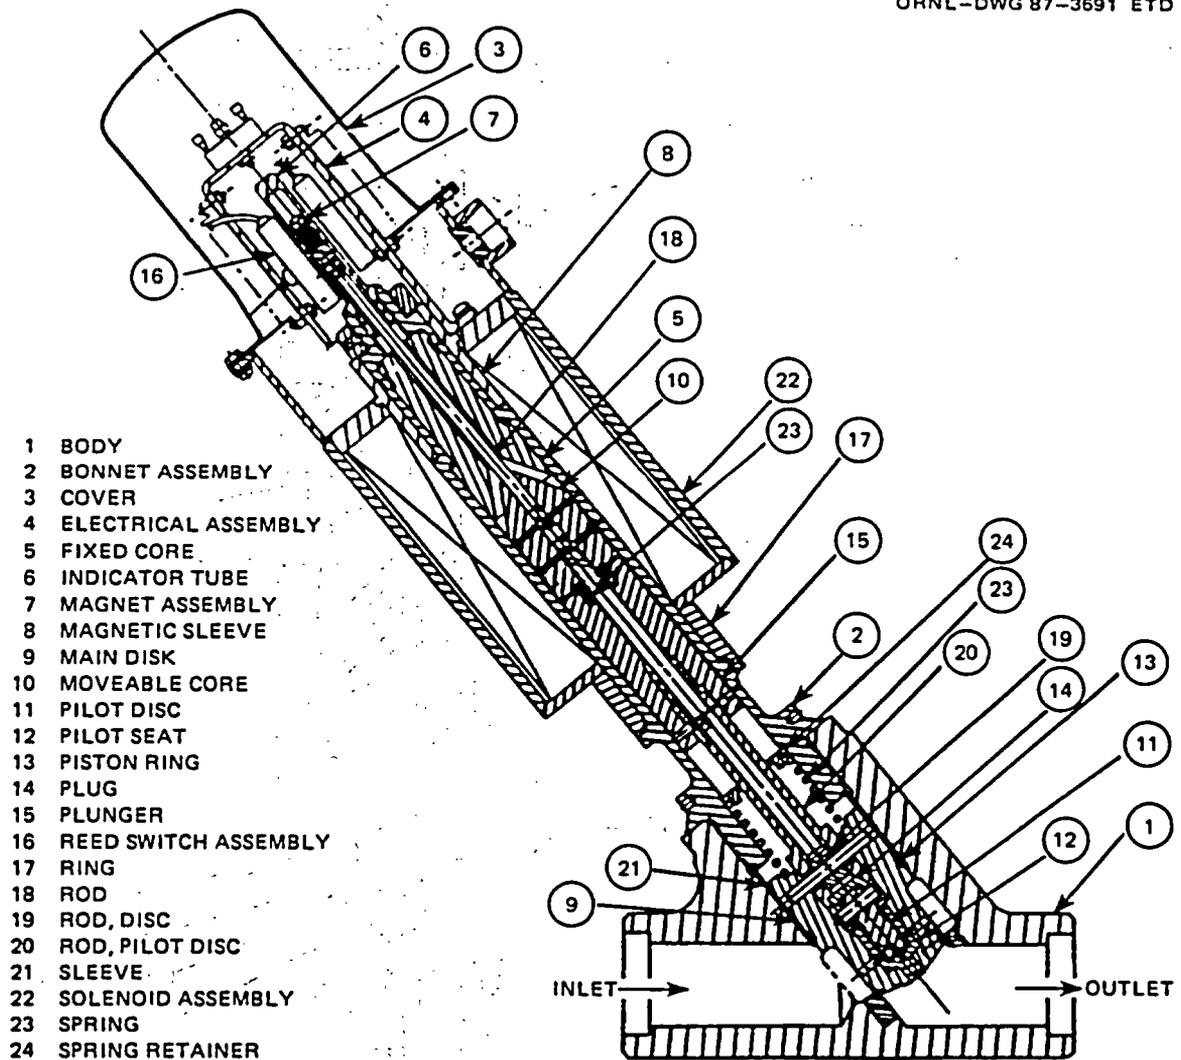
Fig. 5. Solenoid pilot-operated relief valve (Courtesy of Target Rock Corporation)

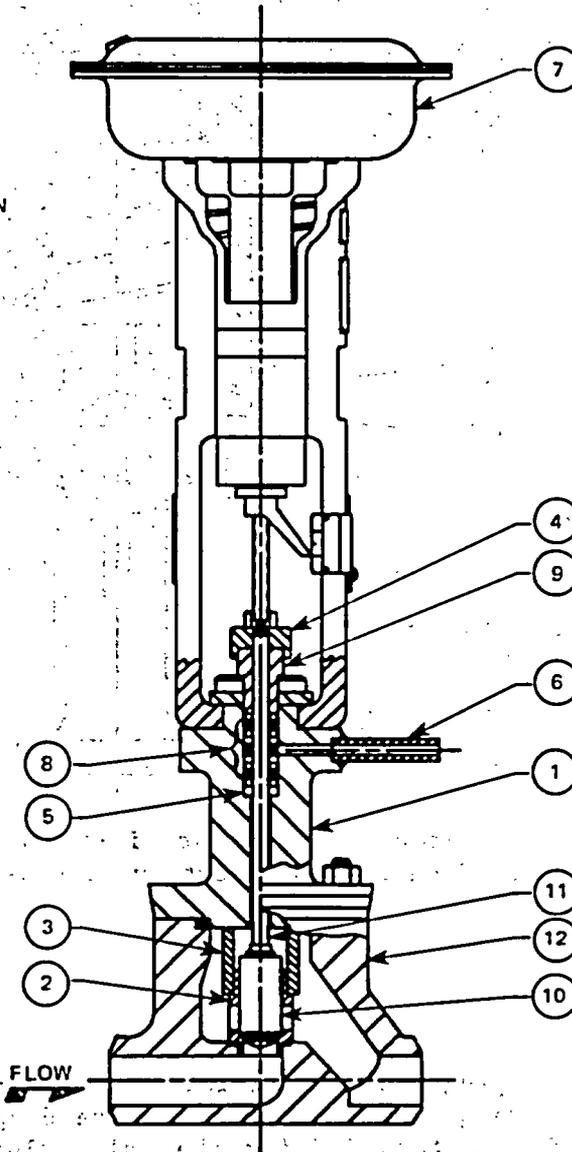
- 1 BONNET
- 2 CAGE WITH SEAT
- 3 CAGE SPACER
- 4 GLAND FOLLOWER
- 5 GUIDE BUSHING
- 6 LEAKOFF CONNECTION
- 7 OPERATOR ASSEMBLY
- 8 PACKING
- 9 PACKING GLAND
- 10 PLUG
- 11 STEM
- 12 VALVE BODY

Fig. 6. Air-operated (spring-loaded) relief valve (Courtesy of Copes-Vulcan)

The air-operated (spring-closure) style of PORV (Figs. 6 and 7) utilizes a large compression spring to provide seating force to the

valve stem and plug with an air-loaded reverse-acting operator attached. To open the valve, air pressure loads the diaphragm chamber to overcome the spring force, thus lifting the valve plug off the seat. Positive closure is provided by the spring return upon venting the air pressure from the diaphragm chamber. The Control Components, Inc., PORV differs in that air pressure provides both the valve opening and closing forces with a compression spring providing a backup closing force.

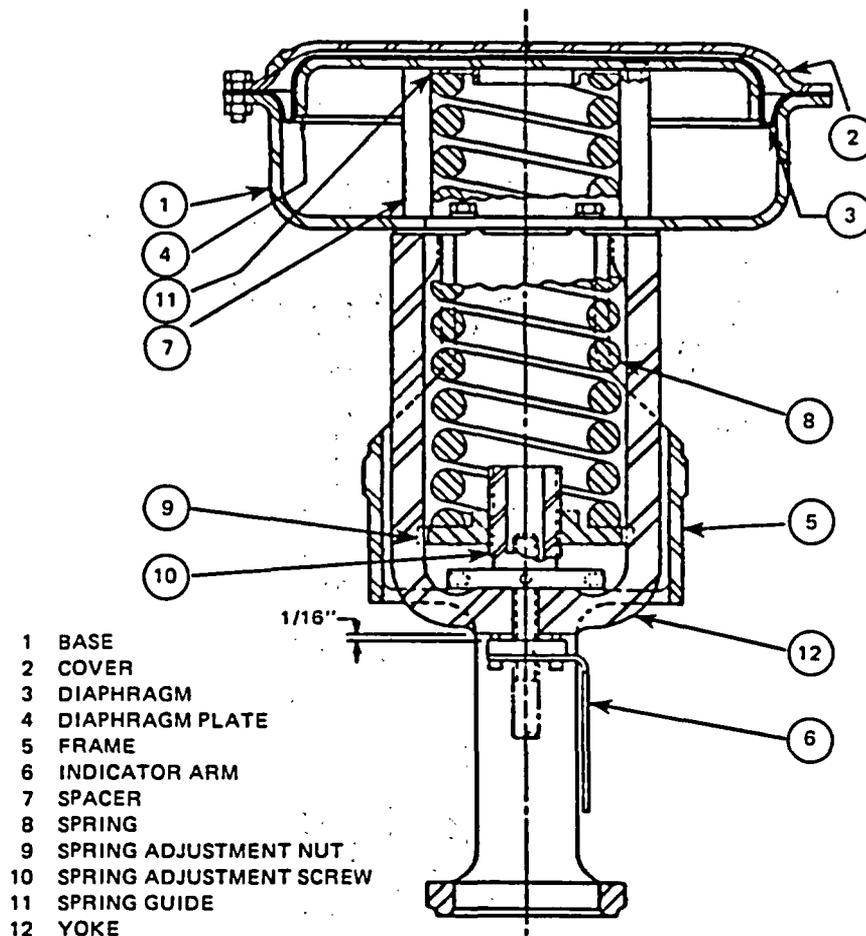
Fig. 7. Operator assembly for air-operated (spring-loaded) relief valve — part No. 7 on Fig. 6 (Courtesy of Copes-Vulcan)
