TRANSMITTAL OF MEETING HANDOUT MATERIALS FOR  
IMMEDIATE PLACEMENT IN THE PUBLIC DOMAIN

Purpose of Meeting  
(copy from meeting notice) Meeting with the BWROG  
to discuss effects of  
extended power updates on  
plant operation.

CONCERNS RELATED TO  
POTENTIAL ADVERSE FLOW EFFECTS  
FROM POWER UPRATES

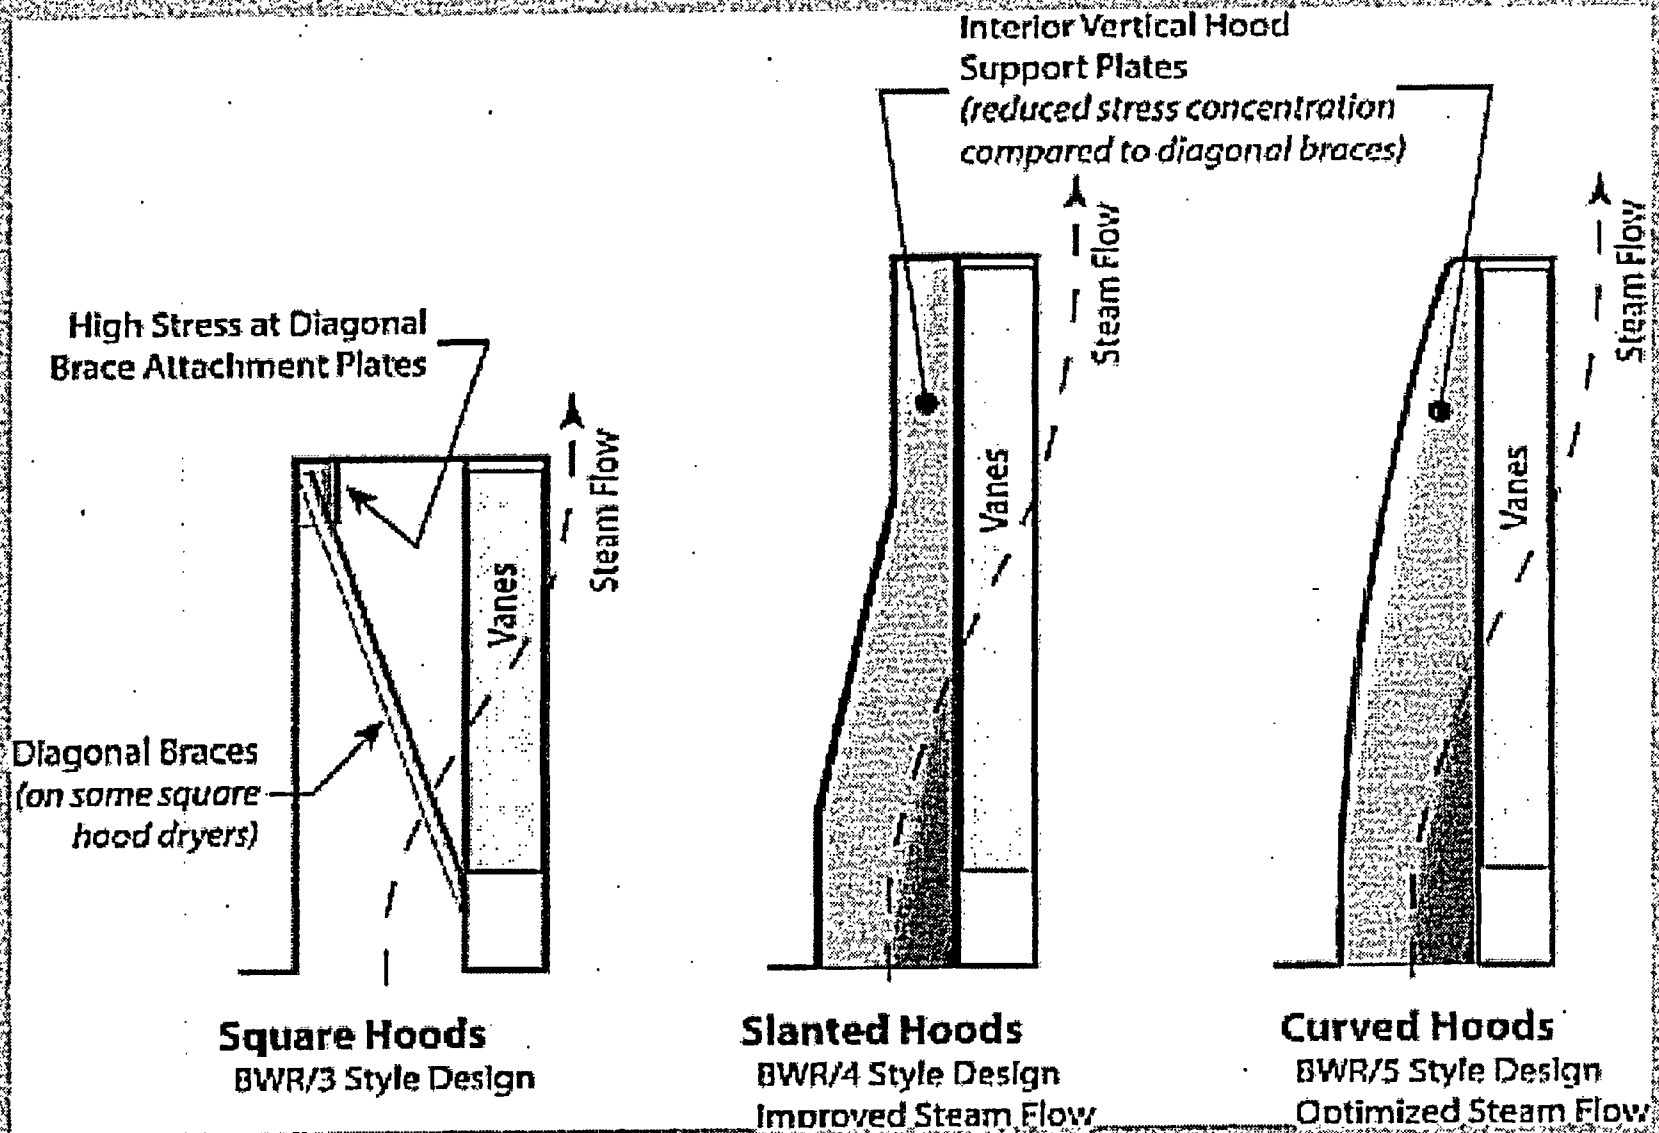
# Basic GE Steam Dryer Hood Types

- \* BWR 3; square hood and internal braces
  - High stresses where braces attach to hood
  - Some BWR 3 dryers do not have internal braces
- \* BWR 4; slanted hoods, internal braces replaced with plates that reduce the maximum stress
- \* BWR 5 and later; curved hoods to optimize steam flow, retained the internal plates; even lower maximum stress
- \* Higher MSL velocities increases the amplitude of flow induced and acoustic load forcing functions that lead to high cycle fatigue
  - Quad Cities and Dresden have small 20" diameter steam lines

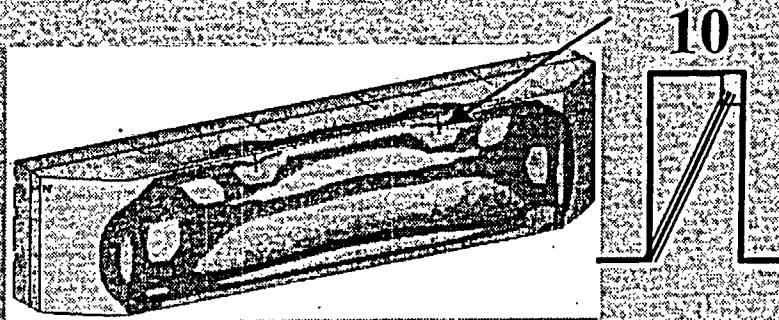
Square Hood w/Struts

# Relative Stress on GE Steam Dryer Hoods

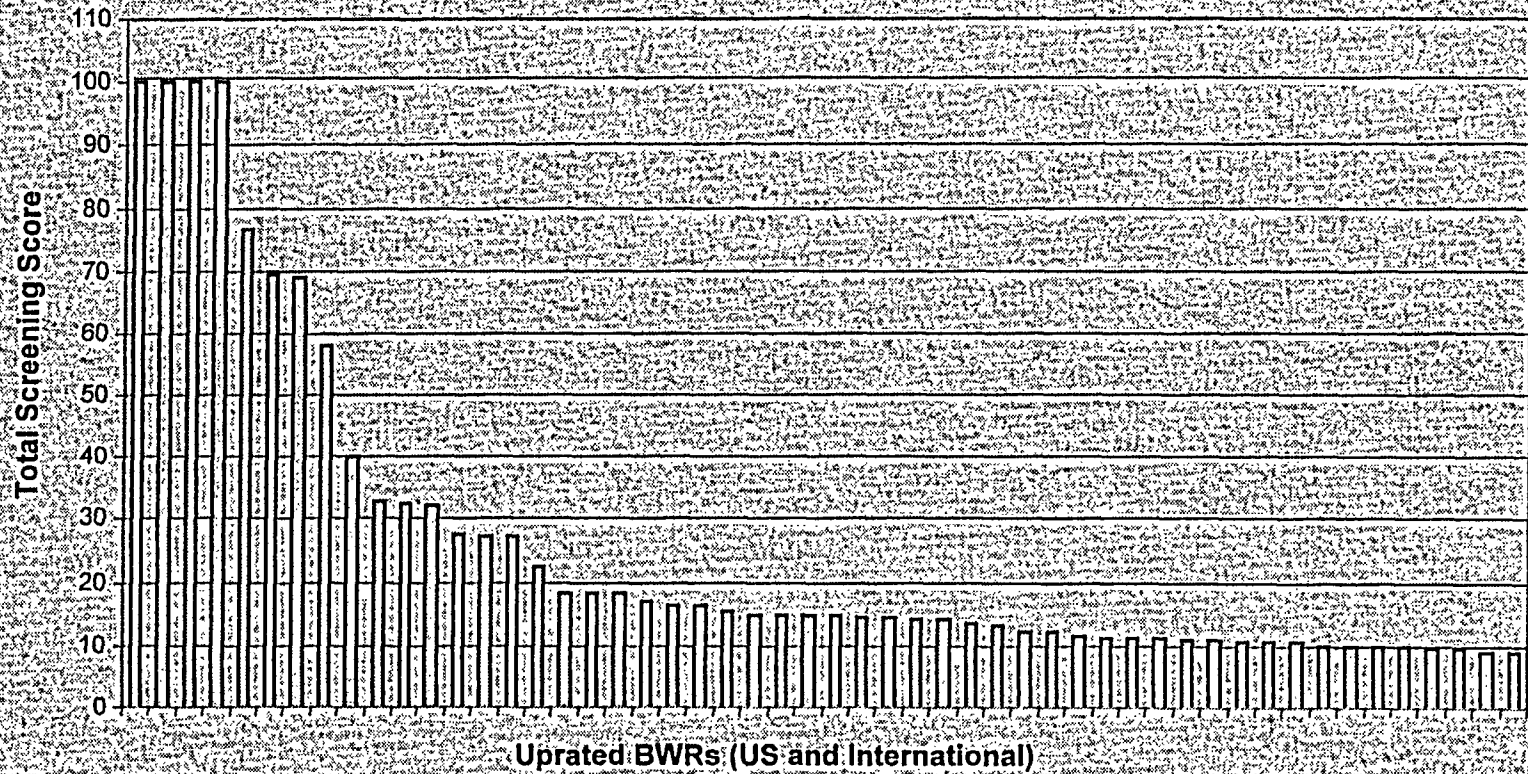
# SCREENING MATRIX RESULTS

**75% of updated U.S. BWR dryer failure probabilities are less than 20% of highest screening matrix results (BWR 3s are highest risk)**

- 
- \* Relative steam dryer failure probability function of:
    - Square of steam velocity
    - Relative stress on steam dryer hoods from finite element analysis

<b>Plant</b>	<b>Average Flow Vel. / Line (ft/sec)</b>	<b>Pressure Load Score</b>	<b>Hood Type</b>	<b>Stress Score</b>	<b>Relative Score</b>
Plant 4	202	10.00	Flat	10	100
Plant 5	168	6.90	Flat	10	69
Plant 17	141	4.87	Slanted	3	15
Plant 20	134	4.43	Slanted	3	13
Plant 22	172	7.23	Curved	2	14
Plant 14	181	8.03	Curved	2	16
