3rd NRC – AERB Nuclear Safety Projects Meeting February 23 – 28, 2004

Materials Degradation Management Regulatory Strategies

Edmund J. Sullivan, Senior Materials Engineer U. S. Nuclear Regulatory Commission Office of Nuclear Reactor Regulation Email: ejs@nrc.gov Phone: 301-415-2796

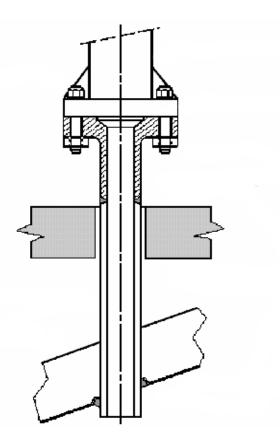
Typical CRD Housing

Cross-section showing the important components of a control rod drive housing and a section of the reactor head.

Depending on the location of the penetration, the J-groove weld will be nearly symmetric (at or near the top of the head), or significantly asymmetric (at a downhill location). The two extremes are reflected in substantially different distributions of the residual stress.

- Control rod drives above reactor vessel in pressurized water reactors
- Control rod drive penetrations in the vessel upper head also called vessel head penetrations (VHP)
- Generic Letter 97-01 issued to motivate inspections of VHPs
