Joseph M. Farley Nuclear Plant Units 1 and 2
Application for License Renewal –
January 22, 2004 and February 3, 2004 Requests for Additional Information

UNIT 1 VERTICAL TENDONS
ACTUAL FORCE TREND
(from past 6 surveillances)

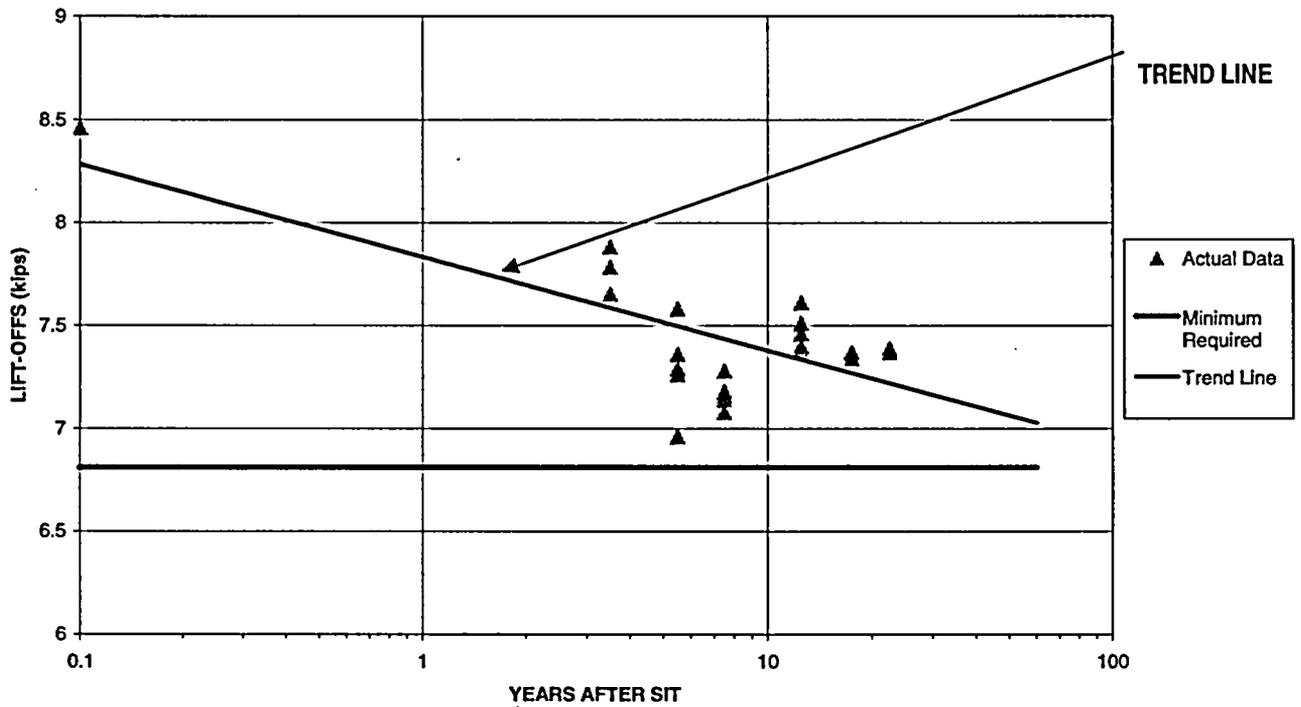
Year	Actual	Year	Actual
0.1	8.46	7.5	7.18
3.5	7.88	7.5	7.28
3.5	7.65	12.5	7.38
3.5	7.78	12.5	7.46
3.5	7.65	12.5	7.61
3.5	7.78	12.5	7.51
5.5	7.36	12.5	7.40
5.5	7.58	17.5	7.34
5.5	7.26	17.5	7.34
5.5	7.29	17.5	7.37
5.5	6.96	22.5	7.39
7.5	7.16	22.5	7.37
7.5	7.14	22.5	7.37
7.5	7.08

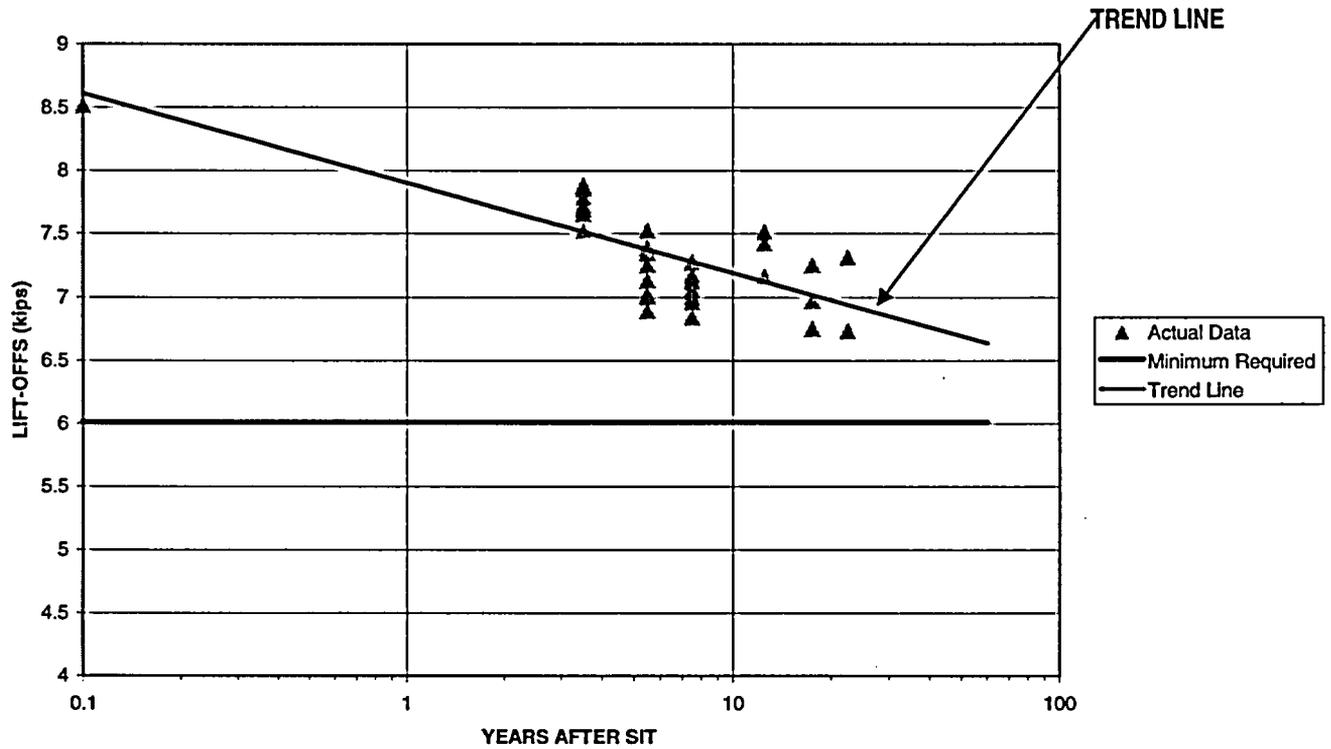
UNIT 1 HOOP TENDONS
ACTUAL FORCE TREND
(from past 6 surveillances)

Year	Actual	Year	Actual
0.1	8.51	7.5	7.28
3.5	7.78	7.5	7.00
3.5	7.87	7.5	6.96
3.5	7.85	7.5	6.84
3.5	7.52	7.5	7.17
3.5	7.88	7.5	7.13
3.5	7.78	7.5	7.12
3.5	7.72	7.5	7.06
3.5	7.69	7.5	7.05
3.5	7.72	7.5	7.27
3.5	7.65	12.5	7.42
5.5	7.52	12.5	7.16
5.5	7.38	12.5	7.51
5.5	7.13	17.5	6.75
5.5	7.02	17.5	6.97
5.5	7.00	17.5	7.25
5.5	7.34	22.5	7.31
5.5	7.39	22.5	6.73
5.5	7.25	22.5	7.31
5.5	6.89		
5.5	7.35

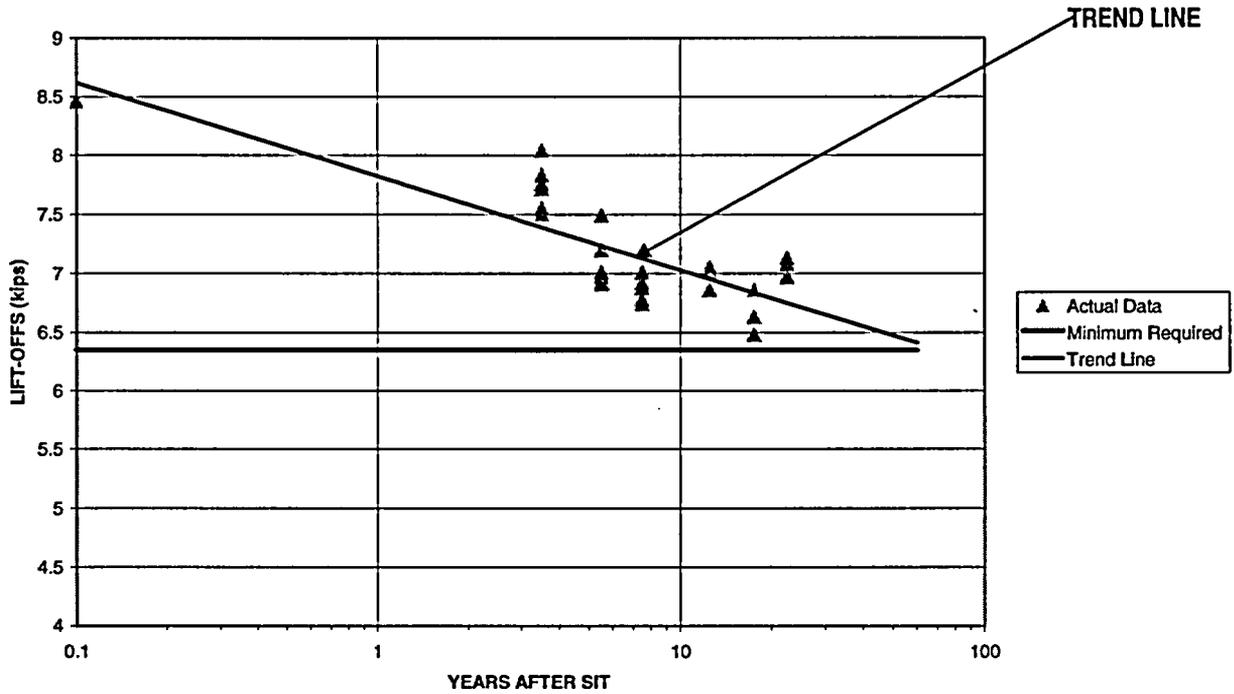
UNIT 1 DOME TENDONS
ACTUAL FORCE TREND
(from past 6 surveillances)

Year	Actual	Year	Actual
0.1	8.46	7.5	6.78
3.5	7.50	7.5	7.01
3.5	7.55	7.5	6.74
3.5	7.72	7.5	6.88
3.5	7.76	7.5	6.92
3.5	7.83	7.5	7.01
3.5	8.04	12.5	7.05
5.5	7.20	12.5	7.02
5.5	6.92	12.5	6.86
5.5	6.91	17.5	6.86
5.5	7.01	17.5	6.48
5.5	7.49	17.5	6.63
5.5	6.97	22.5	7.13
		22.5	6.97
		22.5	7.08
