NL-04-0318

Joseph M. Farley Nuclear Plant Units 1 and 2
Application for License Renewal –
January 22, 2004 and February 3, 2004 Requests for Additional Information

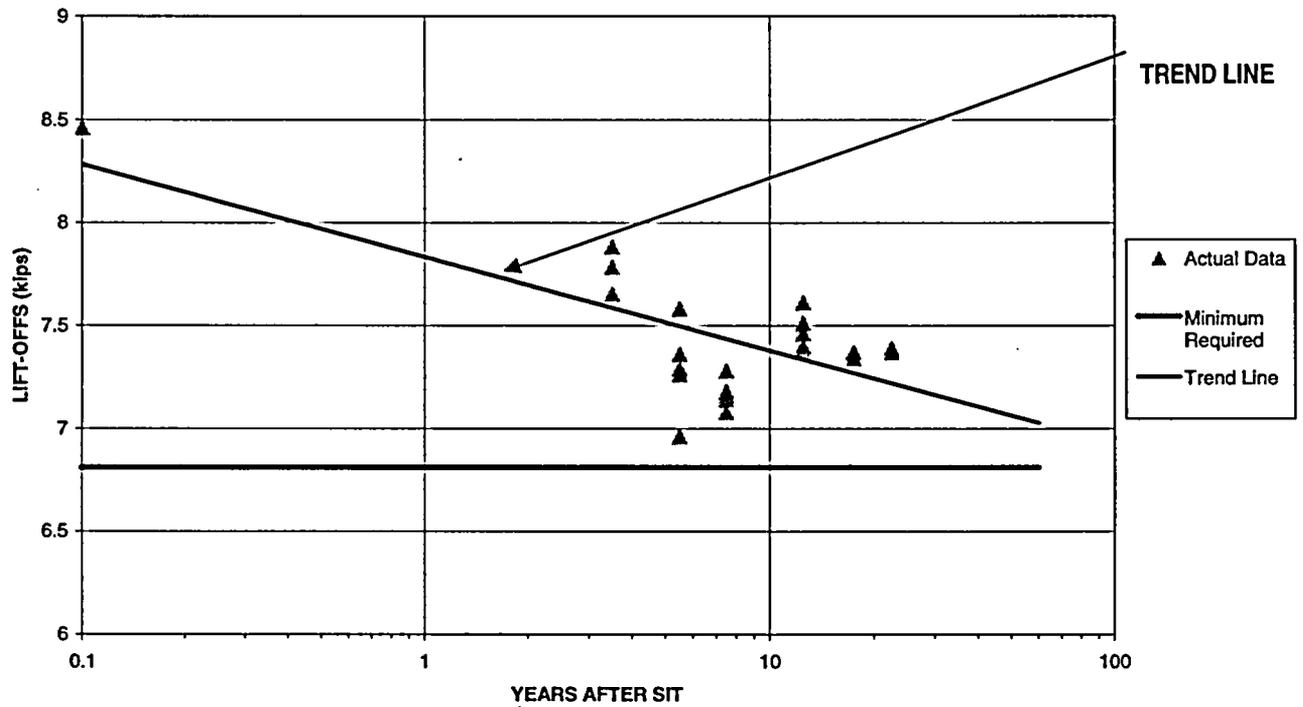
UNIT 1 VERTICAL TENDONS
ACTUAL FORCE TREND
(from past 6 surveillances)

Year	Actual	Year	Actual
0.1	8.46	7.5	7.18
3.5	7.88	7.5	7.28
3.5	7.65	12.5	7.38
3.5	7.78	12.5	7.46
3.5	7.65	12.5	7.61
3.5	7.78	12.5	7.51
5.5	7.36	12.5	7.40
5.5	7.58	17.5	7.34
5.5	7.26	17.5	7.34
5.5	7.29	17.5	7.37
5.5	6.96	22.5	7.39
7.5	7.16	22.5	7.37
7.5	7.14	22.5	7.37
7.5	7.08
