Subject: Licensing Basis for Service Water System Discharge Flow Path

**FirstEnergy Nuclear Operating Company
Davis-Besse Nuclear Power Station, Unit No. 1**

Probability Evaluation for Service Water Return Non-Seismic Flow Paths

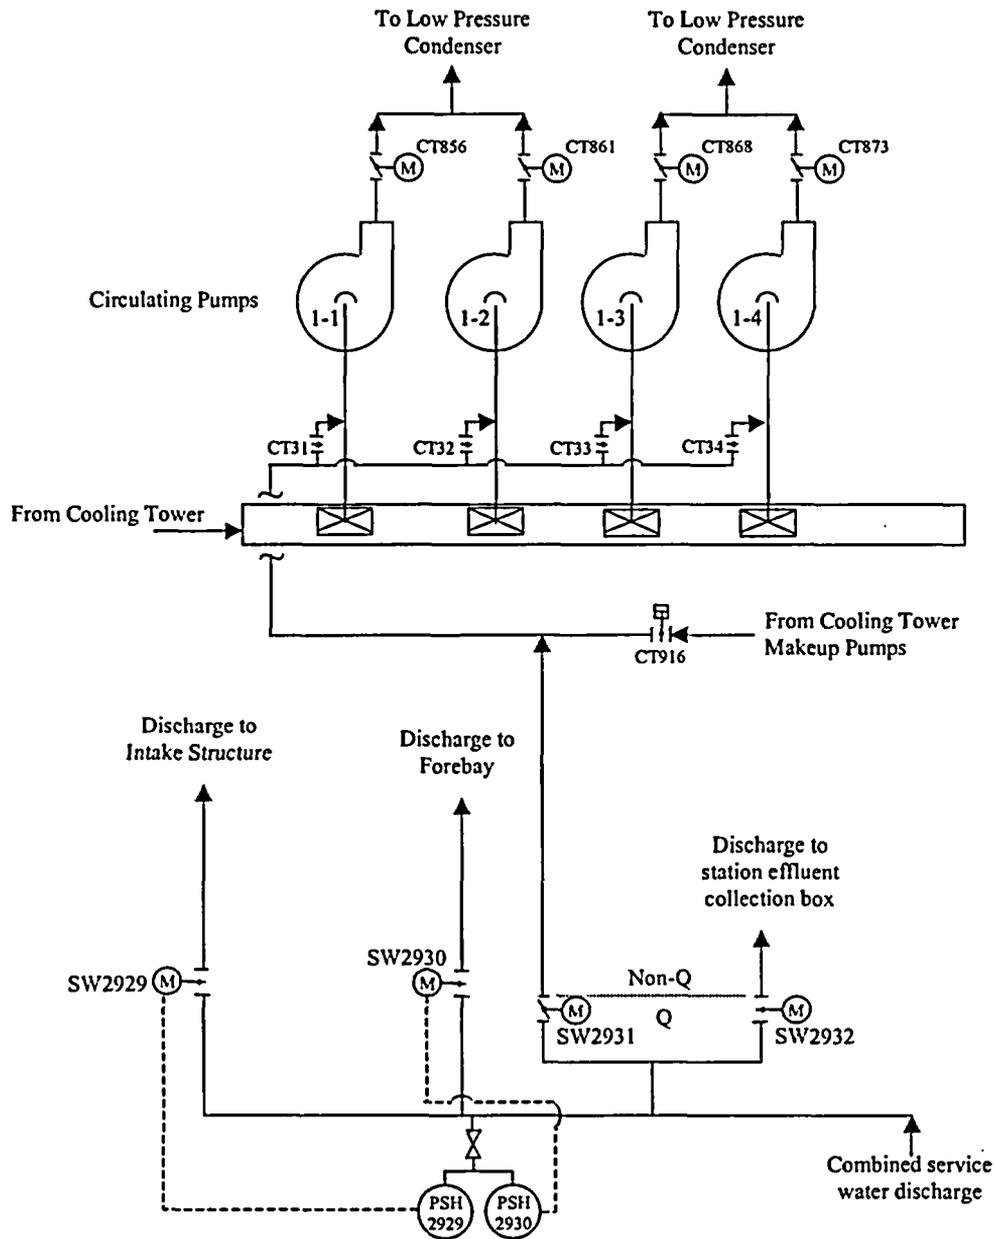
Figure 1
Simplified Service Water Discharge Arrangement
- For Information Only -

The SW discharge from the essential and nonessential headers combine into a common discharge header. This return line is then directed to one of the following locations (see Figure 1):

1. The flow paths discussed in this evaluation are shown on Enclosure 1 Figure 1.
2. This evaluation will not consider failure of seismic piping and valves, for example, SW2931 and SW2932.
3. Failure rate data is available for manual gate valves. However, all of the valves considered in this evaluation are butterfly valves (Ref. 4). The use of failure rate data for manual gate valves is conservative. An internal failure of a butterfly valve is not likely to result in flow isolation, as could happen with a gate valve.

Cooling Tower (CT) valves CT31, CT32, CT33, and CT34 are manual butterfly valves. During normal operation, two of these four valves (one per Circulating Water loop) may be open. This evaluation assumes that two open valves fail to remain fully open, e.g., failure of CT31 and CT33, or failure of CT32 and CT34.
