Joseph M. Farley Nuclear Plant Units 1 and 2
Application for License Renewal –
Requests for Additional Information

1. RAI 4.3.4-1 on Containment Building Tendon Prestress
2. RAI 2.1-1 on 10CFR54.4(a)(2) methodology

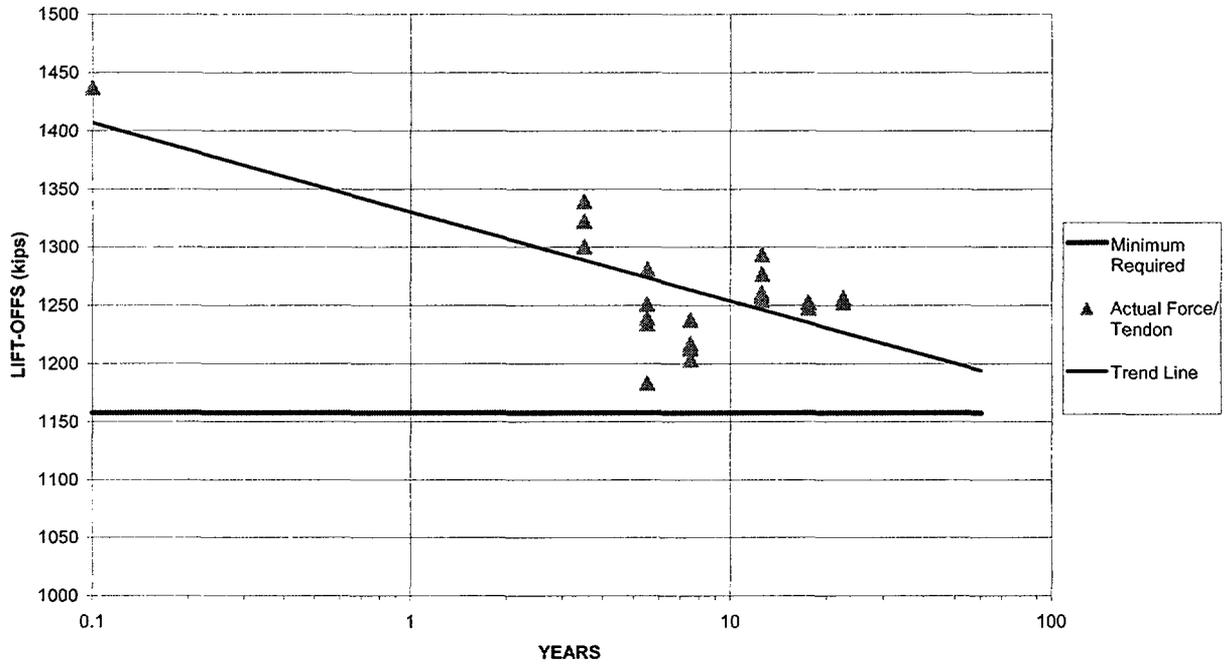
**UNIT 1 VERTICAL TENDONS
ACTUAL FORCE TREND PER TENDON BASIS
(from past 6 surveillances)**

Year	Tendon	No of Wires	Actual Force (kips)	Year	Tendon	No of Wires	Actual Force (kips)
0.1	All	Avg. 169.94	1437.2	7.5	V-100	169	1213.4
3.5	V-16	170	1339.6	7.5	V-128	170	1237.6
3.5	V-39	170	1300.5	12.5	V-14	170	1254.6
3.5	V-66	170	1322.6	12.5	V-31	169	1260.7
3.5	V-95	170	1300.5	12.5	V-72	170	1293.7
3.5	V-116	170	1322.6	12.5	V-109	170	1276.7
5.5	V-16	170	1251.2	12.5	V-120	170	1258.0
5.5	V-27	169	1281.0	17.5	V-61	170	1247.8
5.5	V-86	170	1234.2	17.5	V-99	170	1247.8
5.5	V-105	170	1239.3	17.5	V-113	170	1252.9
5.5	V-126	170	1183.2	22.5	V-1	170	1256.3
7.5	V-5	170	1217.2	22.5	V-43	170	1252.9
7.5	V-18	170	1213.8	22.5	V-80	170	1252.9
7.5	V-60	170	1203.6

- (b) For each group of tendons, trend lines of the projected prestressing forces based on the regression analysis of the measured prestressing forces are included with the plots for item c below.
- (c) Comparison of prestressing forces projected to the end of the extended period of operation with the minimum required prestress are plotted for each group of tendons on a per tendon basis on the subsequent pages.

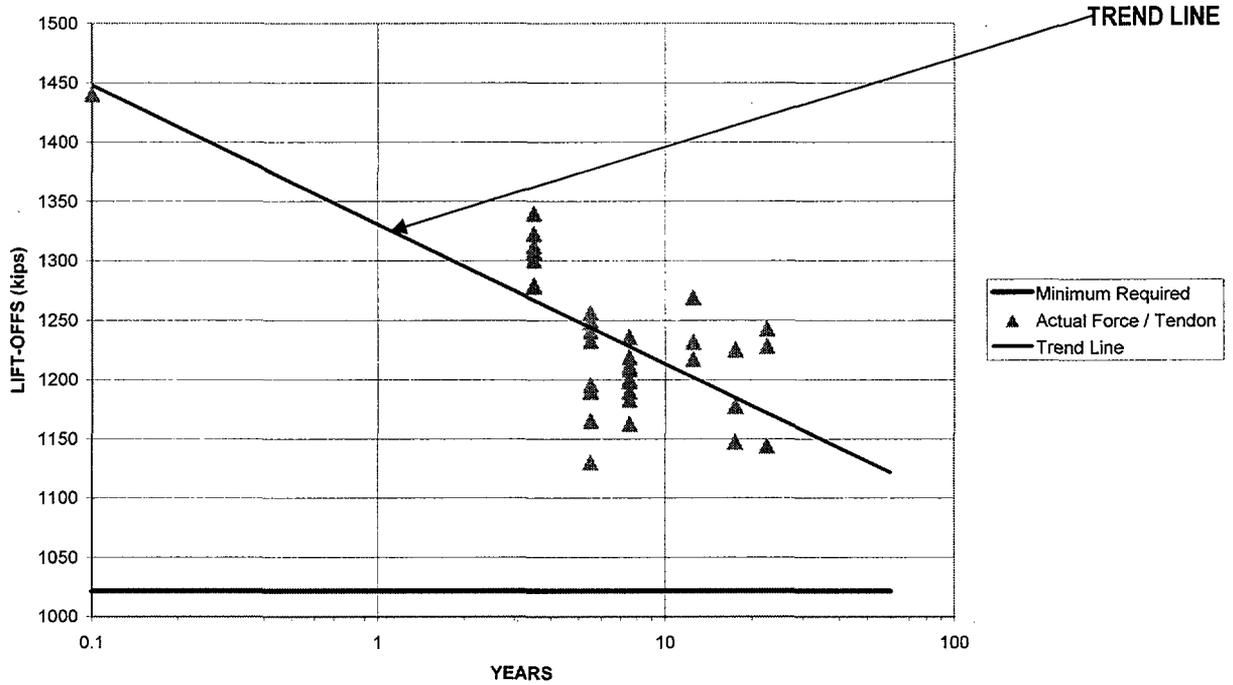
**UNIT 1 HOOP TENDONS
ACTUAL FORCE TREND PER TENDON BASIS
(from past 6 surveillances)**

Year	Tendon	No of Wires	Actual Force (kips)	Year	Tendon	No of Wires	Actual Force (kips)
0.1	All	Avg. 169.14	1440.1	7.5	H8AB	166	1208.5
3.5	H1BA	170	1322.6	7.5	H14AB	170	1190.0

3.5	H6BA	166	1306.4	7.5	H18CA	170	1183.2
3.5	H12BA	163	1279.5	7.5	H20CA	170	1162.8
3.5	H17BA	170	1278.4	7.5	H25BC	170	1218.9
3.5	H24BA	170	1339.6	7.5	H33BC	170	1212.1

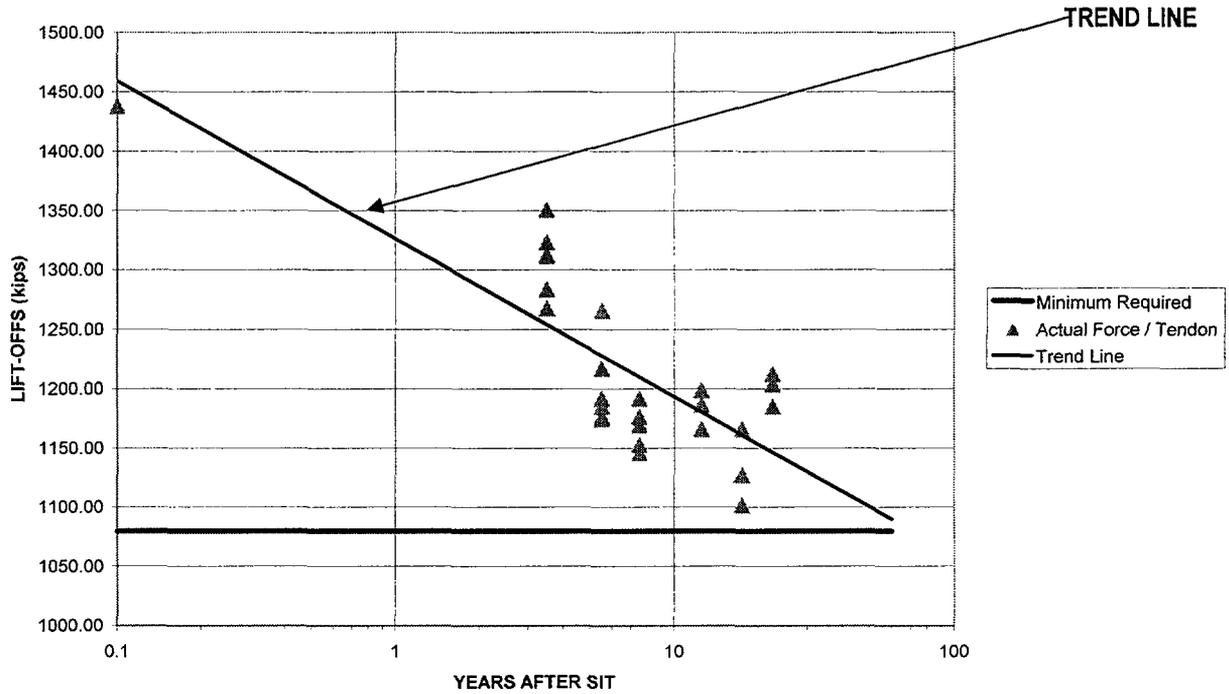
**UNIT 1 DOME TENDONS
ACTUAL FORCE TREND PER TENDON BASIS
(from past 6 surveillances)**

Year	Tendon	No of Wires	Actual Force (kips)	Year	Tendon	No of Wires	Actual Force (kips)
0.1	All	Avg. 169.91	1437.9	7.5	D110	170	1152.6
3.5	D114	169	1267.5	7.5	D119	170	1191.7
3.5	D123	170	1283.5	7.5	D203	170	1145.8
3.5	D202	170	1312.4	7.5	D229	170	1169.6
3.5	D230	169	1311.4	7.5	D303	170	1176.4
3.5	D309	169	1323.3	7.5	D319	170	1191.7
3.5	D317	168	1350.7	12.5	D121	170	1198.5
5.5	D107	169	1216.8	12.5	D228	169	1186.4
5.5	D122	170	1176.4	12.5	D320	170	1166.2
5.5	D227	170	1174.7	17.5	D110	170	1166.2
5.5	D231	170	1191.7	17.5	D201	170	1101.6
5.5	D309	169	1265.8	17.5	D318	170	1127.1
5.5	D324	170	1184.9	22.5	D102	170	1212.1
				22.5	D118	170	1184.9
				22.5	D311	170	1203.6
