NUREG/CR-5461
SAND89-2369

Aging of Cables, Connections, and Electrical Penetration Assemblies Used in Nuclear Power Plants

Prepared by M. J. Jacobus

Sandia National Laboratories
Operated by
Sandia Corporation

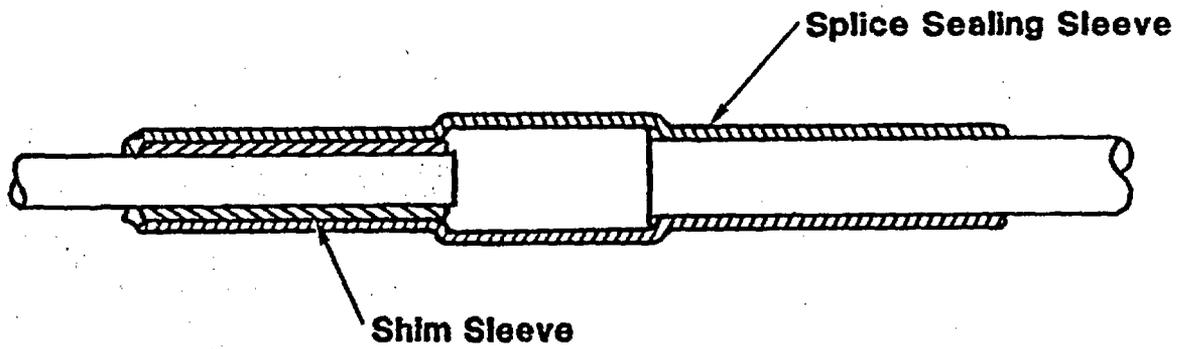
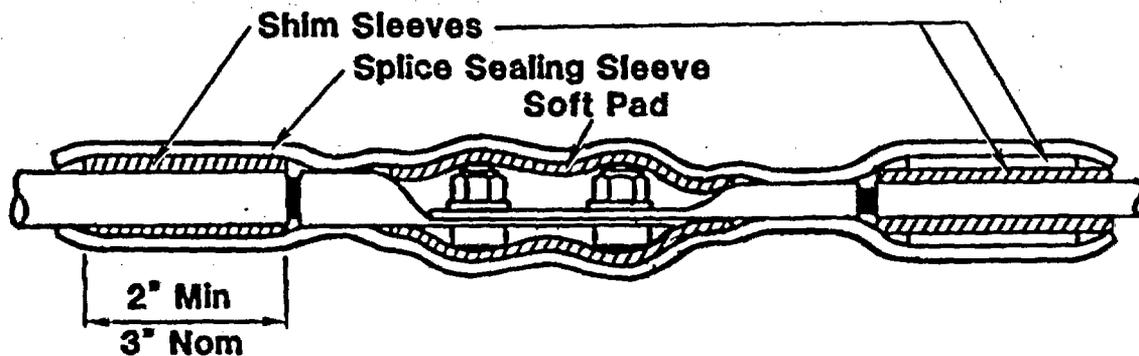
Figure 2 Sample Raychem Installations Over a Crimped Connection and a Bolted Connection

(a) Over Crimped Connection

(b) Over Bolted Connection

Raychem heat shrink tubing, type WCSF(N), is used by most plants in the country. It is composed of a flame retardant, heat shrinkable polyolefin insulation that is coated on the interior with an adhesive designed to form an environmental seal under postulated accident conditions. Another version of the tubing, without the adhesive coating, is available and is designated WCSF(U). This latter version is not qualified to design basis accident conditions, but may be used in areas where no harsh accident environments will exist. Various sizes and configurations are available for making many different types of connections, but all use the same basic materials and method of application. For connection of two different sizes of wire, a special "shim" may be added to the smaller wire. Figure 2 shows two example Raychem installations. Note the use of shims in both installations. Raychem heat shrink tubing is certified to applicable standards that include the aging, accident, and flame spread requirements of IEEE 323-1974 and IEEE 383-1974. The material was tested for 40 year operation at 90°C and is rated at 1000 V. Installation of Raychem heat shrink is governed by a thorough procedure for selection, cable preparation, shrinking, and inspection.

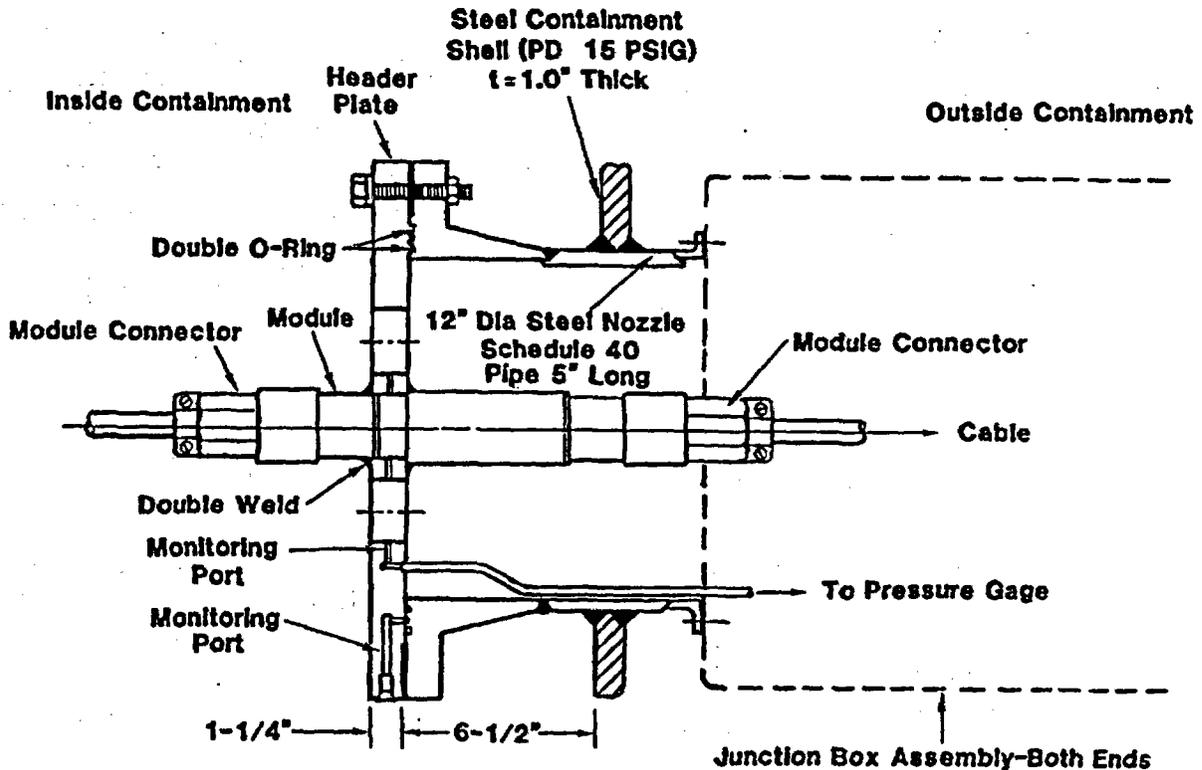
Figure 3 Typical Mounting of D. G. O'Brien EPA⁷

The D. G. O'Brien EPA is one of the three penetrations currently in production. Figure 3 is a schematic of the O'Brien EPA shown in a typical containment wall mounting configuration. As may be observed from the figure, the EPA consists of three components -- the header plate and module assembly, mating module connectors (i.e. mating plugs), and junction box units. It is also noted that the usual attachment of the EPA to the containment nozzle is with bolts (as opposed to welding). Containment integrity is assured by the double "o"-ring sealing configuration. The "o"-ring sealing status may be ascertained via the monitoring port

in the header plate. Because the modules are welded to the EPA header plate, individual modules cannot be removed from the header plate assembly in the event of some sort of module related failure, such as seal integrity failure, electrical shorts or open circuits, etc. A provision for monitoring module seal integrity is provided by a header plate manifold interconnecting the module sockets to a pressure gauge. Insertion of modules in the header plate automatically couples the module interior to the pressure manifold. The header plate-module assembly is evacuated through the manifold-pressure gauge tubing and then backfilled with sulfur hexafluoride gas. Manifold gas pressure is then used as a measure of the module seal integrity.

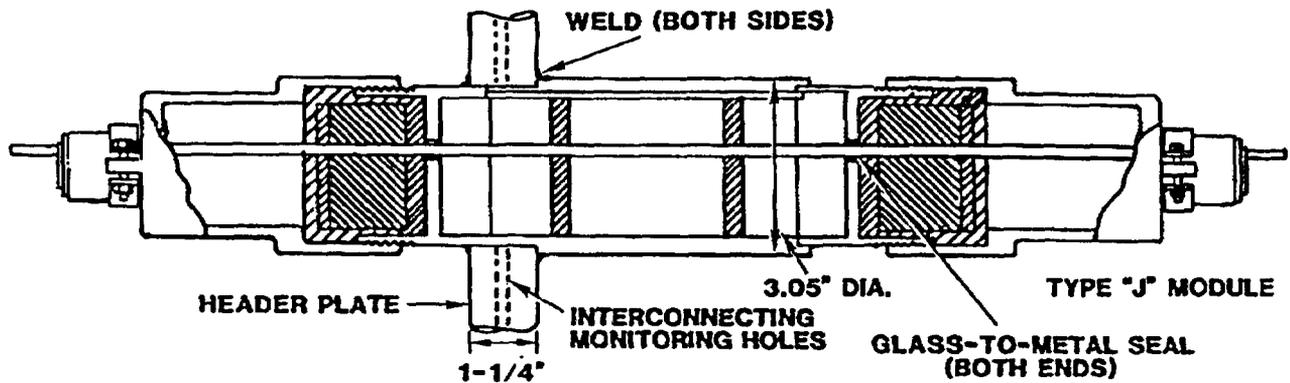
Figure 4 Schematic of Typical D. G. O'Brien Module⁷

A schematic of a typical D. G. O'Brien module with mating connectors is presented in Figure 4. Several design features may be observed from the schematic. First, the (electrical) conductors in the module are terminated at both the inner and outer ends of the module. Termination is into male metal to glass headers that are welded into the module body. Thus individual conductors are insulated from the module housing and one another with an inorganic, relatively inert insulation material. Second, since the electrical cables are terminated at the module (i.e., are not continuous through the module), air leakage through and around individual cables cannot contribute to loss of containment integrity across/through the EPA modules. Thus aging should not be a factor affecting the module electrical or sealing performance.

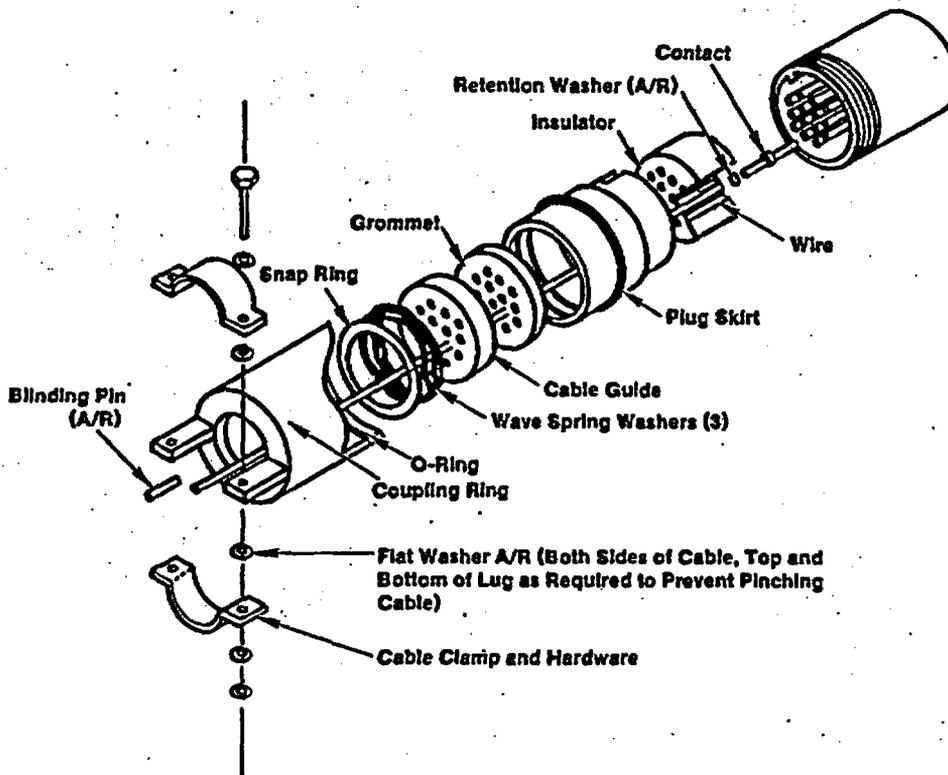
Figure 5 Inboard Mating Plug of D. G. O'Brien Connector¹²

As a result of this elevated temperature behavior, the inboard (containment side) plug was redesigned in an effort to eliminate the destructive effects resulting from close confinement of the grommet/gasket polymer. The redesigned plug is shown in Figure 5. As may be observed from the figure, a major redesign of the plug skirt has resulted. The closed end of the skirt plug has been removed and replaced with a floating polysulfone cable guide. The cable guide rides in the modified end of the plug skirt and restrains the cable grommet. The cable guide is in turn restrained and retained by a snap ring-wave spring washer assembly. When the assembled plug is secured to the mating module by torquing the coupling ring, the compressive force

generated is transmitted through the wave spring and cable guide to the grommet. The stressed grommet then flows into any nearby voids and completes the sealing process. During large temperature excursions, the heated grommet expansion is accommodated by compression of the wave spring washers; during cool down and grommet shrinkage, the wave spring expansion maintains a compressive force on the cable grommet. Thus this plug redesign is intended to assure that grommet behavior will be reversible during large temperature excursions. In contrast, temperature excursions caused irreversible grommet extrusion and sealing loss in the original design EPA plugs.^{10,11} The redesigned module/plug assembly has been qualified and replacements have apparently been made, where required, in all operating plants.

Drawings of the inboard (containment side) and outboard mating plugs (connectors) are presented in Figures 5 and 6, respectively. Since the inboard plug evolved from the outboard design, we consider the outboard design first. Figure 6 is a telescope presentation of the outboard plug in that the various elements "nest" inside the coupling ring in the order shown in the figure. The assembled plug is secured to the module by means of mating threads on the coupling ring and module. Although not obvious from the drawing, the insulator, contact, and washer assembly combine to form a mating female connector for the module male connector formed by the module metal to glass header. All elements of the plug assembly are rigid with the exception of the cable grommet, which is a pliable polymer base rubber.

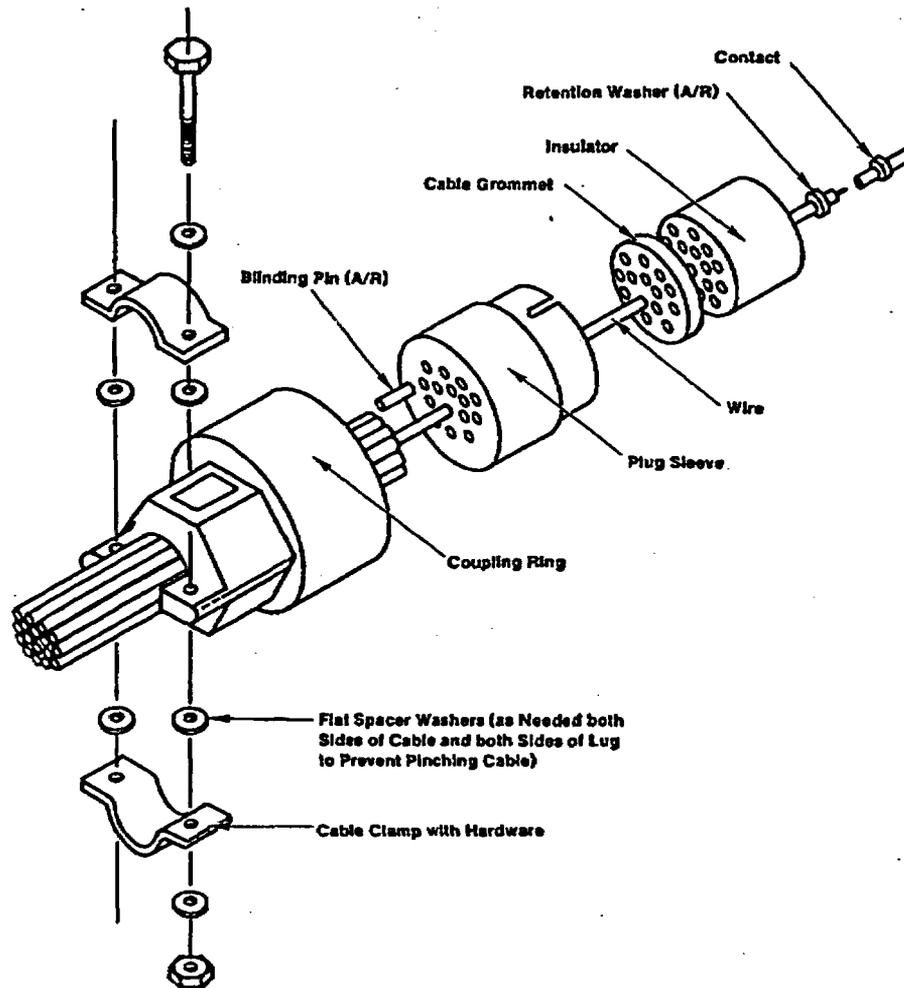
Figure 6 Outboard Mating Plug of D. G. O'Brien Connector¹²

To assure a hermetic seal at the plug-module interface, a gasket of design and composition comparable to the cable grommet is inserted at the junction of the two components (plug and module). Since the grommet/gasket polymer is incompressible (although it is flexible), a torque applied to the coupling ring translates into a compressive loading of the two elements that will then flow into any voids at four (plug sleeve-cable grommet, cable grommet-insulator, insulator-interface gasket, and interface gasket-module header) interfaces and result in a hermetic seal of the plug-module assembly. In earlier design EPAs, the polymer used to fabricate grommet/interface seals had an unusually high coefficient of thermal expansion.^{10,11} Because of this high expansion coefficient and the incompressible mechanical properties of the polymer, heating of the EPA (e.g., during accident conditions) resulted in insulation damage to the cables in the plug and the loss of seal integrity at the plug. Insulation damage and sealing loss was sufficient to cause electrical shorting between adjacent conductors. It should be noted that the exterior plug assemblies incurred no damage.

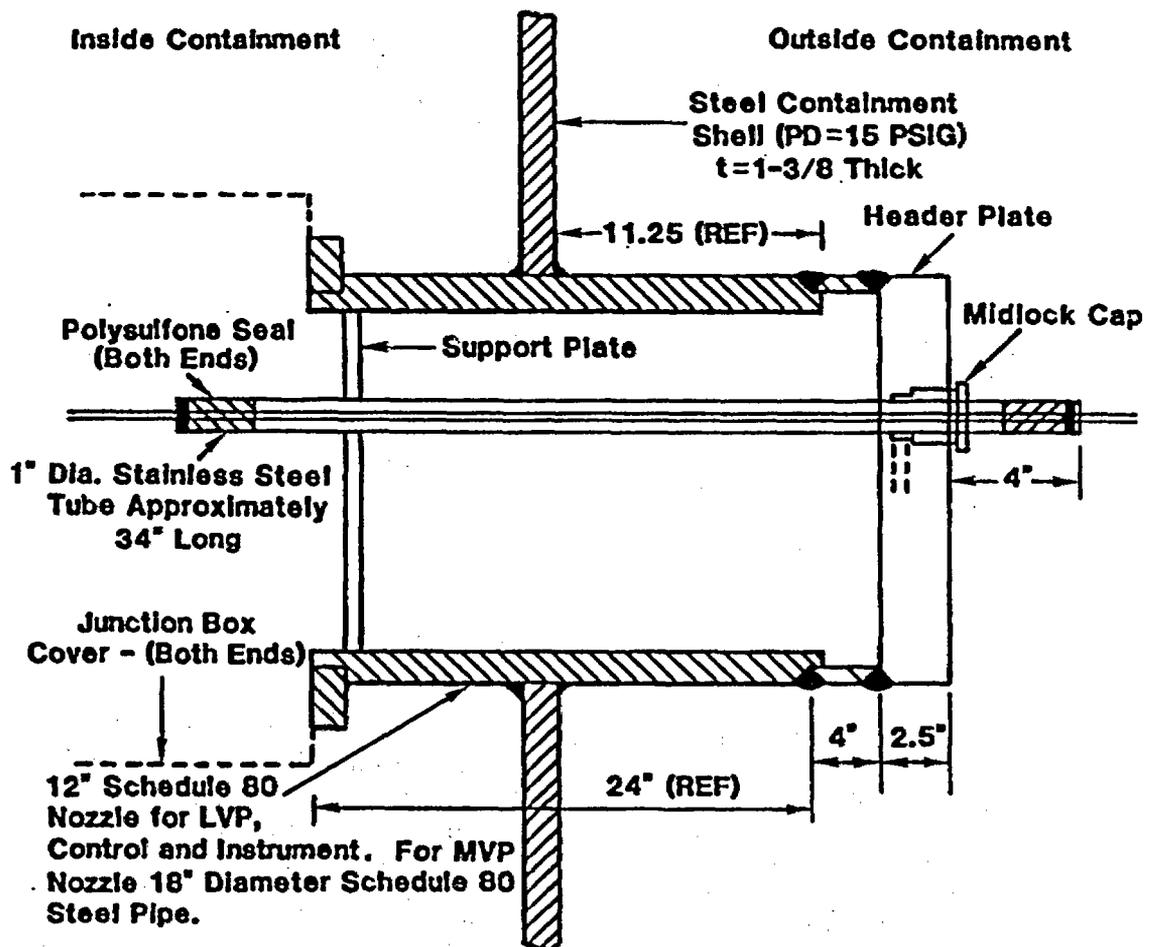
Figure 7 Schematic Diagram of Conax EPA and One Module⁷

The Conax EPA is also one of the three penetrations currently being manufactured. A schematic of the EPA, showing the header plate and a single module, is depicted in a typical mounting configuration in Figure 7. Both the header plate and module are stainless steel. Conductors traversing the module are sealed in a polysulfone polymer at both the inboard and outboard ends of the module. The modules are secured to the header plate by means of a threaded fastening device (a "Midlock Cap"), which

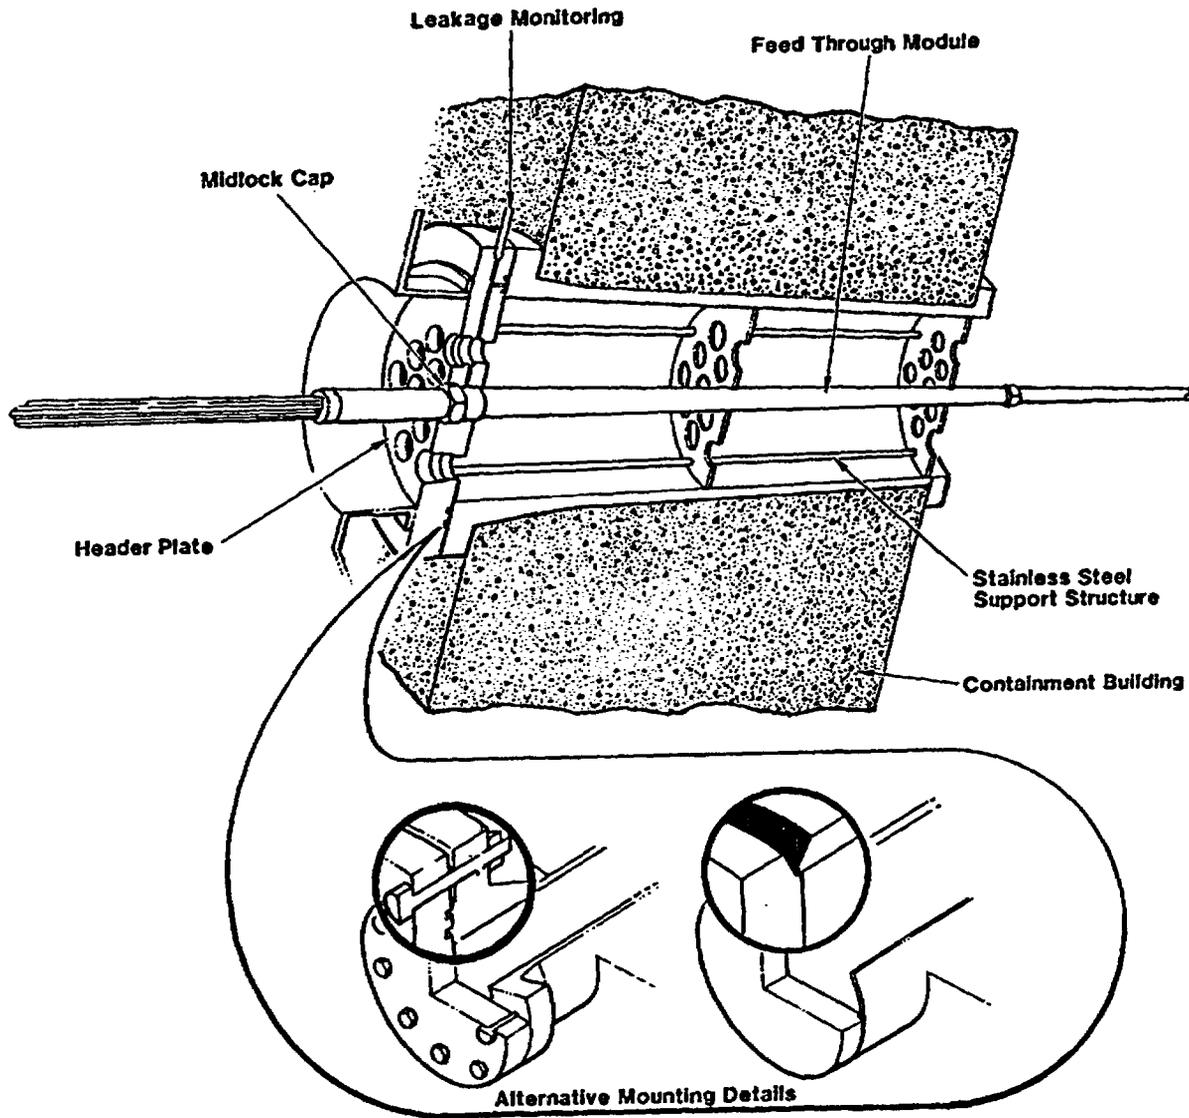
Figure 8 Conax EPA Mounting Methods

allows for removal/replacement of individual modules. Finally, the EPA may be welded (as shown in Figure 8) or bolted to the containment vessel nozzle. Details of the EPA features are expanded in Figures 8 and 9. Figure 8 shows the EPA secured to a containment nozzle. The EPA may be attached to the containment nozzle with bolts or by welding. If bolts are used, dual, concentric "O"-rings assure a hermetic aperture seal at the EPA header plate-nozzle flange interface. In order to assure aperture sealing integrity, the gas pressure in the volume defined by the two "O"-rings is monitored with a conventional (bourdon tube) pressure gage. The method for securing individual modules to the EPA header plate is shown in Figure 9. When an individual module is secured to the header plate, it is automatically tied into a module (internal) pressure monitoring system via a manifold machined in the header plate. During the securing sequence, the module is hermetically sealed to the header plate on either side of the module pressure monitoring manifold. Thus all EPA interfaces through containment contain double barriers. Modules are individually secured and hermetically sealed to the EPA header plate with "Midlock Caps". The caps are analogous to a jam nut and a pair of metal wedge seals. By threading the jam nut into the EPA header plate, the pair of metal seals are forced down on the module body and out into the inside diameter of the header plate hole forming hermetic, metal to metal seals between the module and header plate.

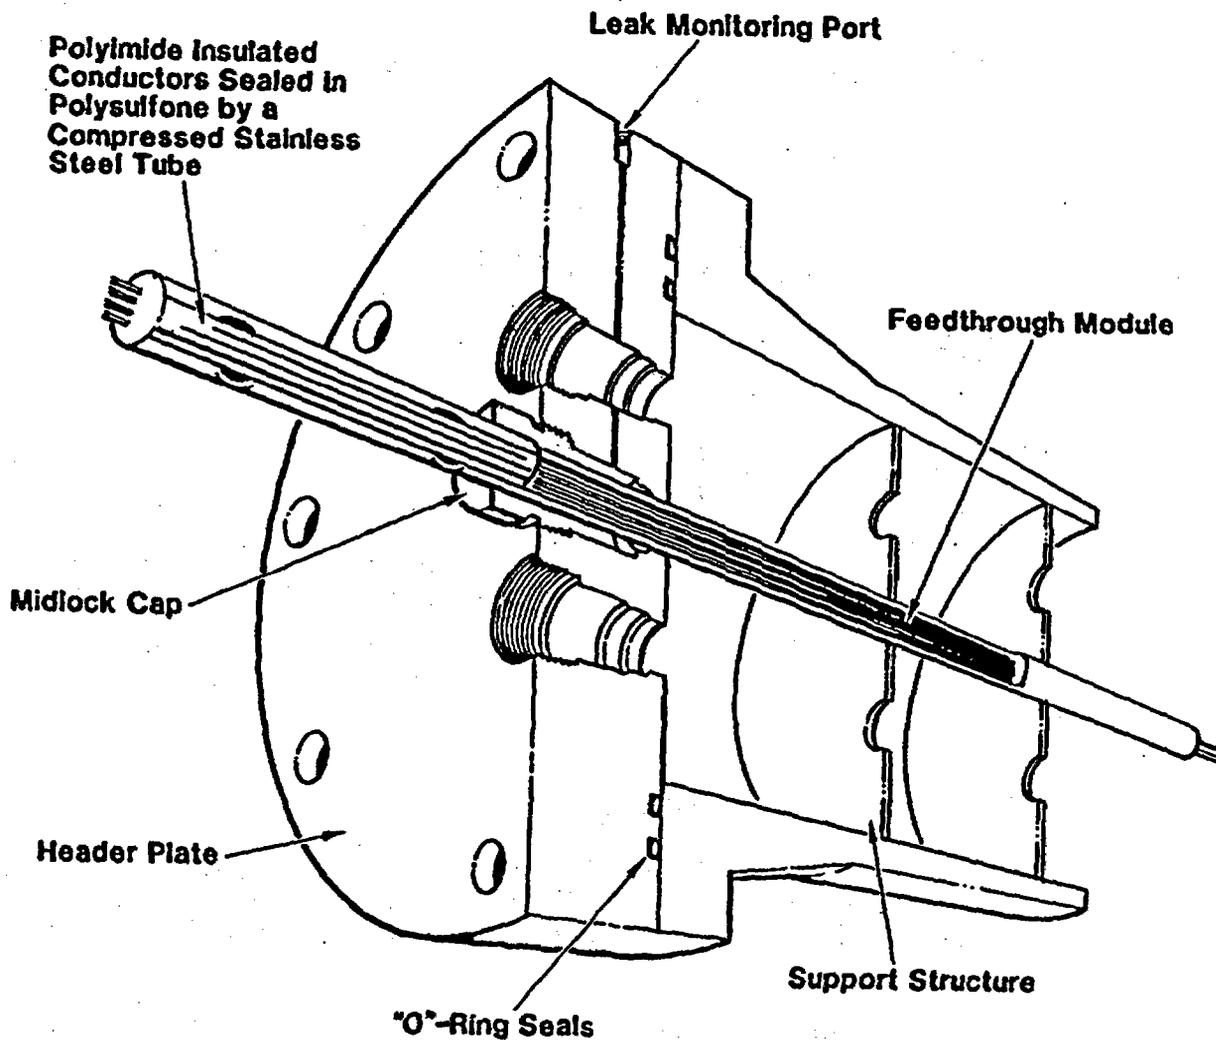
Figure 9 Details of Conax EPA Construction

Module-conductor sealing is now considered. Figure 9 shows the assembly sequence. There are no cable splices or interconnections in the module; rather all cables--fully insulated--make a continuous run through the module. The cable insulation for this application is polyimide (KAPTAN). Each end of the cable run is cast into a polysulfone insulating plug. The cable-plug combination is then assembled into a stainless steel sleeve. The cable-sleeve combination is secured to the stainless sleeve at each end by means of a rolled double crimp operation. This operation compresses, and retains, the polysulfone plug-cable assembly at each end of the stainless steel

sleeve. Sufficient force is applied to the polysulfone plugs to assure hermetic seals between the polysulfone and cables and the polysulfone and stainless steel sleeve. The completed assembly constitutes a module. Each module contains an (internal pressure) monitoring port that is automatically connected to the EPA pressure manifold when the module is assembled to the header plate.

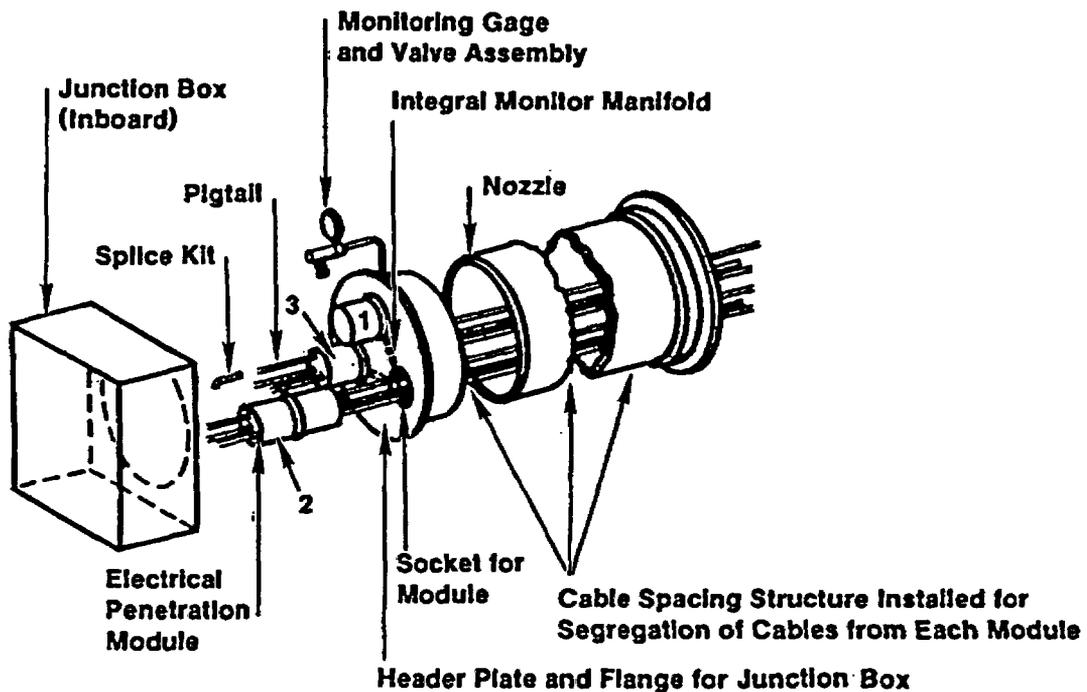
Figure 10 Westinghouse Modular EPA¹²

The Westinghouse electrical penetrations are available in both canister and modular designs. The penetrations are assembled and tested at the factory. Field mounting uses either a single weld or bolted flange. A modular series penetration is shown in Figure 10, with detail of an individual module shown in Figure 11. The modules are held against the header plant with three mounting clamps with dual silicone o-rings forming the header plate to module seal. Connecting a module into the header plate automatically connects it to an integral leak monitoring system. Blank modules may be installed where necessary to maintain monitoring capability and containment integrity. An epoxy sealing material is used to seal the wires inside the module. Individual modules can be field-replaced by removing three clamps.

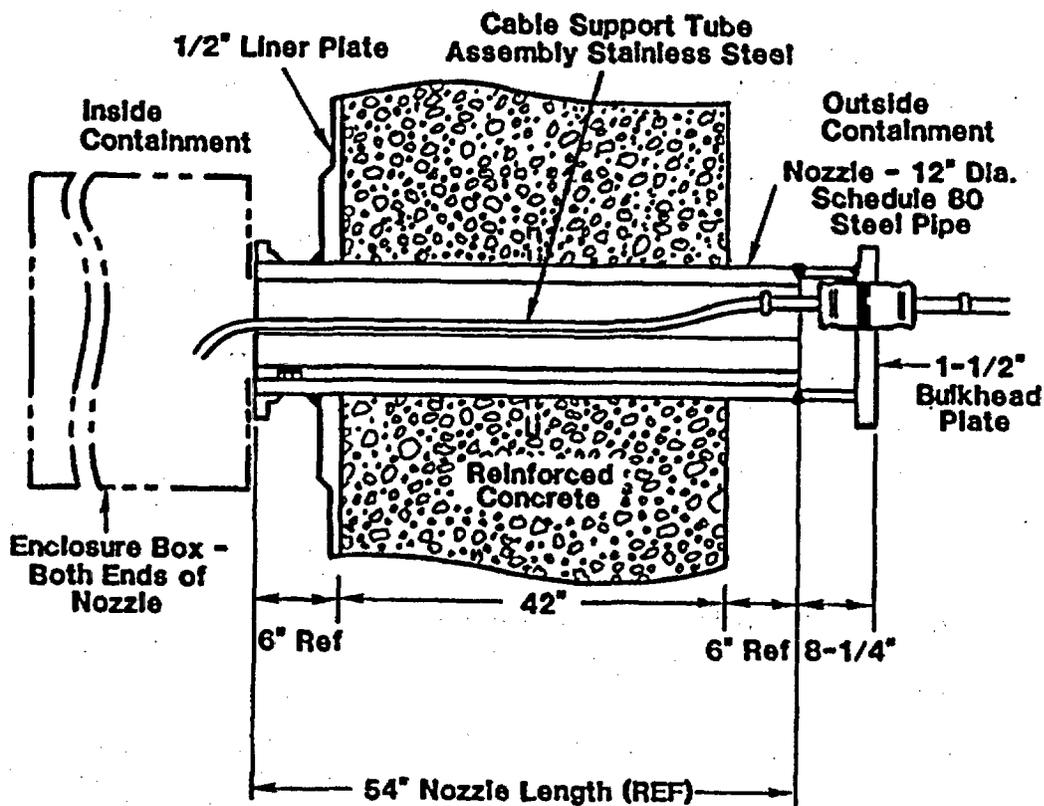
Figure 12 Typical Westinghouse EPA Installation⁷

Figure 12 shows a typical installation of a canister series penetration. A single field weld or bolted flange completes the installation. A canister penetration is somewhat similar to a large single module of the modular penetrations, except that it is installed as a single unit into the containment wall.
