Re: St. Lucie Unit 2
Docket No. 50-389
Order (EA-03-009) Relaxation Request Nos. 3 and 4
Examination Coverage of Reactor
Pressure Vessel Head Penetration Nozzles

**St. Lucie Unit 2 Relaxation Request No. 3
From The First Revised NRC Order EA-03-009**

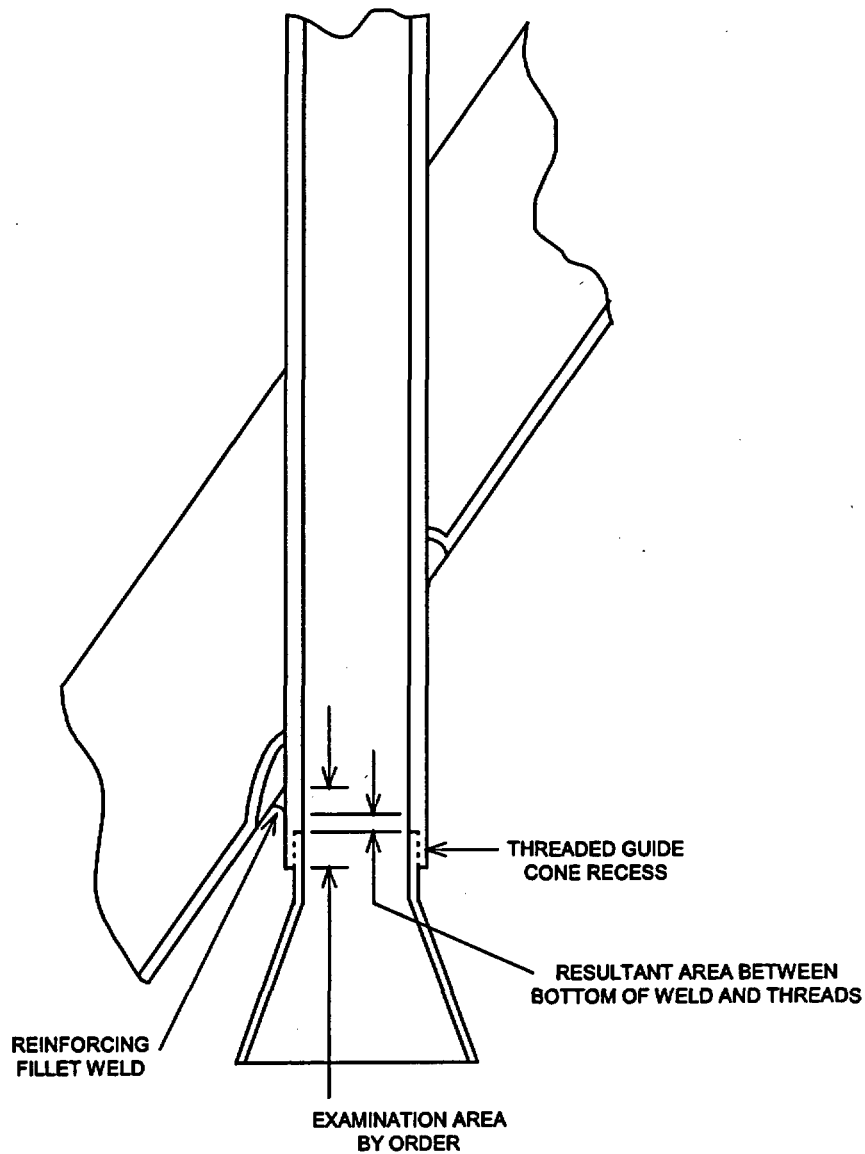
Figure 1
Typical St. Lucie Unit 2 CEDM Nozzle Configuration

A typical example of the internally threaded nozzle, including the externally threaded guide funnel, at a high hillside angle is shown in Figure 1.

Reduced coverage below the weld on the 89 CEDM nozzles is caused by the nozzle configuration associated with an internally threaded guide funnel that limits the Ultrasonic (UT) examination or any surface examination from the nozzle ID surface. During the spring 2003 inspection, the examination coverage for 18 of the nozzles was less than 0.50 inches on the downhill side of the weld because there is less than 0.50 inches of unthreaded material below the weld in this area.

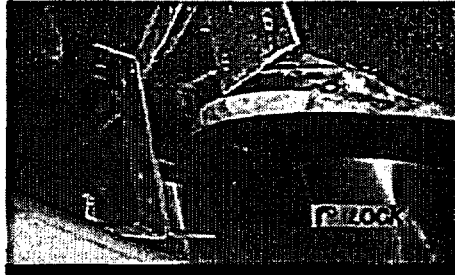
Figure 2: Picture showing Horizontal RMI Support Leg

During April/May 2003, SL2-14, FPL performed a bare metal visual examination of the accessible portions of the RPV head inside the RMI, including 360° visual examination around each RPV head penetration nozzle, to identify any evidence of leakage from the 102 penetrations. Additionally, as shown below in Figure 2, many of the horizontal RMI support legs were tilted allowing additional visual access to the RPV head base material. The bare metal visual examination resulted in inspection of approximately 99% of the RPV head. This percentage does not take credit for the additional coverage obtained by the tilted support legs. A relaxation request was submitted by FPL letter L-2003-129 and approved by the NRC documenting the examination coverage obtained.
