**V. C. SUMMER EXAM
50-395/2004-301**

Licensee Submitted Post-Examination Comments

Subject: VIRGIL C. SUMMER NUCLEAR STATION
DOCKET NO. 50/395
OPERATING LICENSE NO. NPF-12
POST EXAM COMMENTS FOR THE RO EXAM
ADMINISTERED APRIL 28, 2004

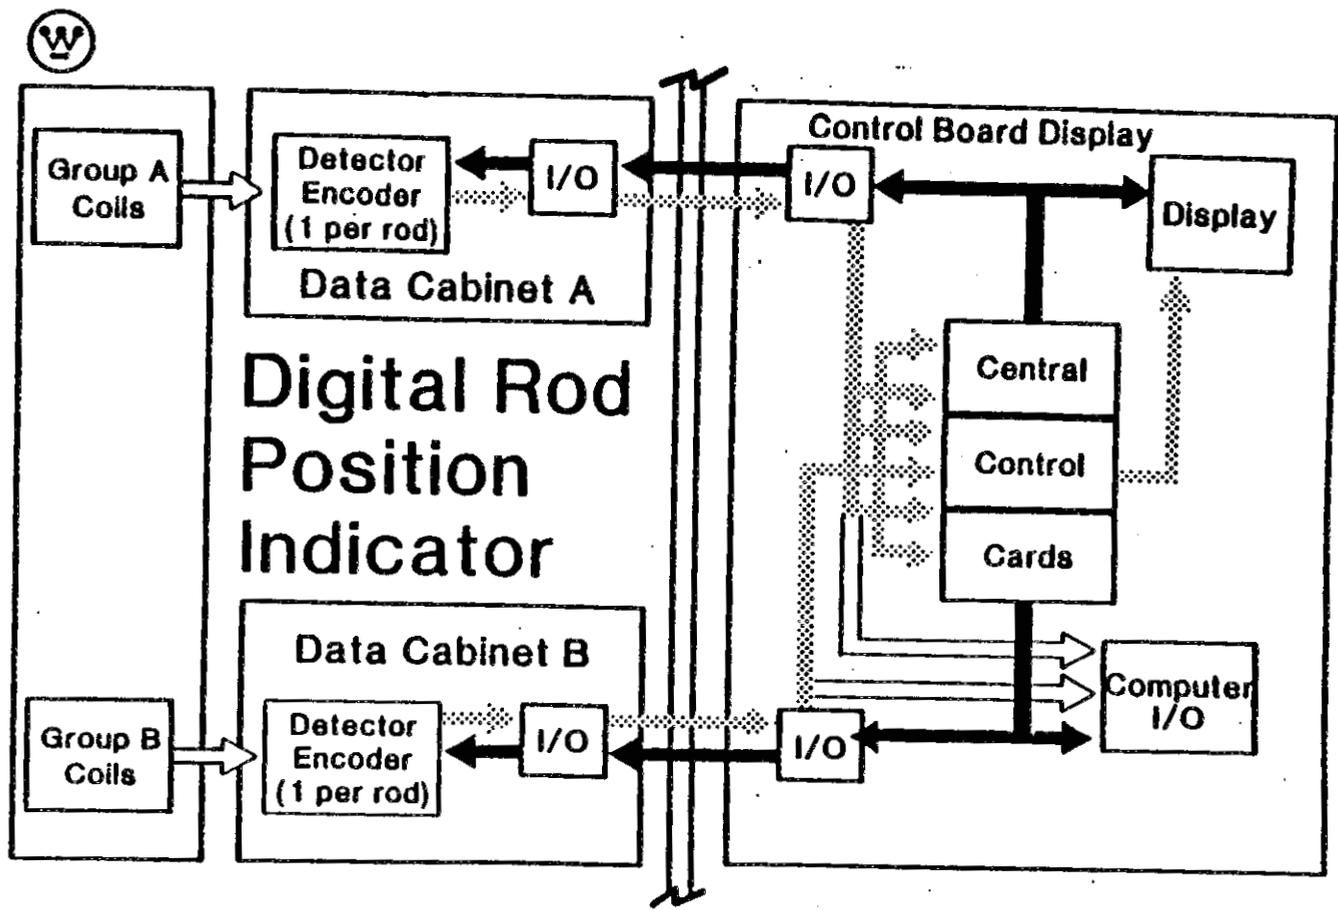
Fig. 23

COMPUTER INPUT/OUTPUT CARD (Refer to Figures 2.92, 2.93 and 2.94)

The Computer I/O card is used to interface the DRPI system with any process computer that has contact closure inputs and outputs. Since this method of interface is slow, the DRPI system must be synchronized with, but not slaved to, the computer. Therefore, a memory is provided on the card to contain all information concerning rod position which can be interrogated by the computer at its own speed. The information is continuously updated and can be interrogated by the computer at any time (Figure 2.92).

Refer *to* the attached Figure 2-3 from the Westinghouse DRPI technical manual. The DRPI cabinets receive a signal from each individual rod *as* to its position. The signal is then sent to the control board display I/O card, which is in turn sent to the plant computer (IPCS) I/O card and compared to expected rod position based on demand. **If** a discrepancy exists **at** >12 steps, computer point Y2001C generates an alarm on XCP 620, window 2-5, CMPTR ROD DEV. The ARP lists IPCS computer failure (answer D) as a probable cause, along with three other possibilities.

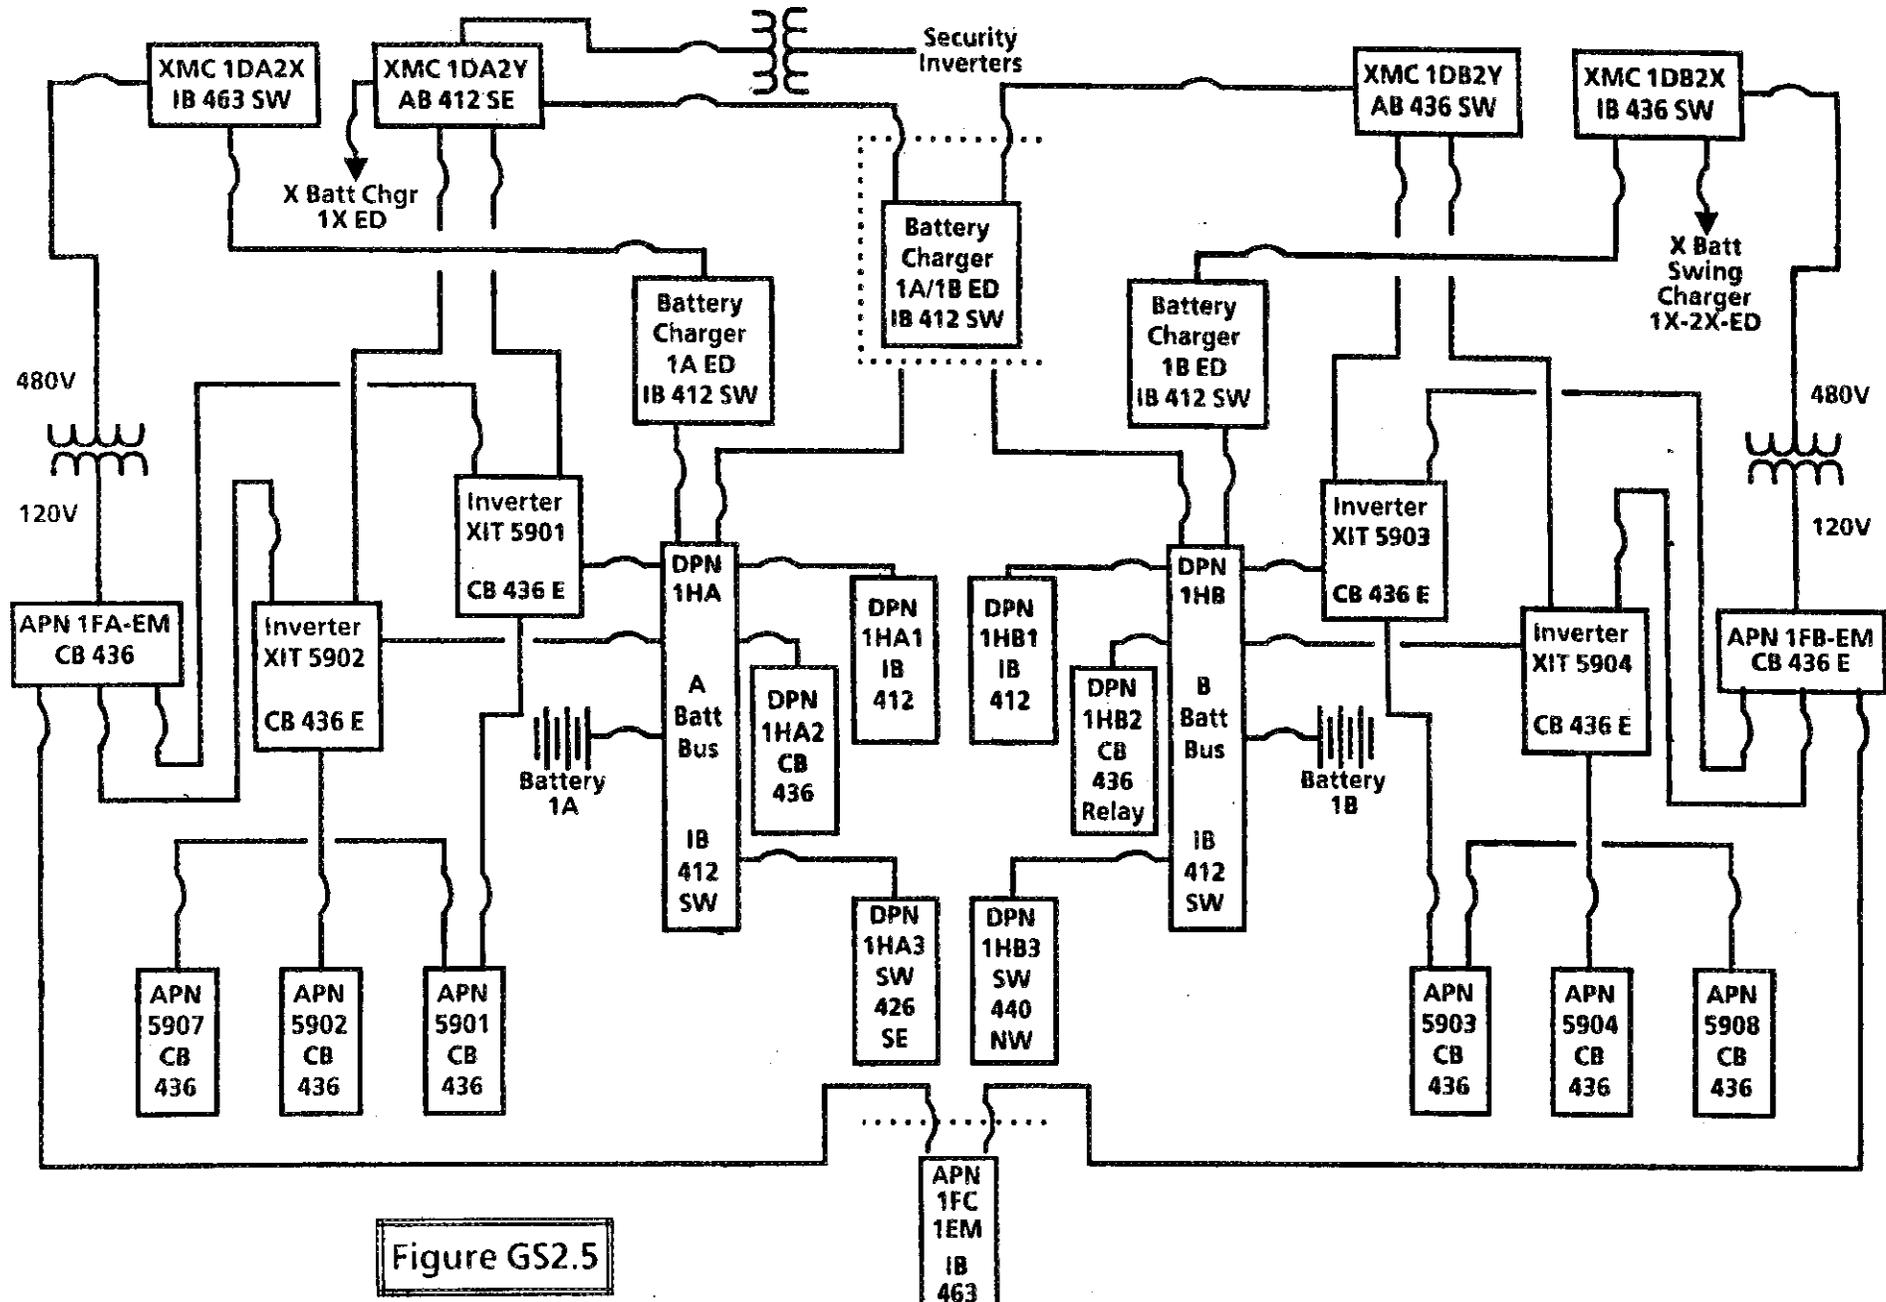
Figure GS2.5

VITAL 120VAC AND 125DC

The given conditions have inverter XIT-5901 undergoing maintenance; therefore, APN-5901 is being powered from APN-1FA. The question stipulates that the feeder breaker to APN-1FA then trips, de-energizing APN-1FA.

With APN-1FA supplying APN-5901, power to the A Train ESFLS is lost when the normal feeder breaker to APN-1FA trips. Since the second part of Choices C. & D. does not specify which Train of ESFLS is disabled, the second part would be correct since A Train is disabled. Said another way, the second part of Choice D. would only be *incorrect* if it referred specifically to B Train ESFLS.
