Subject: Duke Energy Corporation
Catawba Nuclear Station, Unit 1
Docket Number 50-413
Steam Generator Outage Summary Report for End of Cycle
14 Refueling Outage
Reply to Request for Additional Information
(TAC Number MC1703)

**Attachment 1
CFR 80 Steam Generators**

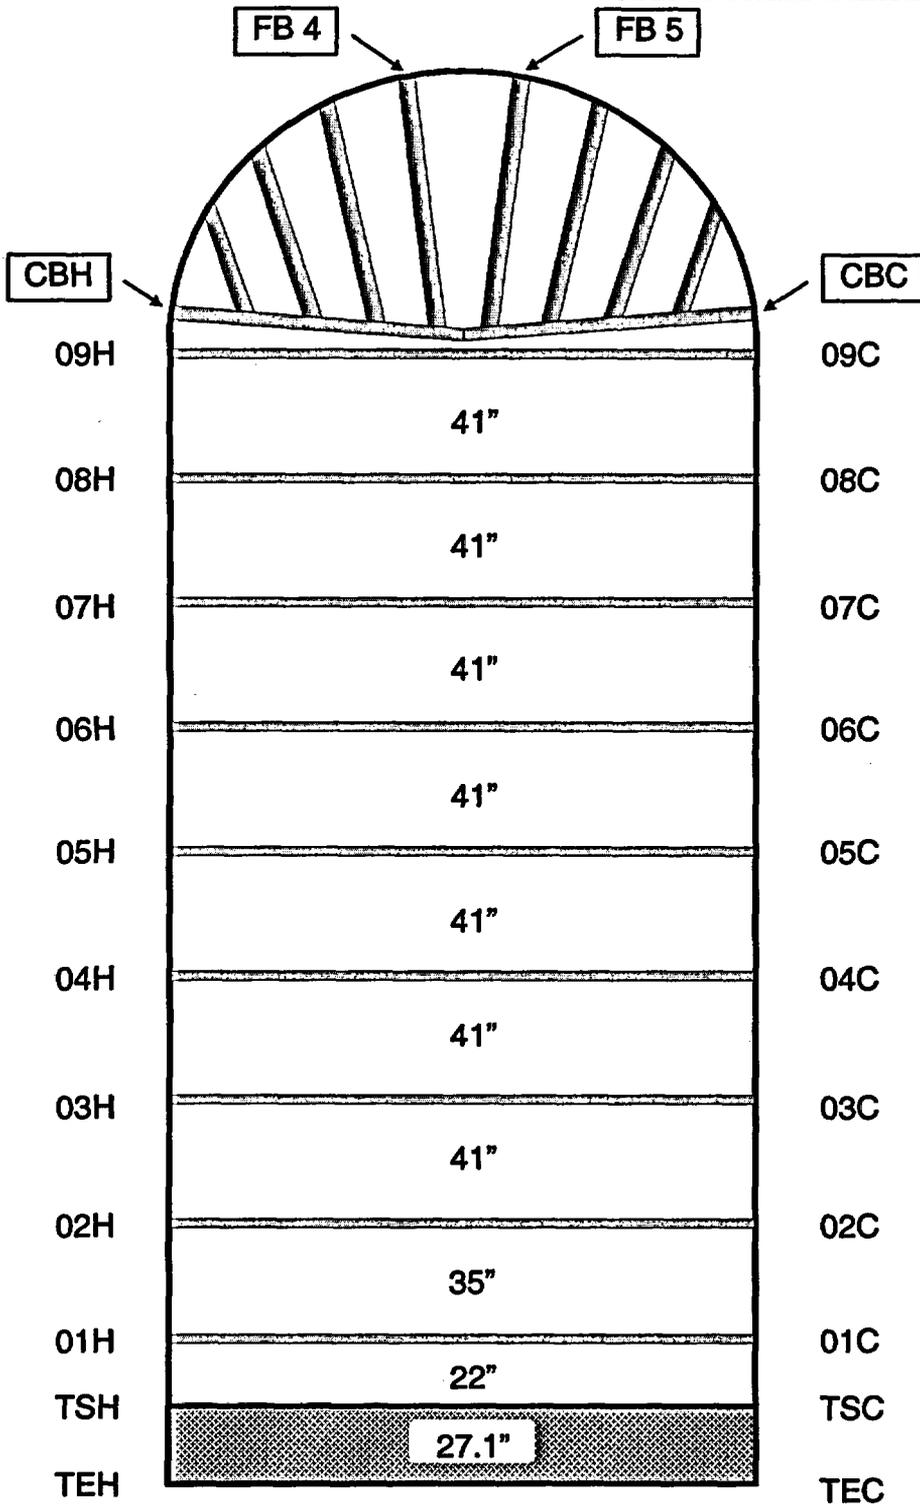
CFR 80	
Tube Information:	
No. of Tubes	6633
Material:	Inconel 690
Nominal Dia.:	0.688"
Nominal Wall:	0.040"
Row 1 Radius:	3.973"
Straight Length:	31.9'/32.7'
Tube Pitch:	.930"
Roll Plug Information:	
Material:	Inconel 690
Nominal Dia.:	0.594"
Nominal Wall:	0.052"
Tube Support Information	
Type:	Lattice
Material	410 Stainless
Thickness:	
High:	3.150"
Med.:	2.562"
Low:	1.000"
Connector Bar	
Material:	410 Stainless
Fan Bars	
Material:	410 Stainless
Thickness	0.110"
Width	1.25"

NOTE: Dimensions are to the centerline of the tube support
