Subject: Duke Energy Corporation
Catawba Nuclear Station, Unit 1
Docket Number 50-413
Steam Generator Outage Summary Report for End of Cycle
14 Refueling Outage
Reply to Request for Additional Information
(TAC Number MC1703)

**Attachment 1
CFR 80 Steam Generators**

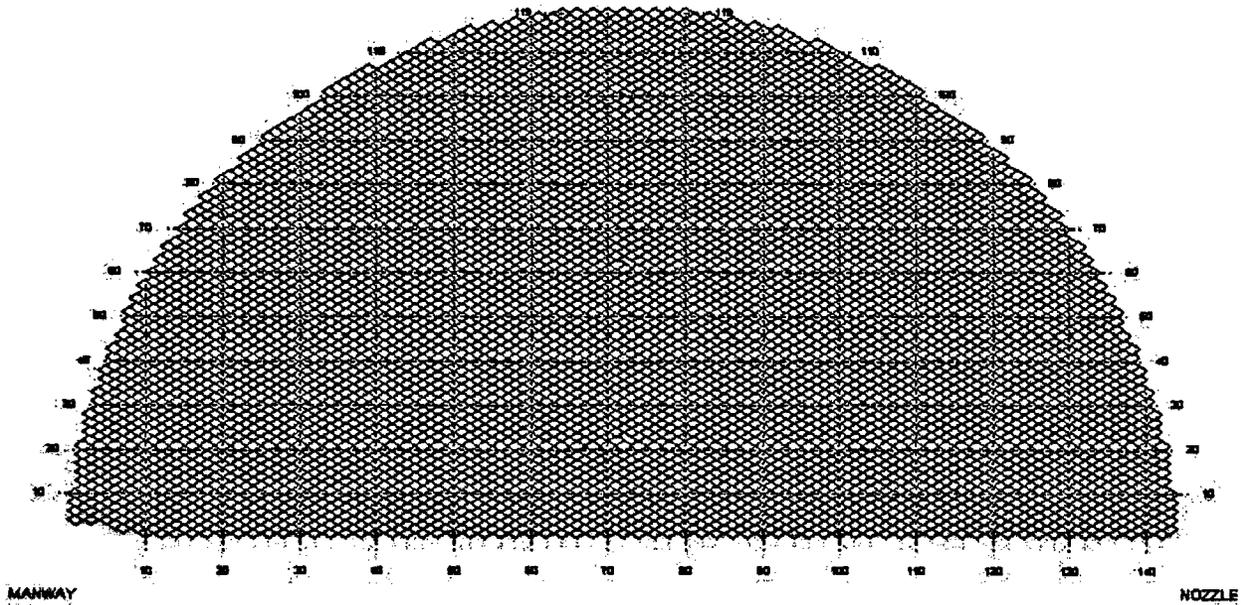
Attachment 2

Catawba Nuclear Station
Unit 1

S/O A:
NOT
PRIMARY FACE

TOTAL TUBES: 6633
SELECTED TUBES: 0
OUT OF SERVICE (#): NA
