BWR Owners' Group Extended Power Uprate Committee

Presentation for Meeting with NRC Staff August 18, 2004 Rockville, MD

BWR Extended Power Uprate Presentation Agenda

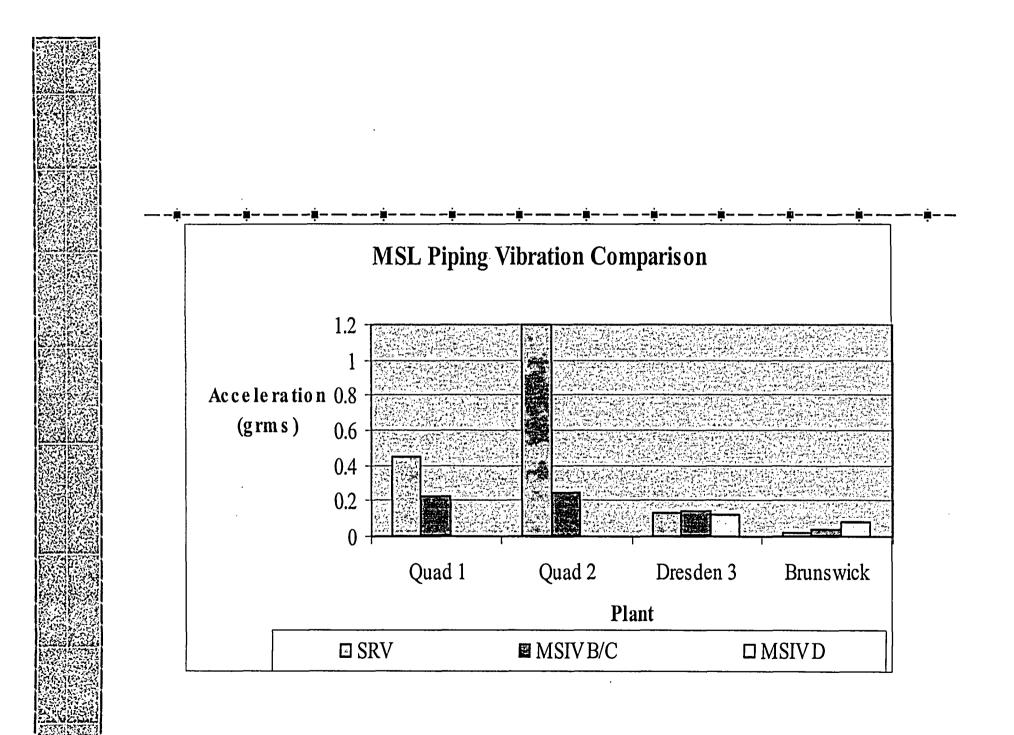
- * Available data suggests that the major vibration problems that have occurred at Quad Cities are an anomaly related to high steam velocities and unusually high acoustic vibration levels
 - Compared vibration levels at selected BWRs at maximum licensed EPU power levels (see next slide)
 - Brunswick SRV inlet vibration levels (120% OLTP) are about 60 times lower than at Quad Cities 2 (117% OLTP)
 - Dresden 3 SRV inlet vibration levels (117% OLTP) are about 8 times lower than at Quad Cities 2 (117% OLTP)
- * Steam dryer load definition work expected to confirm this anomaly
