License SUA-1341
Docket 40-8502
WDEQ Permit To Mine
No. 478

RE: Christensen Ranch Pond 3 & 4 leaks - conclusion.

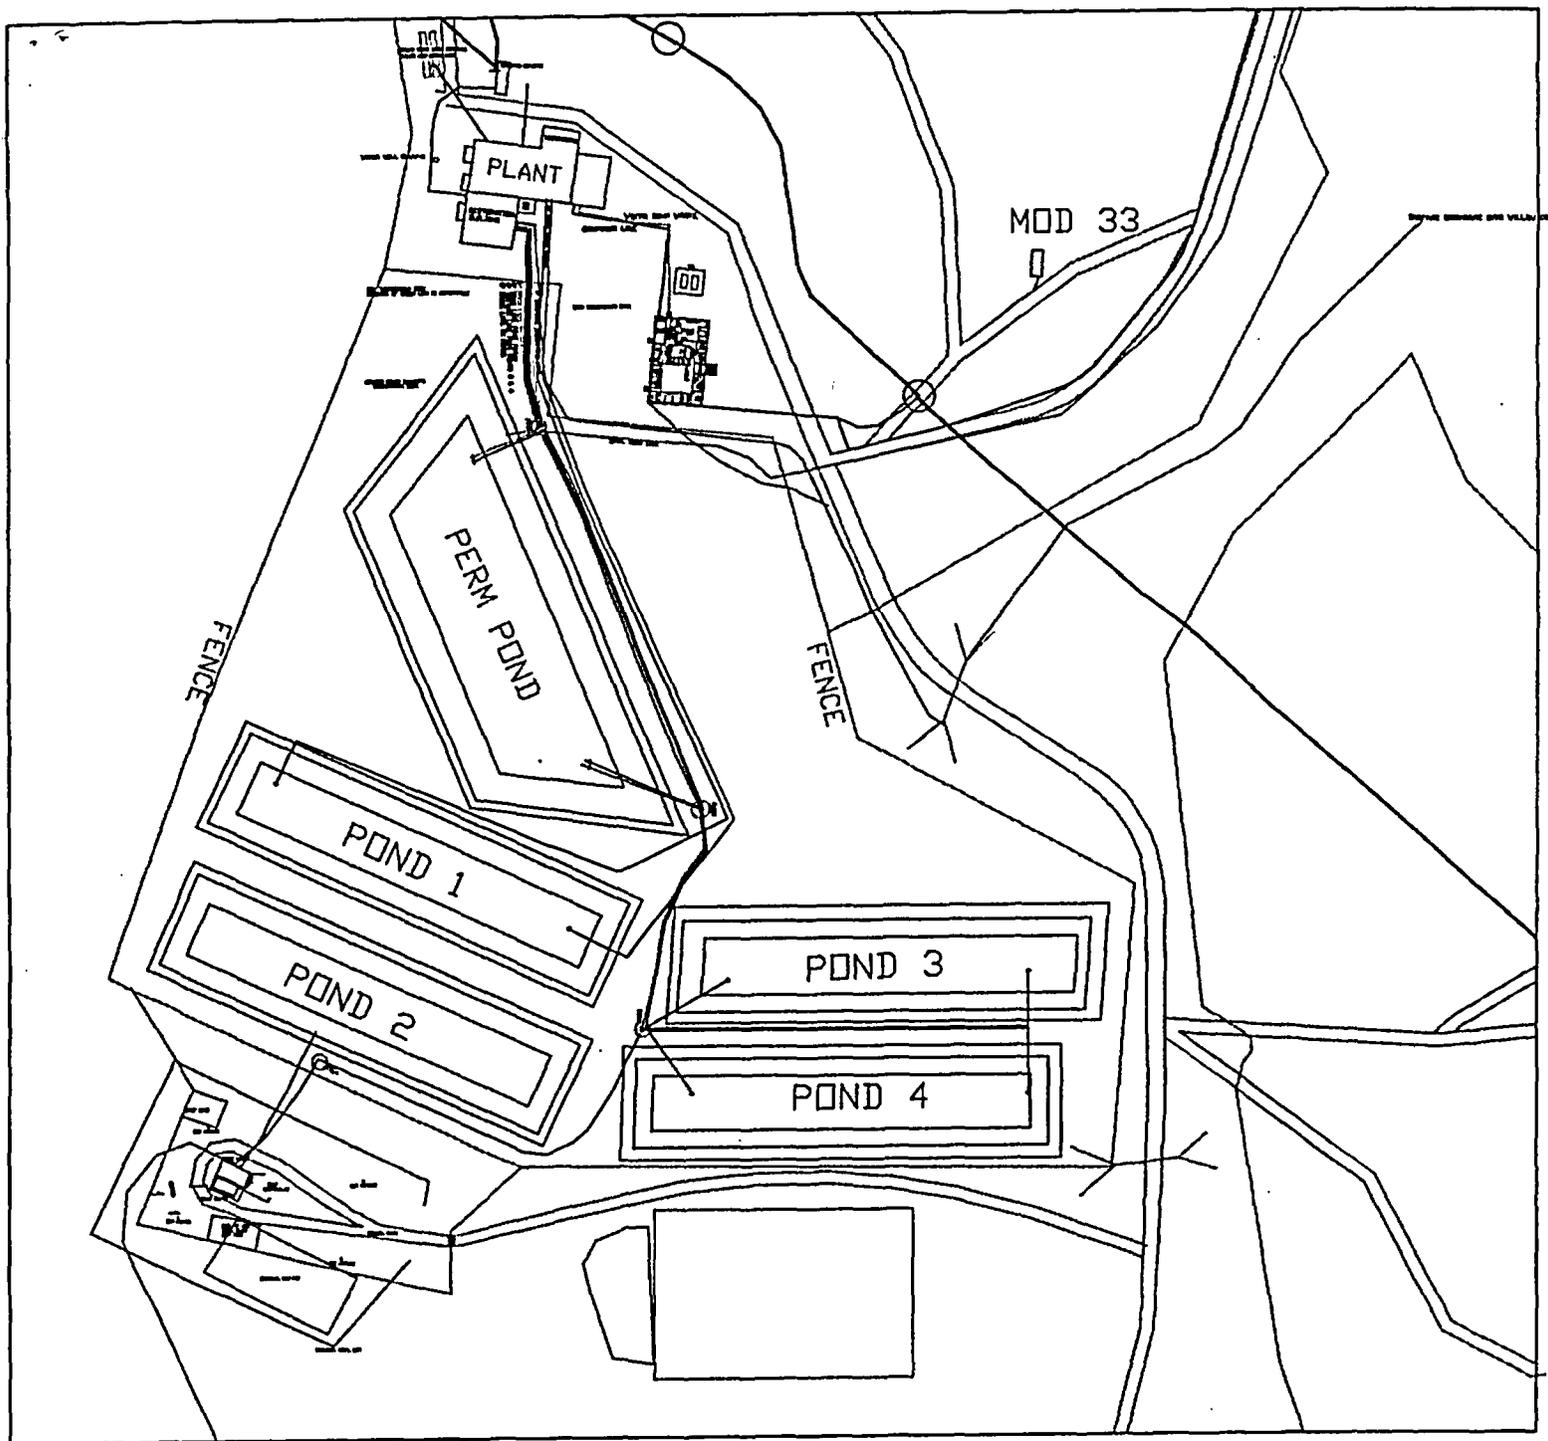
Attachments: Area Map.

The Christensen evaporation ponds are constructed such that each pond contains six cells that are monitored individually by a leak detection system (LDS). In Pond 3, fluid was detected only in the southwest corner cell (see attached map), thus indicating that the source of the leak is isolated to that portion of the pond. Fluid was detected in only the northwest corner cell of Pond 4, also indicating that the source of the leakage should be in that particular part of the pond.
