**Subject: Beaver Valley Power Station, Unit No. 2
BV-2 Docket No. 50-412, License No. NPF-73
Proposed Revision to the Previously Approved Deviation From Branch
Technical Position (BTP) CMEB 9.5-1**

FirstEnergy Nuclear Operating Company (FENOC) hereby requests review and approval of a revision to a previously approved deviation from Branch Technical Position (BTP) CMEB 9.5-1, "Guidelines for Fire Protection for Nuclear Power Plants."

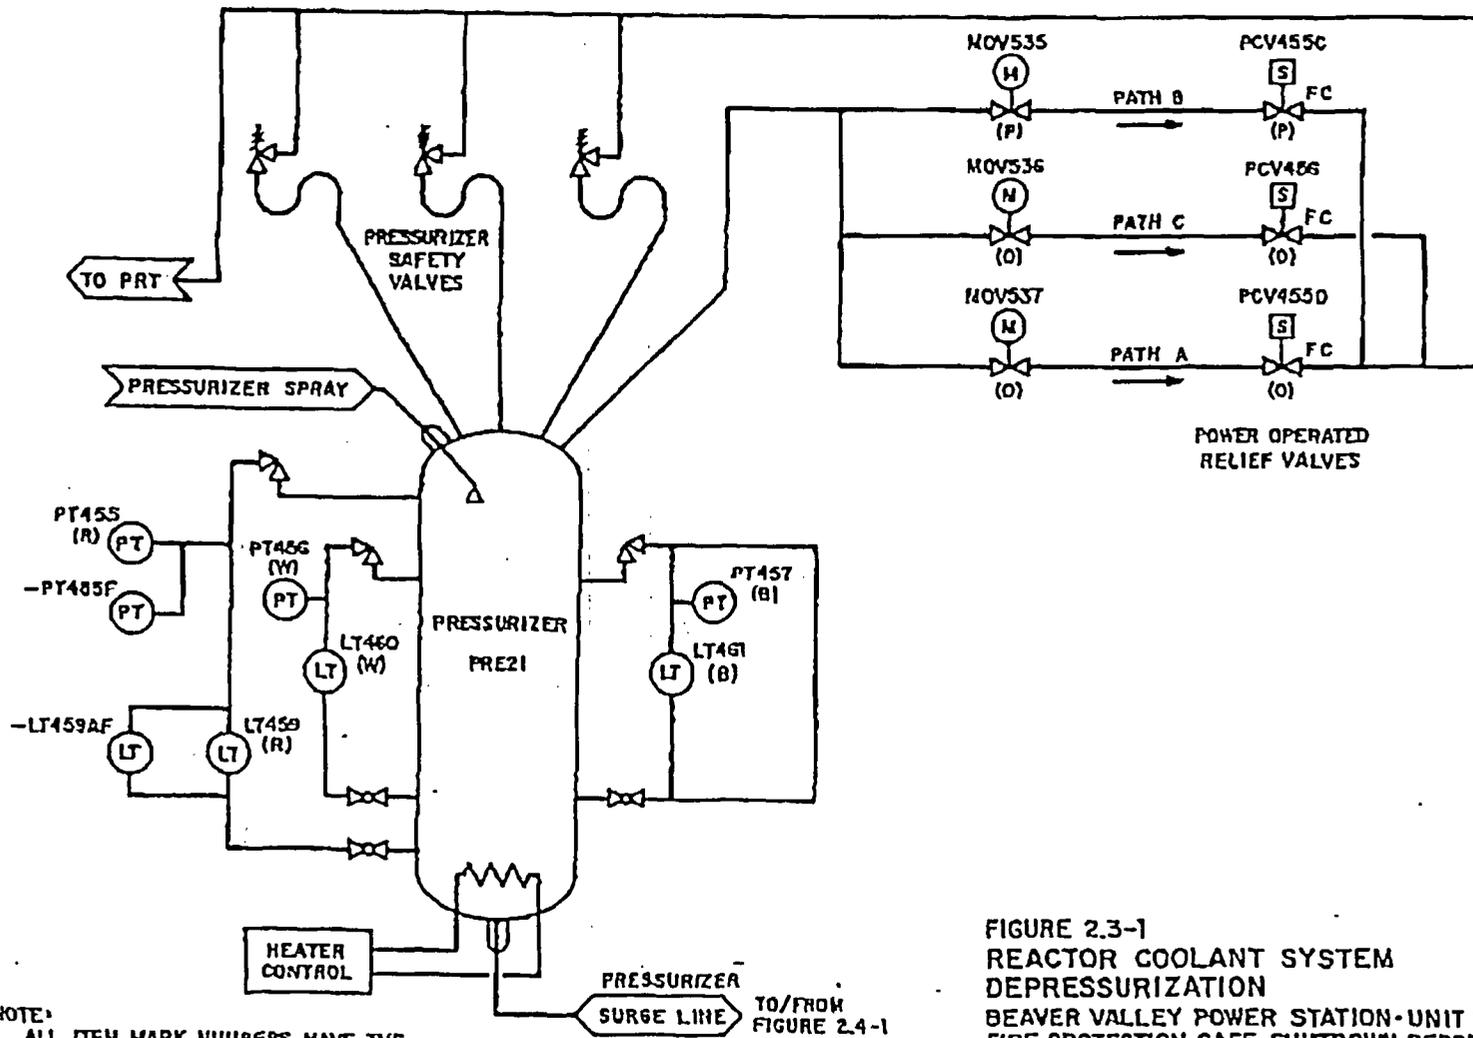
FIGURE 2.3-1
REACTOR COOLANT SYSTEM
DEPRESSURIZATION
BEAVER VALLEY POWER STATION-UNIT 2
FIRE PROTECTION SAFE SHUTDOWN REPORT

The Pressurizer Power Operated Relief Valves (PORVs) 2RCS*PCV455C, D, and 456 depressurize the RCS during cooldown in preparation for residual heat removal system operation. These solenoid-operated fail-closed valves discharge to the pressurizer relief tank via a common header. Normally open block valves are installed upstream of each PORV to prevent leakage. Three depressurization paths via the PORVs are provided. (See attached Figure 2.3-1 from the BVPS-2 Fire Protection Safe Shutdown Report.) The PORVs limit RCS pressure during large power mismatches, prevent actuation of the fixed high pressure reactor trip, and limit undesirable pressurizer safety valve opening during normal plant (power) operation.
