# BWR OWNERS' GROUP

**SUBJECT: *TRANSMITTAL OF BWR OWNERS' GROUP EXTENDED POWER UPRATE (EPU) LESSONS LEARNED AND RECOMMENDATIONS (NEDO-33159)***

**Attachment: NEDO-33159, Extended Power Uprate (EPU) Lessons Learned and Recommendations, Revision 0 dated November 2004**

NEDO-33159  
Revision 0  
Class I  
November 2004

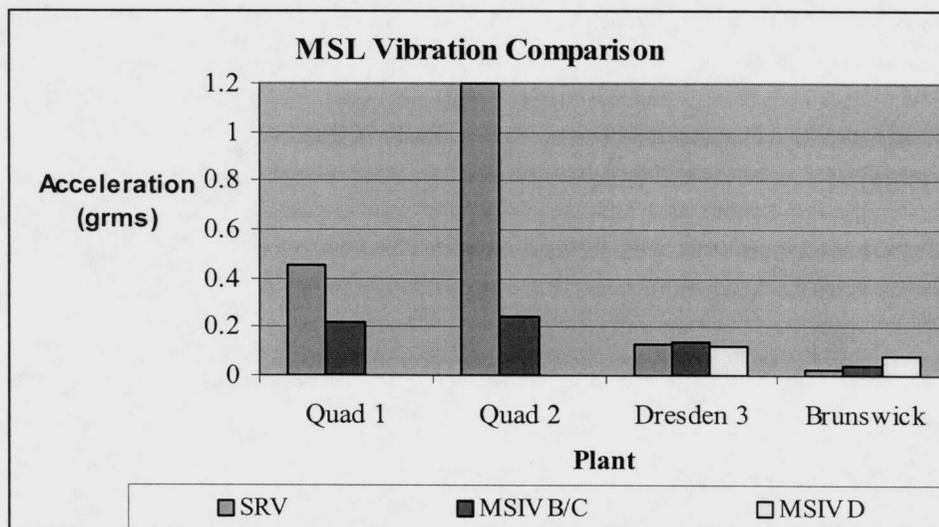
The following chart supports the BWROG conclusion that the Quad Cities vibration levels are an anomaly. All values are total root mean square acceleration in g's taken at the uprated power level. Note that the SRV vibration levels at Brunswick (120% OLTP) are approximately 60 times lower than at Quad Cities 2 whereas the SRV vibration levels at Dresden 3 are approximately 10 times lower than at Quad Cities 2.

Based on the number of component failures at the Quad Cities plants and the vibration levels in comparison with other BWRs, the BWROG preliminary conclusions are that the vibration problems at the Quad Cities plants are an anomaly related to high steam velocities that produced high vibration levels (inside the steam piping). The BWROG/BWRVIP is following the development of acoustic load methodologies and believes that these methodologies can be employed to verify the uniqueness of the Quad Cities vibration levels.
