SUBJECT: *TRANSMITTAL OF BWR OWNERS' GROUP EXTENDED POWER UPRATE (EPU) LESSONS LEARNED AND RECOMMENDATIONS (NEDO-33159)*

Attachment: NEDO-33159, Extended Power Uprate (EPU) Lessons Learned and Recommendations, Revision 0 dated November 2004

NEDO-33159
BWR Owners' Group
EPU Lessons Learned and Recommendations

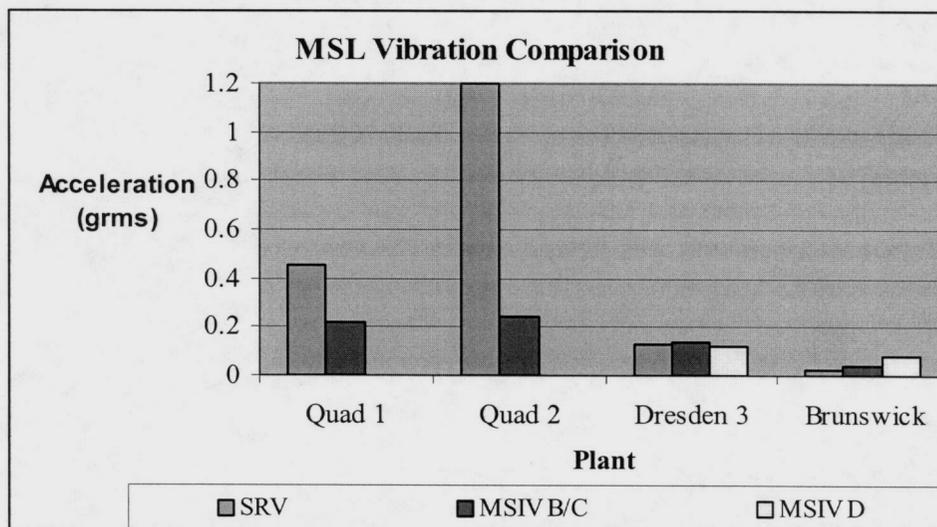
The following chart supports the BWROG conclusion that the Quad Cities vibration levels are an anomaly. All values are total root mean square acceleration in g's taken at the uprated power level. Note that the SRV vibration levels at Brunswick (120% OLTP) are approximately 60 times lower than at Quad Cities 2 whereas the SRV vibration levels at Dresden 3 are approximately 10 times lower than at Quad Cities 2.

Based on the number of component failures at the Quad Cities plants and the vibration levels in comparison with other BWRs, the BWROG preliminary conclusions are that the vibration problems at the Quad Cities plants are an anomaly related to high steam velocities that produced high vibration levels (inside the steam piping). The BWROG/BWRVIP is following the development of acoustic load methodologies and believes that these methodologies can be employed to verify the uniqueness of the Quad Cities vibration levels.
