FPL

Nuclear Engineering

NRC / FPL Interface Meeting

December 6, 2004

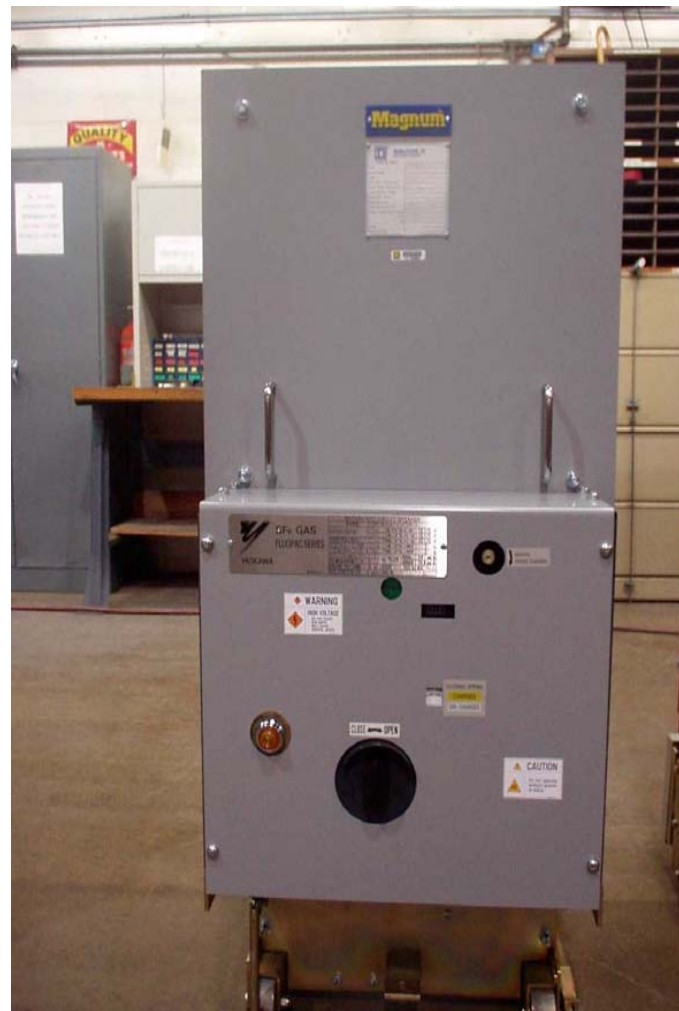
Breaker Program - St. Lucie 4 KV Breaker Replacement

- SF6 breakers selected
 - Simple operating mechanism with less failure modes
 - Reduced required maintenance
- SL1-19 Installation
 - Extensive OE review to minimize potential issues
 - Maintenance and testing on key interfaces
 - Additional oversight dedicated to Project

6 Non Safety breakers
installed with no issues
