Dominion Nuclear Connecticut, Inc.
Millstone Power Station
Rope Ferry Road
Waterford, CT 06385

DOMINION NUCLEAR CONNECTICUT, INC. (DNC)
MILLSTONE POWER STATION UNITS 2 AND 3
RESPONSE TO REQUEST FOR ADDITIONAL INFORMATION
LICENSE RENEWAL APPLICATIONS

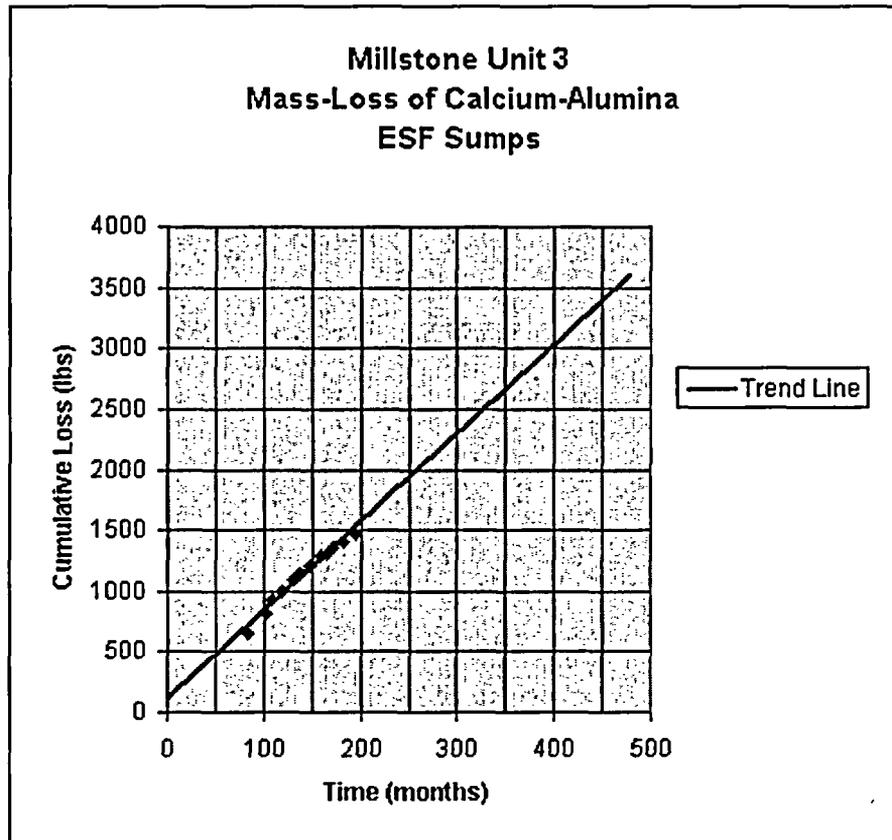
Figure 1
Millstone Unit 3
Mass-Loss of Calcium-Alumina
ESF Sumps

Millstone Unit 3 has performed extensive analysis of the condition of the porous concrete subfoundation, including the effect of cement erosion, the potential loss of strength of the subfoundation due to conversion of the high alumina cement, the effect of cement erosion on the load bearing capacity of the porous concrete, and the functional integrity of the containment structure (J. A. Price to NRC, *Millstone Power Station Unit No. 3 License Renewal – Request for Exemption From the Requirements of 10 CFR 54.17(c), Response to Request for Additional Information*, Letter B18948 dated September 3, 2003). The mass-loss of high alumina (calcium-alumina) residue discharged into the ESF sumps has been monitored since the startup of Millstone Unit 3 in 1986. A commitment (captured in the Structures Monitoring Program) to continue this periodic monitoring was made as a means of insuring that no new or adverse changes are occurring in the porous concrete subfoundation (M. L. Bowling to NRC, *Millstone Nuclear Power Station Unit 3, Response to Request for Additional Information – Erosion of Cement From the Underlying Porous Concrete Drainage System*, Letter B17115 dated April 16, 1998). ESF sump sample results can be found in Table 1. These results are conservatively projected to year 2026 (480 months) in Figure 1. The 480 months represents the current 40-year license x 12 months/year. By 2026 approximately 3,600 pounds (or 0.5%) of the 670,000 pounds of calcium-alumina cement in the porous media could be lost. This loss is not expected to adversely affect the function of the porous media (NRC to M. L. Bowling, *NRC Combined*

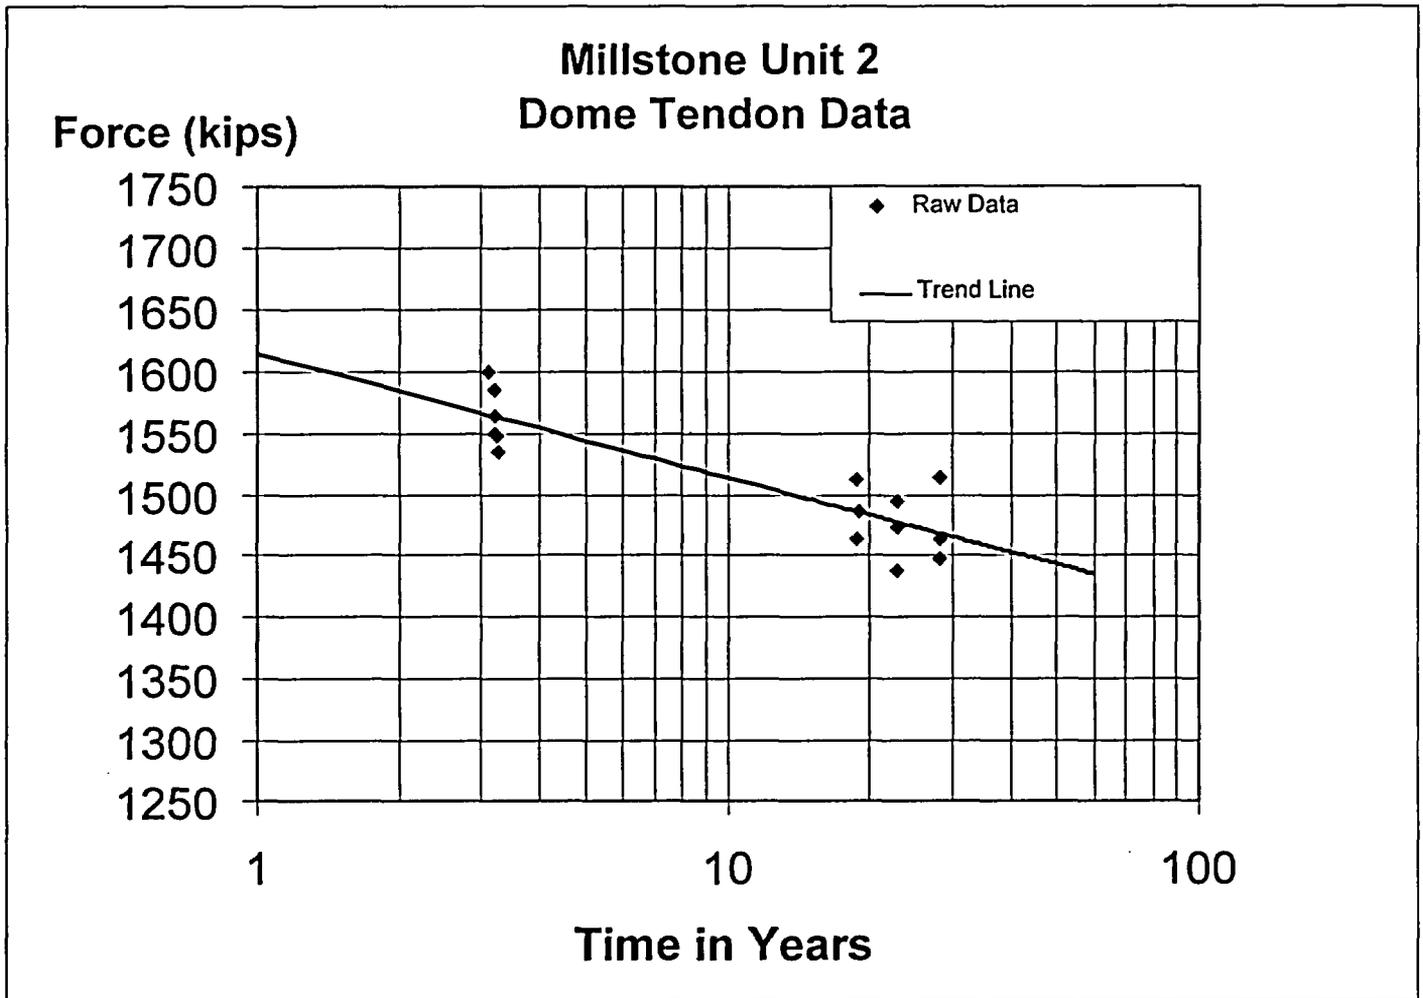
Figure 1
Millstone Unit 2
Containment Tendon Prestress
Dome Tendons
(Raw Data)

As a supplement to the regression analysis results contained in the response to RAI 4.5-5, the raw dome, vertical and horizontal tendon force data contained in Tables 1, 2 and 3 was used to develop the indicated best-fit trend-lines in Figures 1, 2 and 3. Tendon force data developed in accordance with Regulatory Guide 1.35, Revision 1 requirements (3, 5 and 10-year inspections) was not used for trending purposes since this revision required repetitive detensioning and retensioning of the same tendon groups. Prestressing forces for the 15, 20 and 25-year containment tendon inspections were developed using the requirements of Regulatory Guide 1.35, Revision 3. Only prestressing forces from previously untested tendons are used for projection purposes.

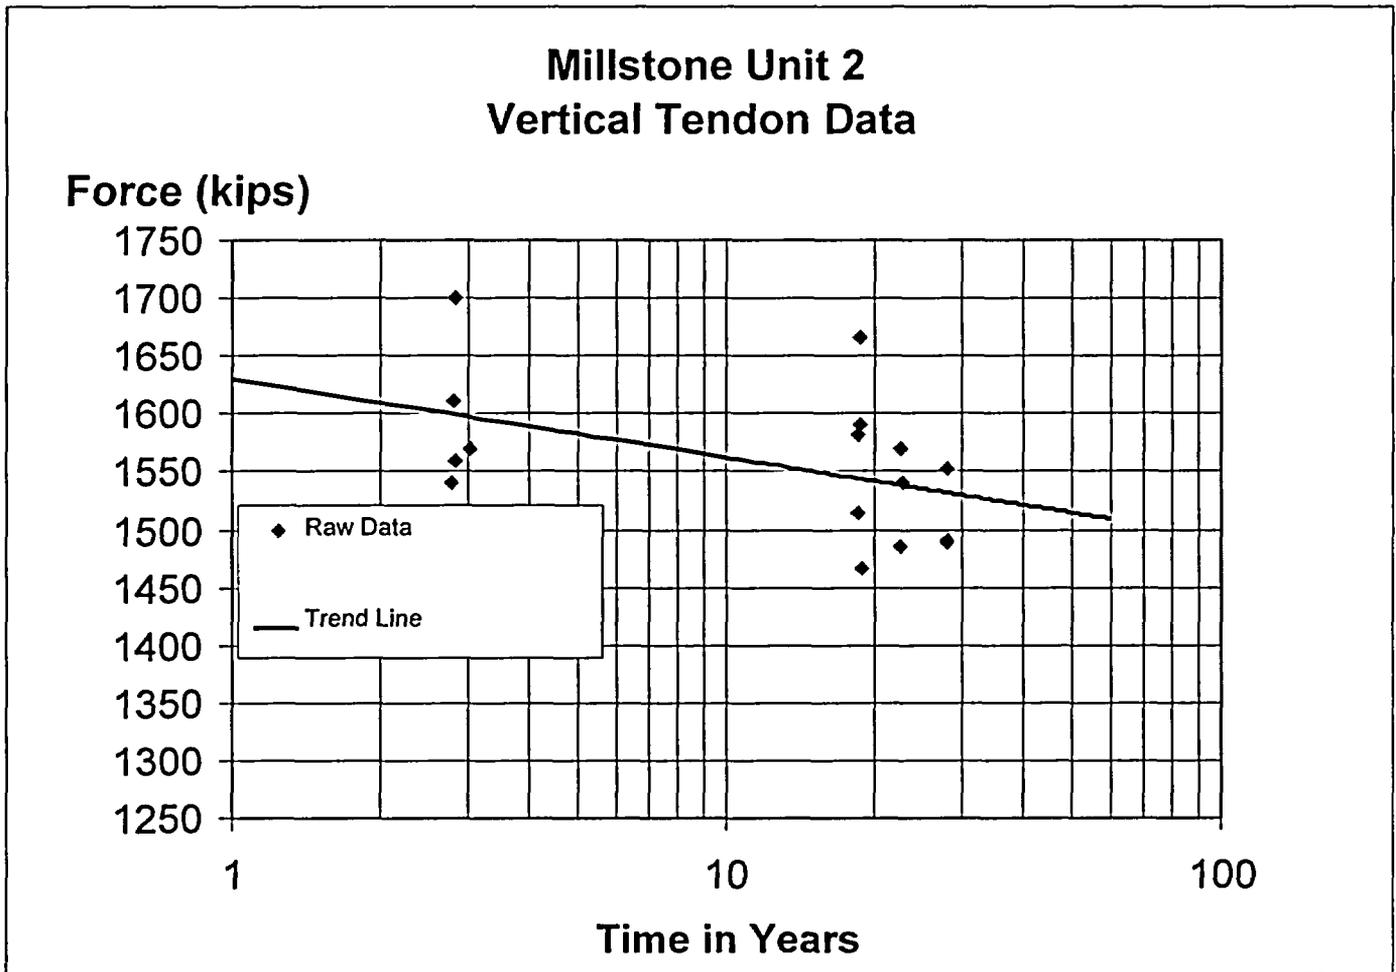
Figure 2
Millstone Unit 2
Containment Tendon Prestress
Vertical Tendons
(Raw Data)

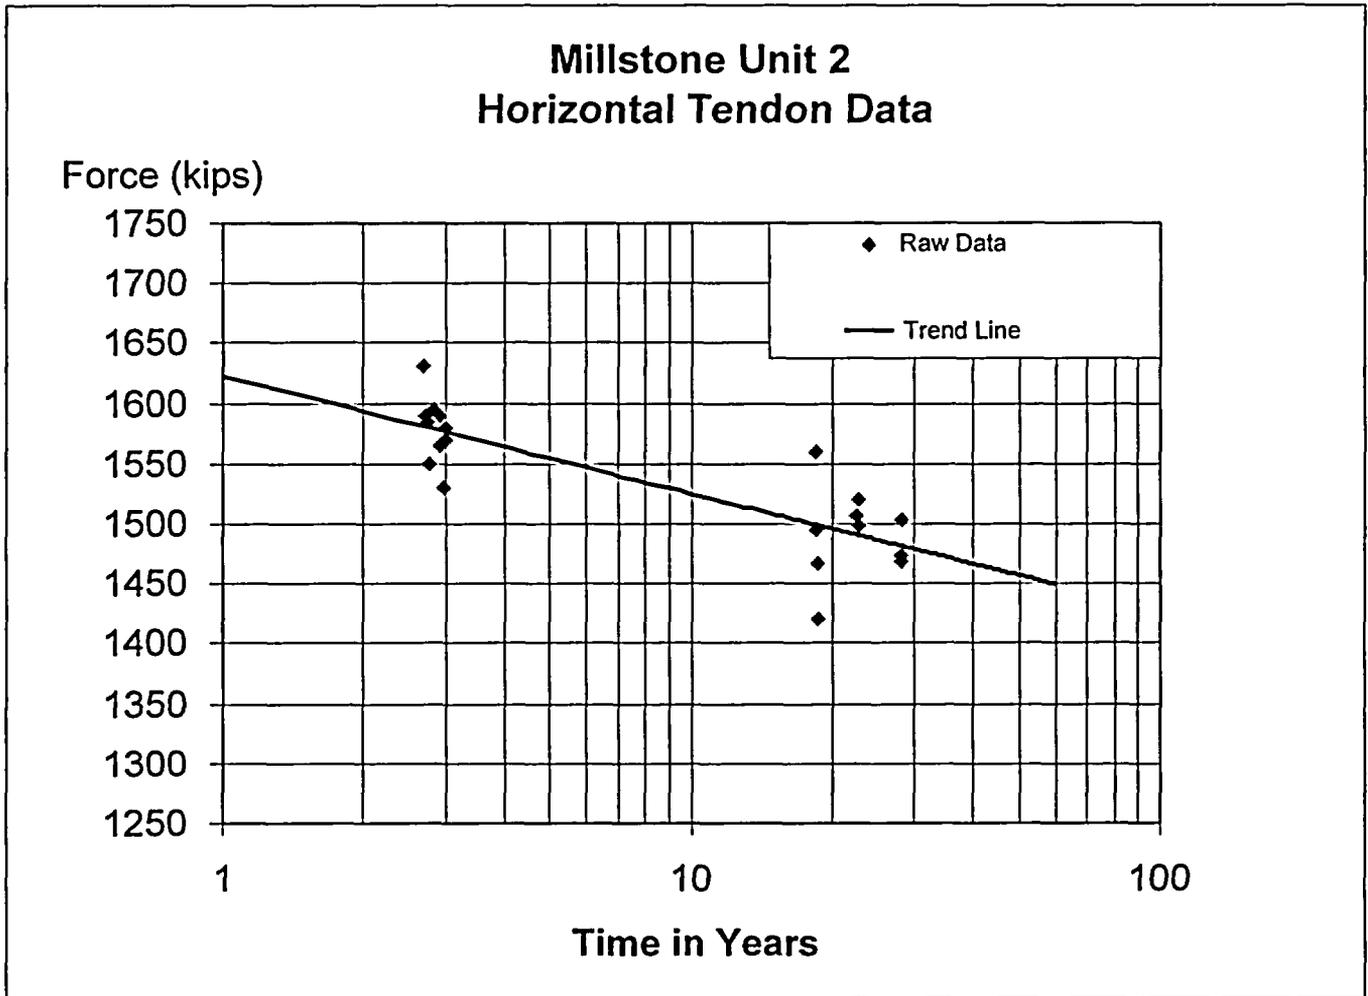
Figure 3
Millstone Unit 2
Containment Tendon Prestress
Horizontal Tendons
(Raw Data)

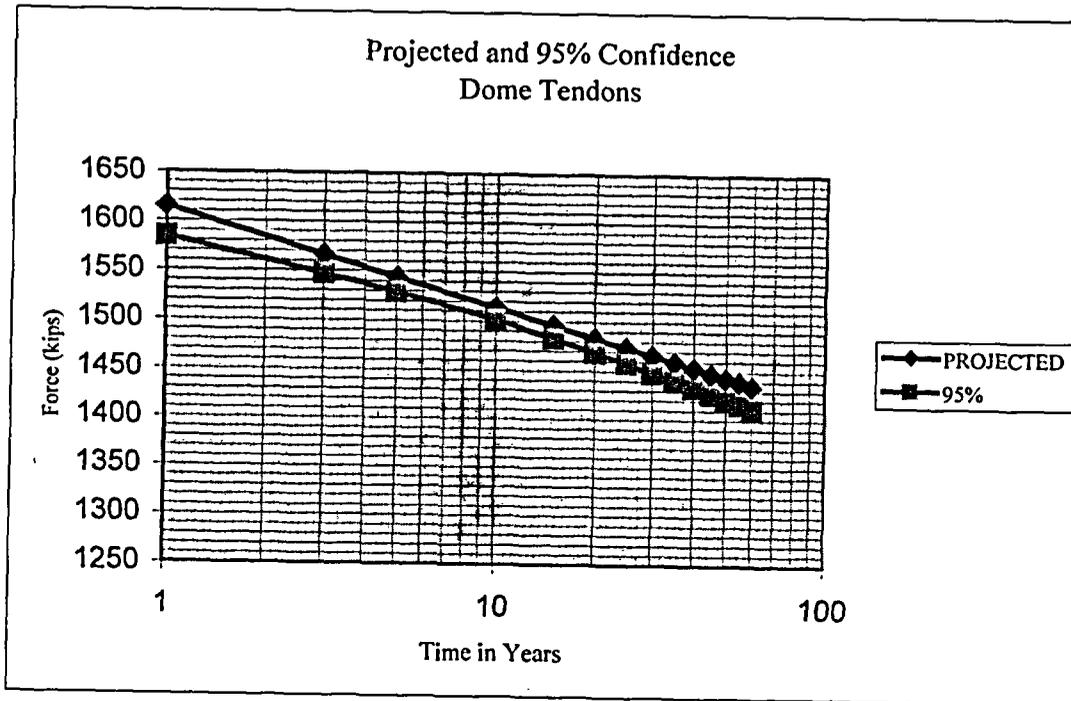
Figure 1
Millstone Unit 2
Containment Tendon Prestress
Dome Tendons

Consistent with Regulatory Guide 1.35.1, the containment dome, horizontal and vertical tendon surveillance results (Millstone Unit 2 LRA, Section 4, Tables 4.5-1, 4.5-2 and 4.5-3) used in the development of LRA Figure 4.5-1 have been plotted in the following Figures 1, 2 and 3, against the logarithm of time using the methodology identified in Attachment 3 of NRC Information Notice 99-10. Prestressing forces for the Millstone Unit 2 containment dome, horizontal and vertical tendon are shown to vary linearly with time. Further discussion and information on the development of these curves can be found in the responses to RAI 4.5-2, RAI 4.5-4 and RAI 4.5-7.

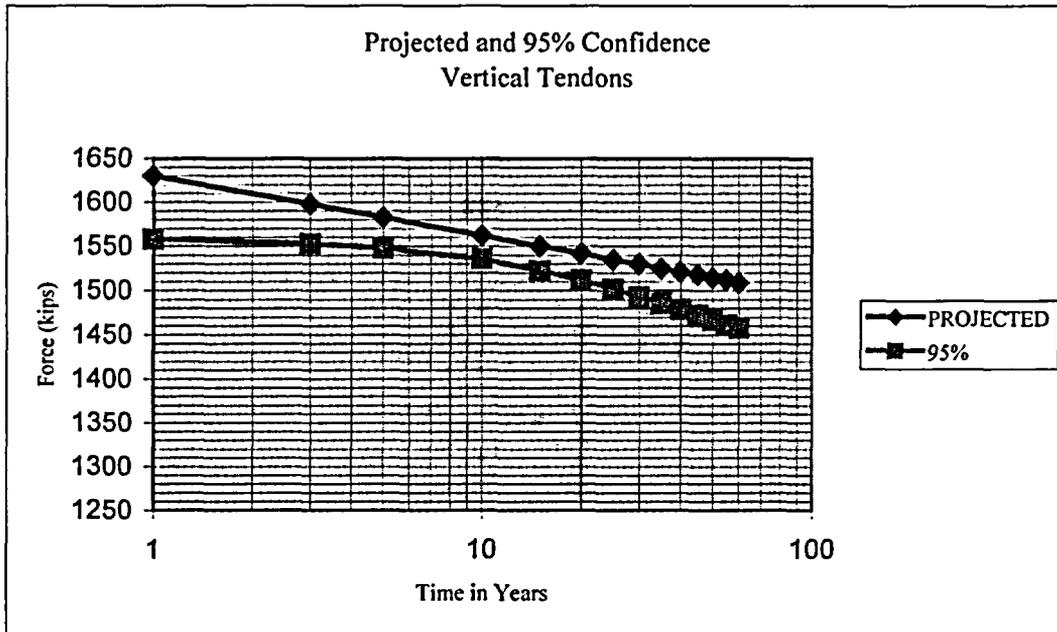
Figure 2
Millstone Unit 2
Containment Tendon Prestress
Vertical Tendons

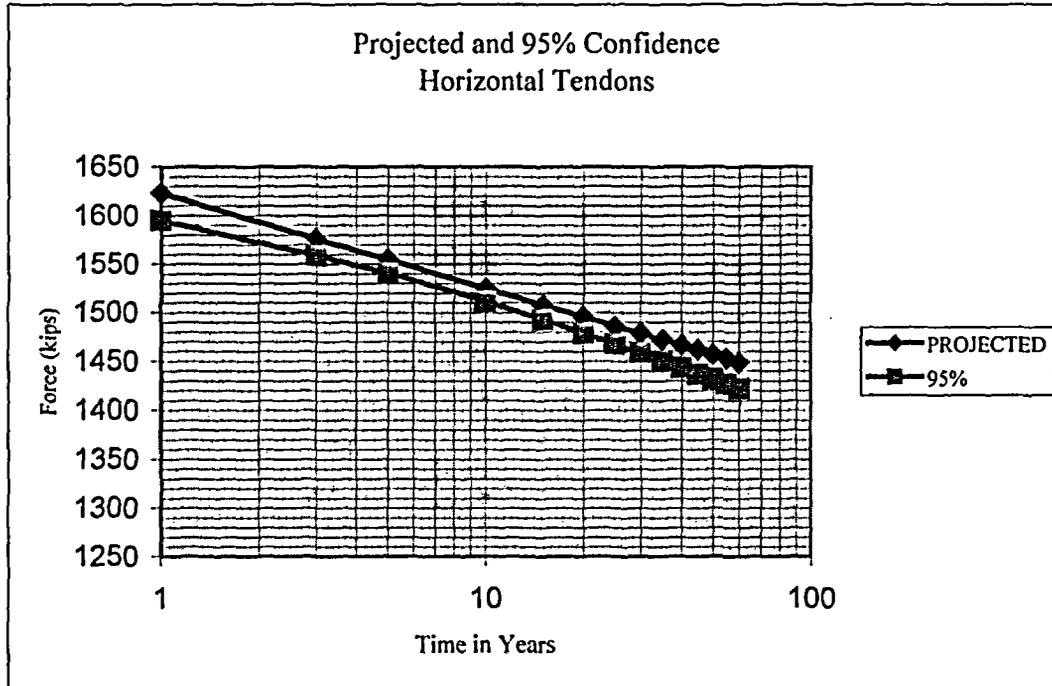
Figure 3
Millstone Unit 2
Containment Tendon Prestress
Horizontal Tendons
