Joseph M. Farley Nuclear Plant - Unit 2  
Response to Request for Additional Information  
Regarding Fall 2002 Steam Generator Inspection

Response to Request for Additional Information  
Regarding FNP 2R15 Steam Generator Inspection

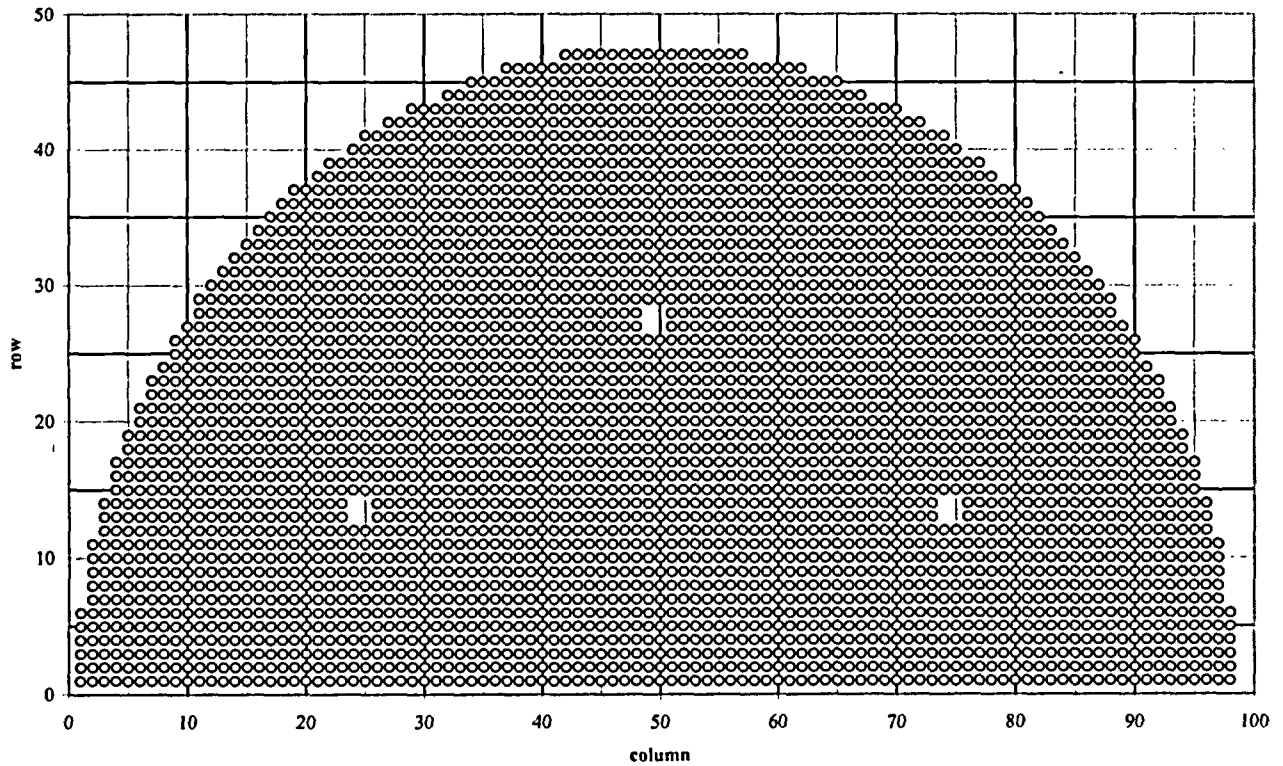
Model 54F ILL Tubesheet Map

Tubesheet Map (Hotleg Side) for Westinghouse Model 54F Steam Generators  
as used at Farley Nuclear Plant

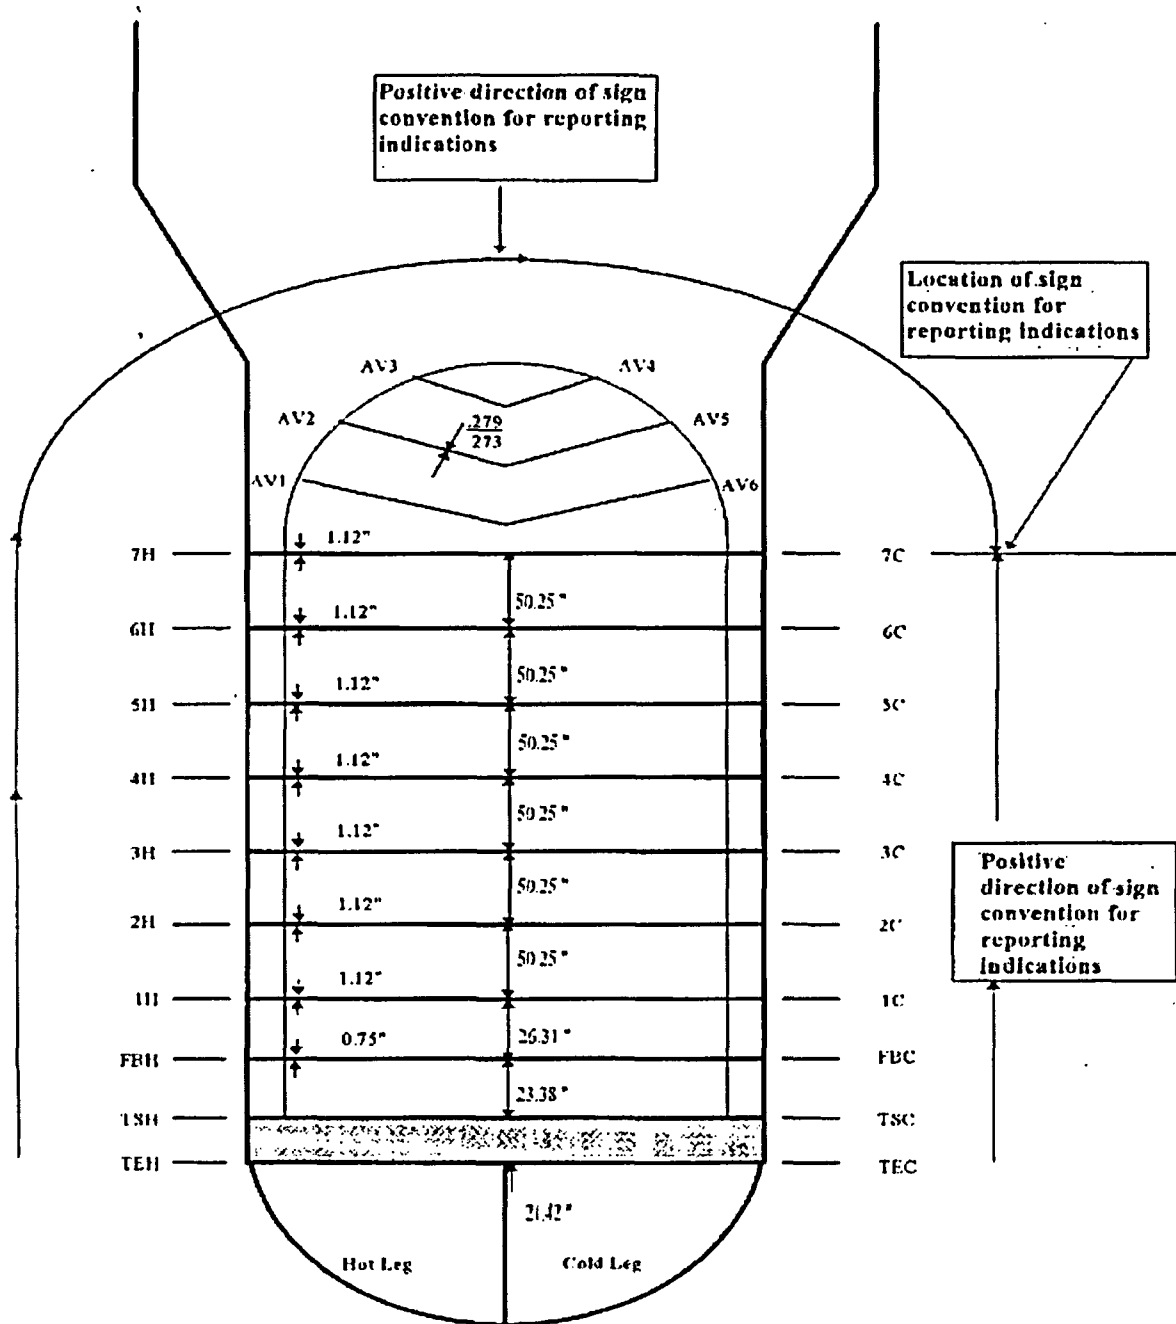
MODEL 54F DESIGN SPECIFICS

Tube Support Plate Layout for Westinghouse Model 54F Steam Generators  
as used at Farley Nuclear Plant
