**FIGURE 36**  
 Effects of Past Pumping to Dewater Zone 3  
 United Nuclear Corporation, Church Rock Site, Church Rock, New Mexico

United Nuclear Corporation Church Rock Site,  
 Church Rock, New Mexico

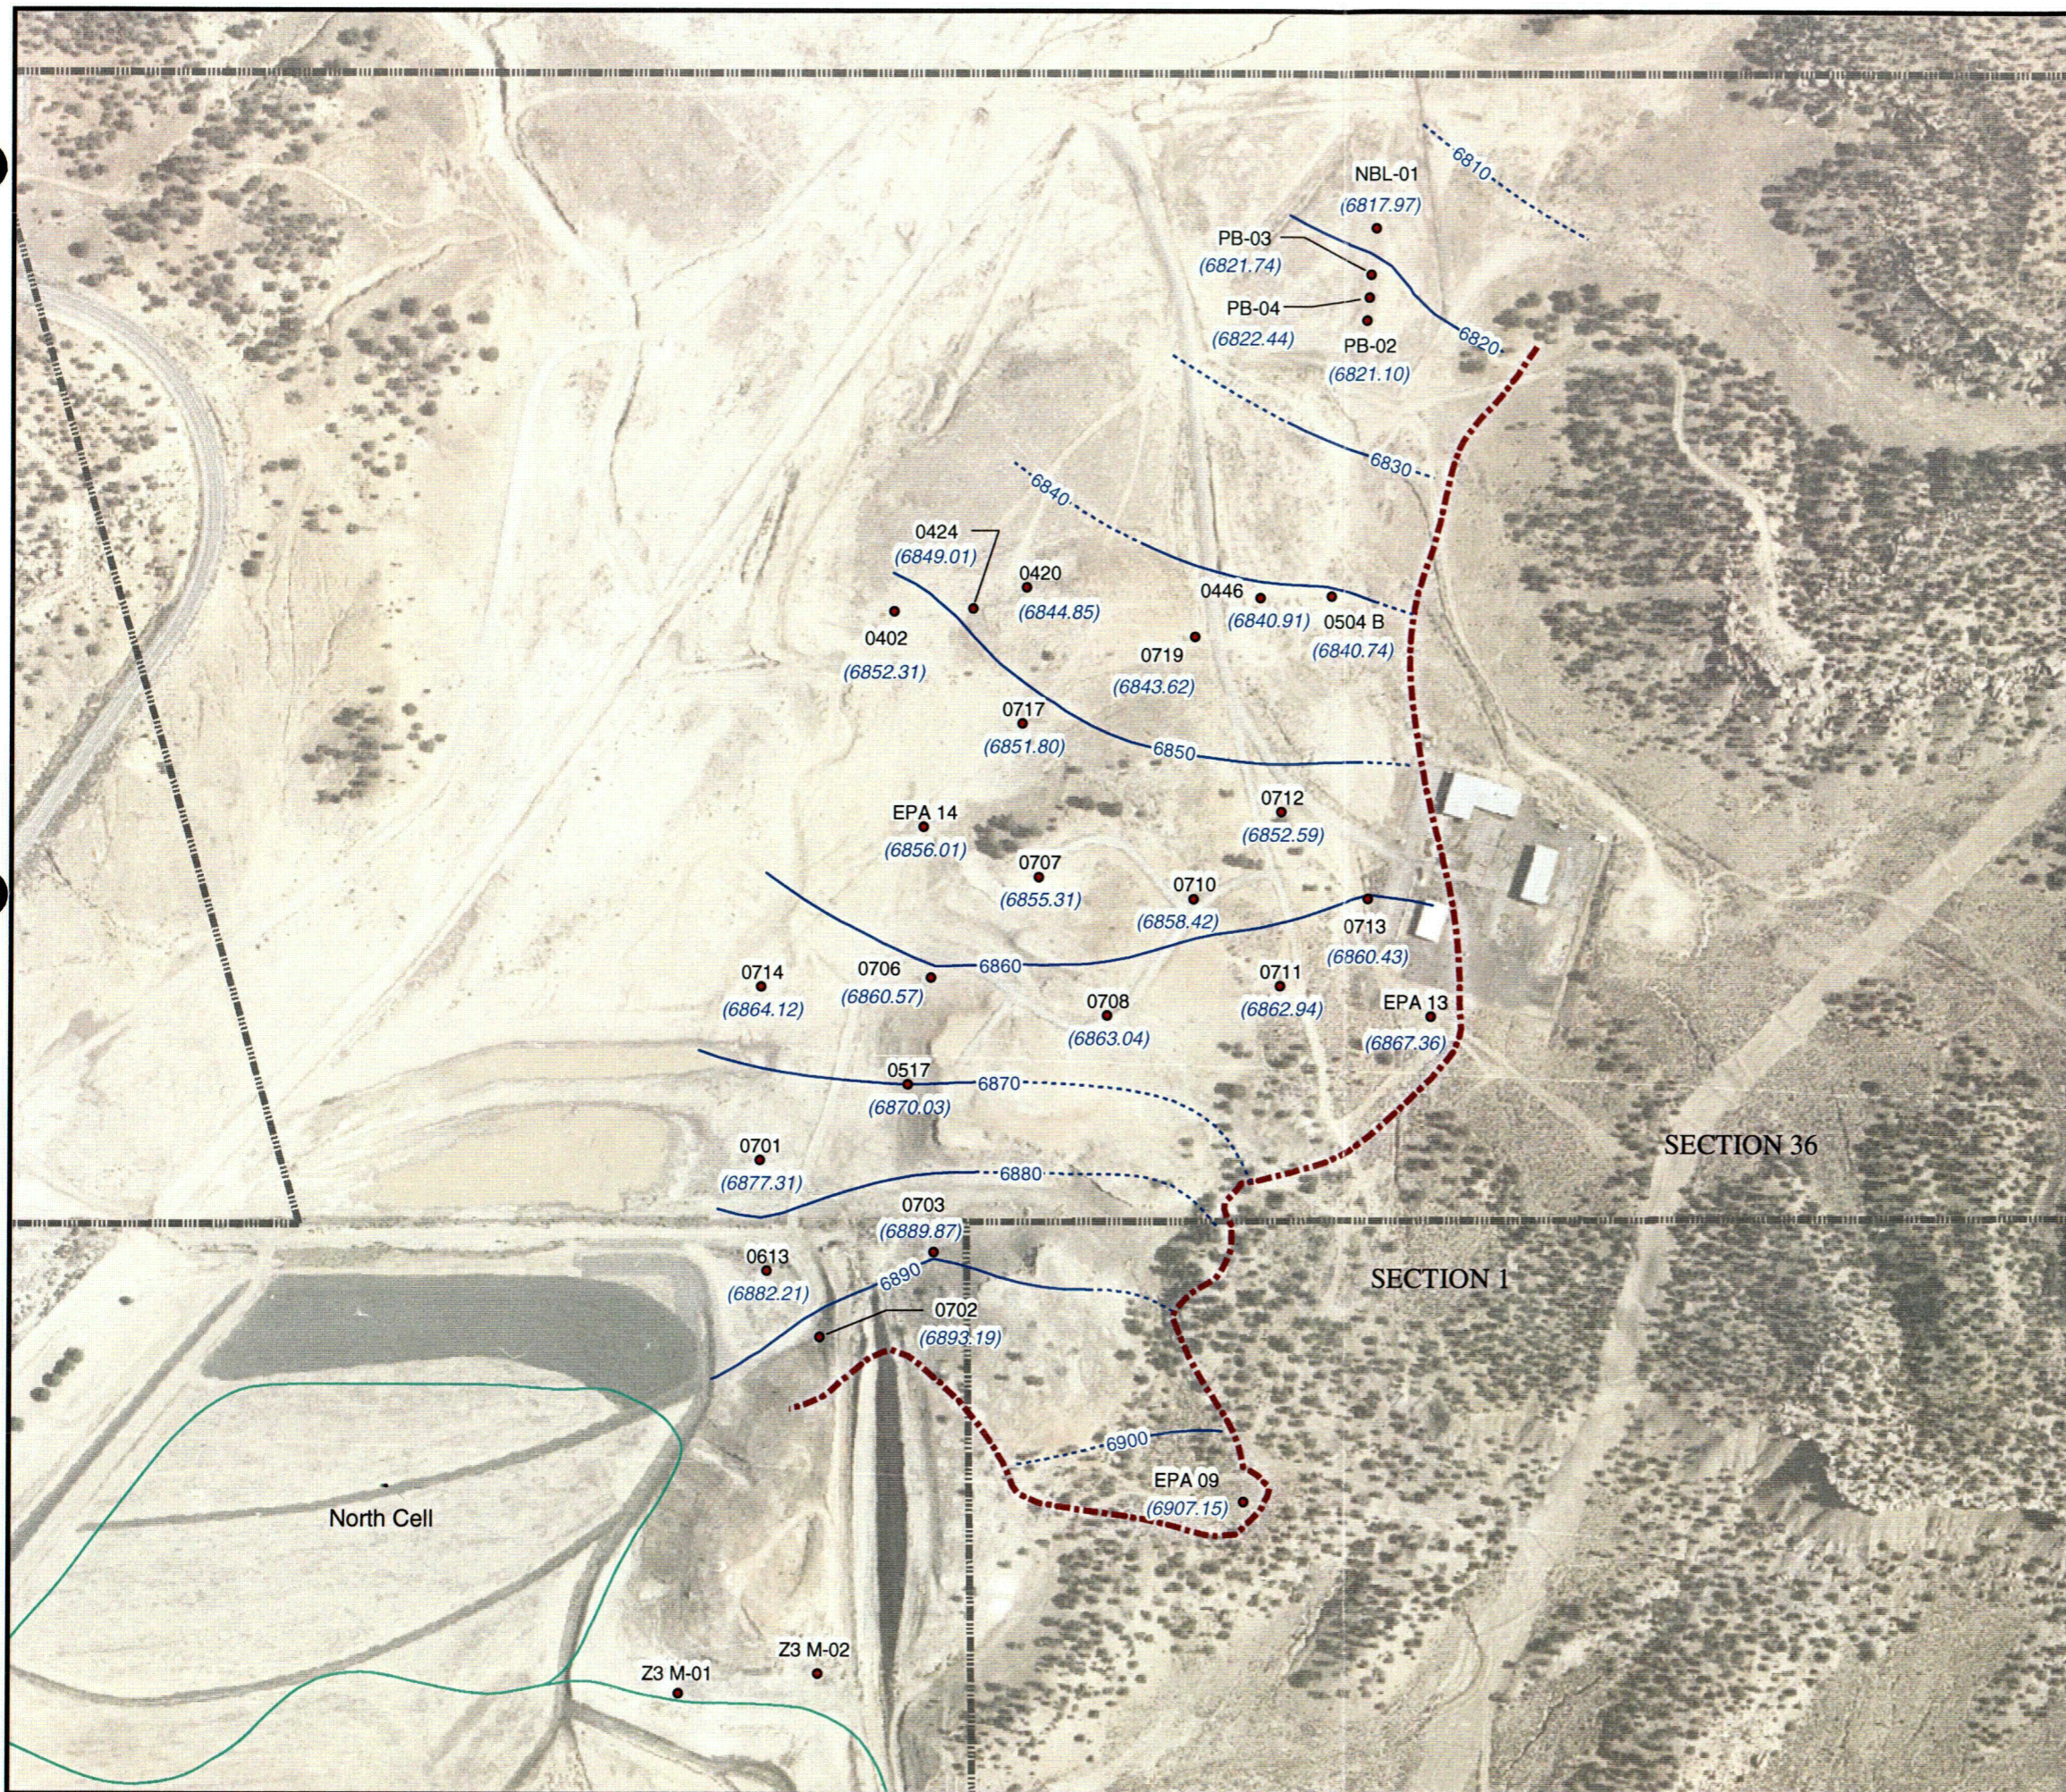
1. Groundwater elevation values are displayed in feet above mean sea level.
2. Well names are displayed with black text.
3. Groundwater elevations are shown with blue text.
4. Aerial photo taken on August 1, 1996.

**FIGURE 37**  
 Zone 3 Potentiometric Surface Map  
 October 2004

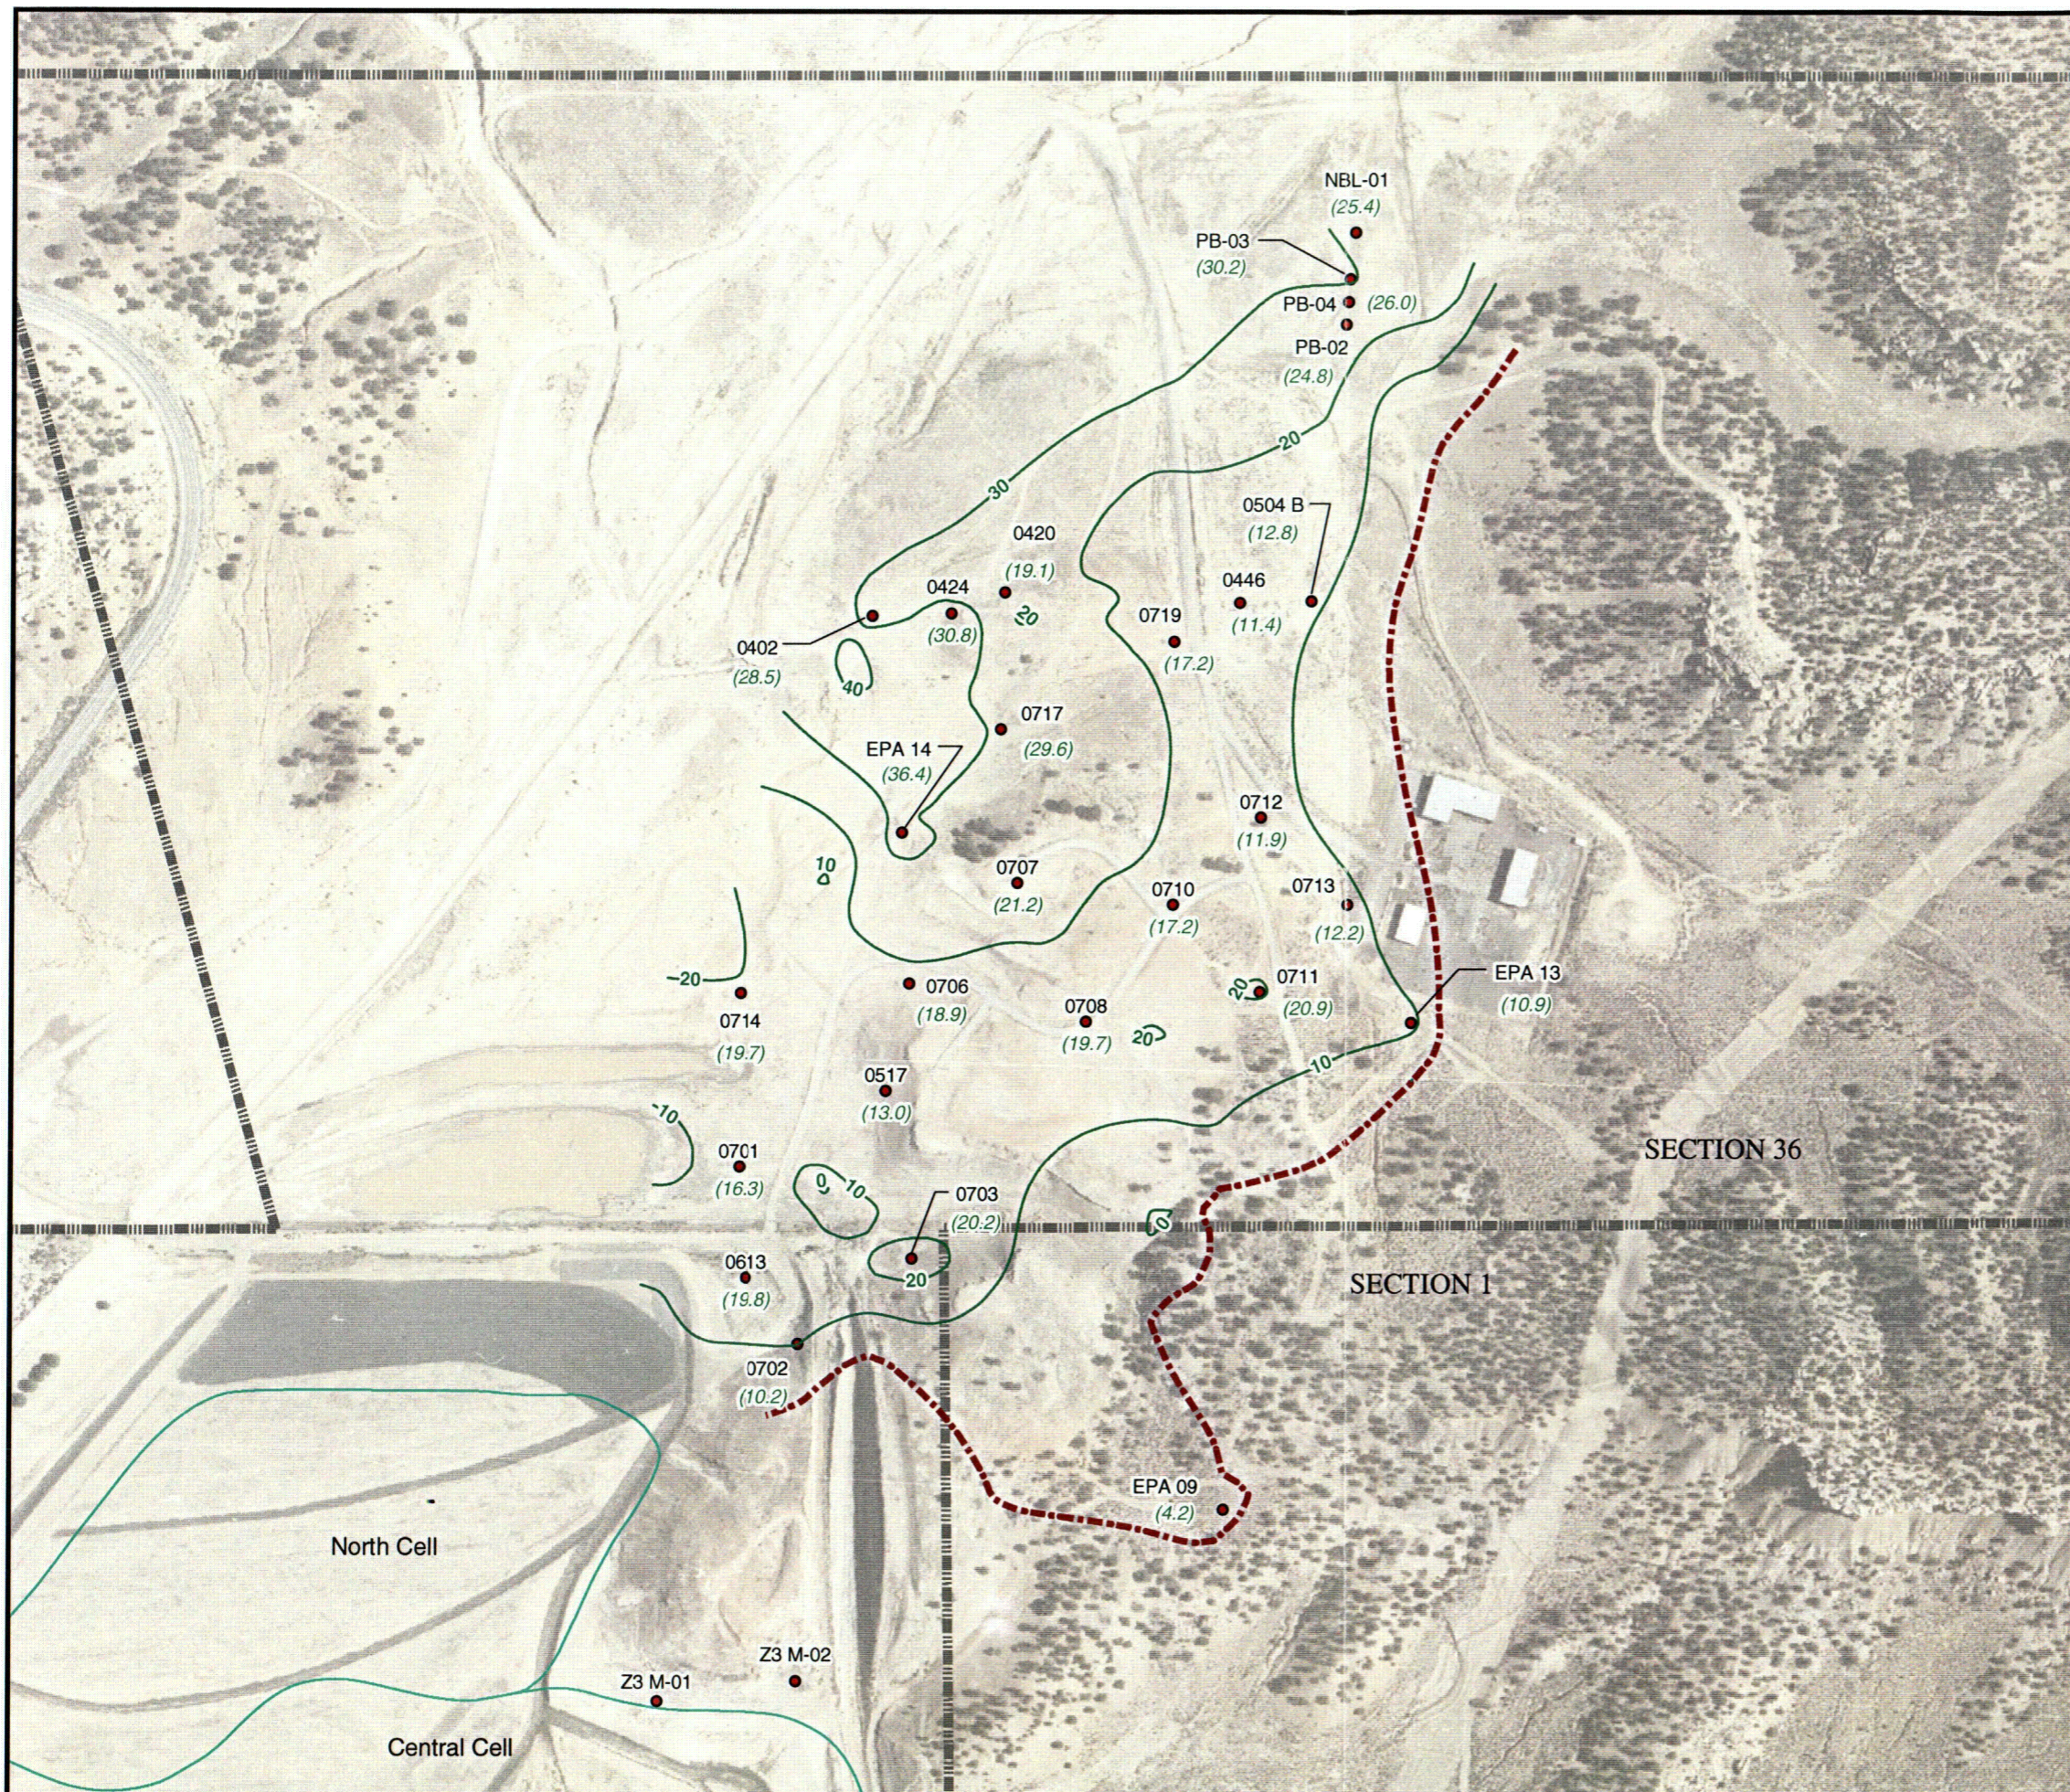
1. Well names are displayed with black text.
2. Values for saturated thickness in feet are shown with dark green text and enclosed in parentheses.
3. Aerial photo taken on August 1, 1996.

**FIGURE 38**  
 Zone 3 Saturated Thickness Map  
 October 2004

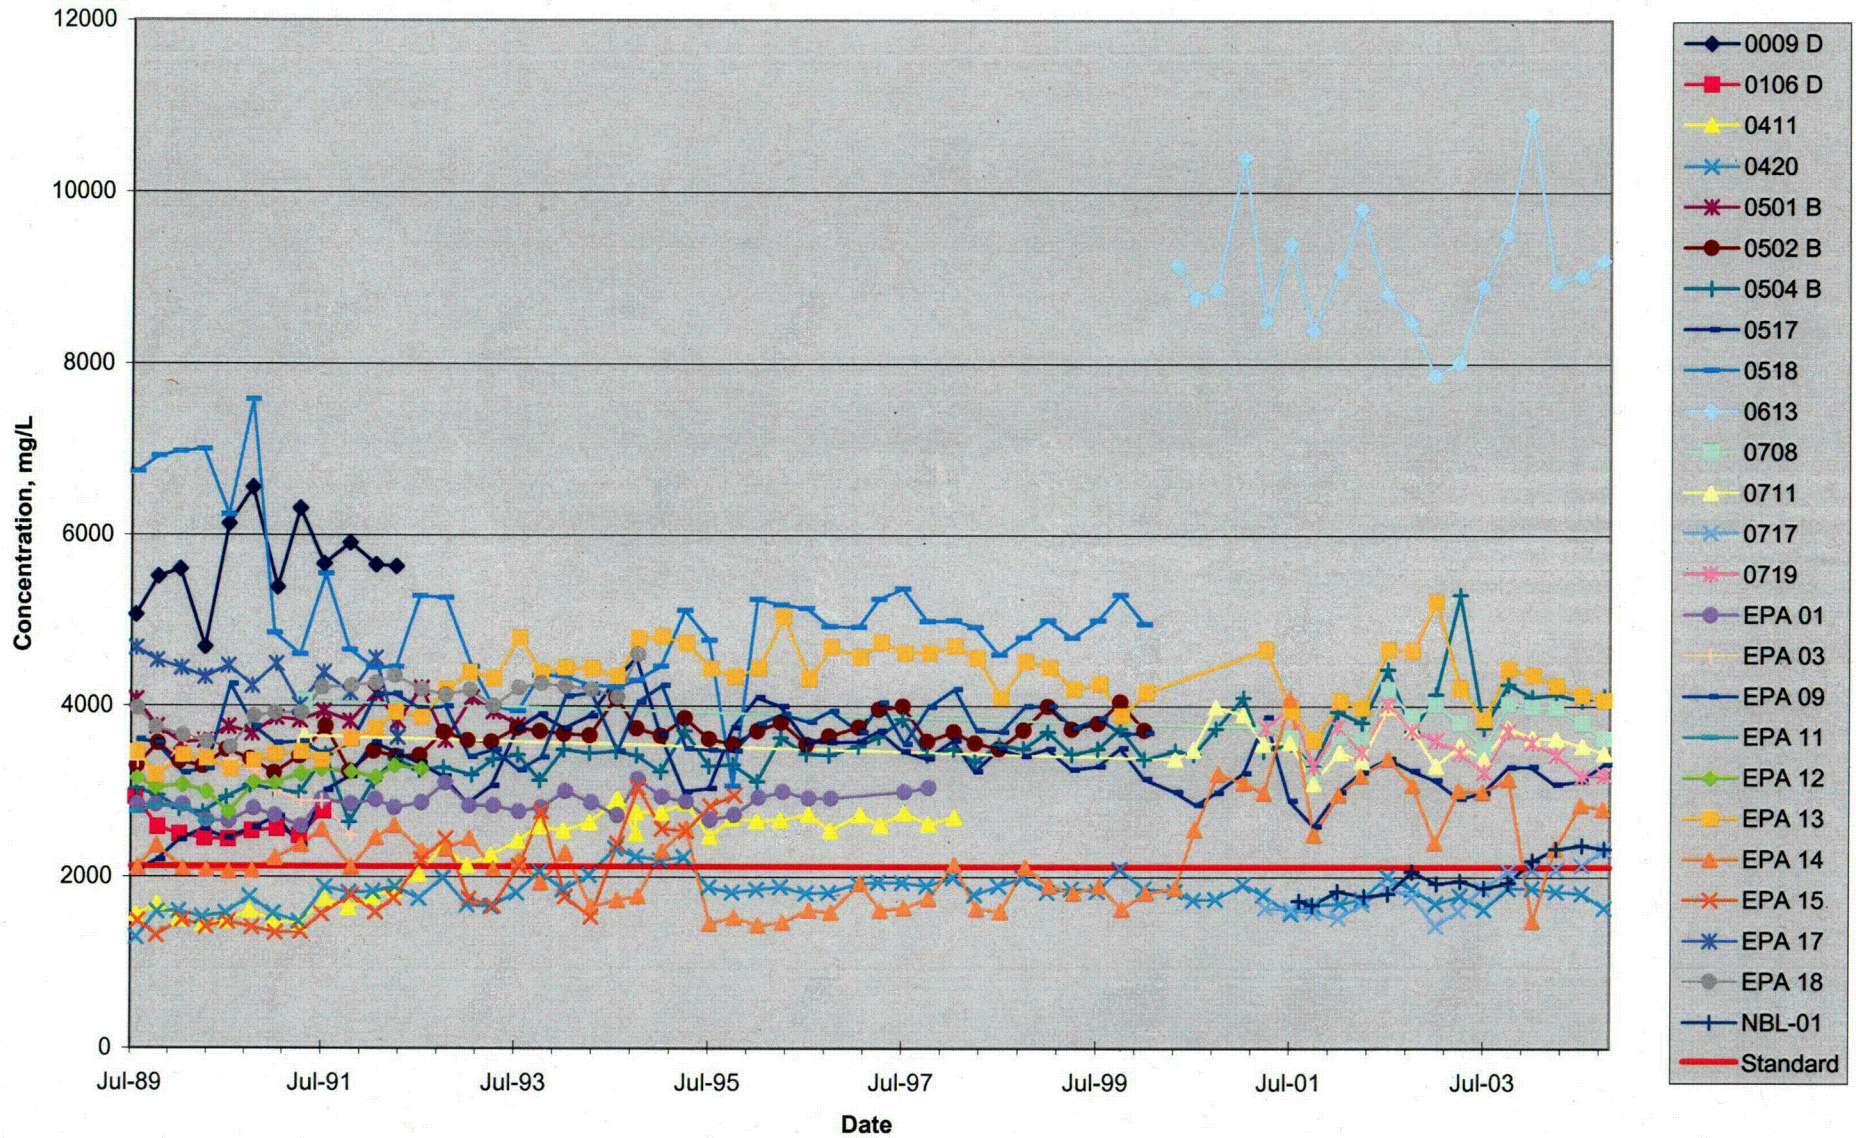
**FIGURE 39**  
 Zone 3 Sulfate Concentrations Over Time  
 United Nuclear Corporation, Church Rock site, Church Rock, New Mexico

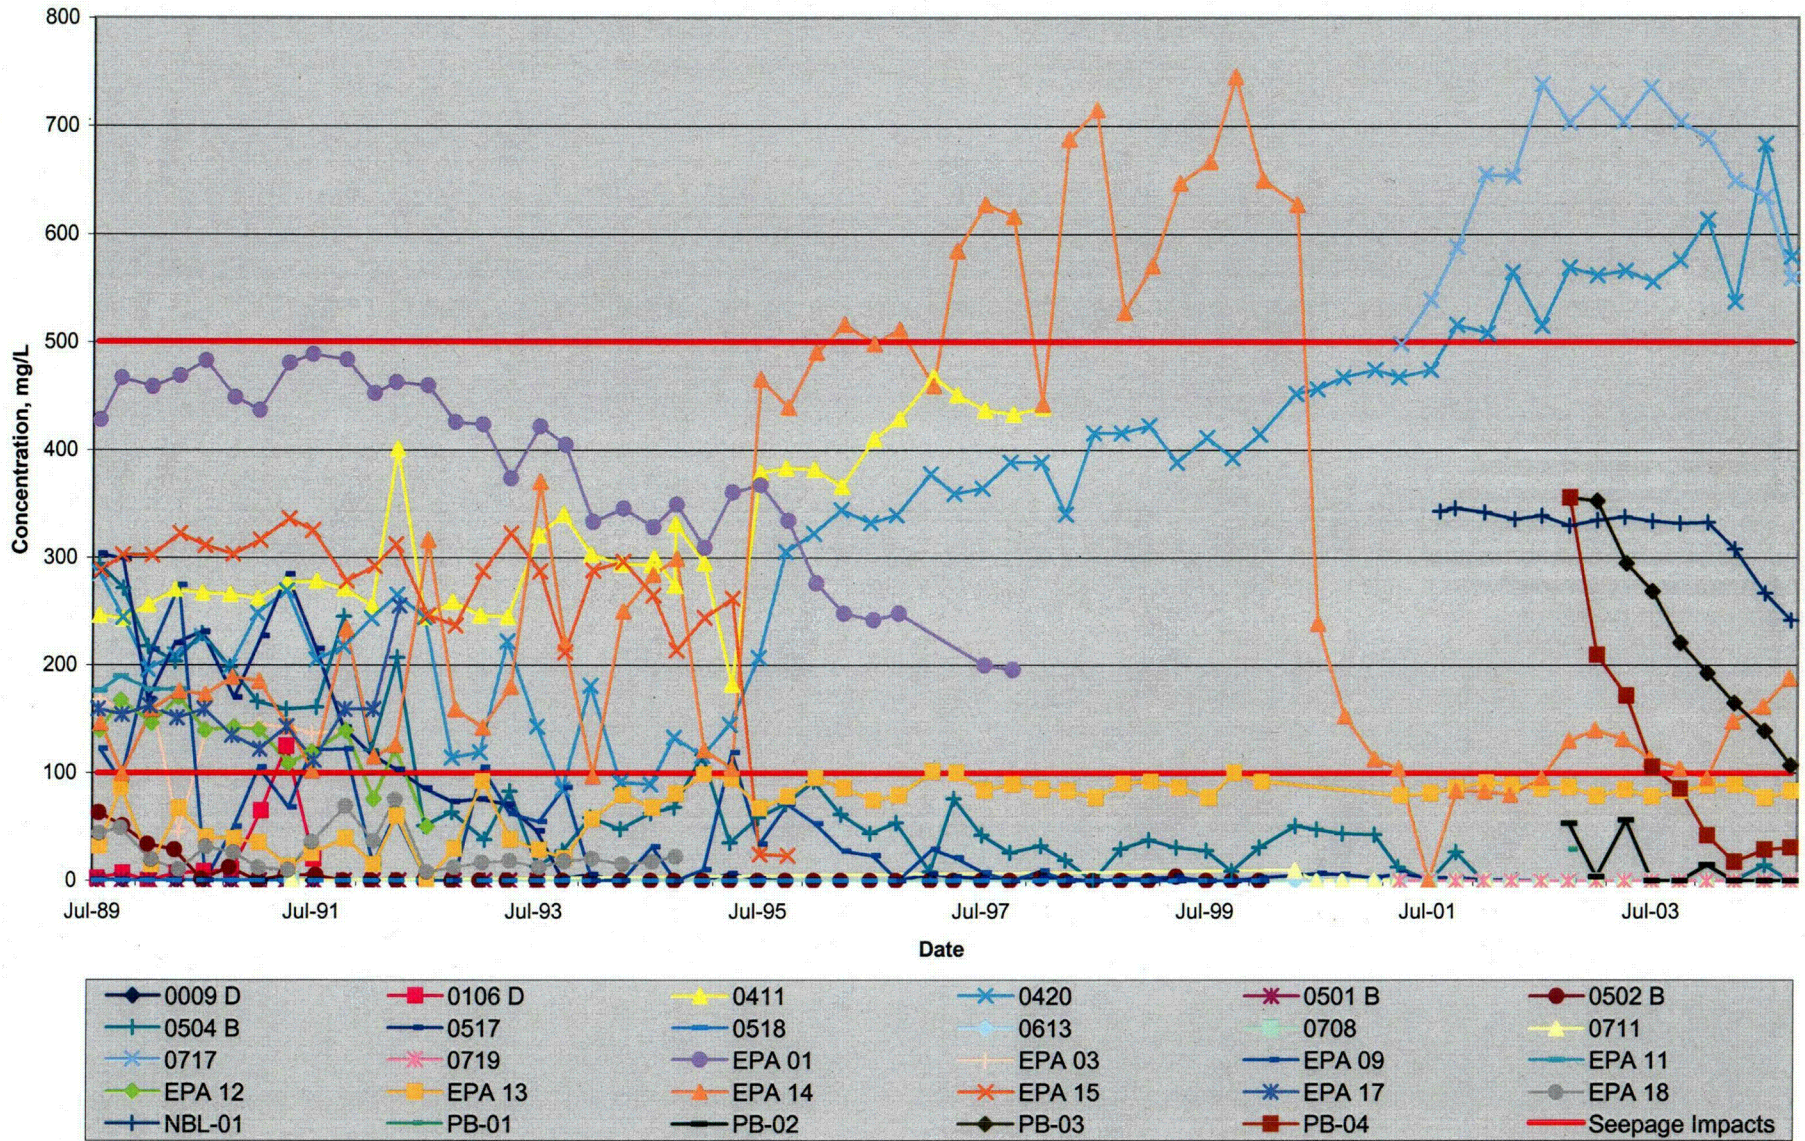
**FIGURE 40**  
 Zone 3 Bicarbonate Concentrations Over Time  
 United Nuclear Corporation, Church Rock Site, Church Rock, New Mexico

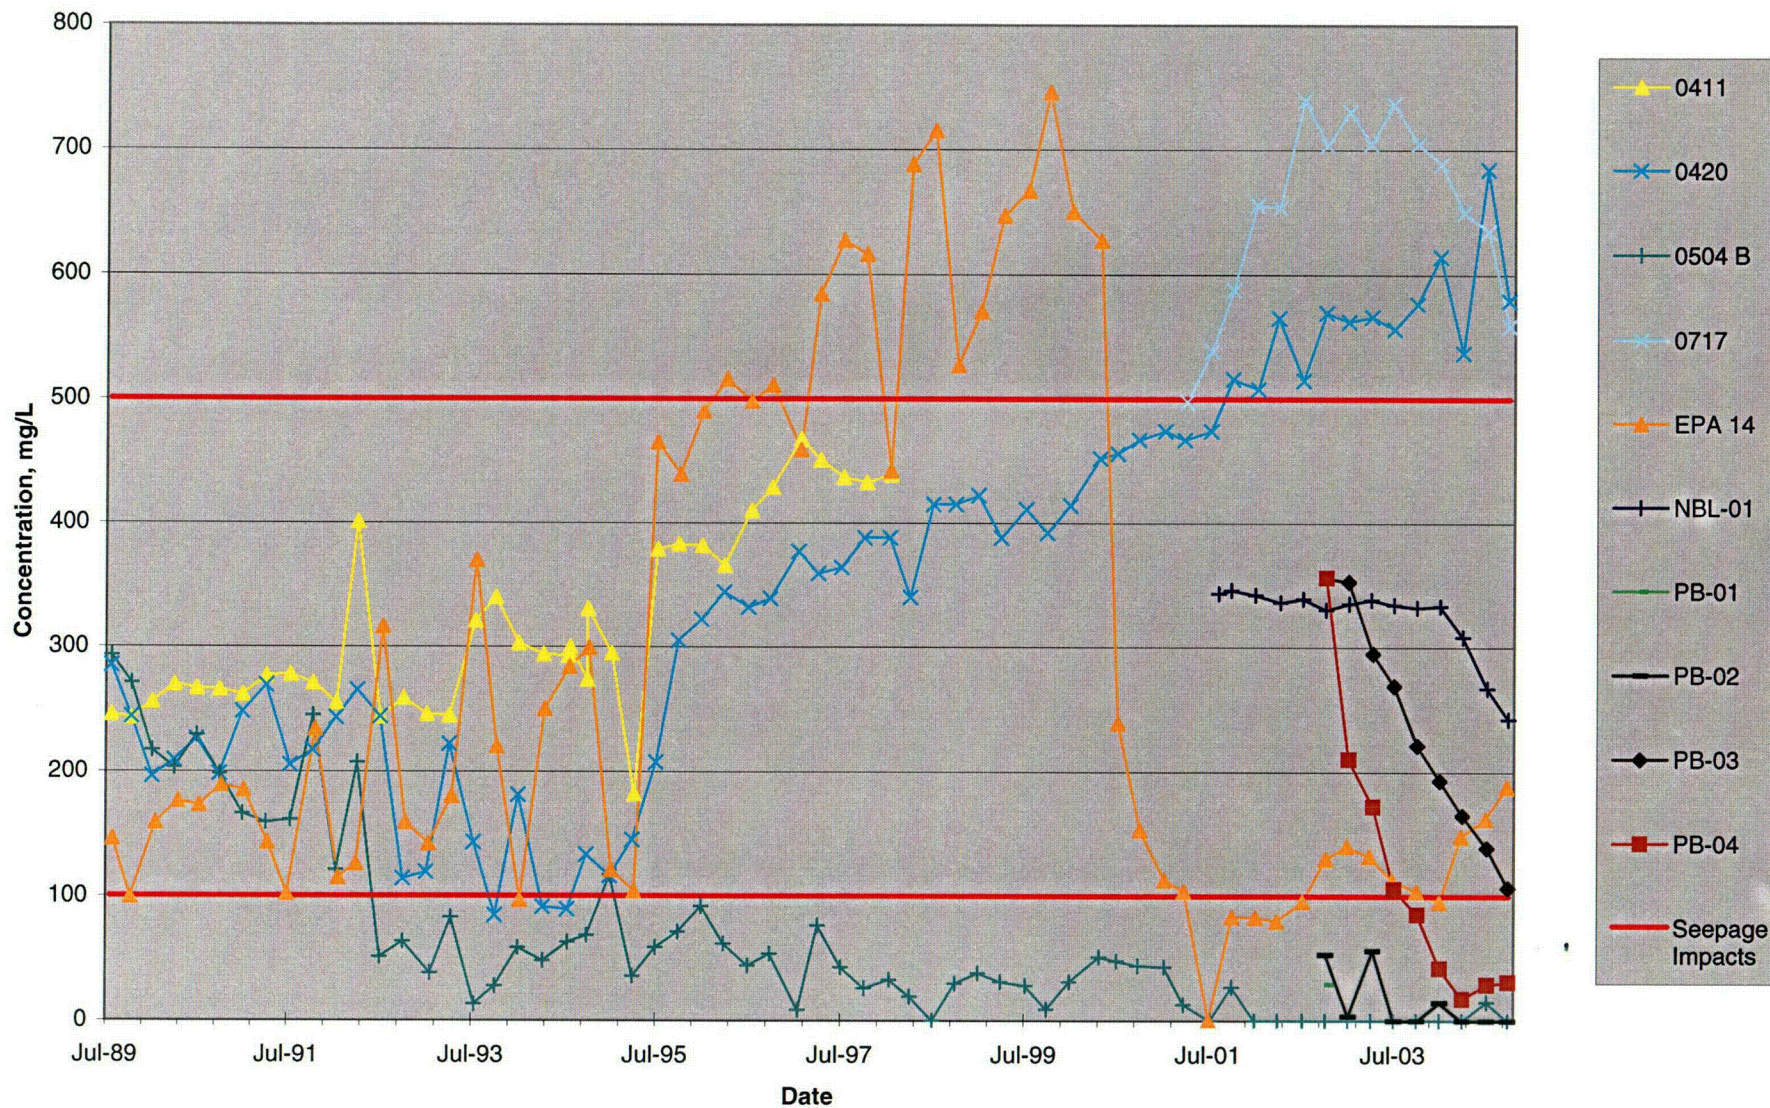
**FIGURE 41**  
 Zone 3 Impact Perimeter Bicarbonate Concentrations Over Time  
 United Nuclear Corporation, Church Rock Site, Church Rock, New Mexico

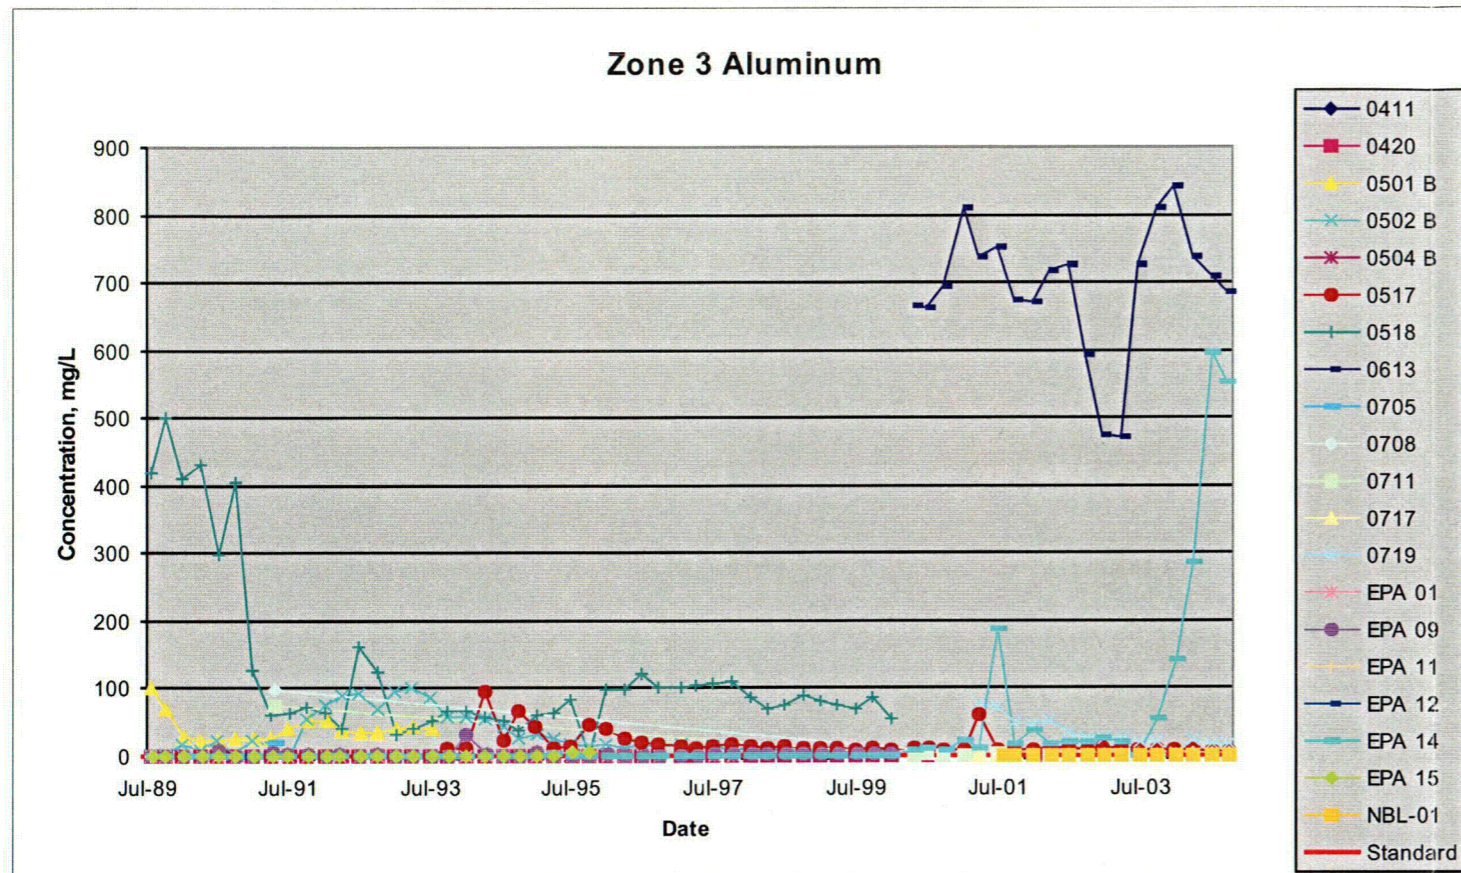
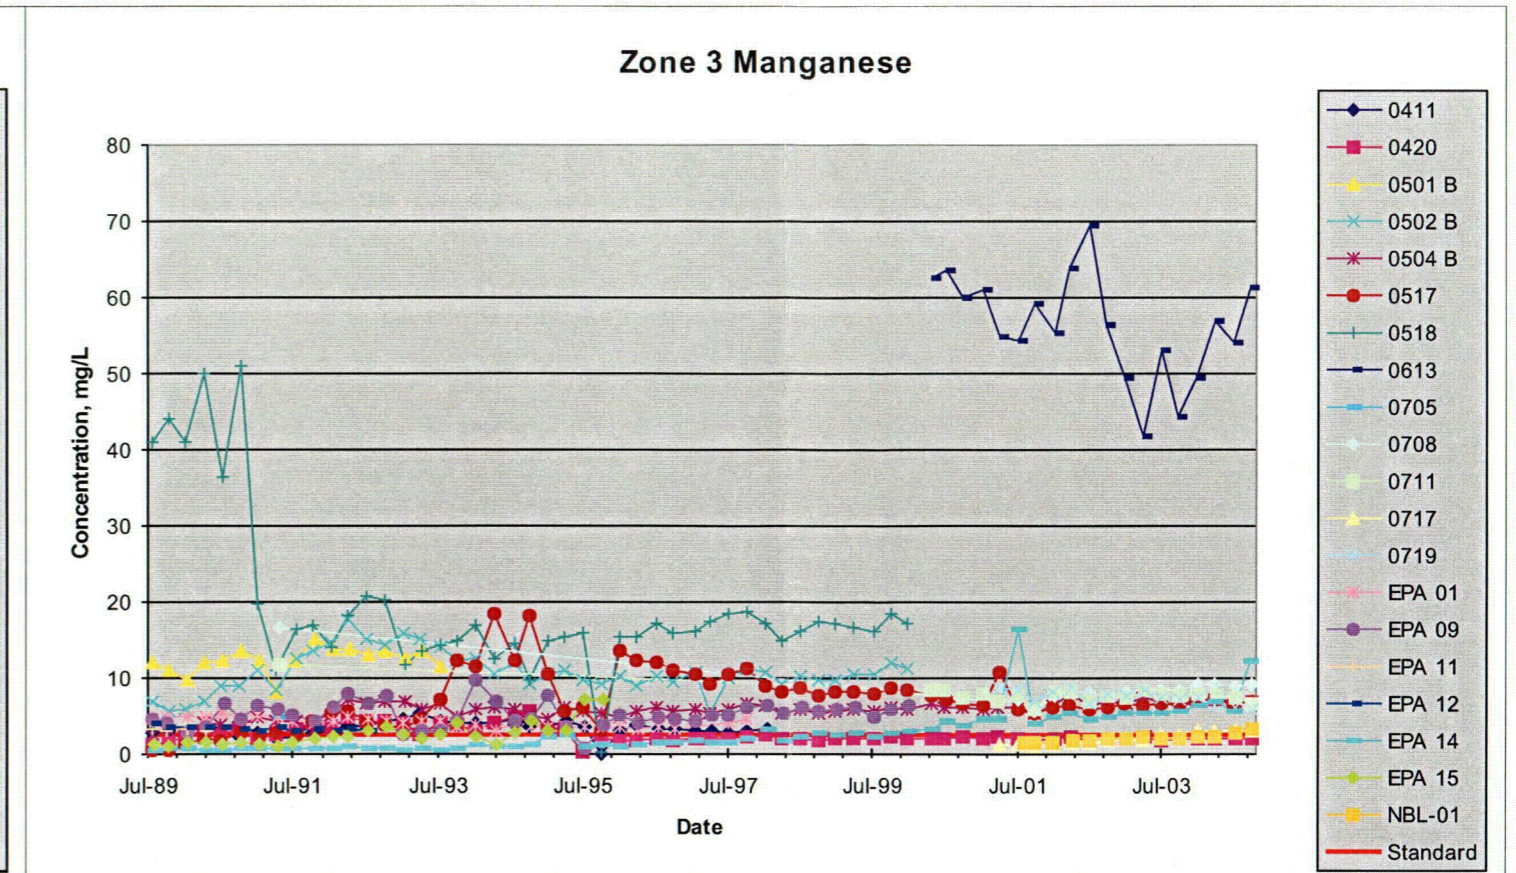
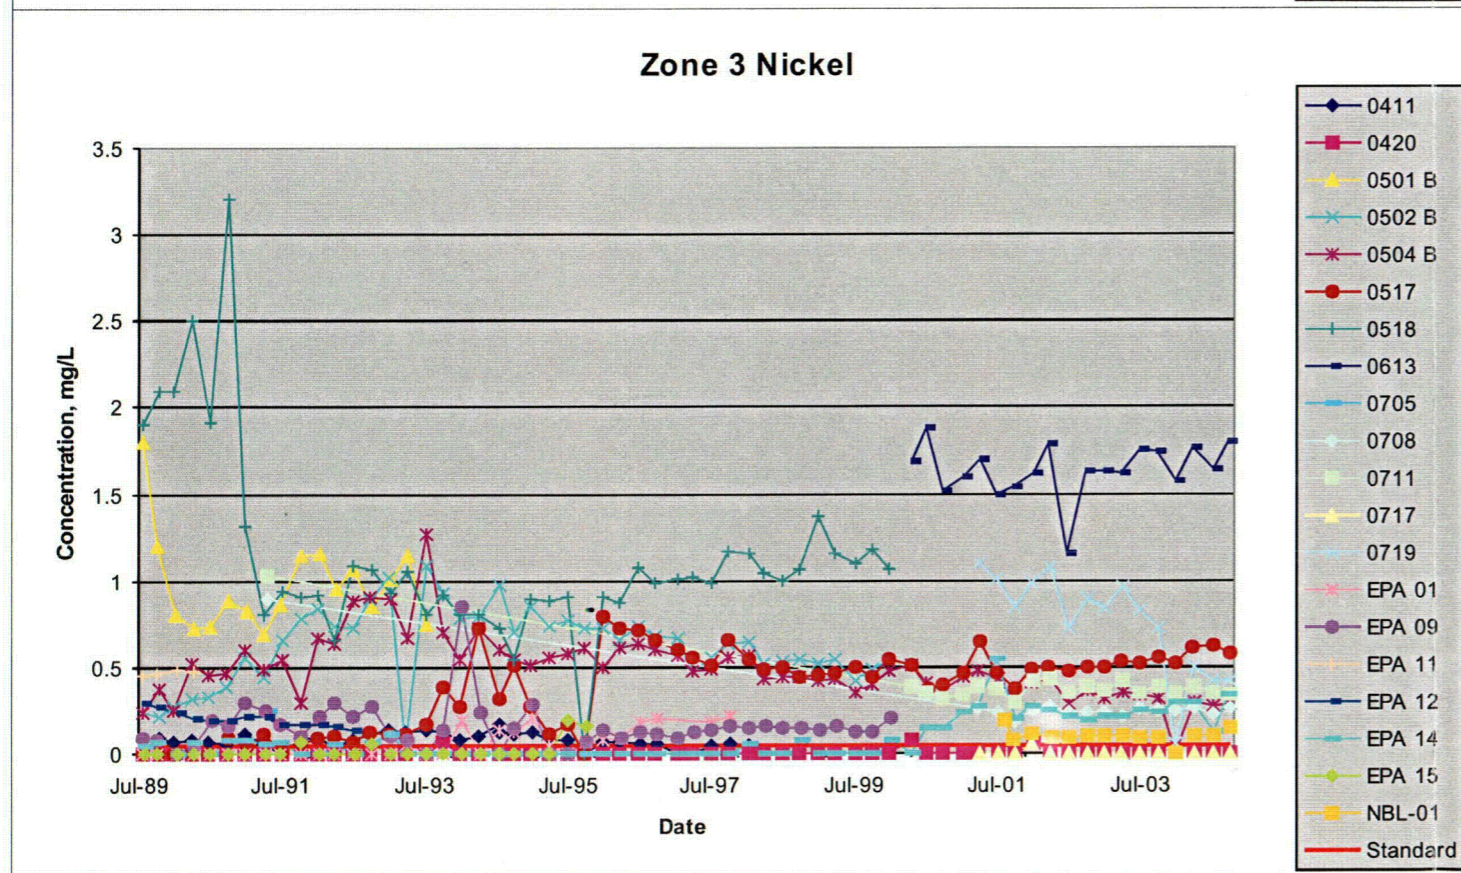
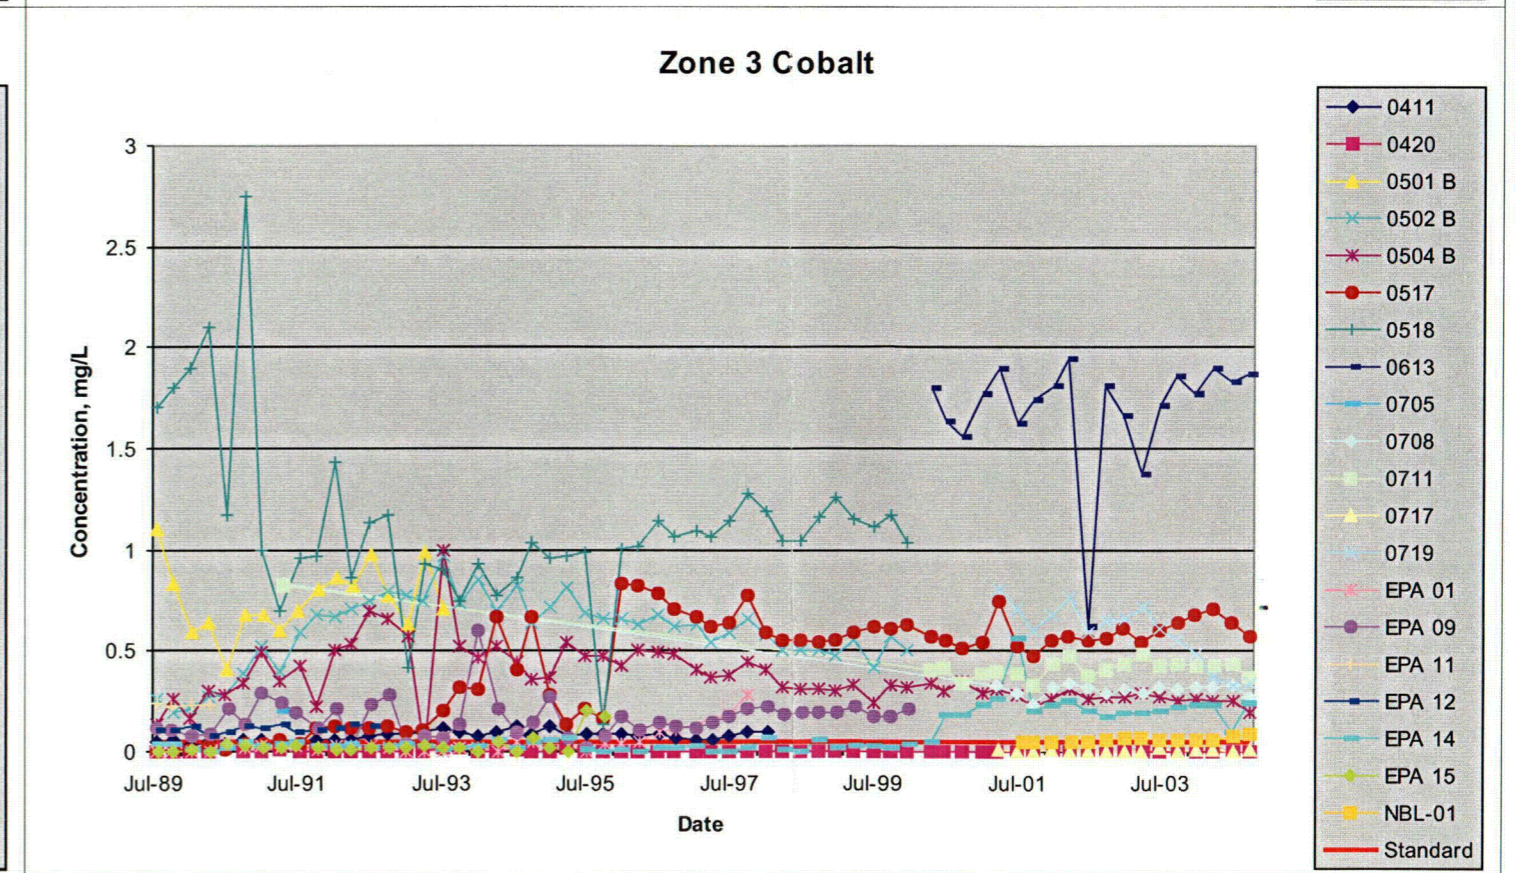
**FIGURE 42A**  
 Zone 3 Metals Concentrations Over Time  
 United Nuclear Corporation Church Rock site, Church Rock, New Mexico
