**FIGURE 36**  
 Effects of Past Pumping to Dewater Zone 3  
 United Nuclear Corporation, Church Rock Site, Church Rock, New Mexico

United Nuclear Corporation Church Rock Site,  
 Church Rock, New Mexico

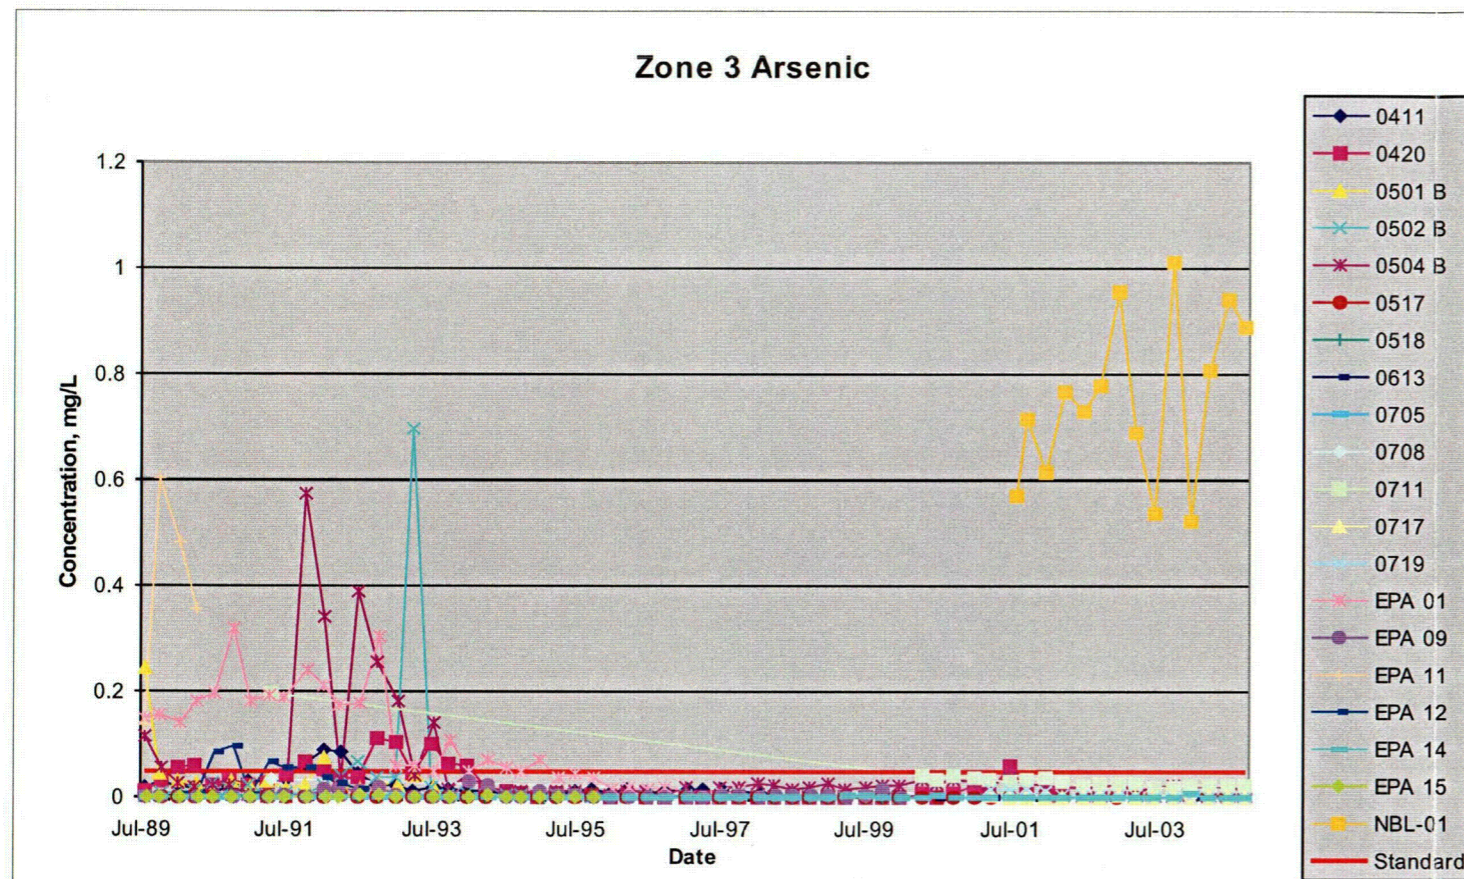
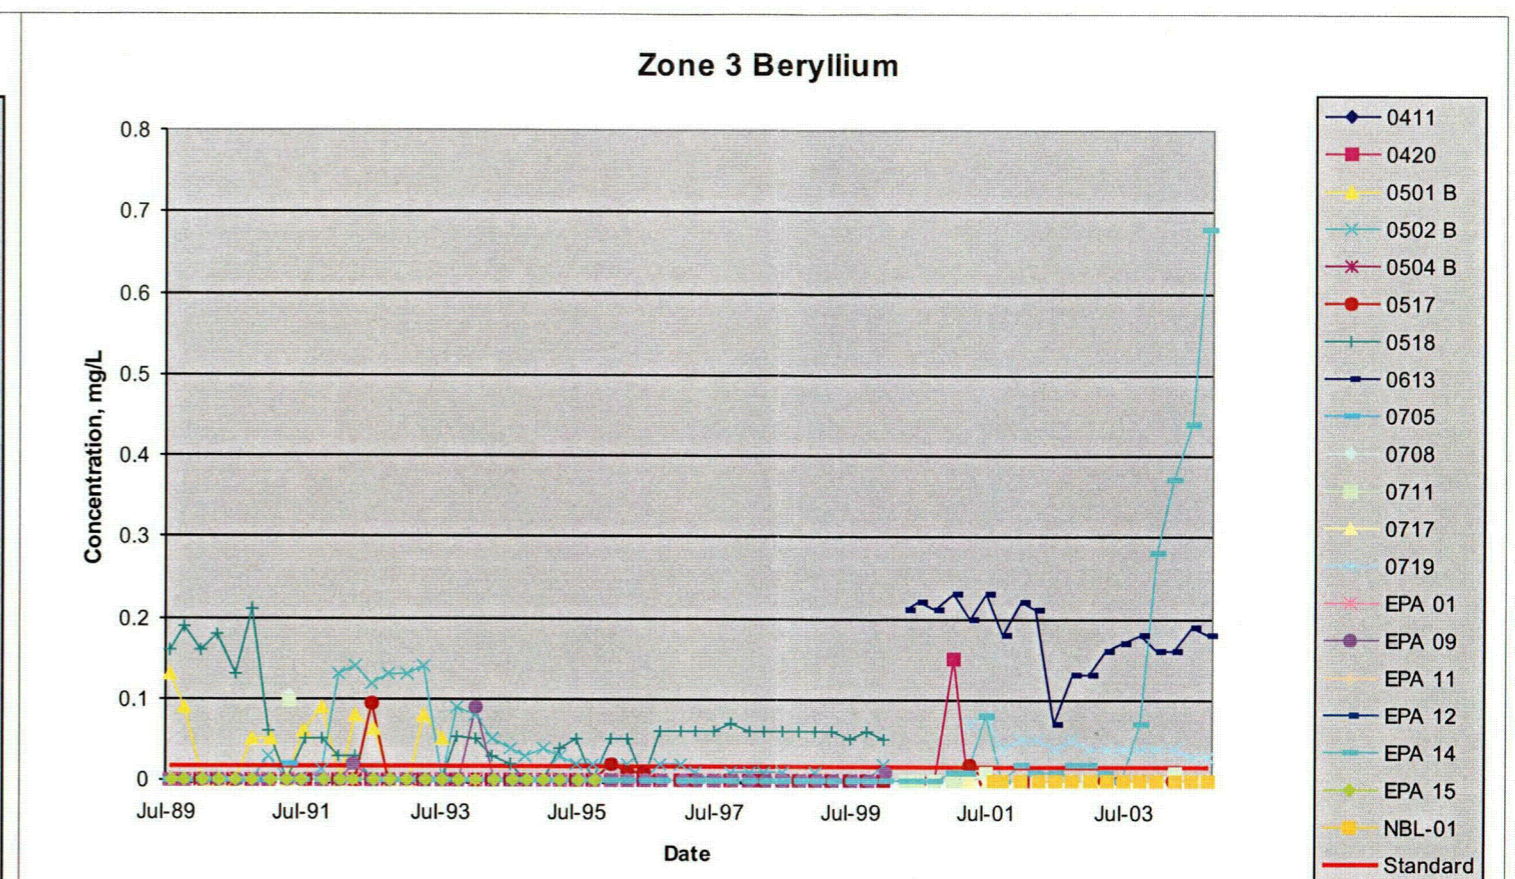
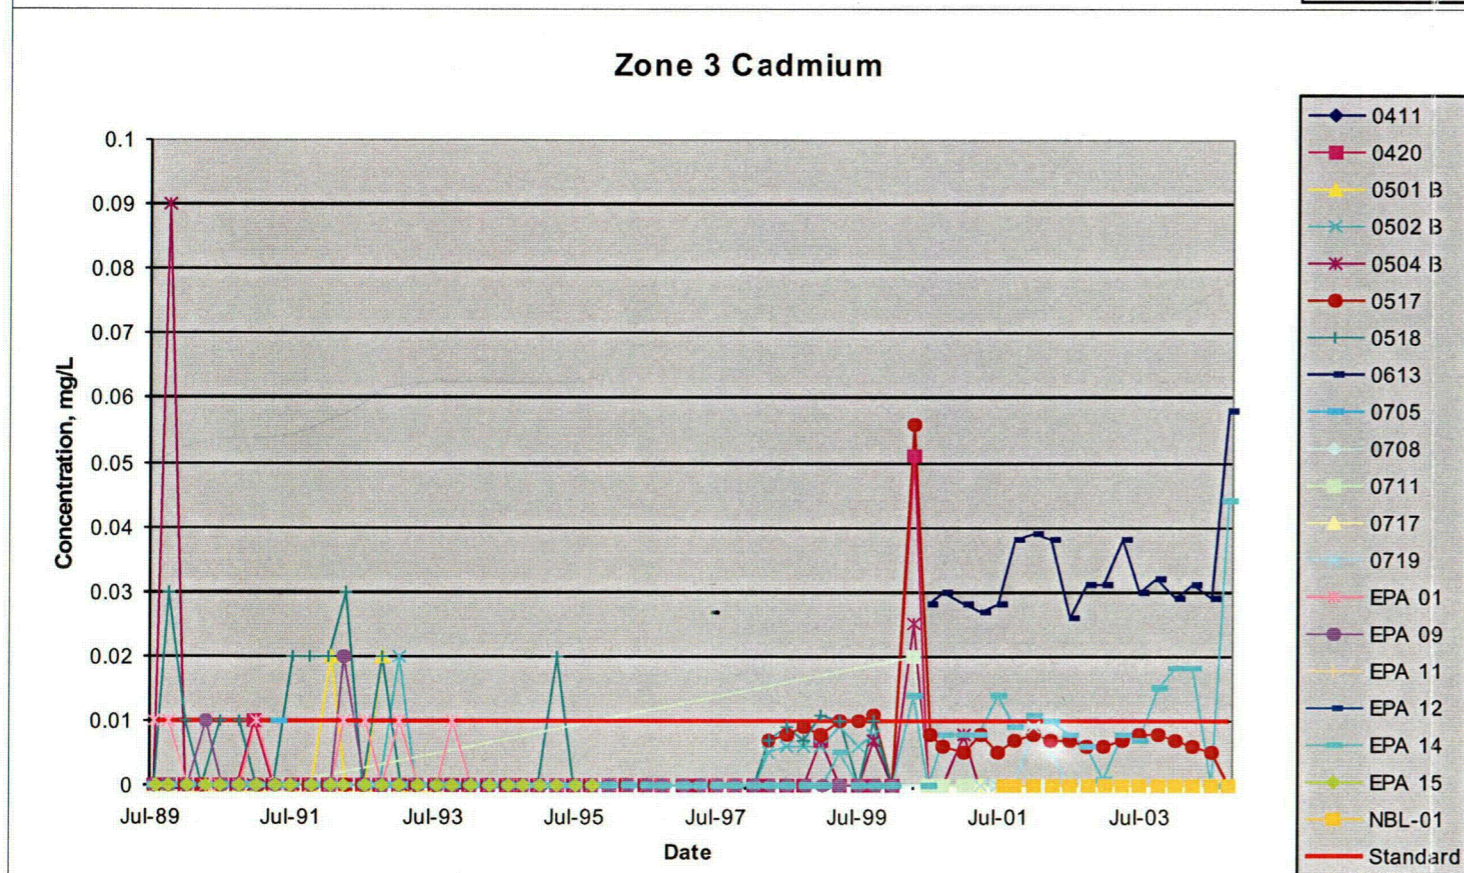
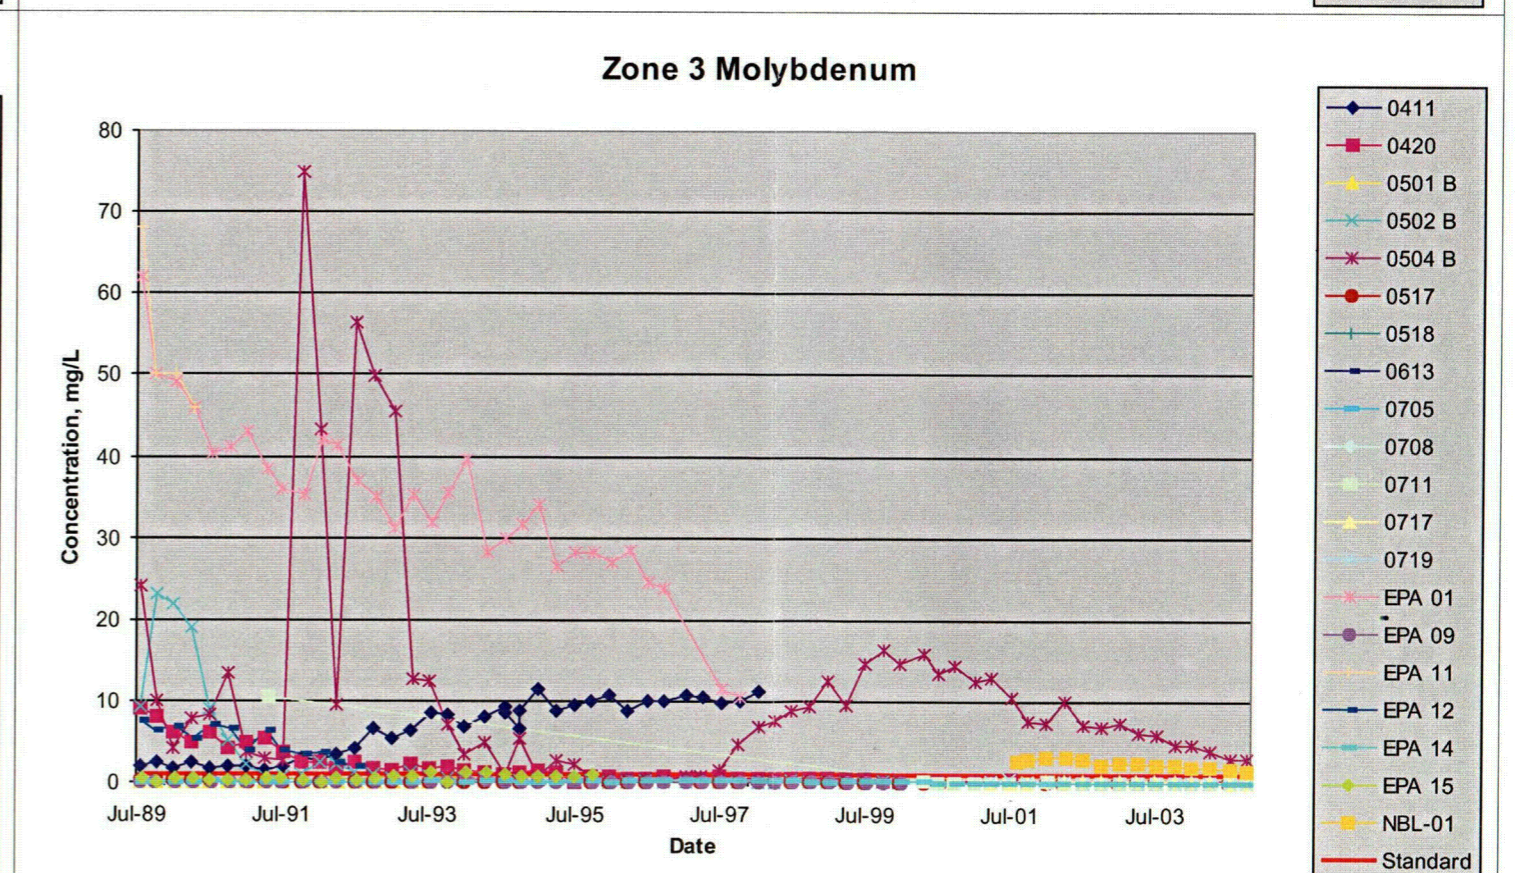
**FIGURE 42B**  
 Zone 3 Metals Concentrations Over Time  
 United Nuclear Corporation Church Rock site, Church Rock, New Mexico

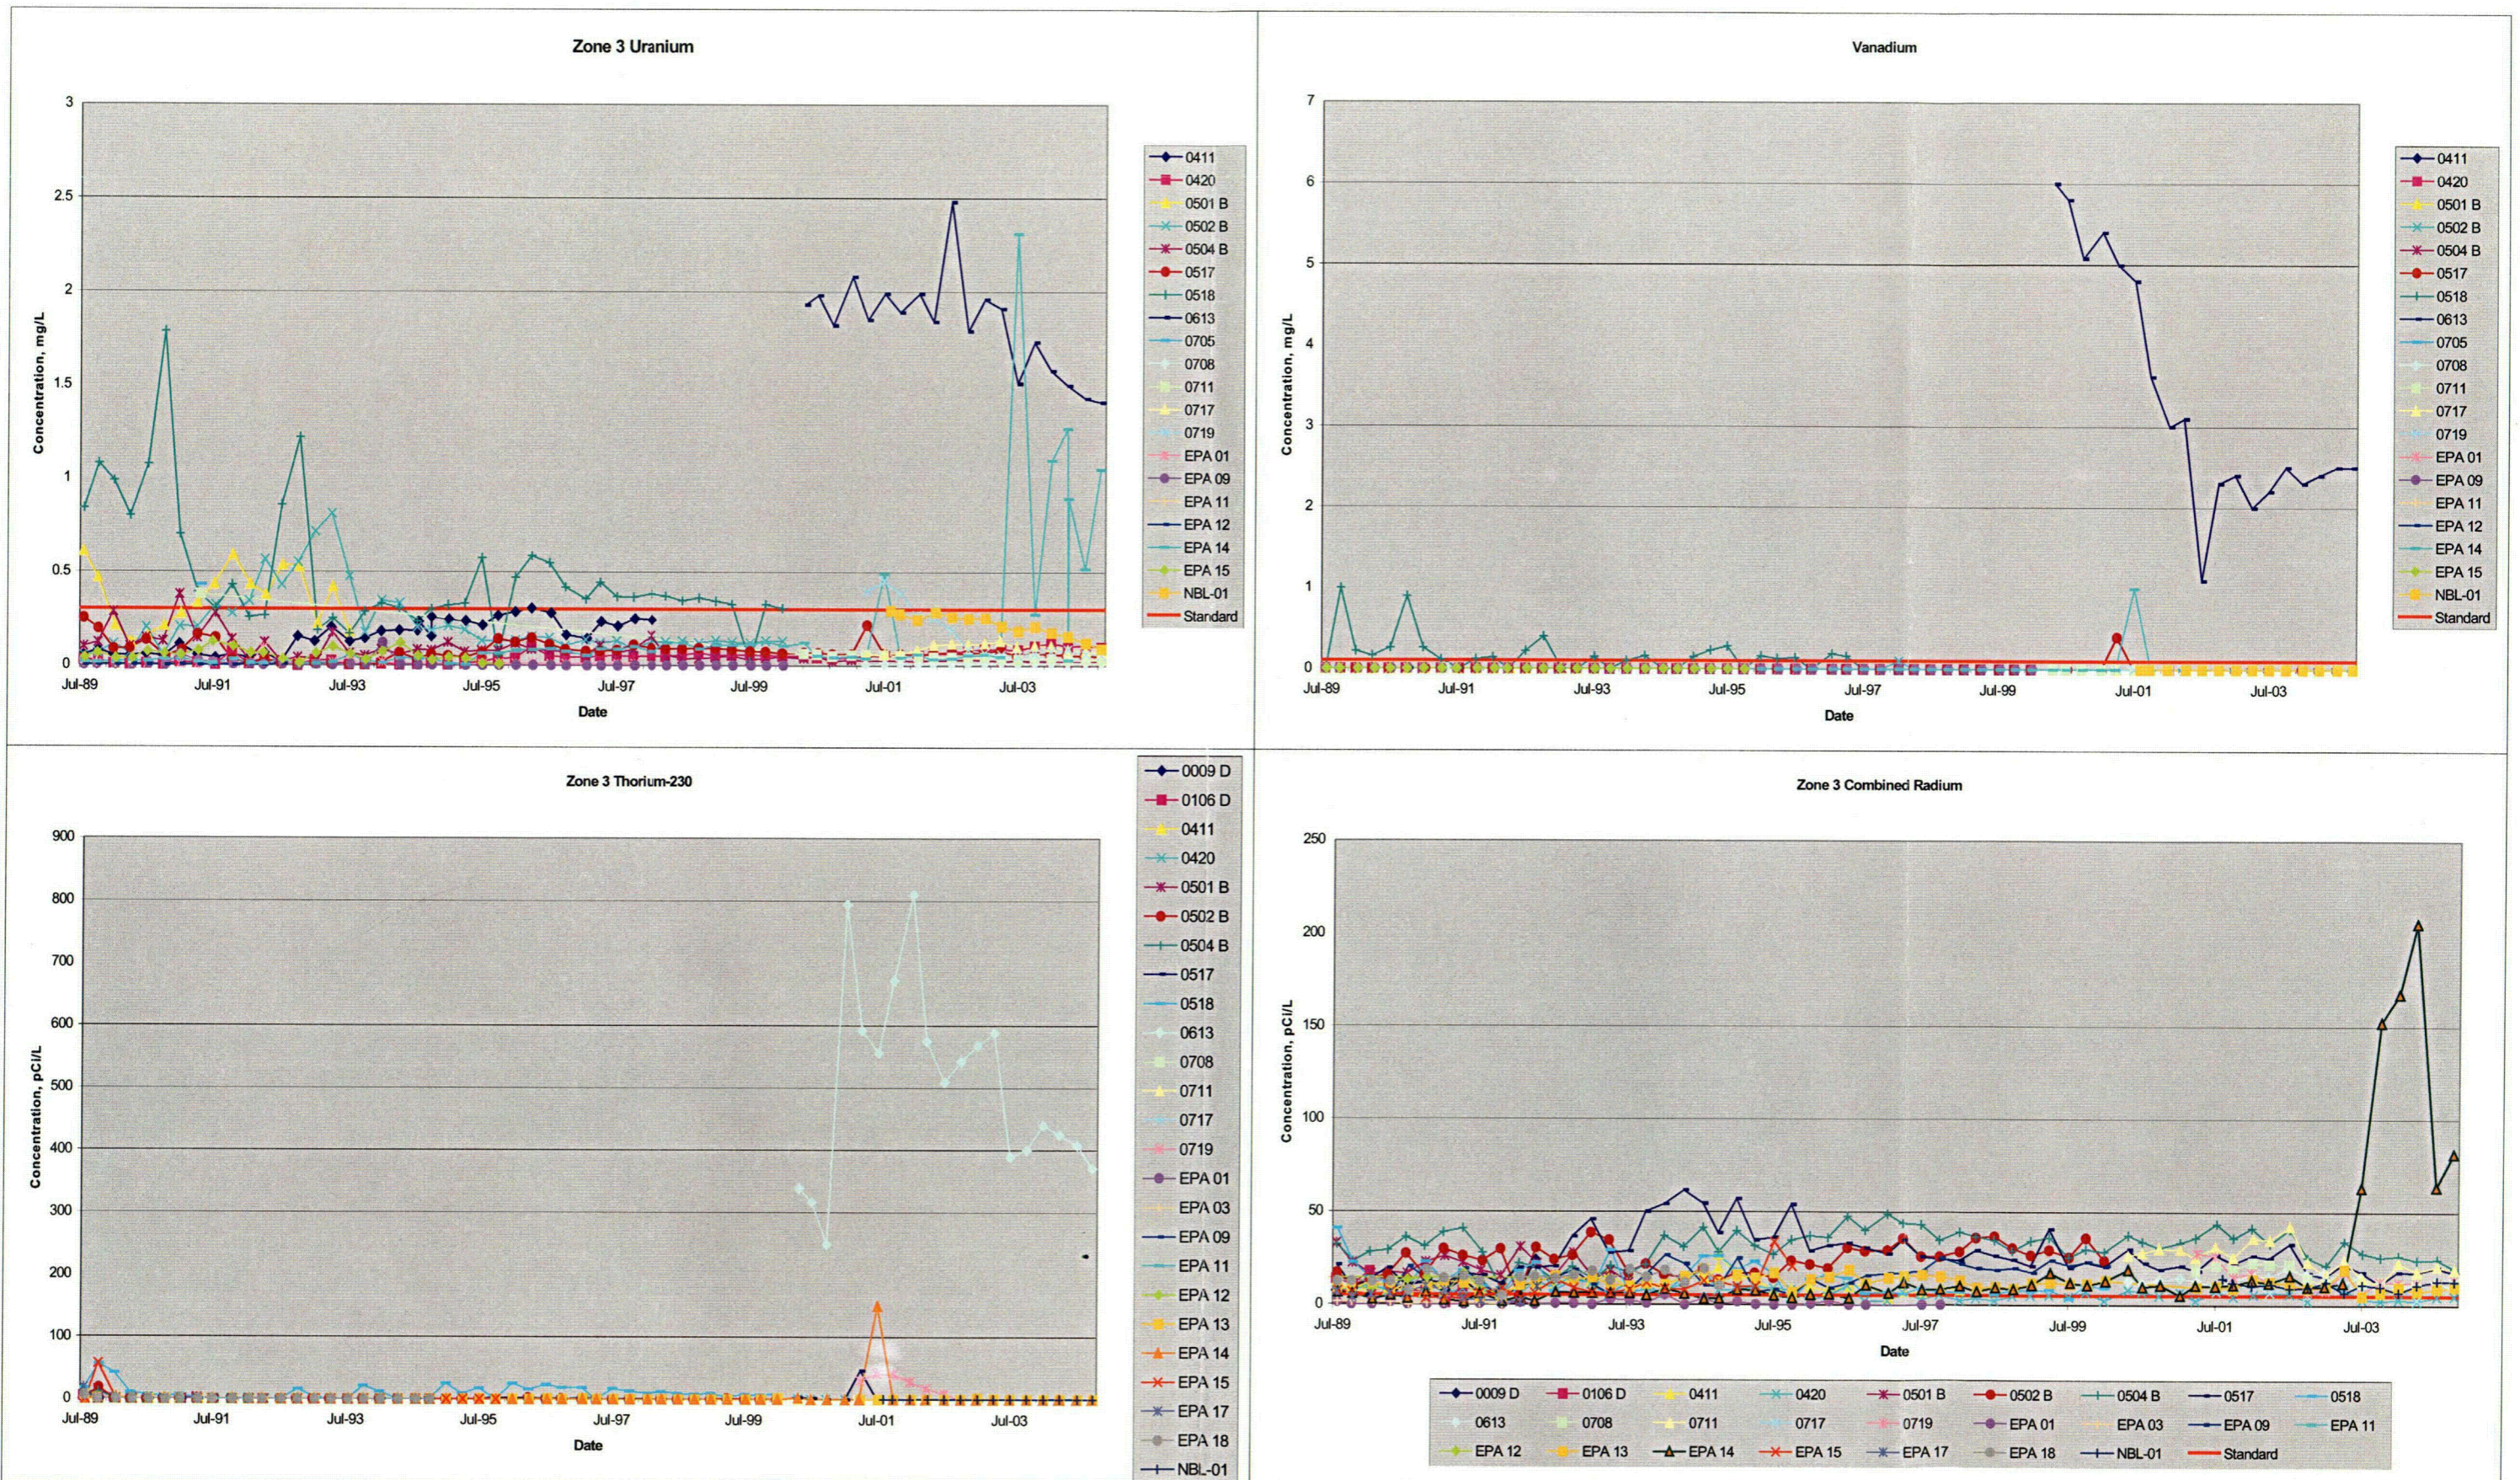
**FIGURE 44**  
 Zone 3 Uranium, Vanadium, and Radionuclides Concentrations Over Time  
 United Nuclear Corporation Church Rock site, Church Rock, New Mexico

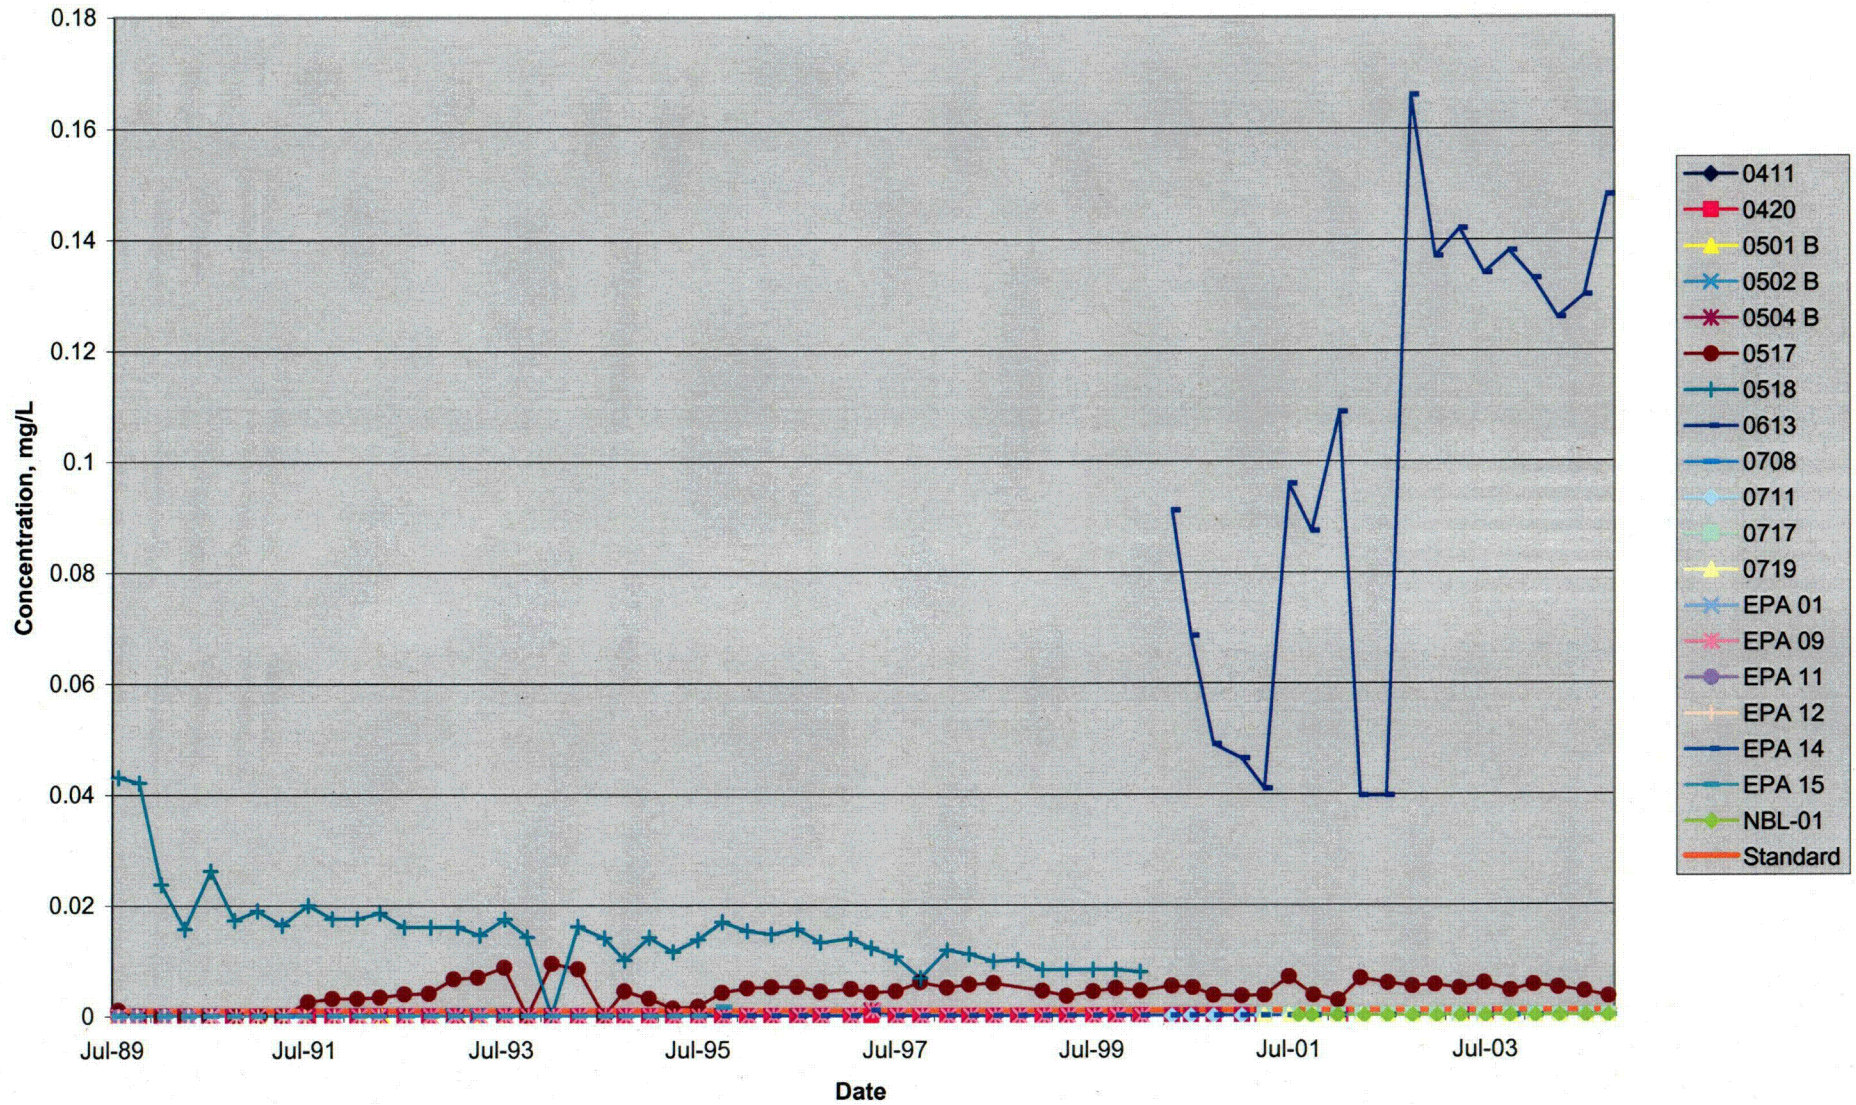
**FIGURE 45**  
 Zone 3 Chloroform Concentrations Over Time  
 United Nuclear Corporation, Church Rock Site, Church Rock, New Mexico

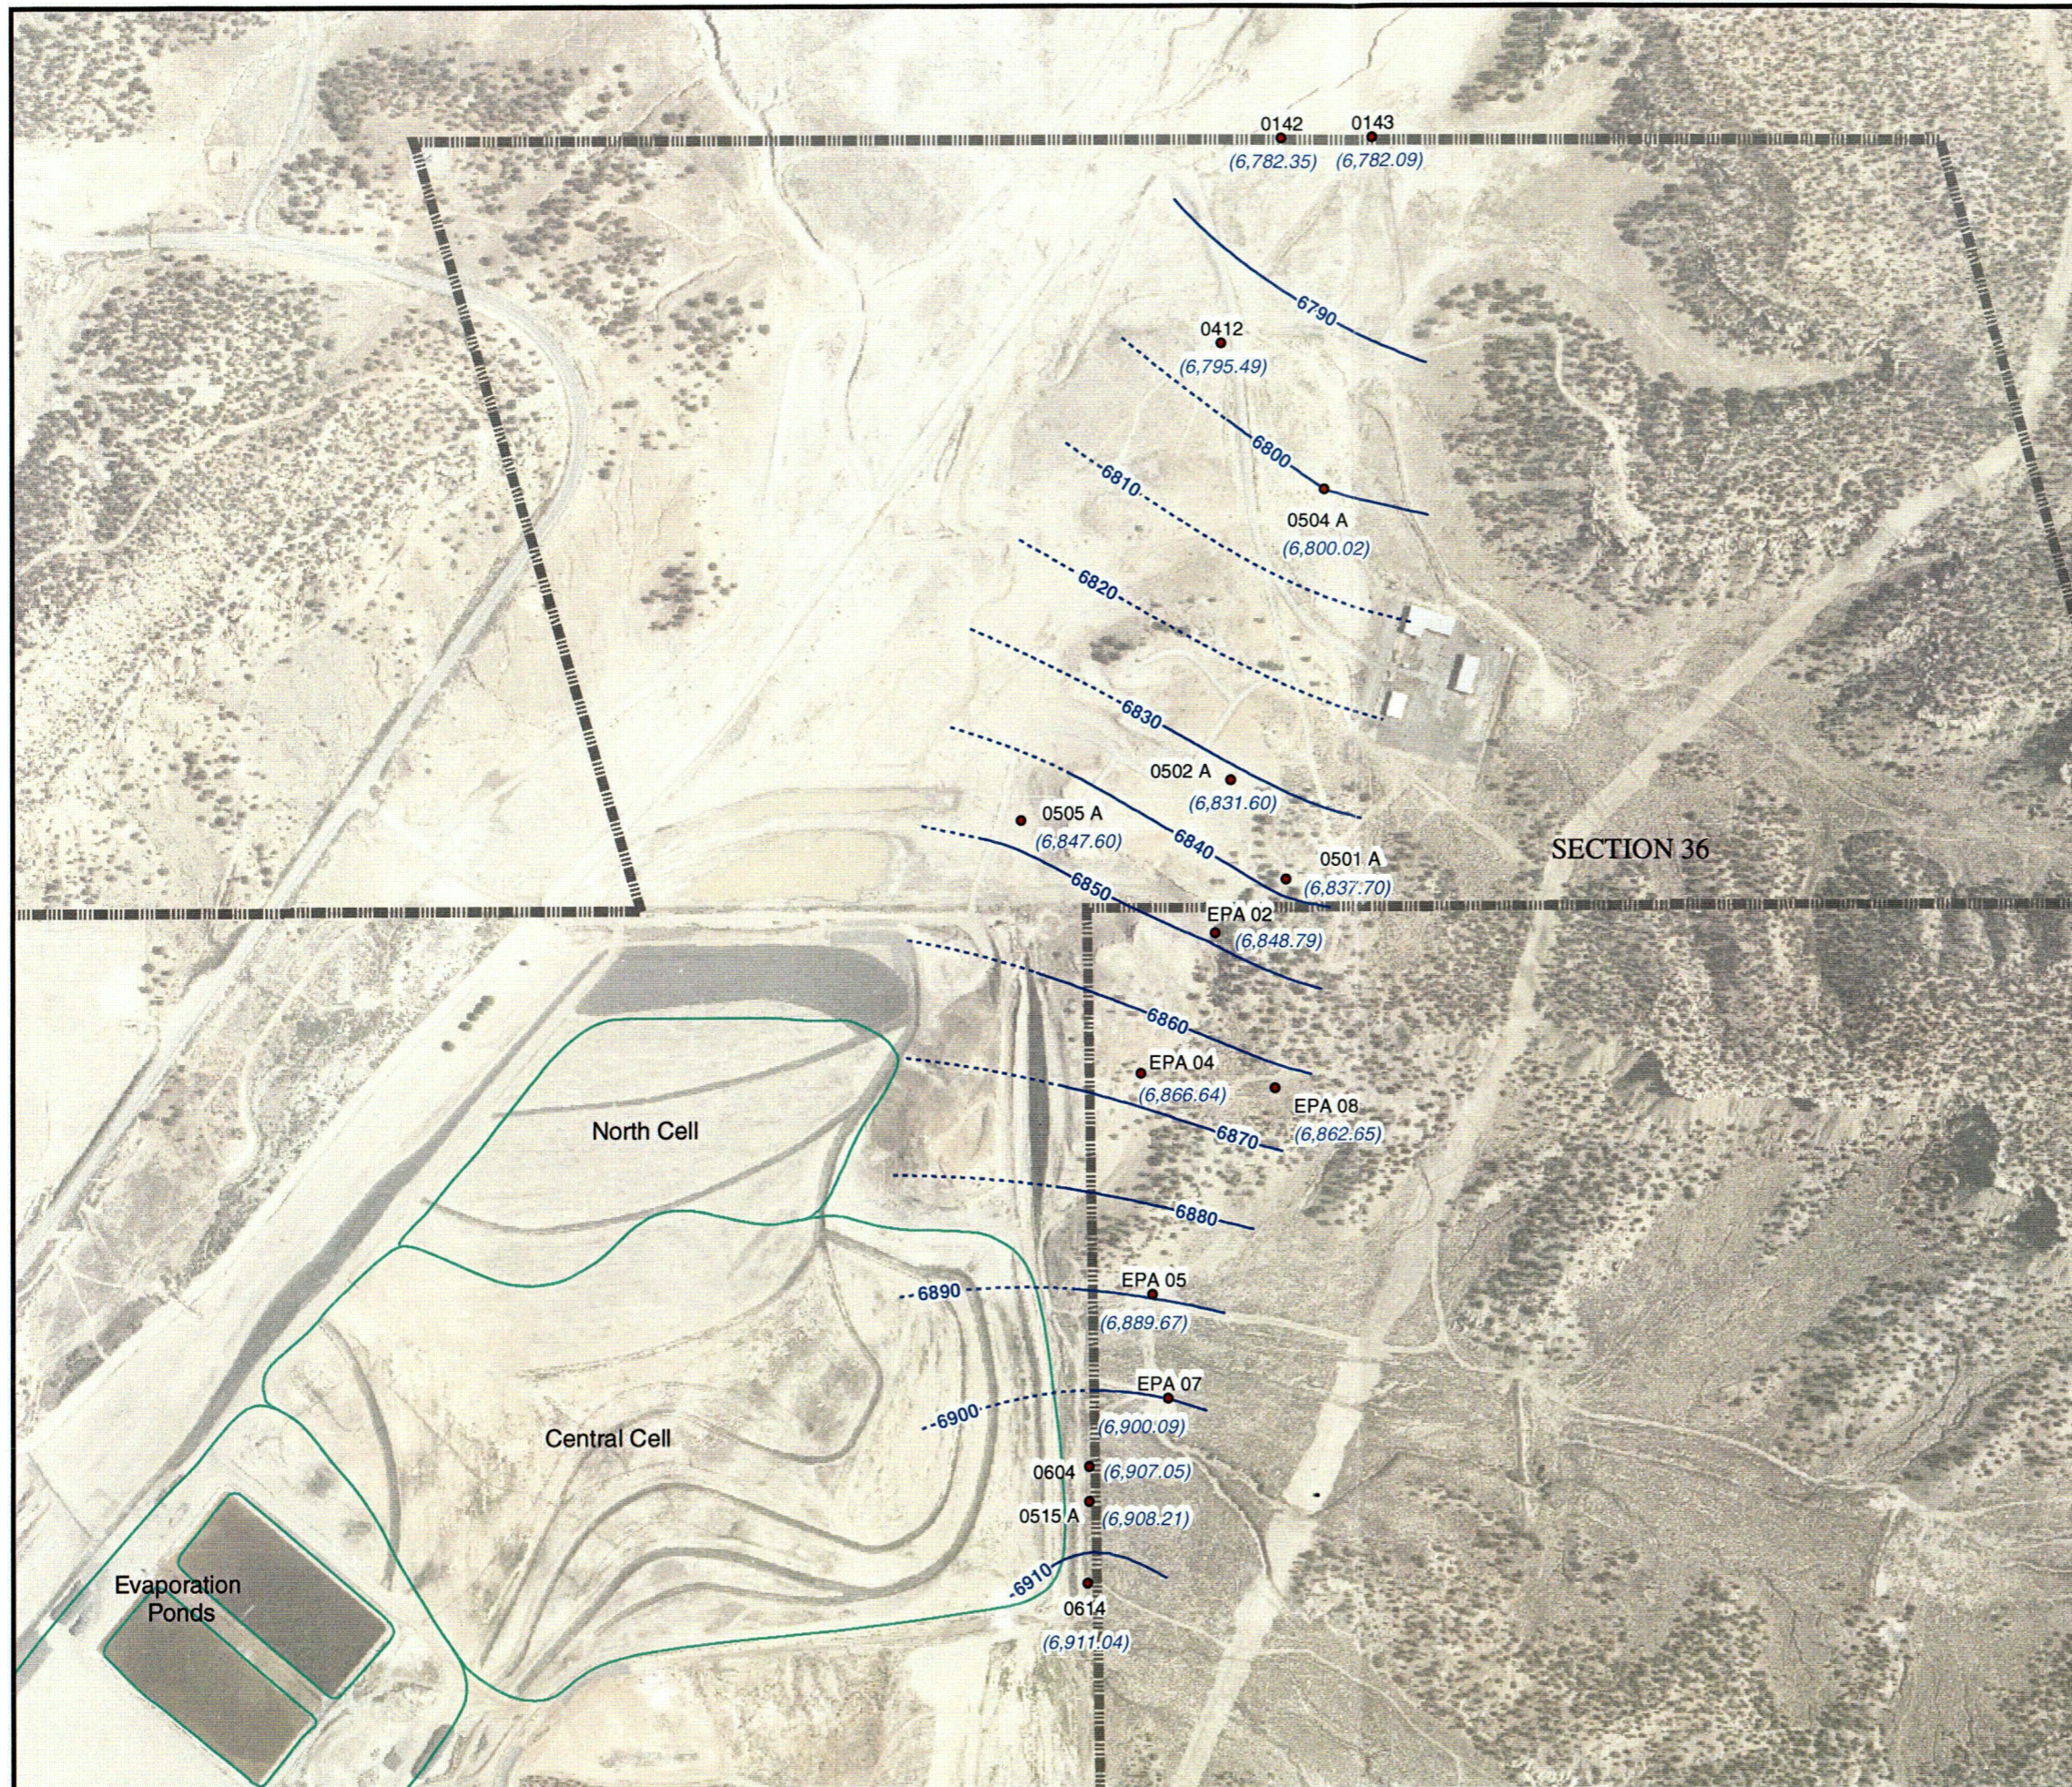
1. Groundwater elevation values are displayed in feet above mean sea level.
2. Well names are displayed with black text.
3. Groundwater elevations are shown with blue text and enclosed in parentheses.
4. Aerial photo taken on August 1, 1996.

**FIGURE 46**  
 Zone 1 Potentiometric Surface Map  
 October 2004

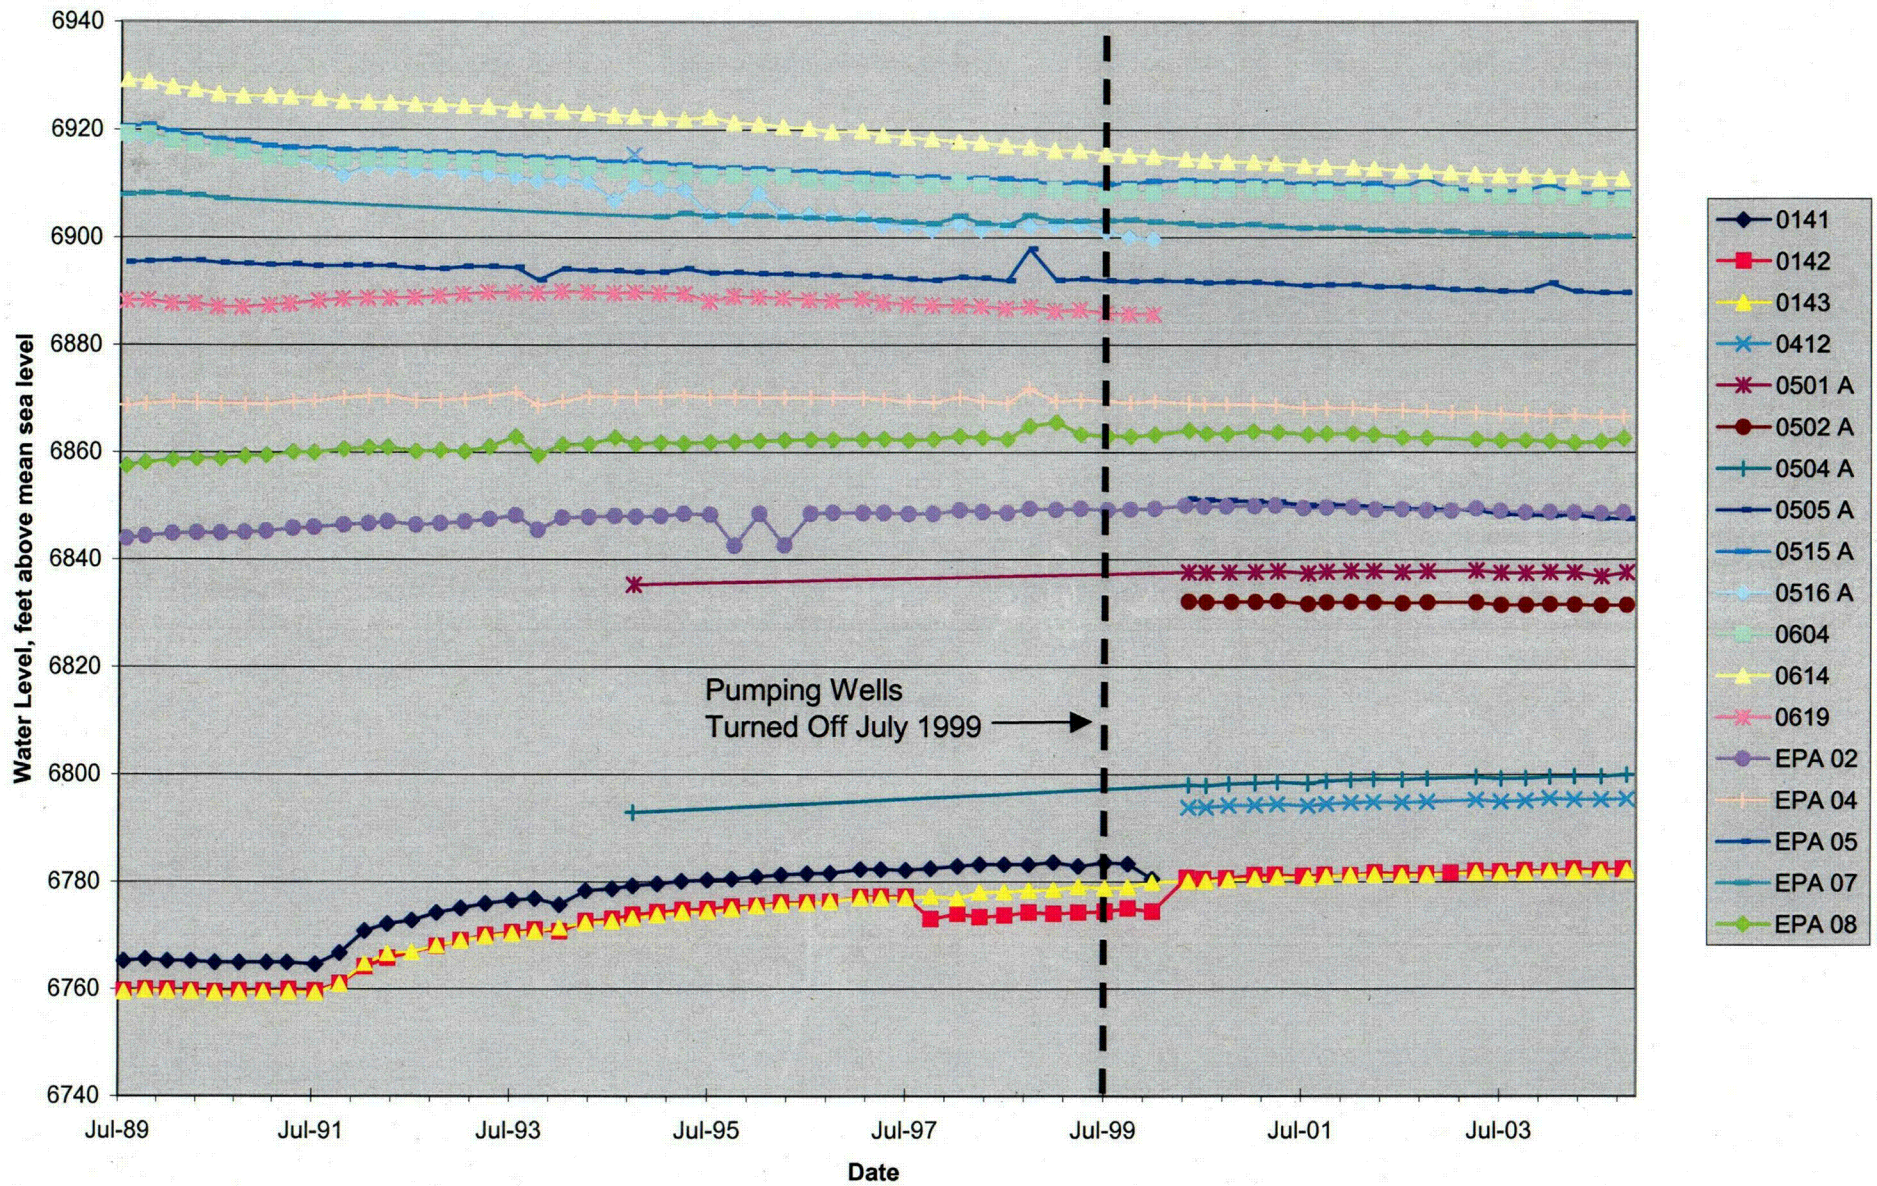
**FIGURE 47**

Zone 1 Water Levels Over Time  
United Nuclear Corporation, Church Rock Site, Church Rock, New Mexico

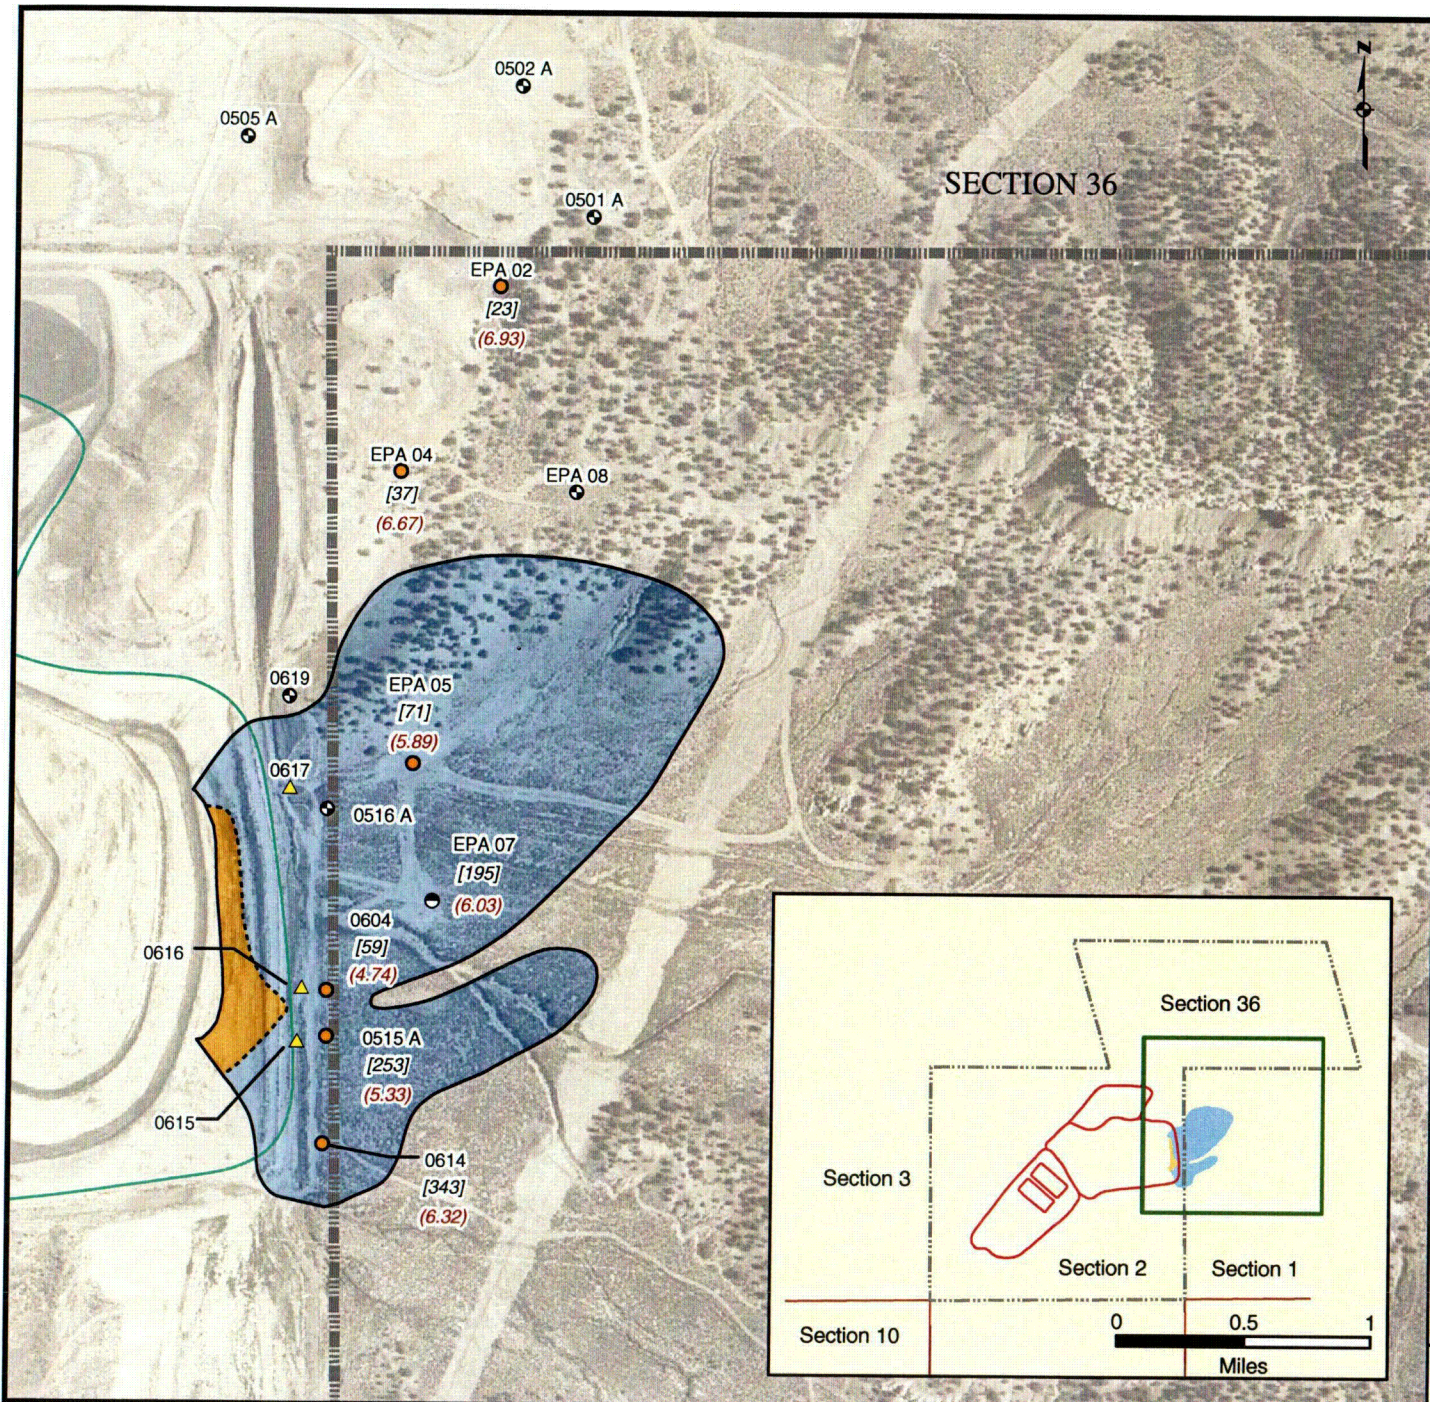
- Notes:**
1. Seepage impacts delineated by Chloride detections greater than 50 mg/L.
  2. Aerial photo taken on August 1, 1996.

**FIGURE 48**  
 Zone 1 Extent of Seepage Impacts, October 2004  
 United Nuclear Corporation Church Rock Site,  
 Church Rock, New Mexico

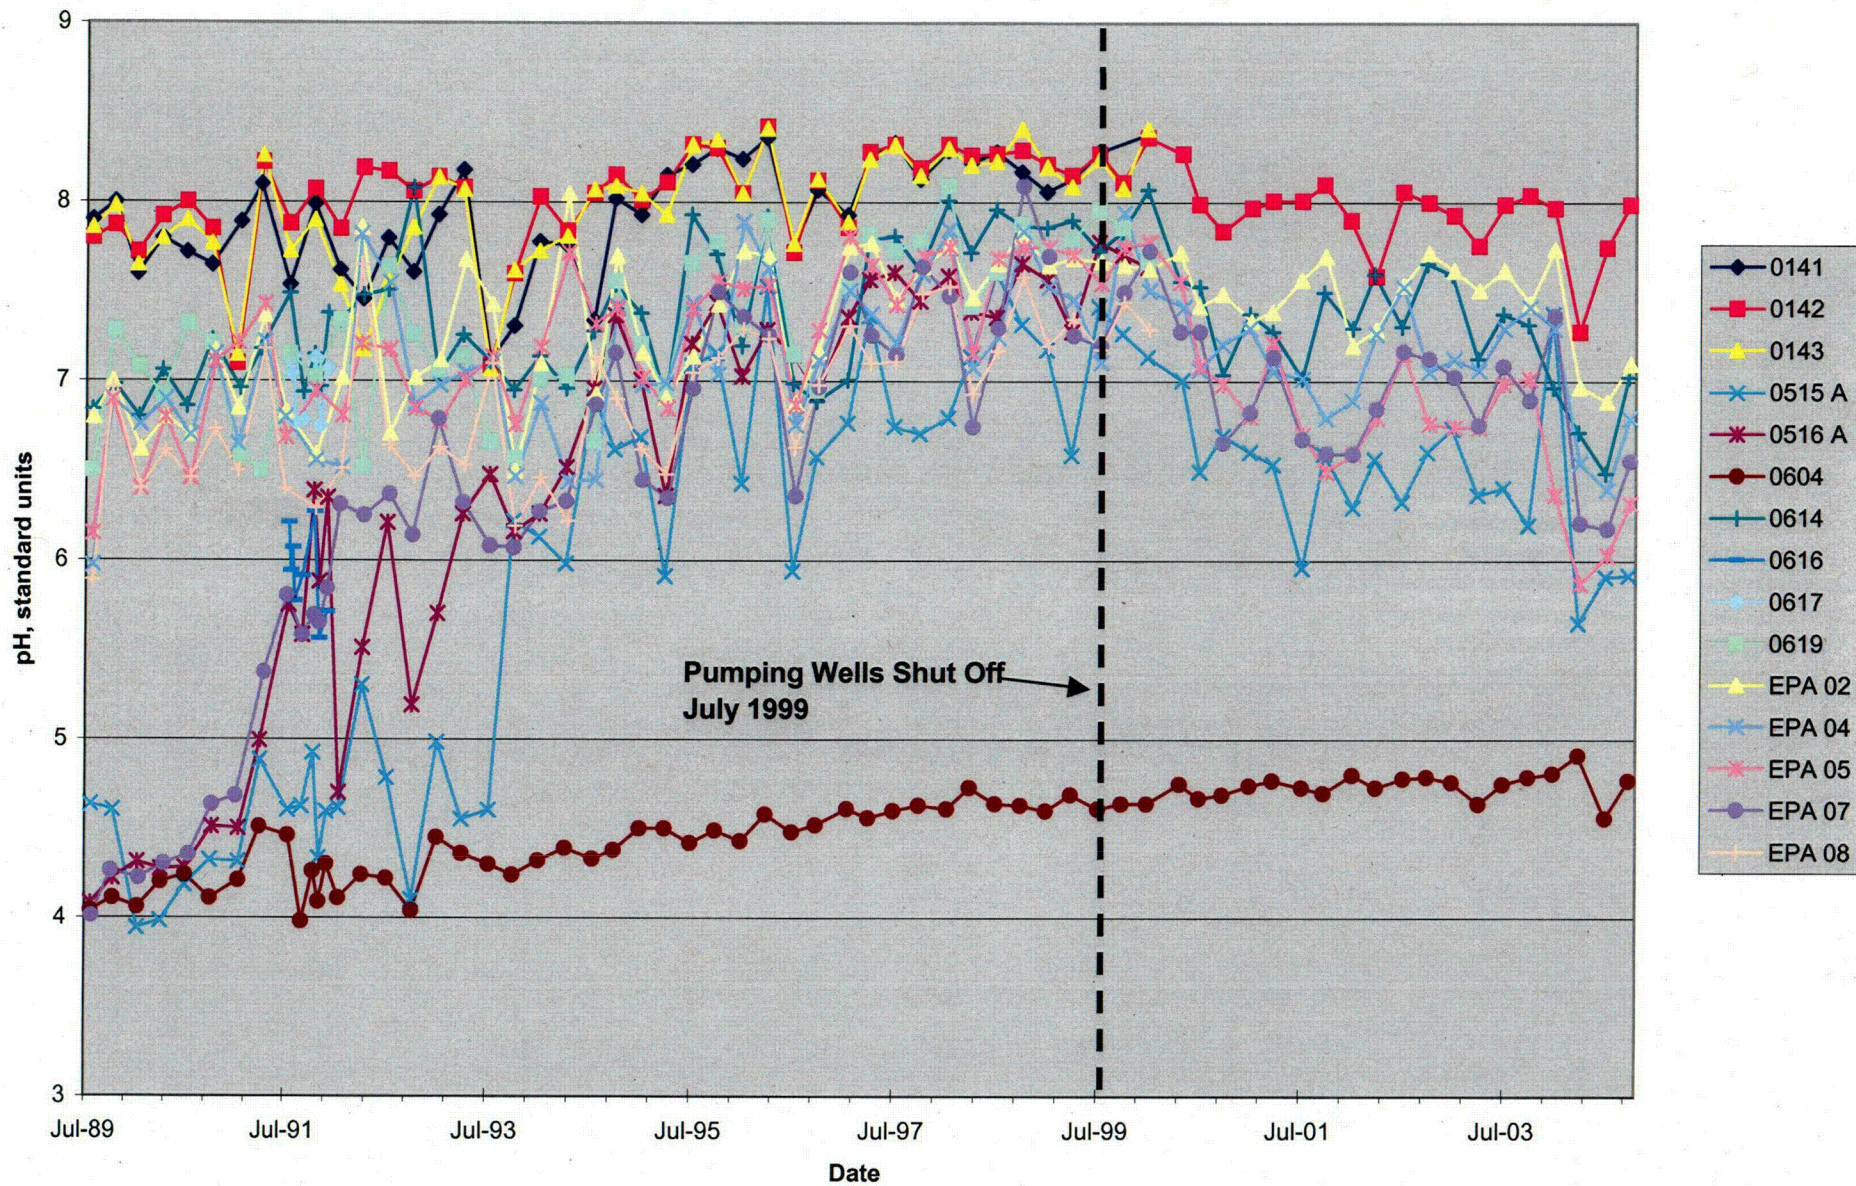
**FIGURE 49**  
 Zone 1 pH Over Time  
 United Nuclear Corporation, Church Rock Site, Church Rock, New Mexico
