**FIGURE 36**  
 Effects of Past Pumping to Dewater Zone 3  
 United Nuclear Corporation, Church Rock Site, Church Rock, New Mexico

United Nuclear Corporation Church Rock Site,  
 Church Rock, New Mexico

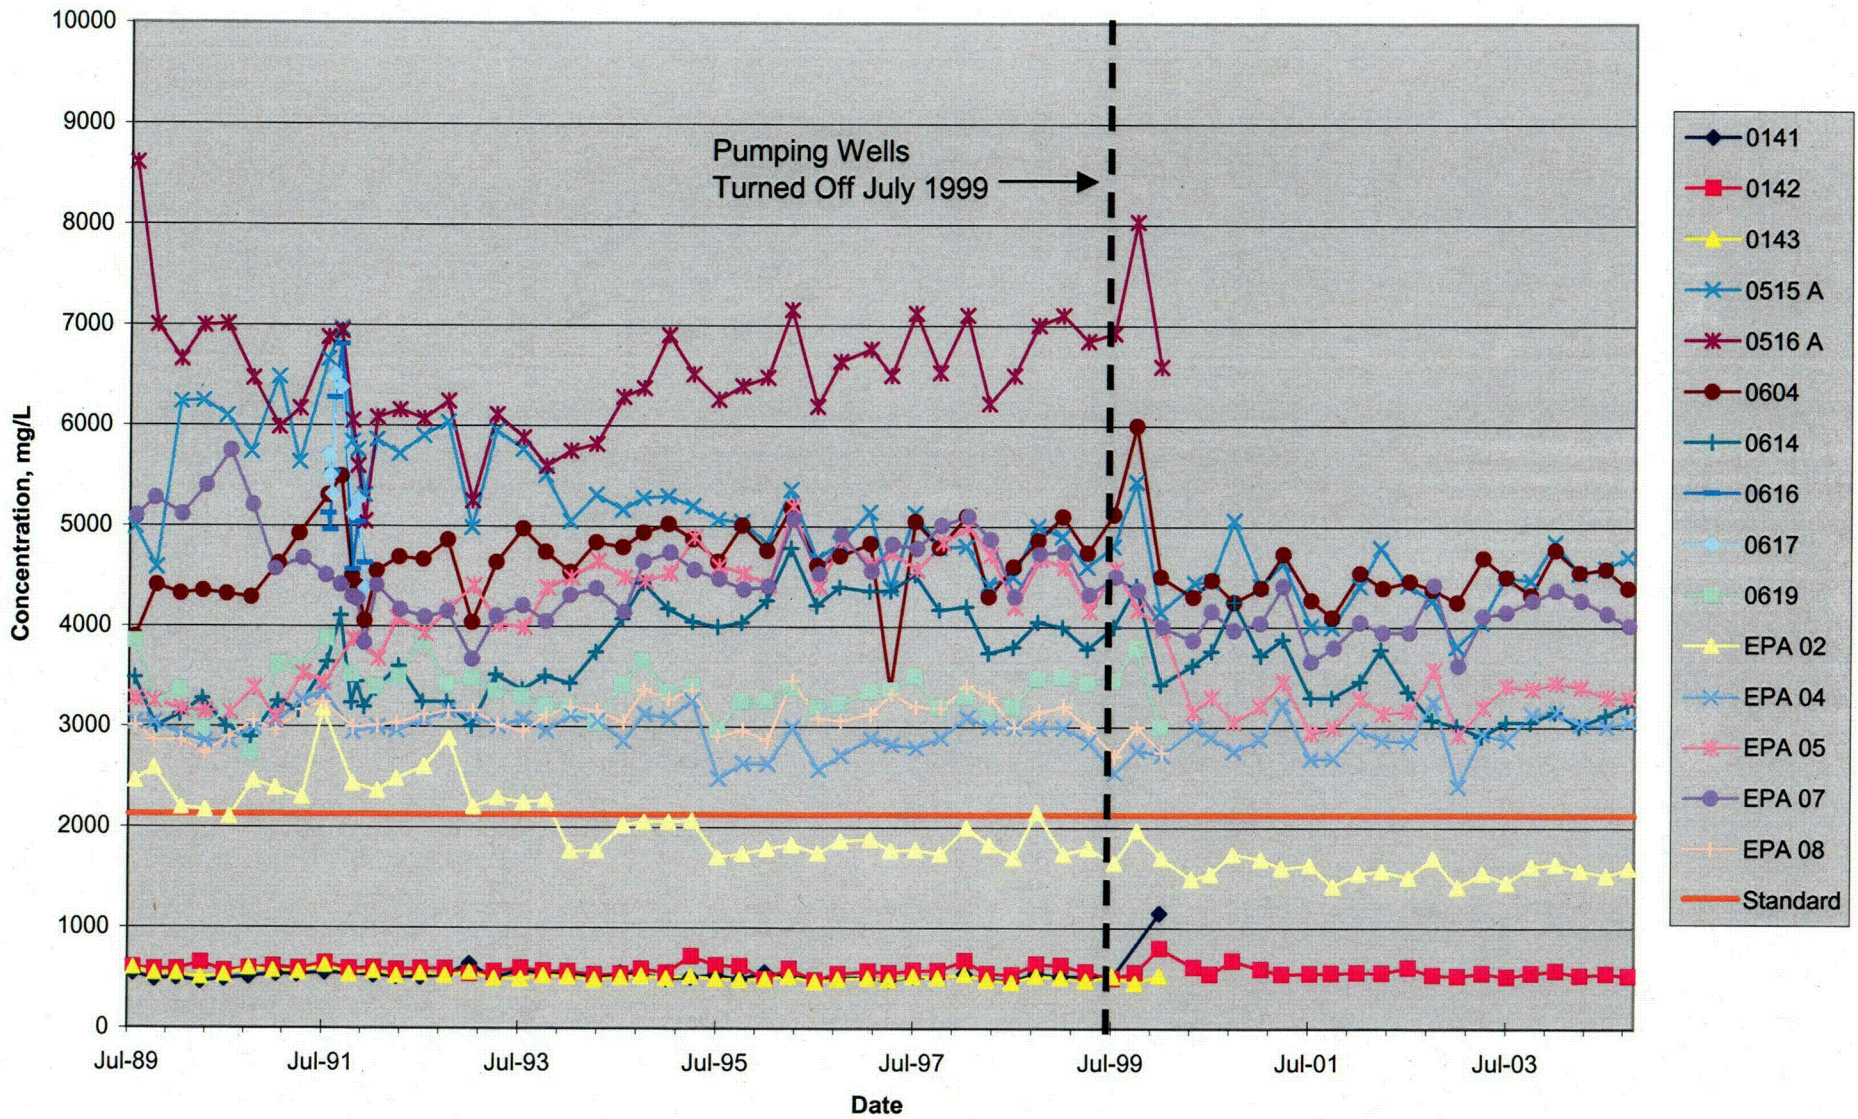
**FIGURE 50**  
 Zone 1 Sulfate Concentrations Over Time  
 United Nuclear Corporation, Church Rock Site, Church Rock, New Mexico

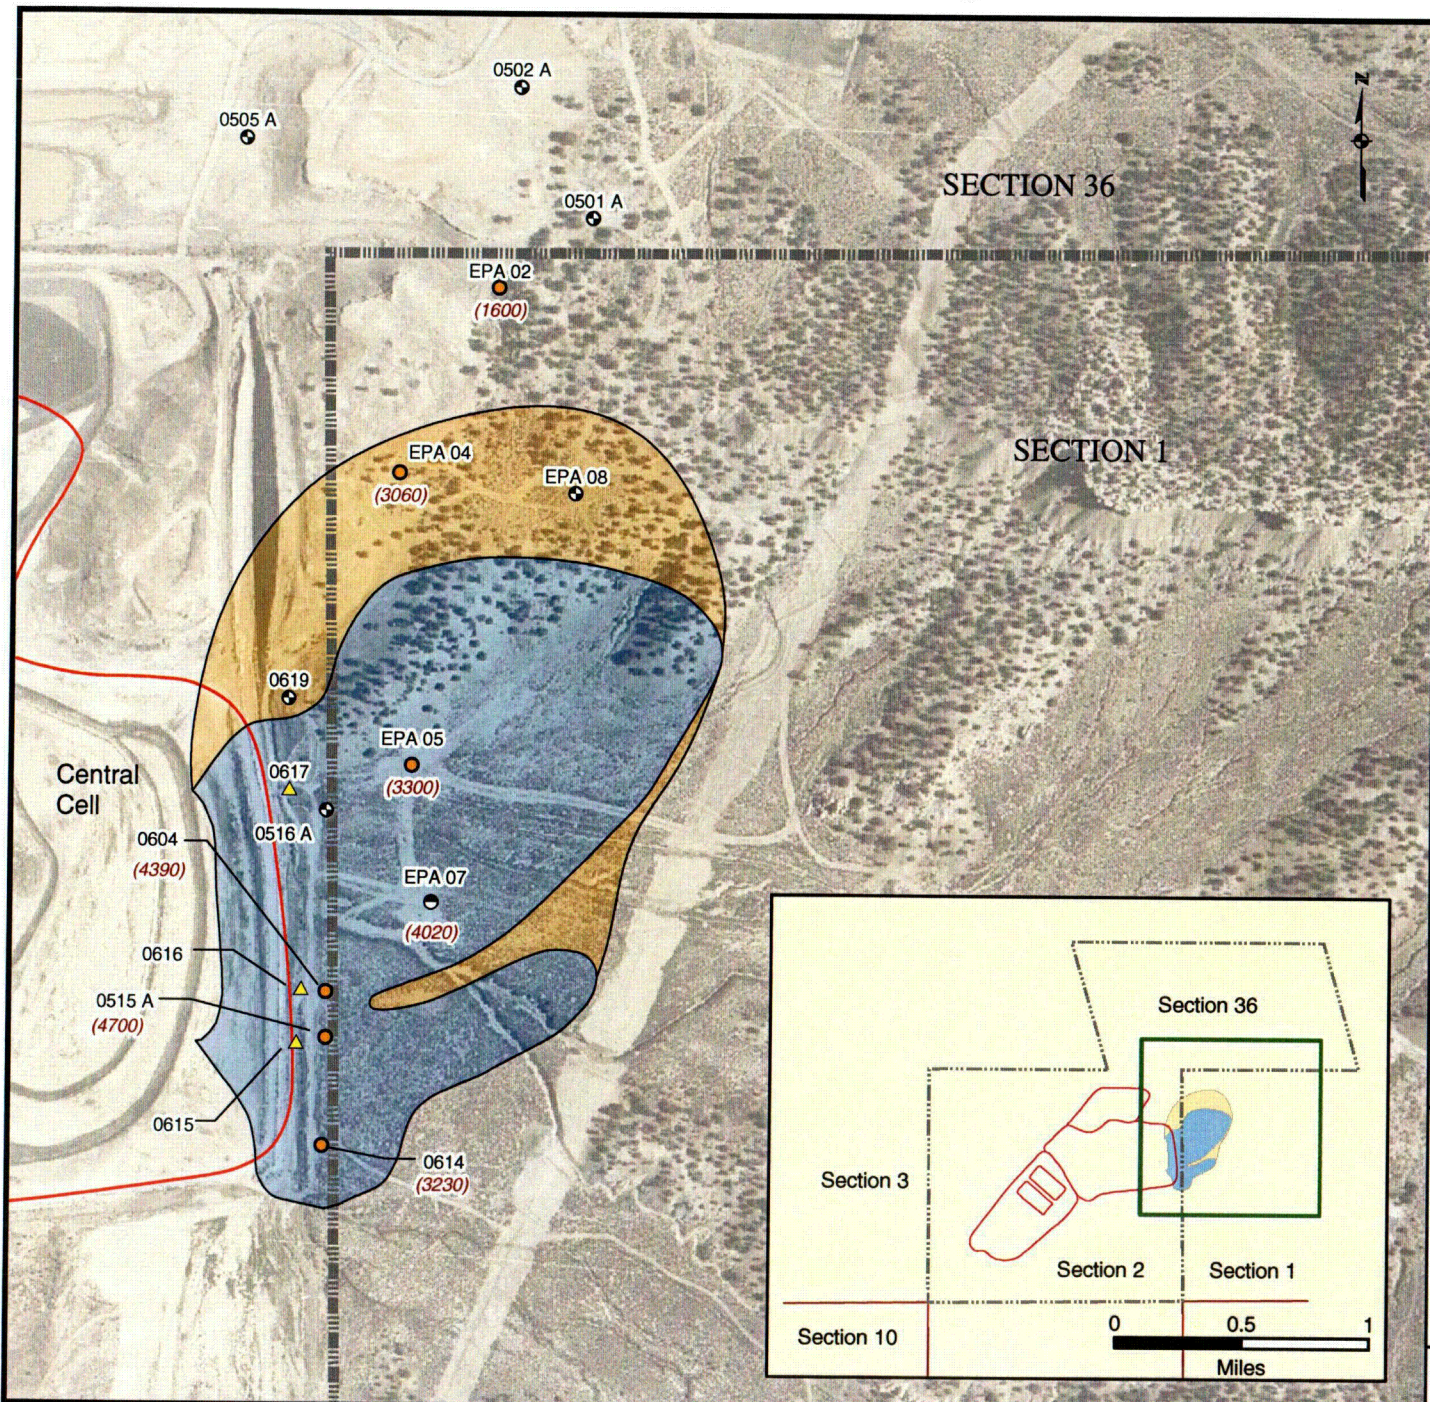
**FIGURE 51**

1. Seepage impacts delineated by Chloride detections greater than 50 mg/L.
2. Well names are displayed with black text.
3. Aerial photo taken on August 1, 1996.

**Zone 1 Approximate Extent of Sulfate Exceeding 2,125 mg/L, October 2004**

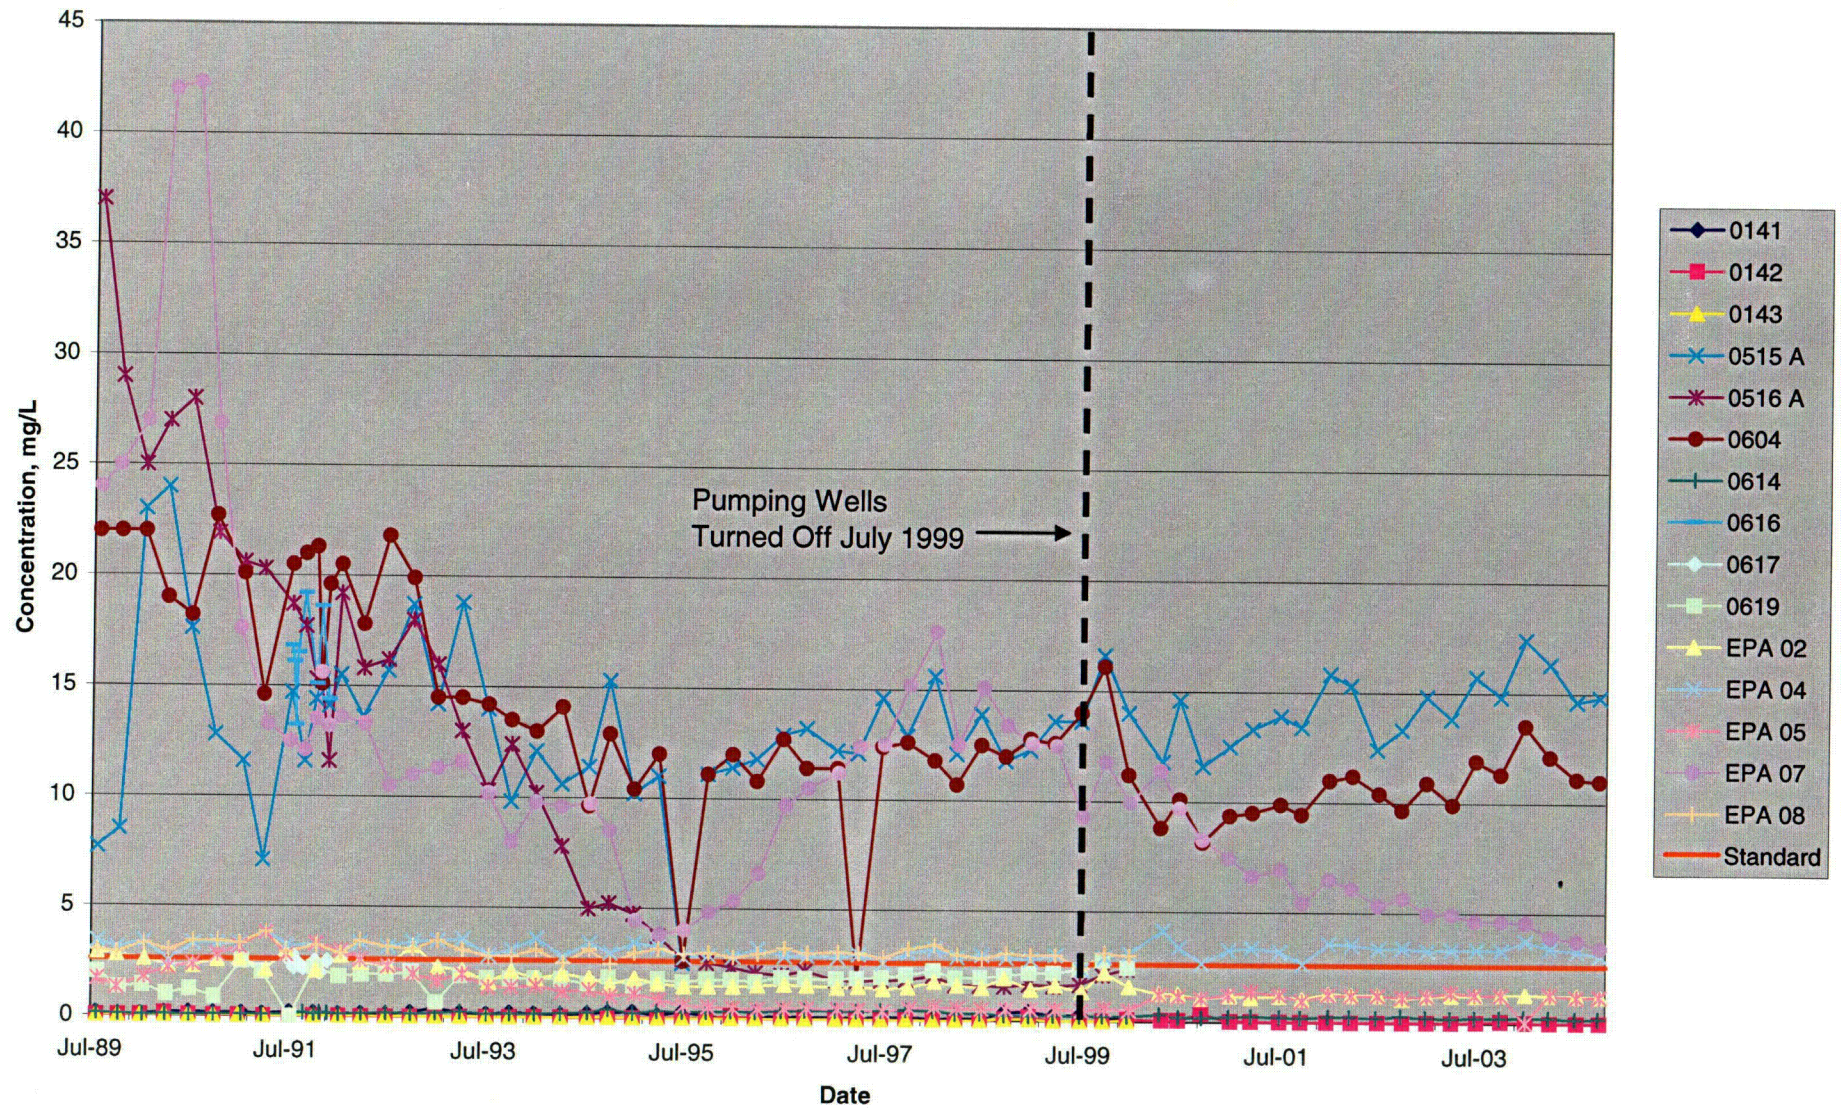
**FIGURE 52**  
 Zone 1 Manganese Concentrations Over Time  
 United Nuclear Corporation, Church Rock Site, Church Rock, New Mexico

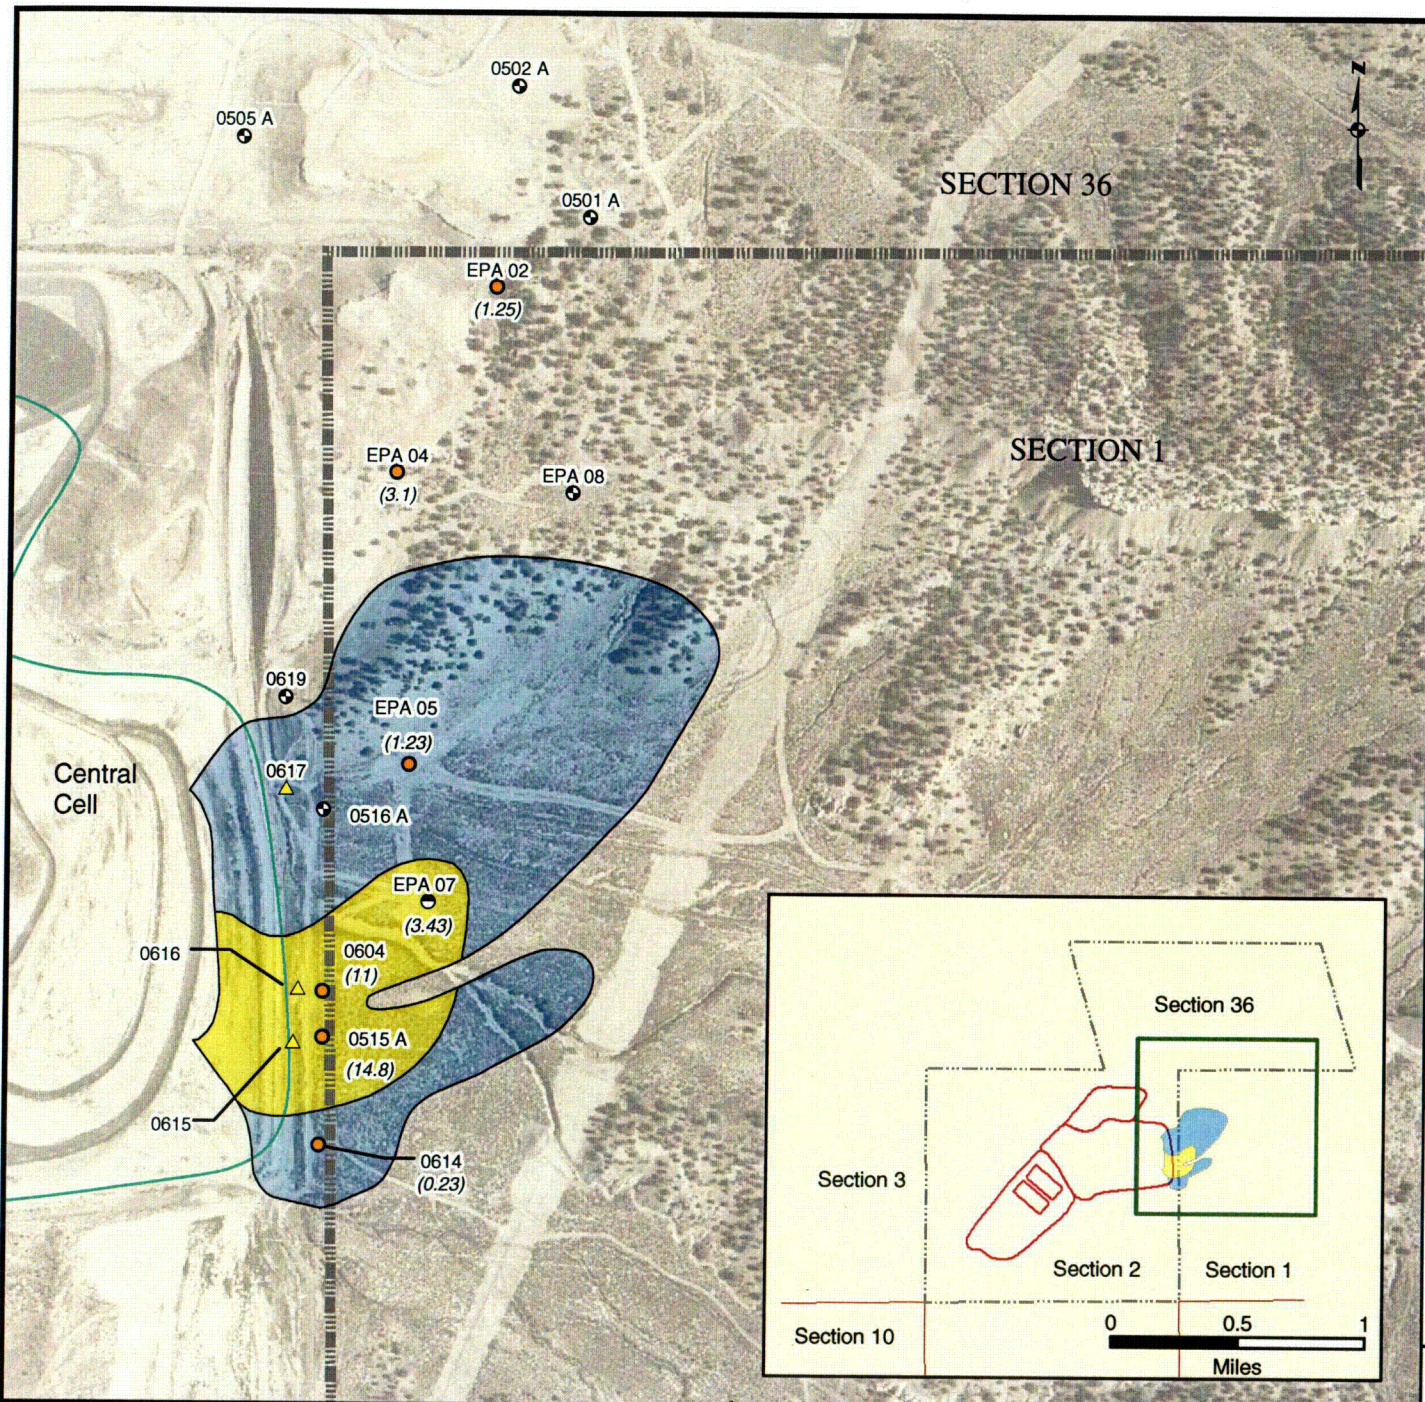
**FIGURE 53**

1. Seepage impacts delineated by Chloride detections greater than 50 mg/L.
2. Aerial photo taken on August 1, 1996.

**Zone 1 Approximate Extent of Manganese Exceeding 2.6 mg/L, October 2004**

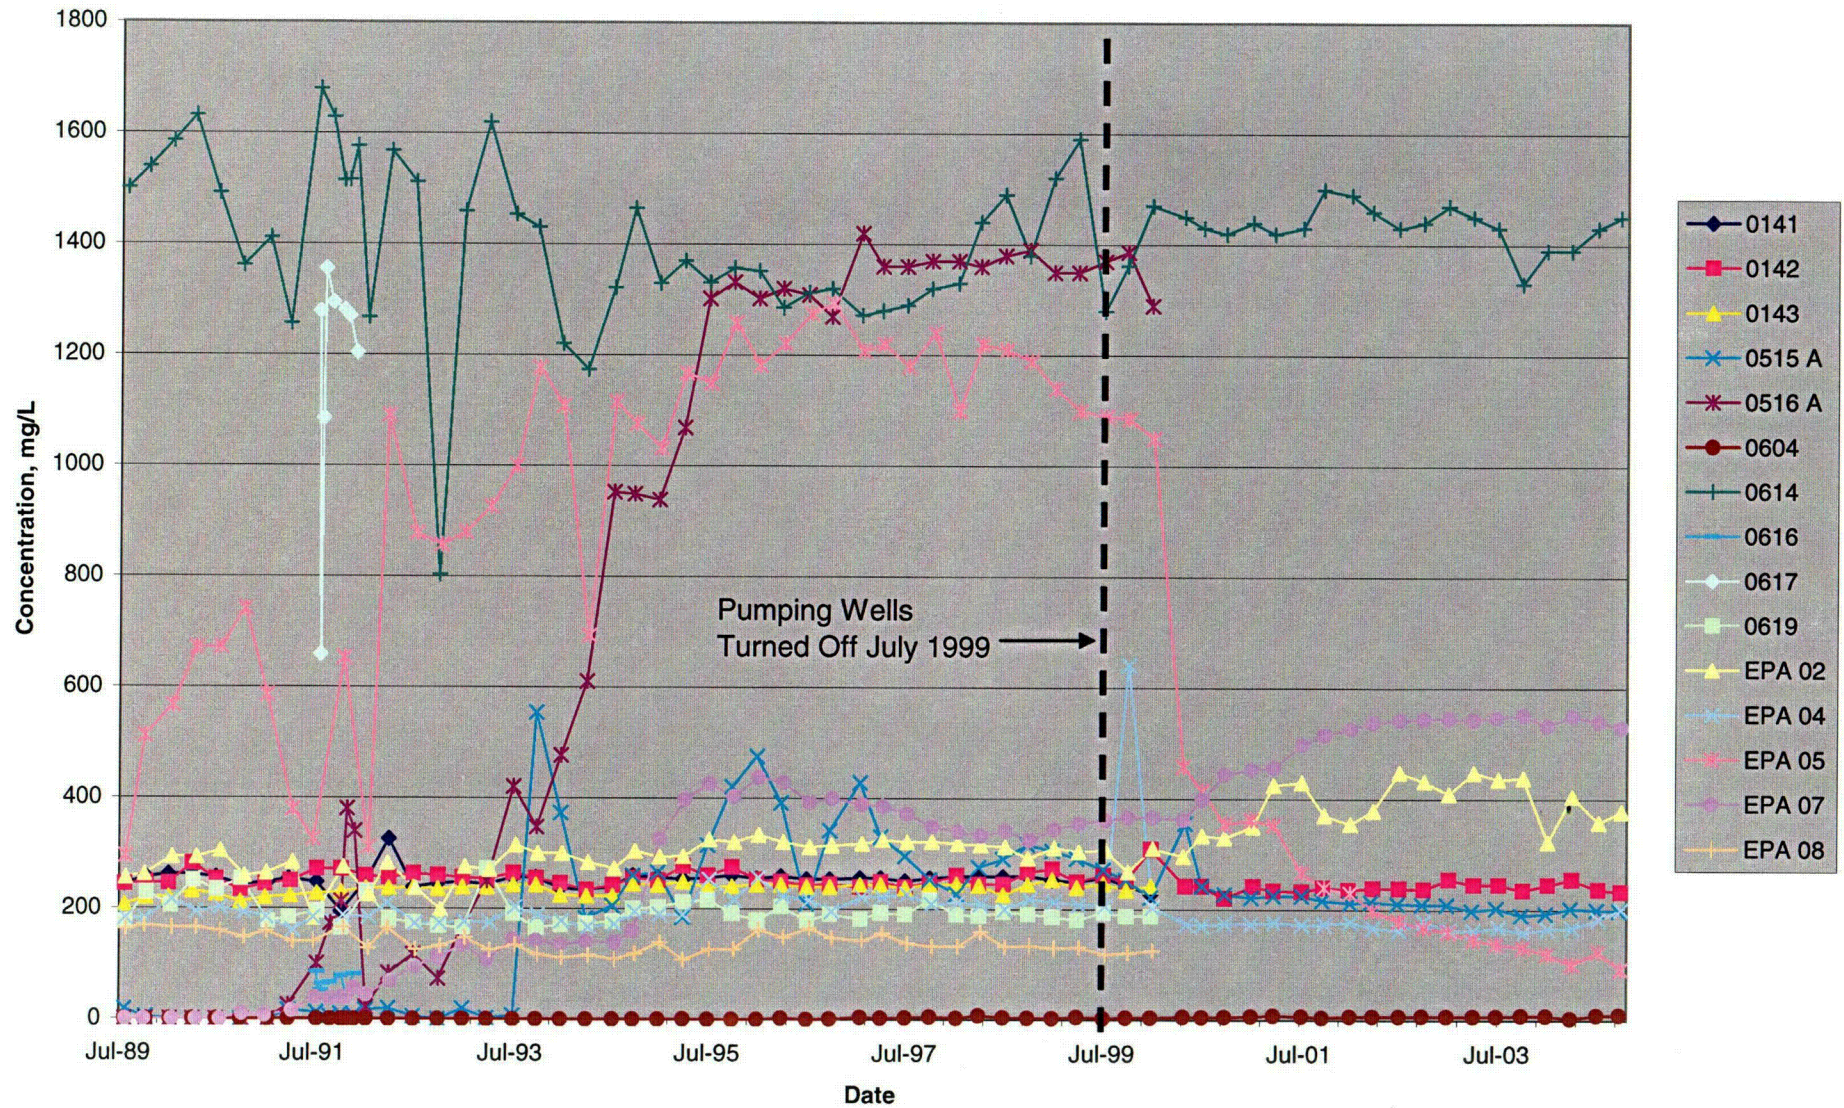
**FIGURE 54**  
 Zone 1 Bicarbonate Concentrations Over Time  
 United Nuclear Corporation, Church Rock Site, Church Rock, New Mexico

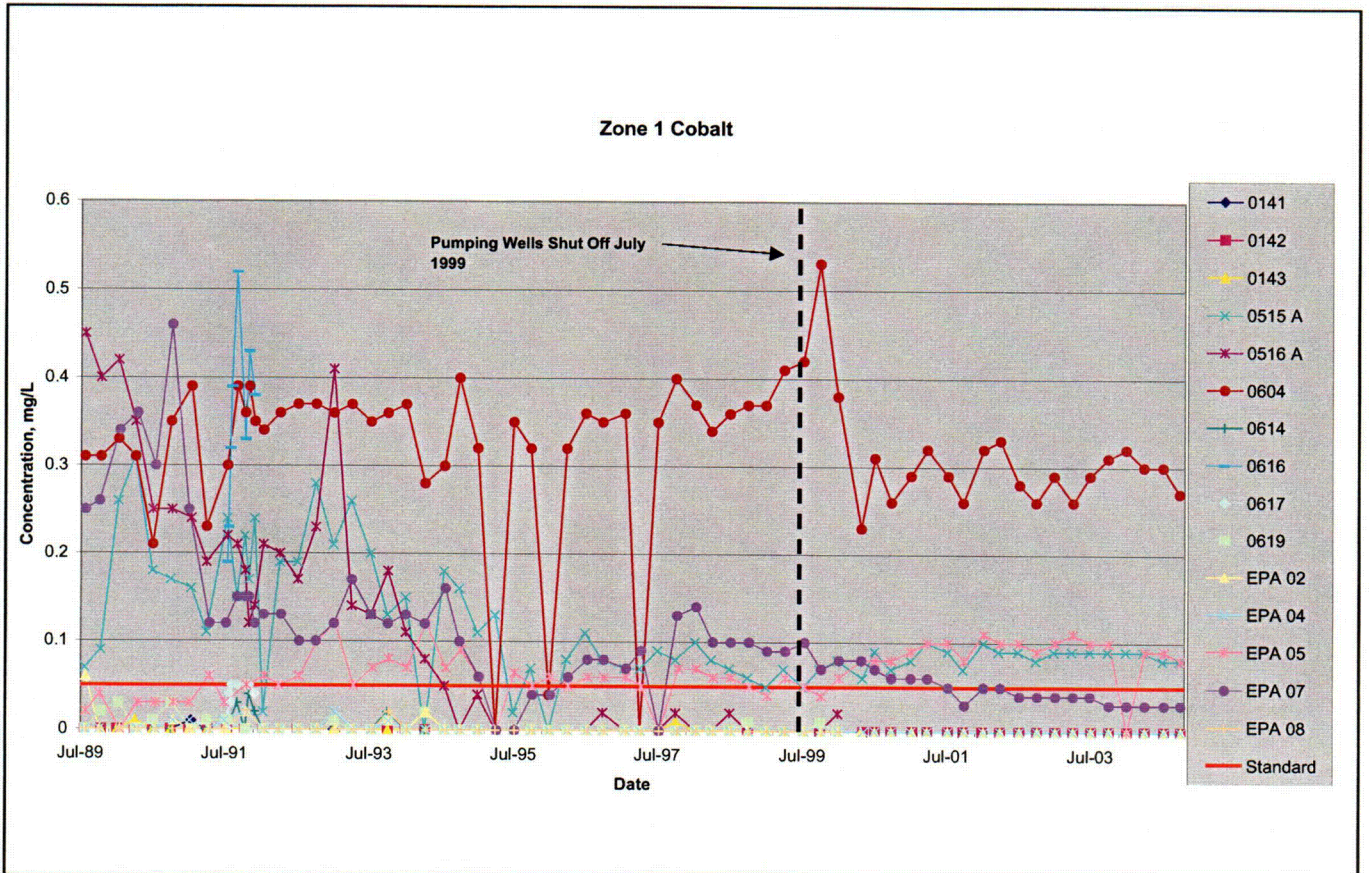
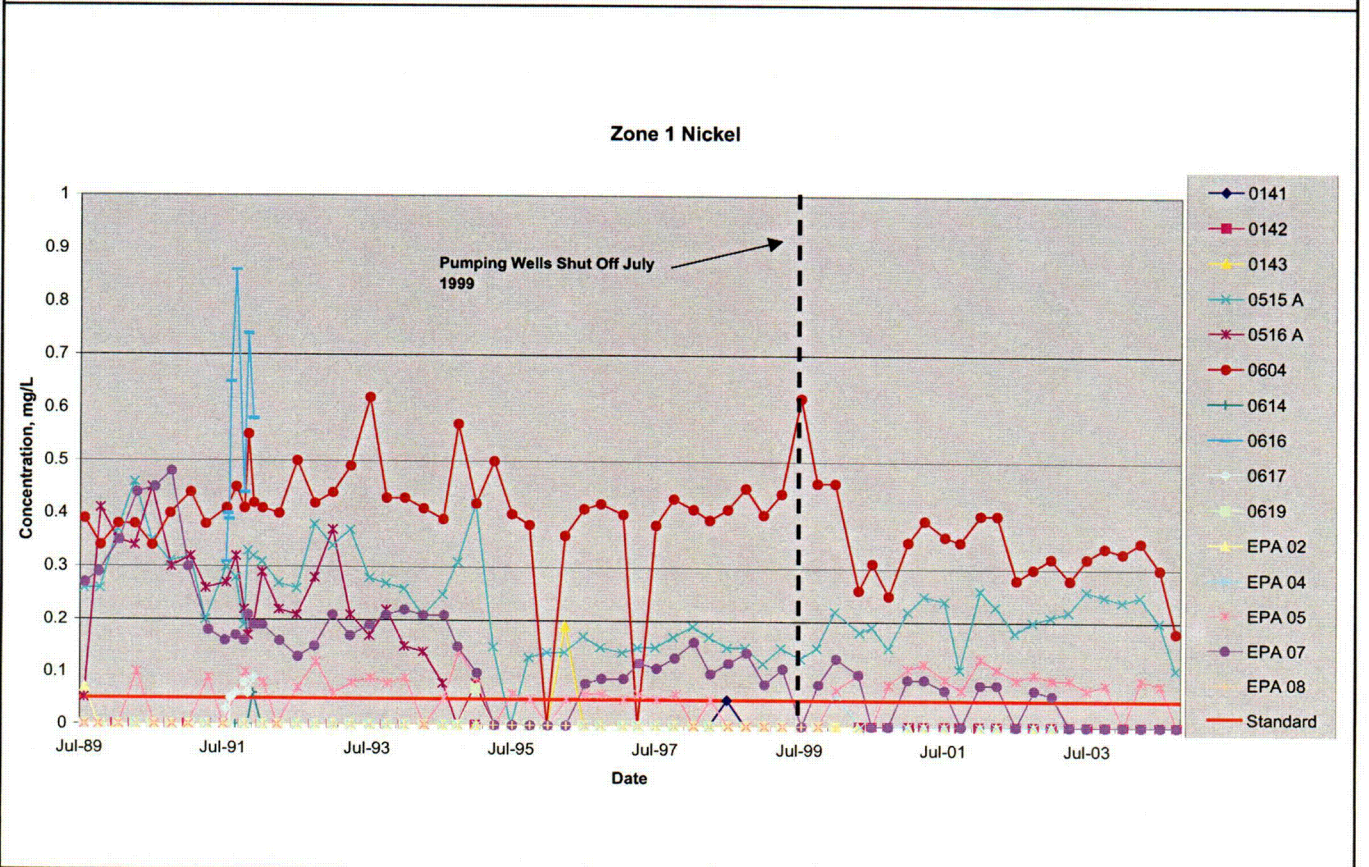
**FIGURE 55**  
**Zone 1 Cobalt and Nickel Concentrations Over Time**  
 United Nuclear Corporation Church Rock site, Church Rock, New Mexico

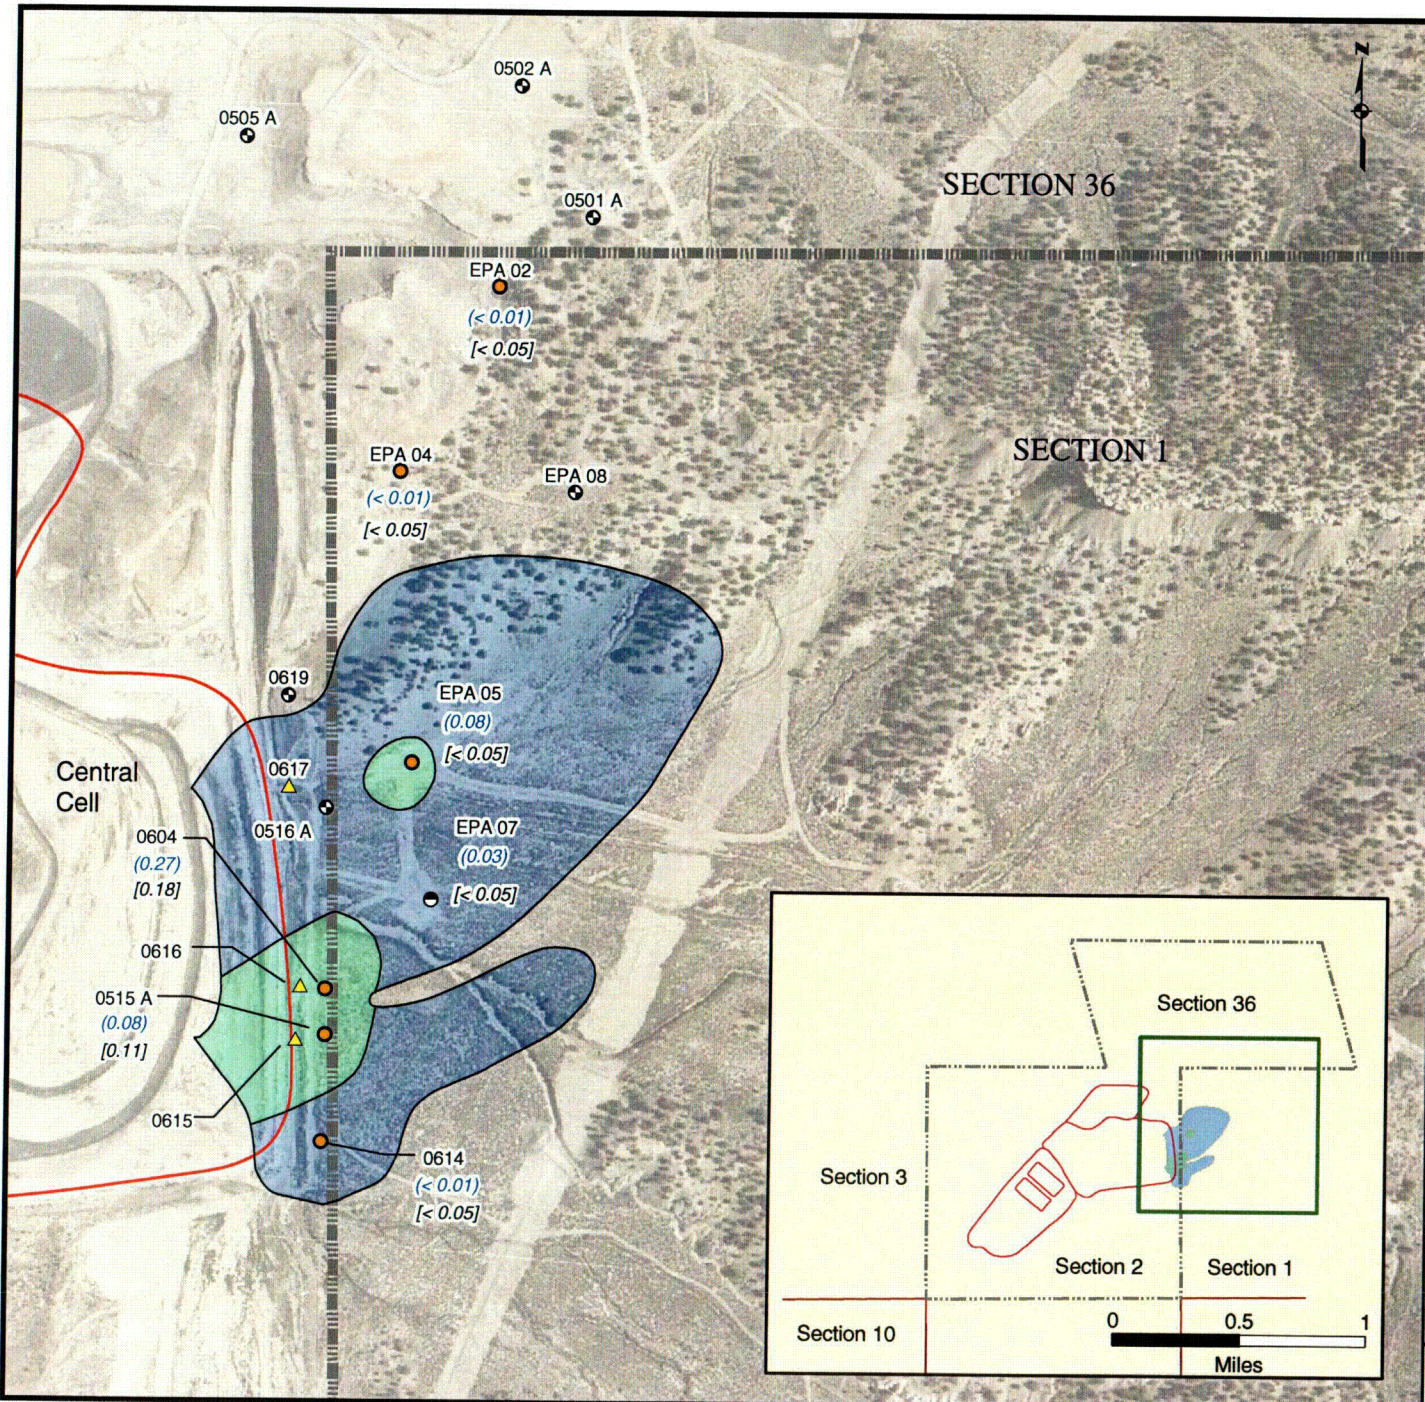
- Notes:**
1. Seepage impacts delineated by Chloride detections greater than 50 mg/L.
  2. Well names are displayed with black text.
  3. Aerial photo taken on August 1, 1996.

**FIGURE 56**  
**Zone 1 Extent of Cobalt and Nickel Exceeding 0.05 mg/L, October 2004**  
 United Nuclear Corporation Church Rock Site, Church Rock, New Mexico

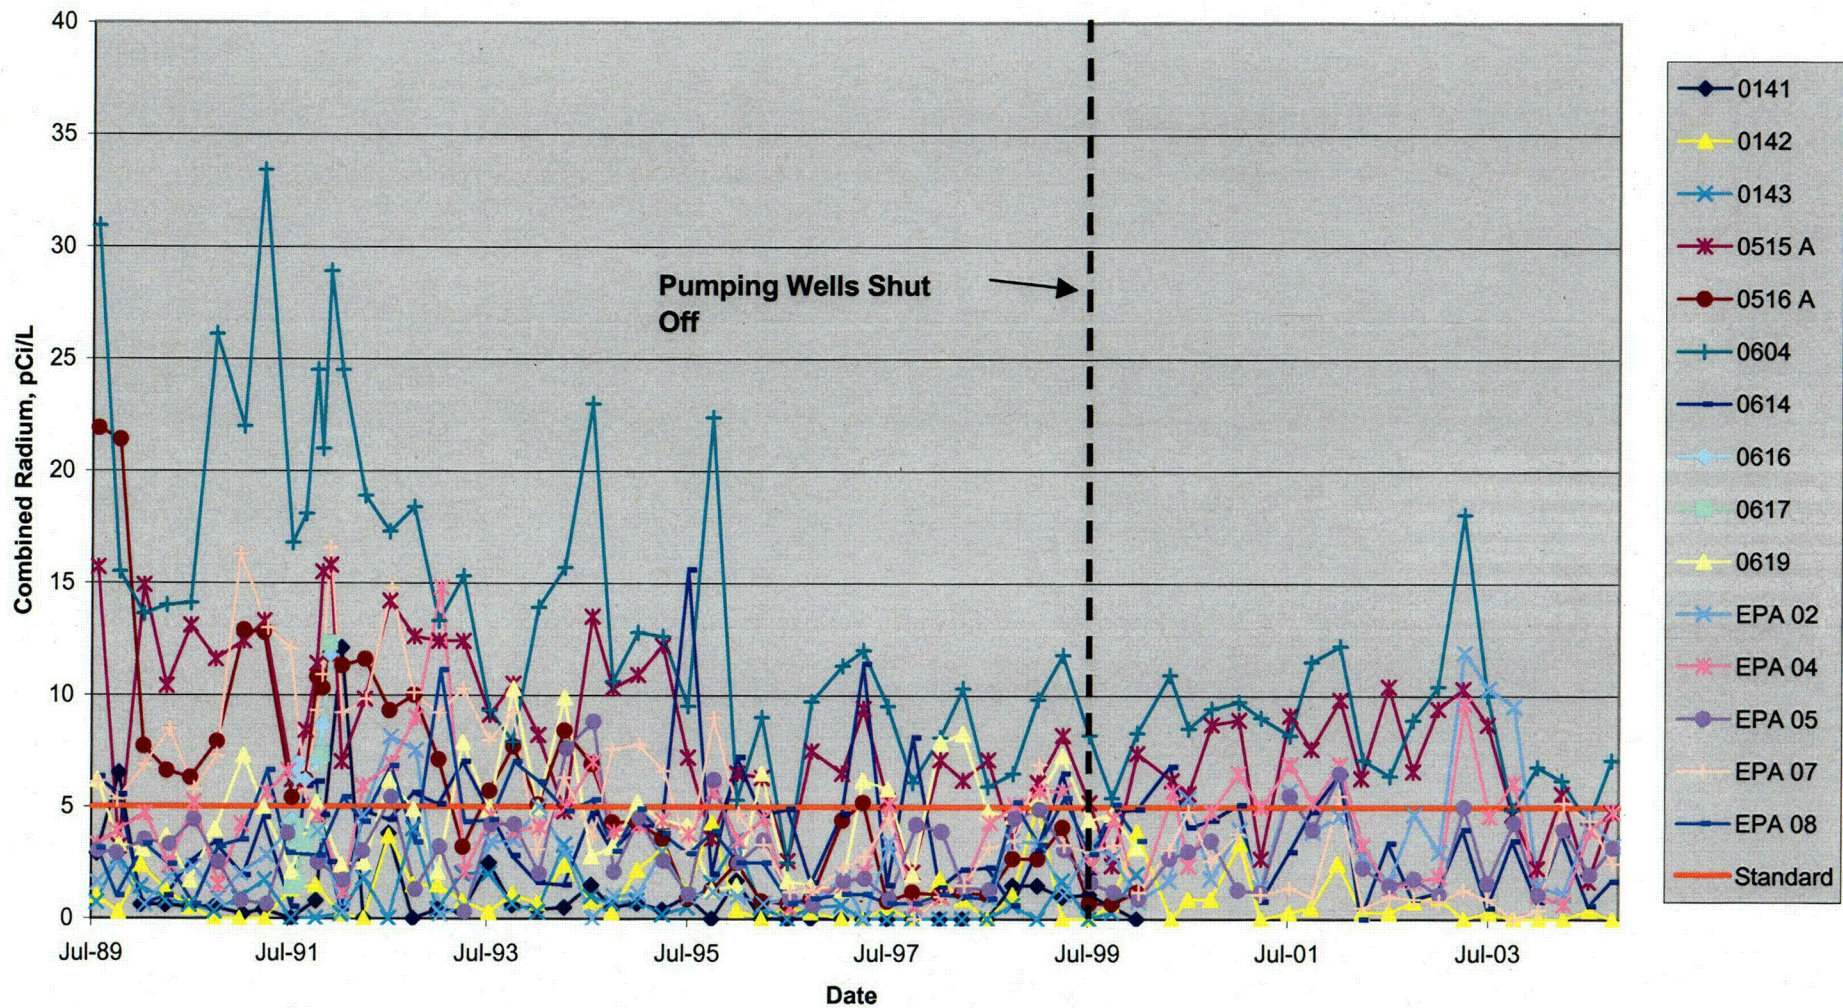
**FIGURE 57**  
 Zone 1 Combined Radium-226 and Radium-228 Over Time  
 United Nuclear Corporation, Church Rock Site, Church Rock, New Mexico
