LICENSEE: Nuclear Management Company, LLC
FACILITY: Point Beach Nuclear Plant, Units 1 and 2
SUBJECT: SUMMARY OF TELEPHONE CONFERENCE HELD ON JANUARY 10, 2005,
BETWEEN THE U.S. NUCLEAR REGULATORY COMMISSION AND
NUCLEAR MANAGEMENT COMPANY, LLC, CONCERNING REQUESTS FOR
ADDITIONAL INFORMATION PERTAINING TO THE POINT BEACH NUCLEAR
PLANT, UNITS 1 AND 2, LICENSE RENEWAL APPLICATION

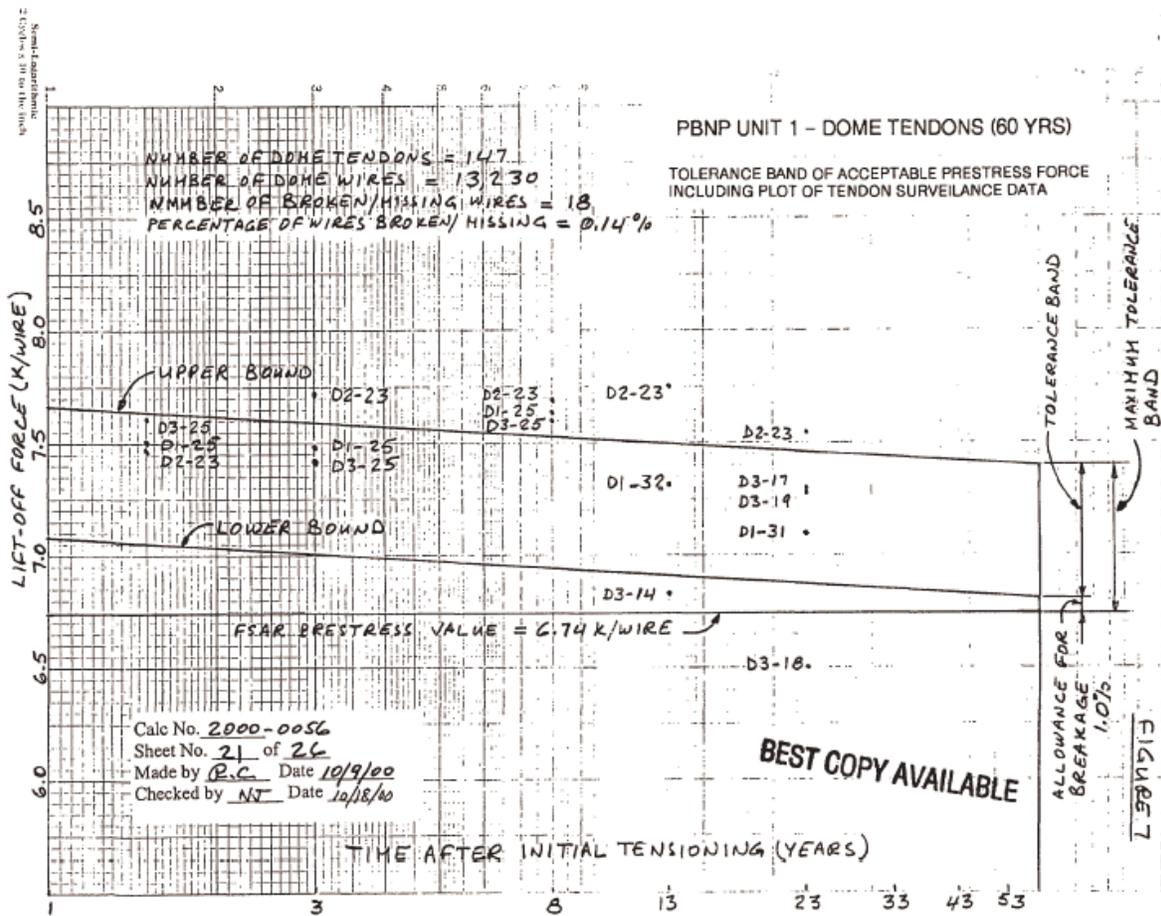
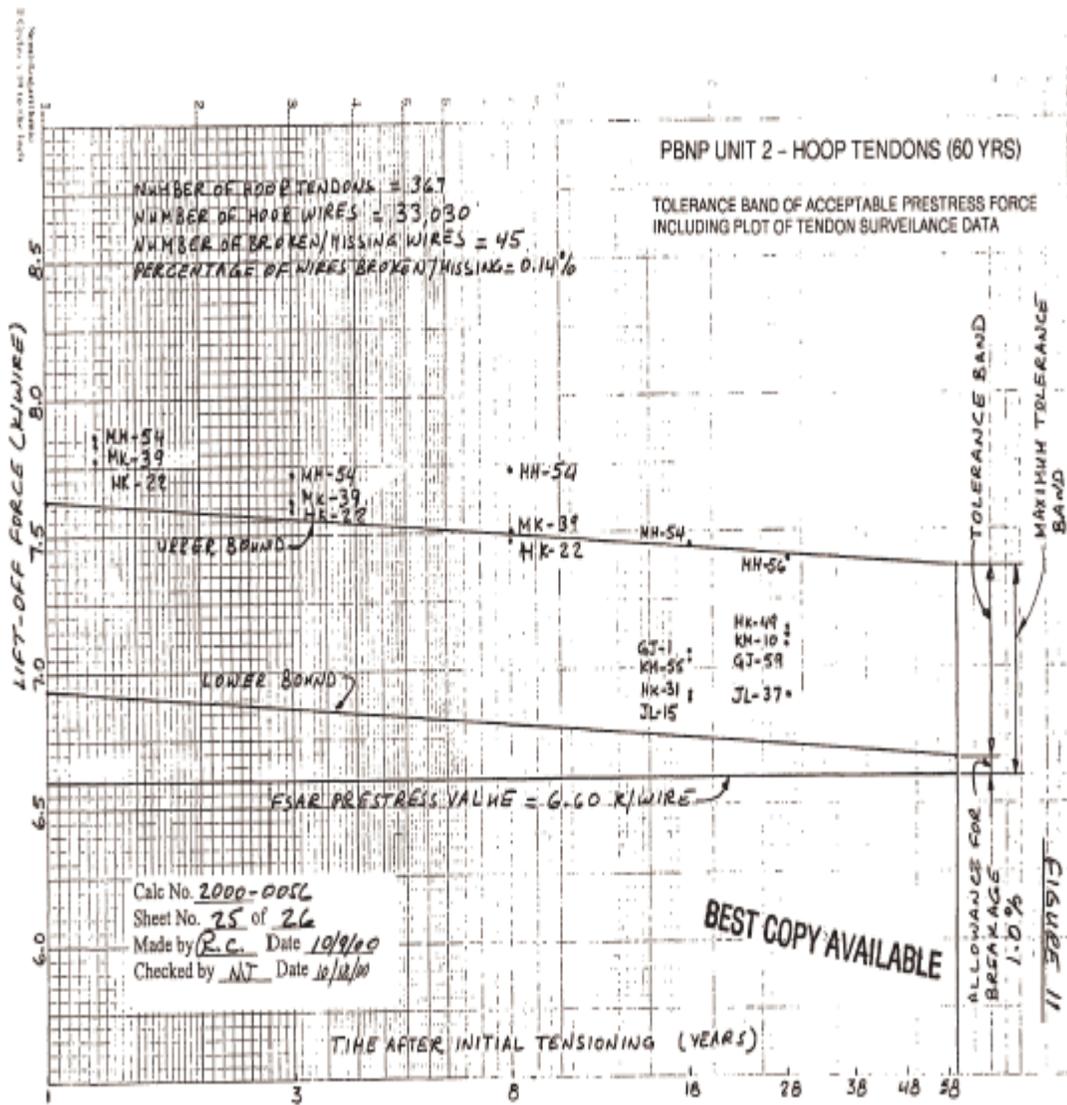
A set of tendon prestressing plots have been developed in accordance with RG 1.35.1, reference Calculation 2000-0056, Tendon Prestress Acceptance Limits, Rev. 0. The plots for 60 years (6 total) include the upper and lower bound lines and the minimum required prestressing force for each group of tendons for each of the containments per RG 1.35.1.

The response to item b. is after the plots below.

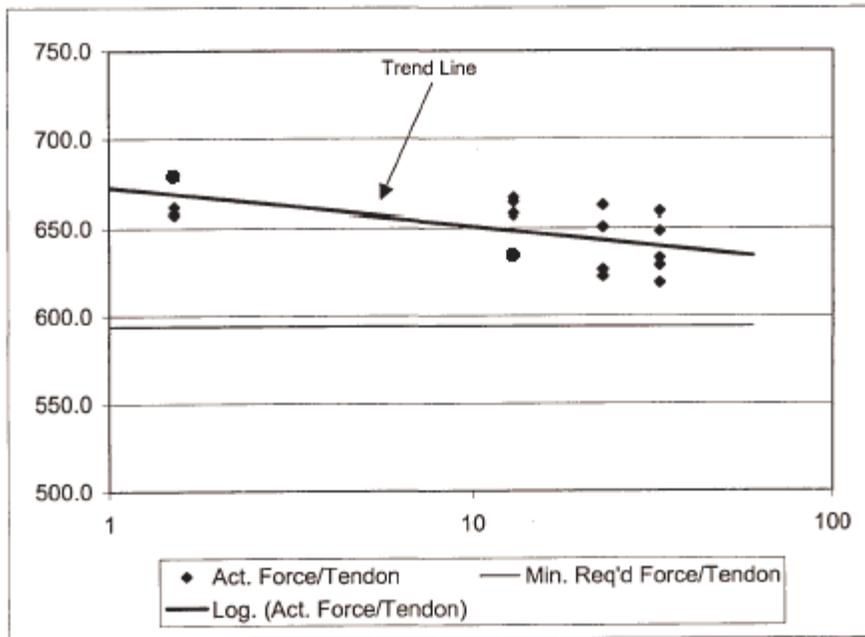
UNIT 1 HOOP TENDONS
Actual Force Trend

Year	Actual	Year	Actual
1.5	657.5	23	662.0
1.5	661.0	23	650.5
1.5	679.5	23	622.45
13	634.5	33	648.2
13	666.5	33	618.9
13	664.0	33	658.7
13	657.5	33	633.0
23	626.35	33	628.8

Also included are the prestressing plots with the trend lines of the projected prestressing forces for each group of tendons out to 60 years. The trend lines were developed using linear regression analysis and all of the individual lift-off force data from all of the tendon surveillances to date. This technique/guidance was provided by the NRC in a teleconference on July 13, 2004 with Hansraj G. Ashar. Note that this trend line information is based upon a draft calculation. If the final approved calculation comes to a different conclusion, NMC will provide that information.

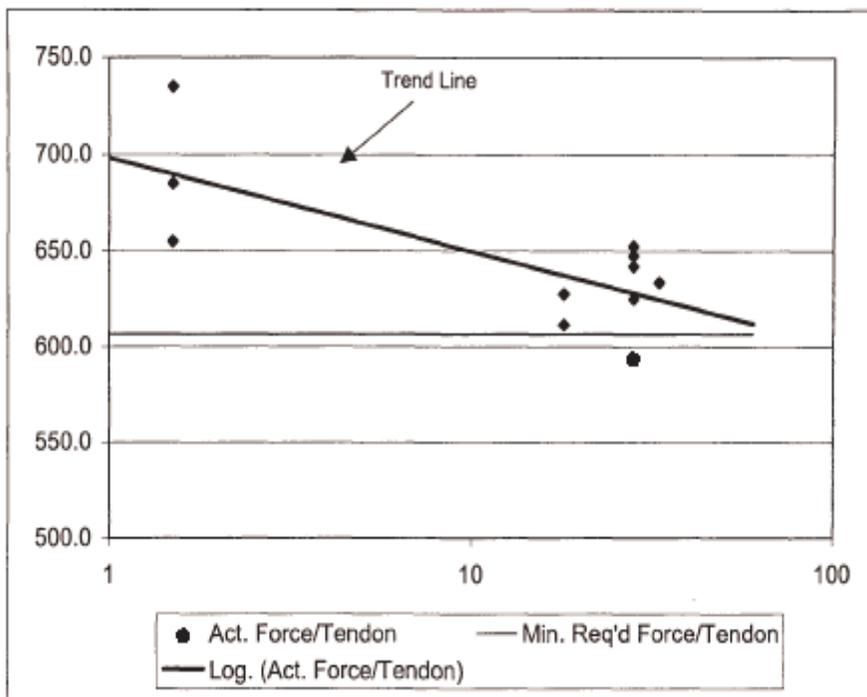
UNIT 2 DOME TENDONS
Actual Force Trend

Year	Actual	Year	Actual
1.5	685.0	28	594.0
1.5	735.0	28	642.0
1.5	655.0	28	652.5
18	627.5	33	633.6
18	611.5		
28	625.0		
28	647.5
