LICENSEE: Nuclear Management Company, LLC  
FACILITY: Point Beach Nuclear Plant, Units 1 and 2  
SUBJECT: SUMMARY OF TELEPHONE CONFERENCE HELD ON JANUARY 10, 2005,  
BETWEEN THE U.S. NUCLEAR REGULATORY COMMISSION AND  
NUCLEAR MANAGEMENT COMPANY, LLC, CONCERNING REQUESTS FOR  
ADDITIONAL INFORMATION PERTAINING TO THE POINT BEACH NUCLEAR  
PLANT, UNITS 1 AND 2, LICENSE RENEWAL APPLICATION

The U.S. Nuclear Regulatory Commission staff (the staff) and representatives of Nuclear Management Company, LLC (NMC) held a telephone conference on January 10, 2005, to discuss and clarify the staff's requests for additional information (RAIs) concerning the Point Beach Nuclear Plant, Units 1 and 2, license renewal application. The conference call was useful in clarifying the intent of the staff's RAIs.

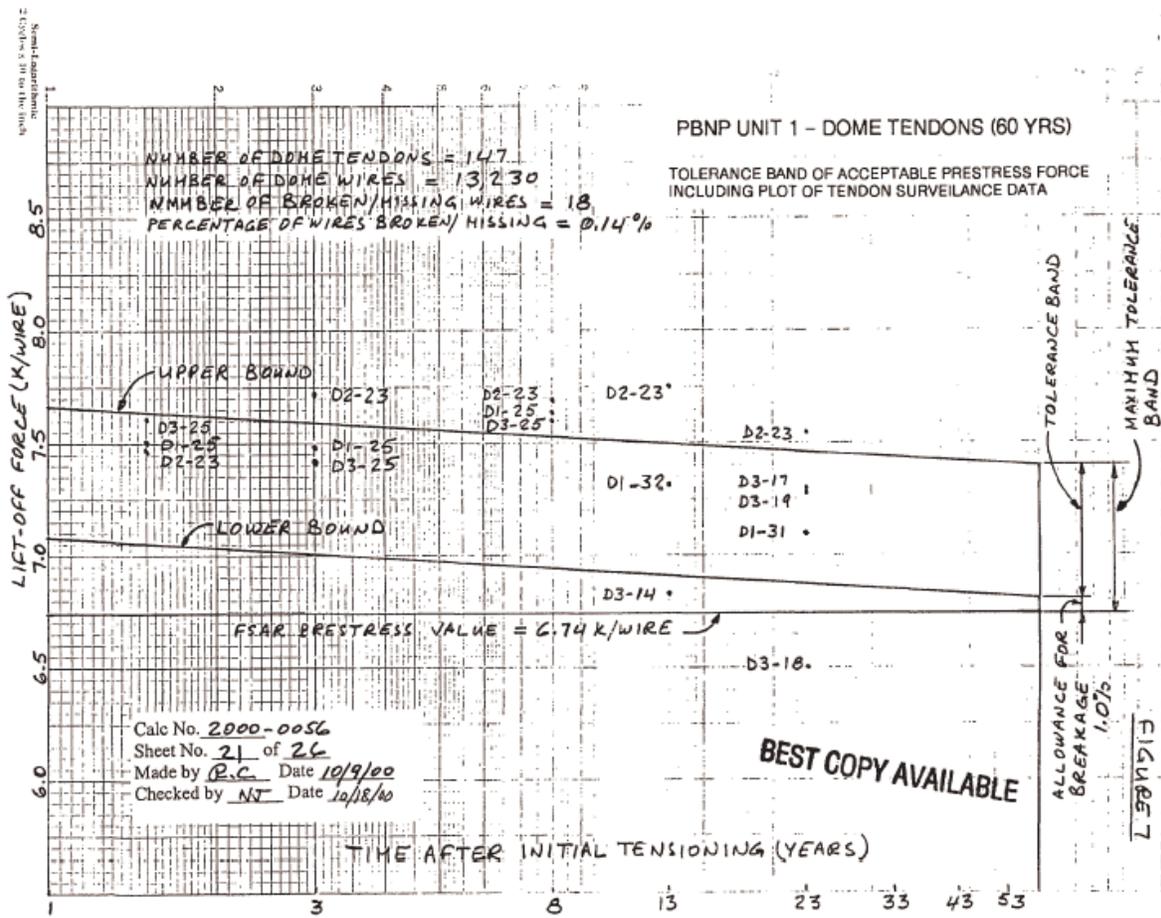
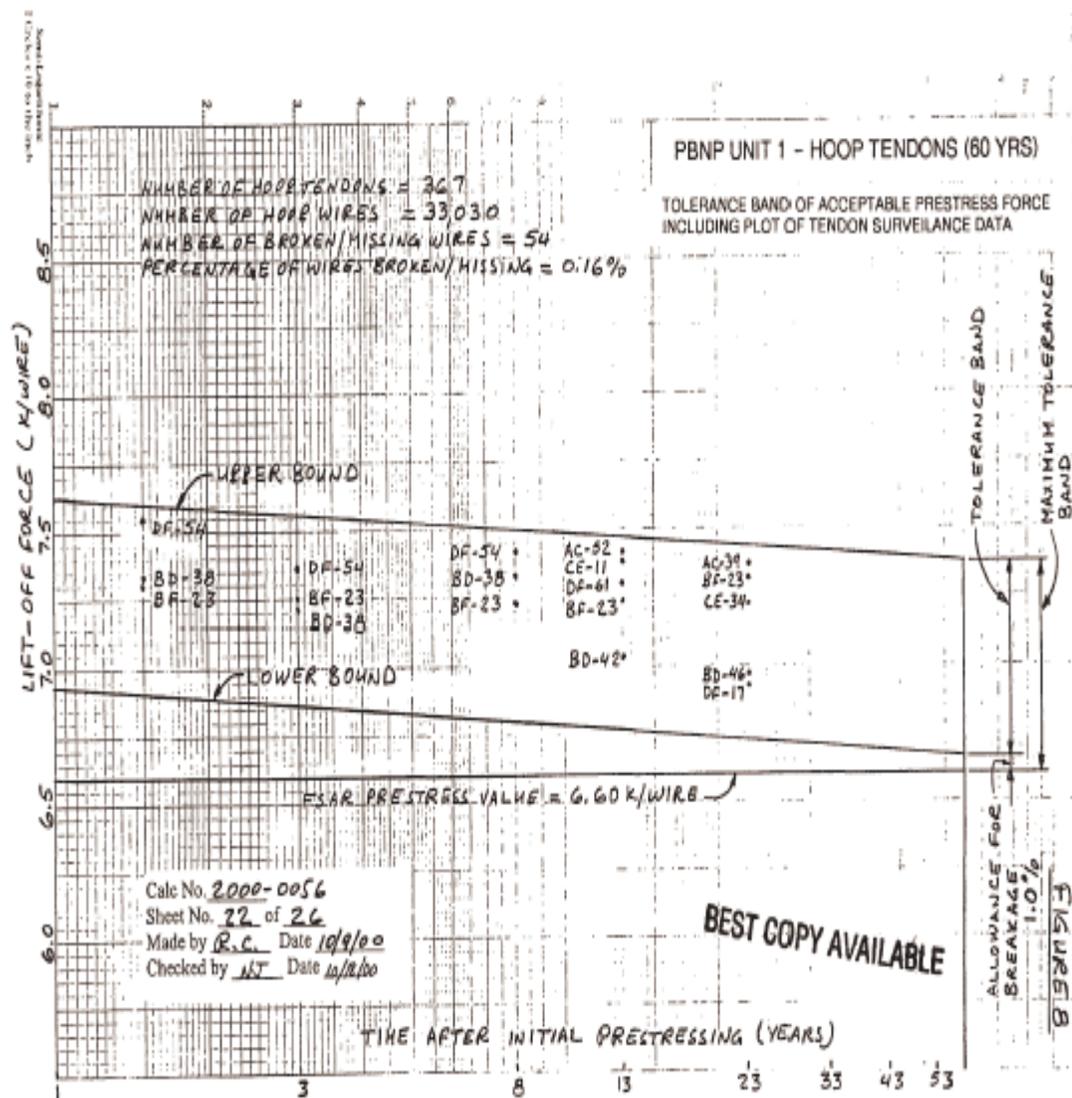
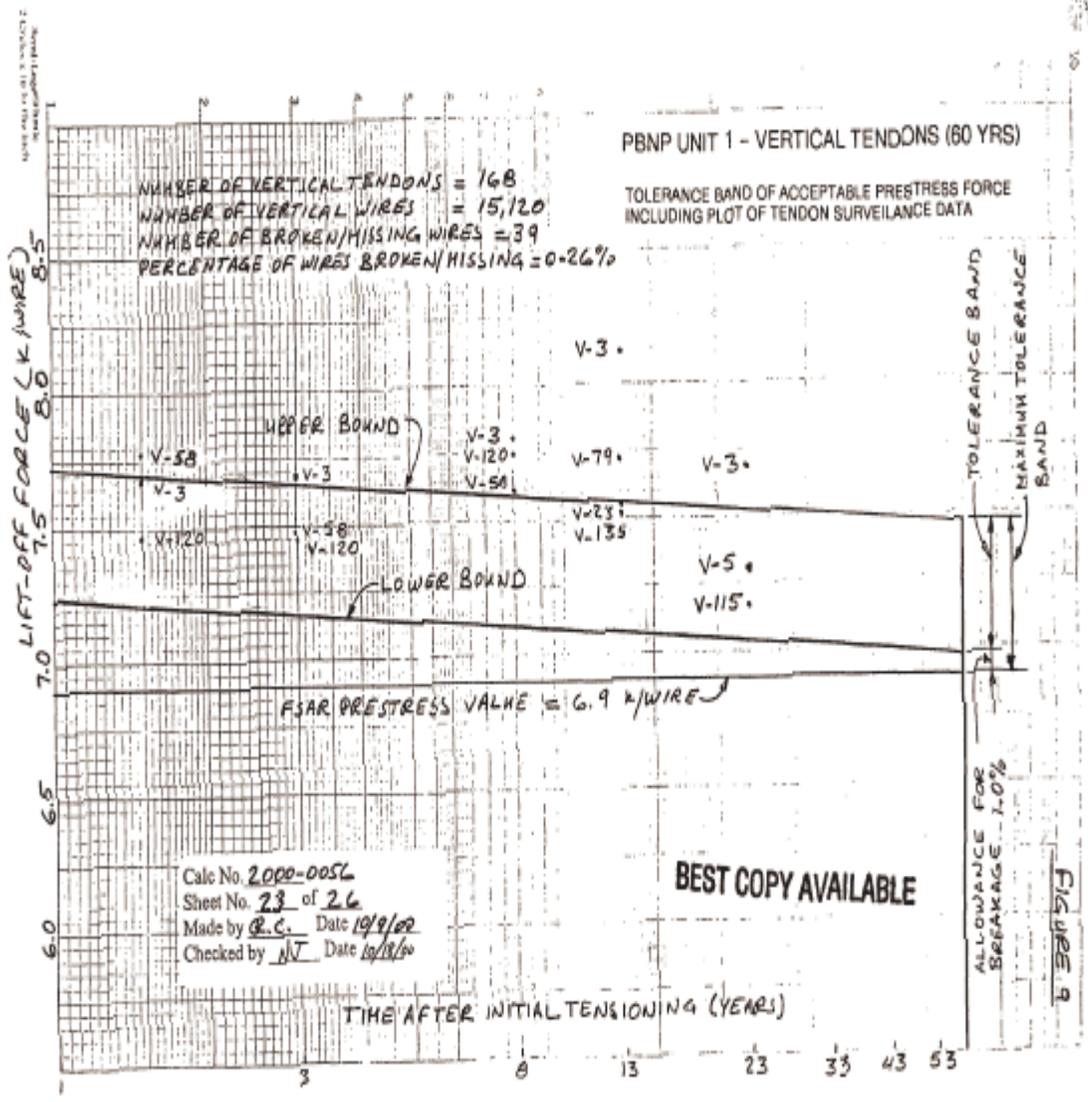
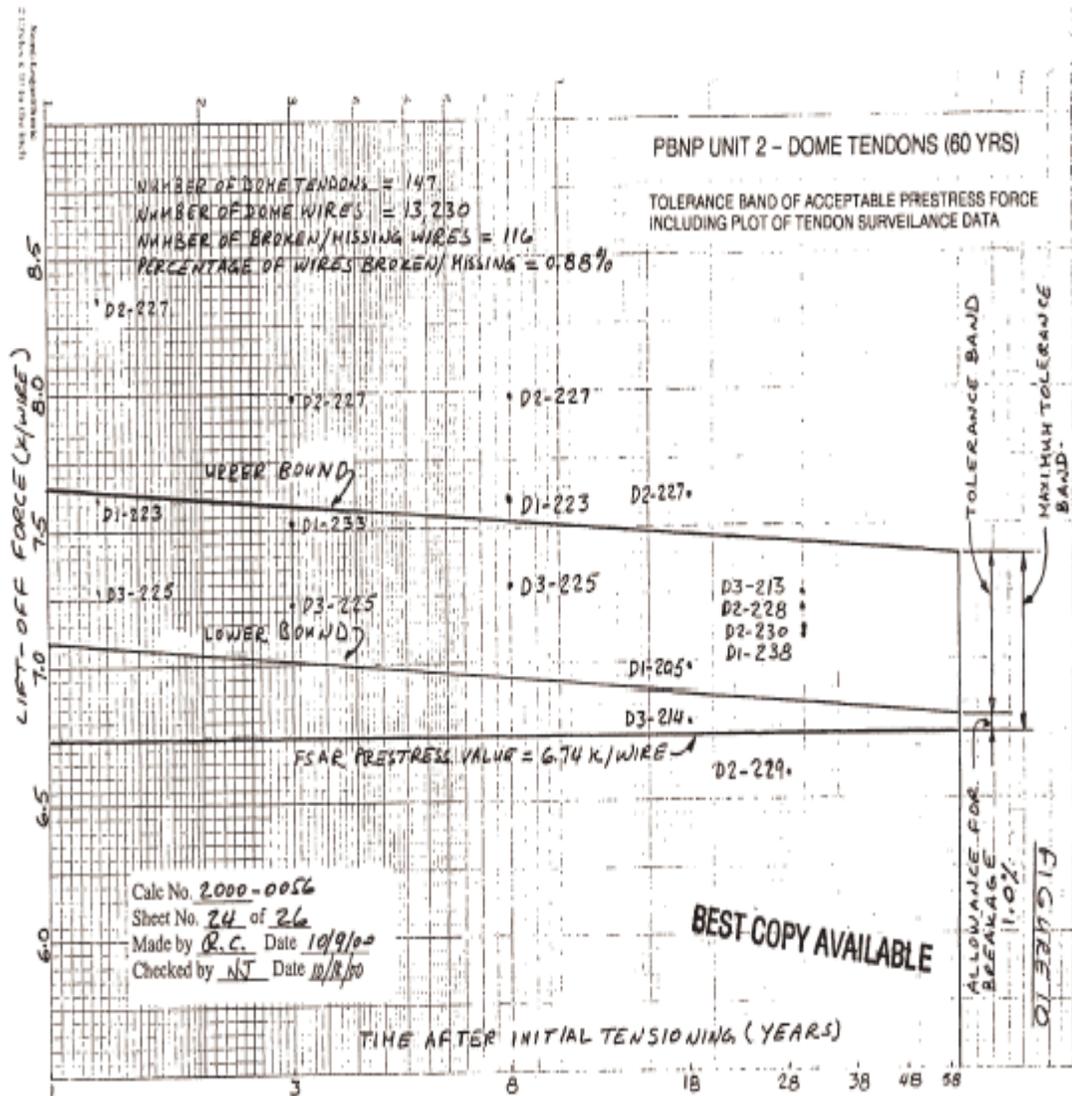
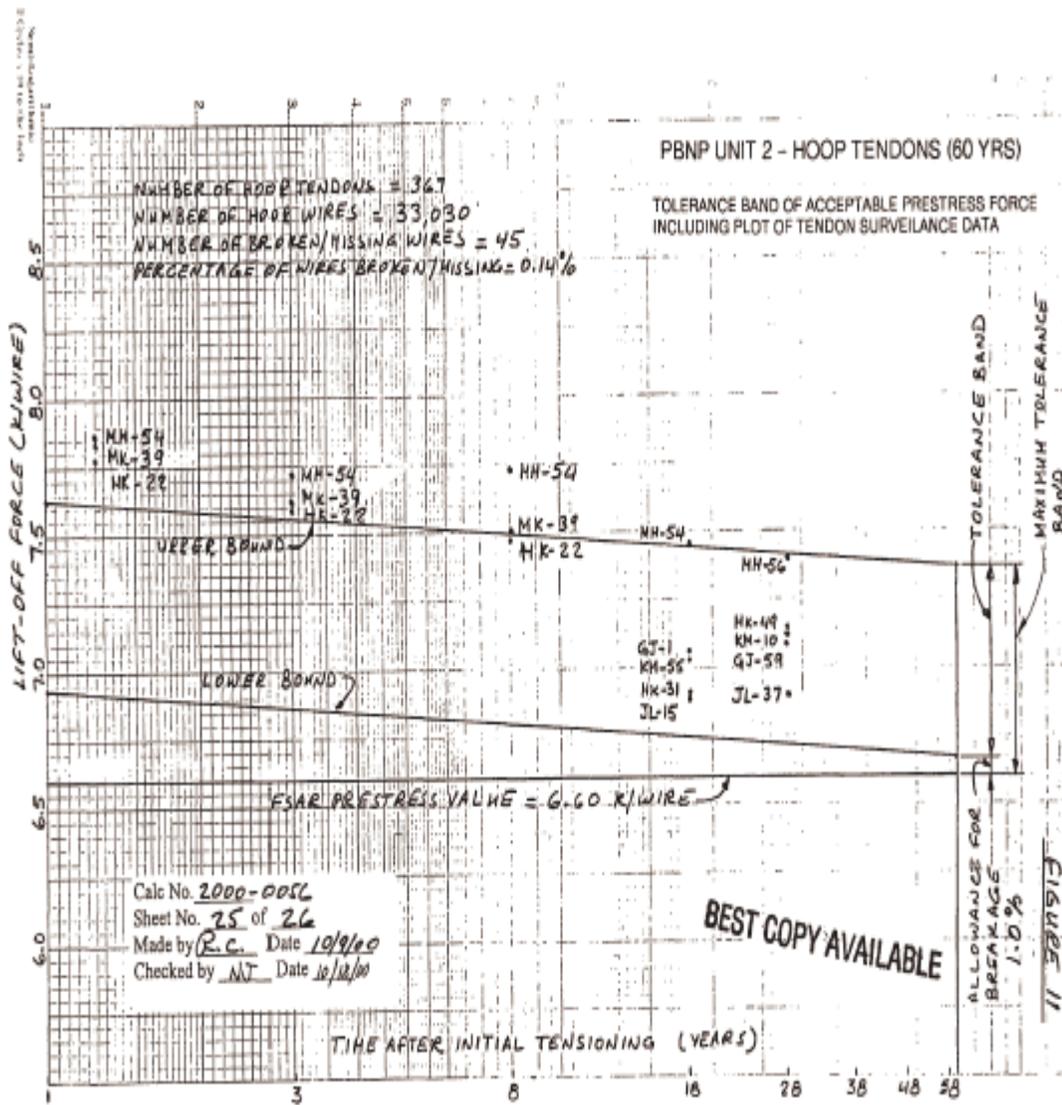
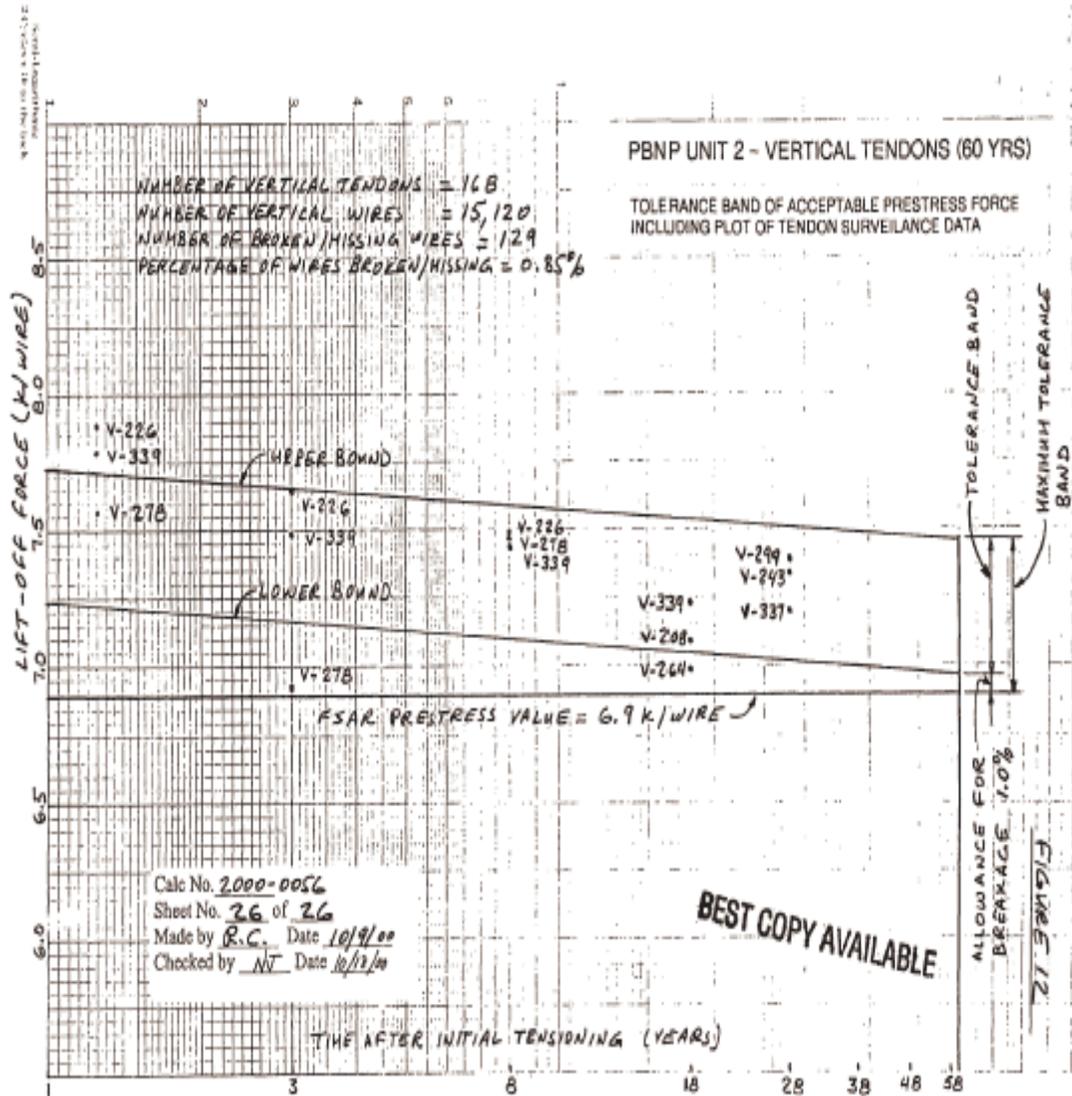
A set of tendon prestressing plots have been developed in accordance with RG 1.35.1, reference Calculation 2000-0056, Tendon Prestress Acceptance Limits, Rev. 0. The plots for 60 years (6 total) include the upper and lower bound lines and the minimum required prestressing force for each group of tendons for each of the containments per RG 1.35.1.

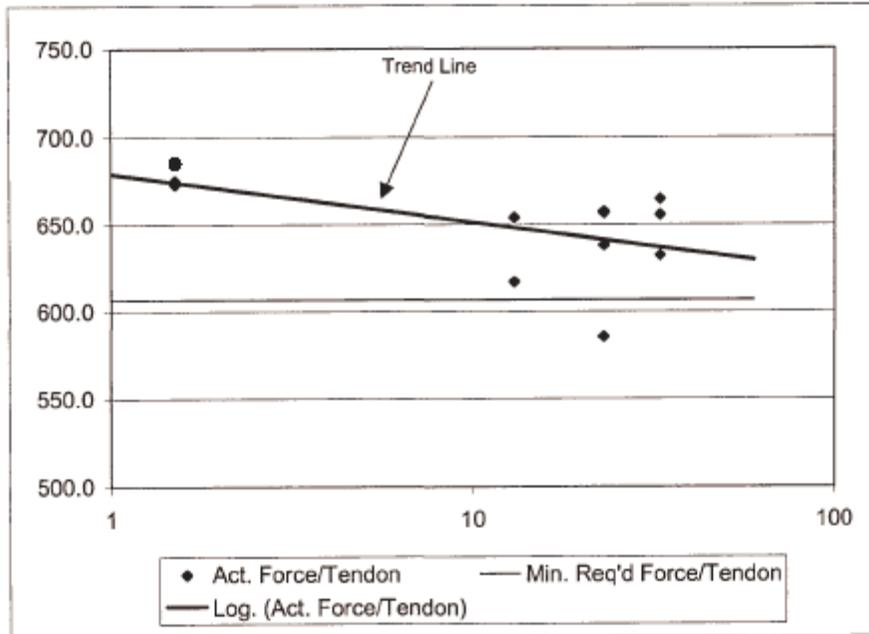
**UNIT 1 DOME TENDONS**  
**Actual Force Trend**

Year	Actual	Year	Actual
1.5	675.0	23	656.5
1.5	673.0	33	655.5
1.5	685.5	33	632.0
13	653.8	33	664.4
13	616.9		
23	637.85		
23	657.15		
23	585.3

Also included are the prestressing plots with the trend lines of the projected prestressing forces for each group of tendons out to 60 years. The trend lines were developed using linear regression analysis and all of the individual lift-off force data from all of the tendon surveillances to date. This technique/guidance was provided by the NRC in a teleconference on July 13, 2004 with Hansraj G. Ashar. Note that this trend line information is based upon a draft calculation. If the final approved calculation comes to a different conclusion, NMC will provide that information.

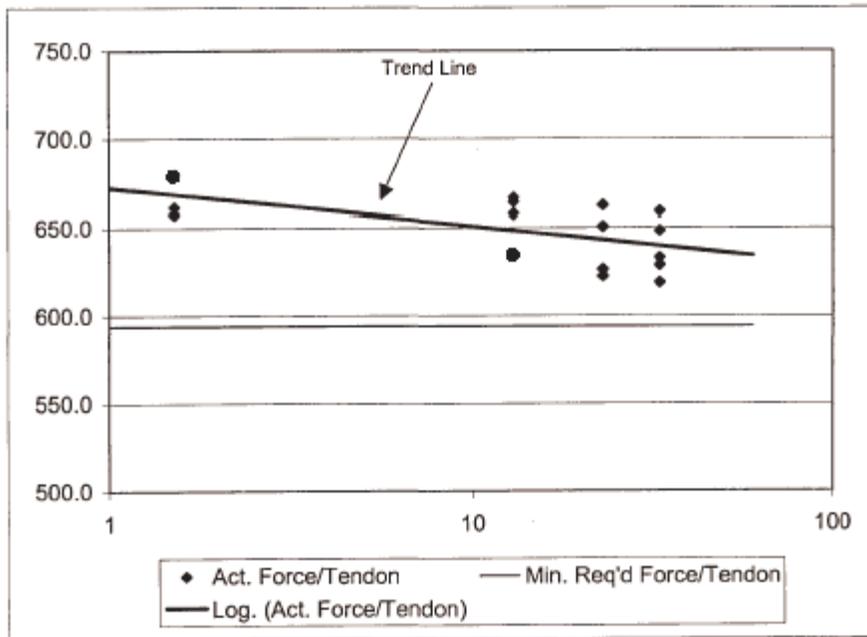
**UNIT 1 HOOP TENDONS  
Actual Force Trend**

Year	Actual	Year	Actual
1.5	657.5	23	662.0
1.5	661.0	23	650.5
1.5	679.5	23	622.45
13	634.5	33	648.2
13	666.5	33	618.9
13	664.0	33	658.7
13	657.5	33	633.0
23	626.35	33	628.8

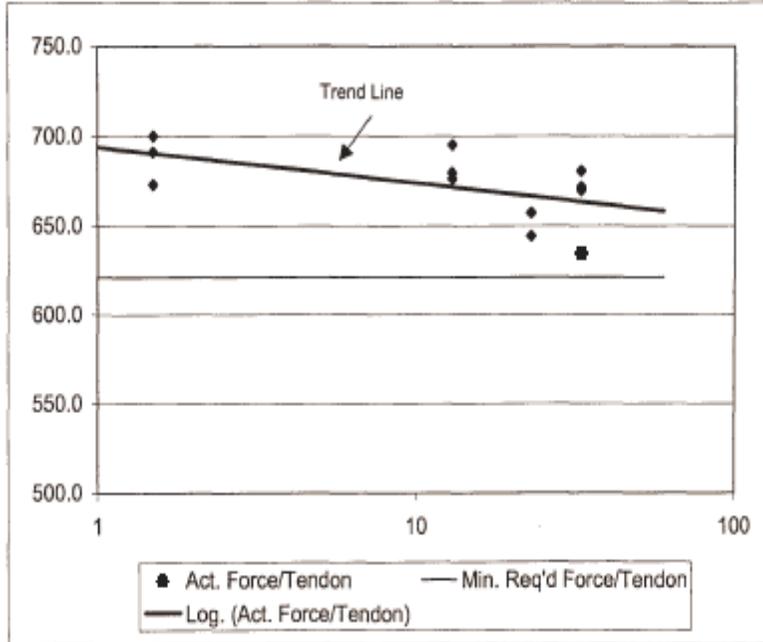
UNIT 1 VERTICAL TENDONS  
Actual Force Trend

Year	Actual	Year	Actual
1.5	691.0	23	644.0
1.5	700.0	33	680.3
1.5	673.0	33	669.6
13	679.3	33	671.5
13	695.0	33	634.6
13	676.0		
23	657.1

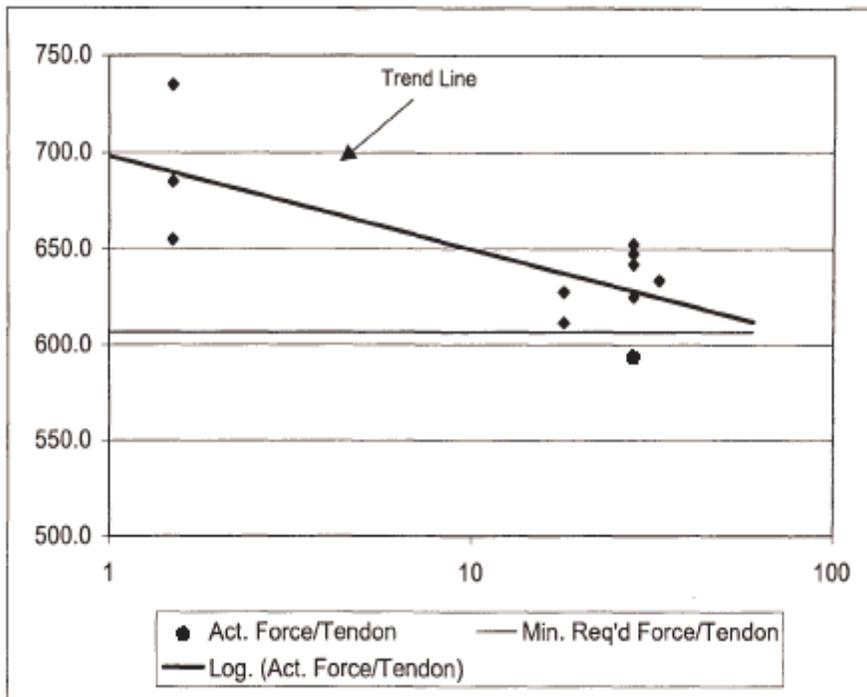
**UNIT 2 DOME TENDONS**  
**Actual Force Trend**

Year	Actual	Year	Actual
1.5	685.0	28	594.0
1.5	735.0	28	642.0
1.5	655.0	28	652.5
18	627.5	33	633.6
18	611.5		
28	625.0		
28	647.5

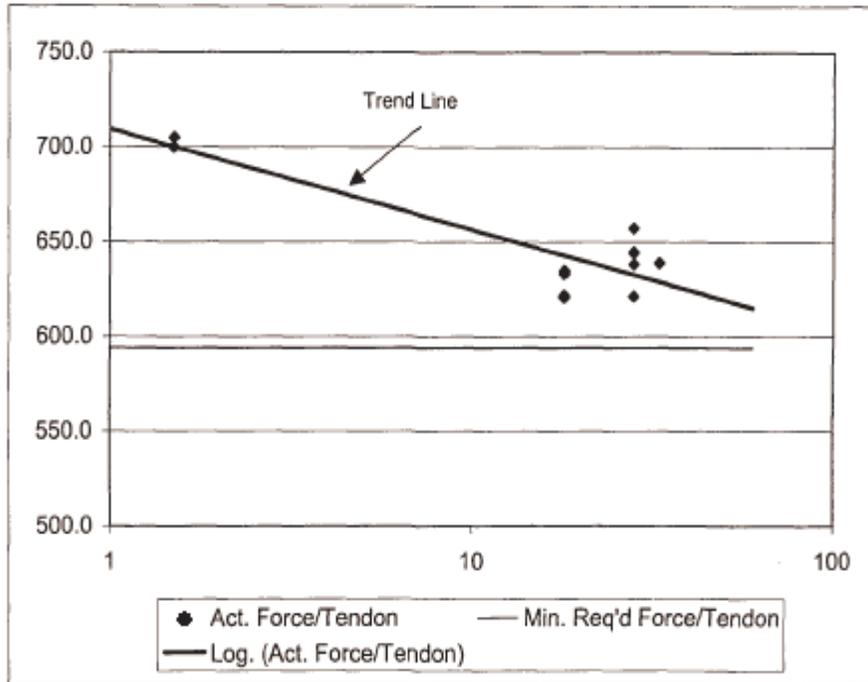
**UNIT 2 HOOP TENDONS**  
**Actual Force Trend**

Year	Actual	Year	Actual
1.5	700.0	28	621.0
1.5	705.0	28	638.0
1.5	705.0	28	644.0
18	634.5	28	644.5
18	620.5	28	657.0
18	621.5	33	638.7
18	633.0

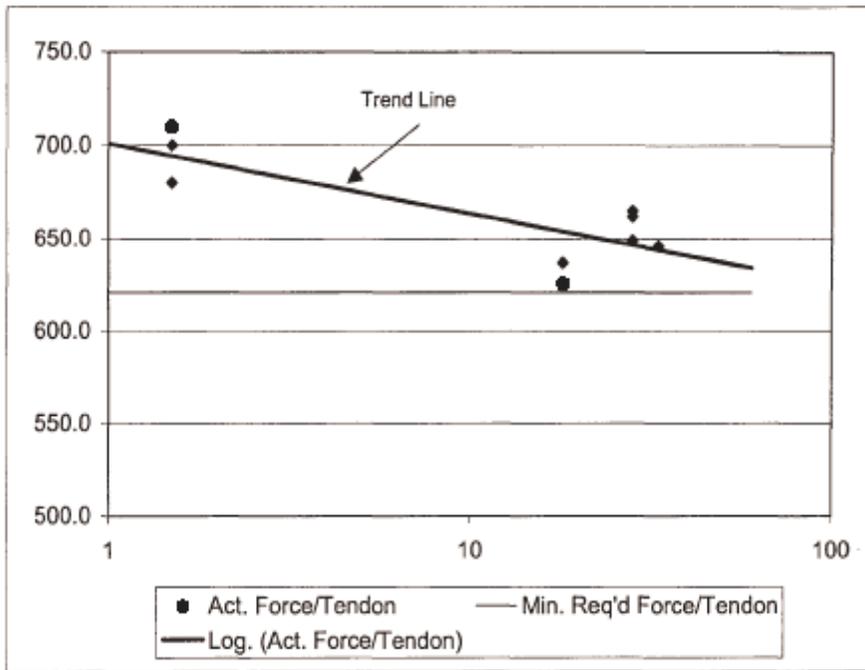
**UNIT 2 VERTICAL TENDONS**  
**Actual Force Trend**

Year	Actual	Year	Actual
1.5	710.0	28	649.0
1.5	680.0	33	646.0
1.5	700.0		
18	637.0		
18	626.0		
28	662.0		
28	665.0
