SUBJECT: Information abstracted from NRC Inspection Reports for the Dresden Generation Station, Units 2 and 3, involving the unanticipated release of tritium and/or radioactive contaminants from the Dresden, Braidwood, and LaSalle Stations since 1990.

Braidwood Nuclear Station Discharge Pipe Vacuum Breaker Leak Dose Assessment

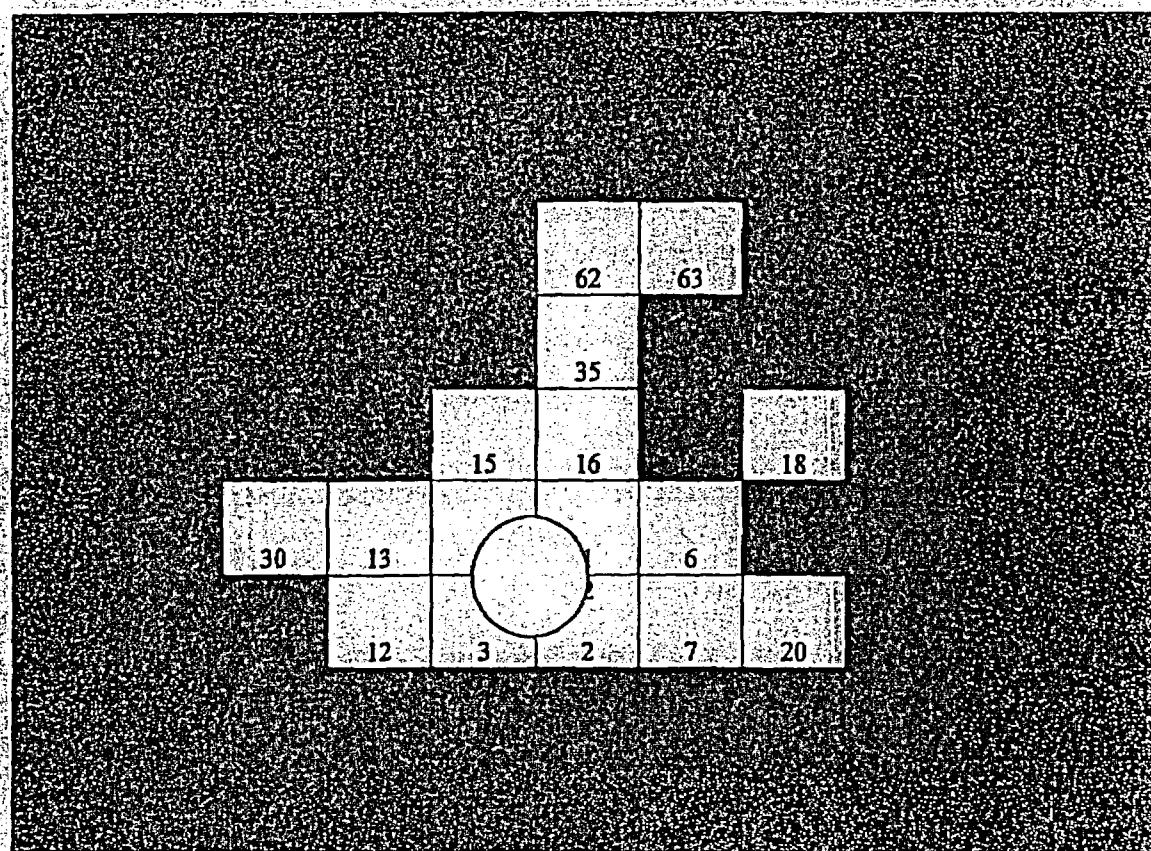
SAMPLING GRID

NORTH

Table 1
Soil Sampling Isotopic Results

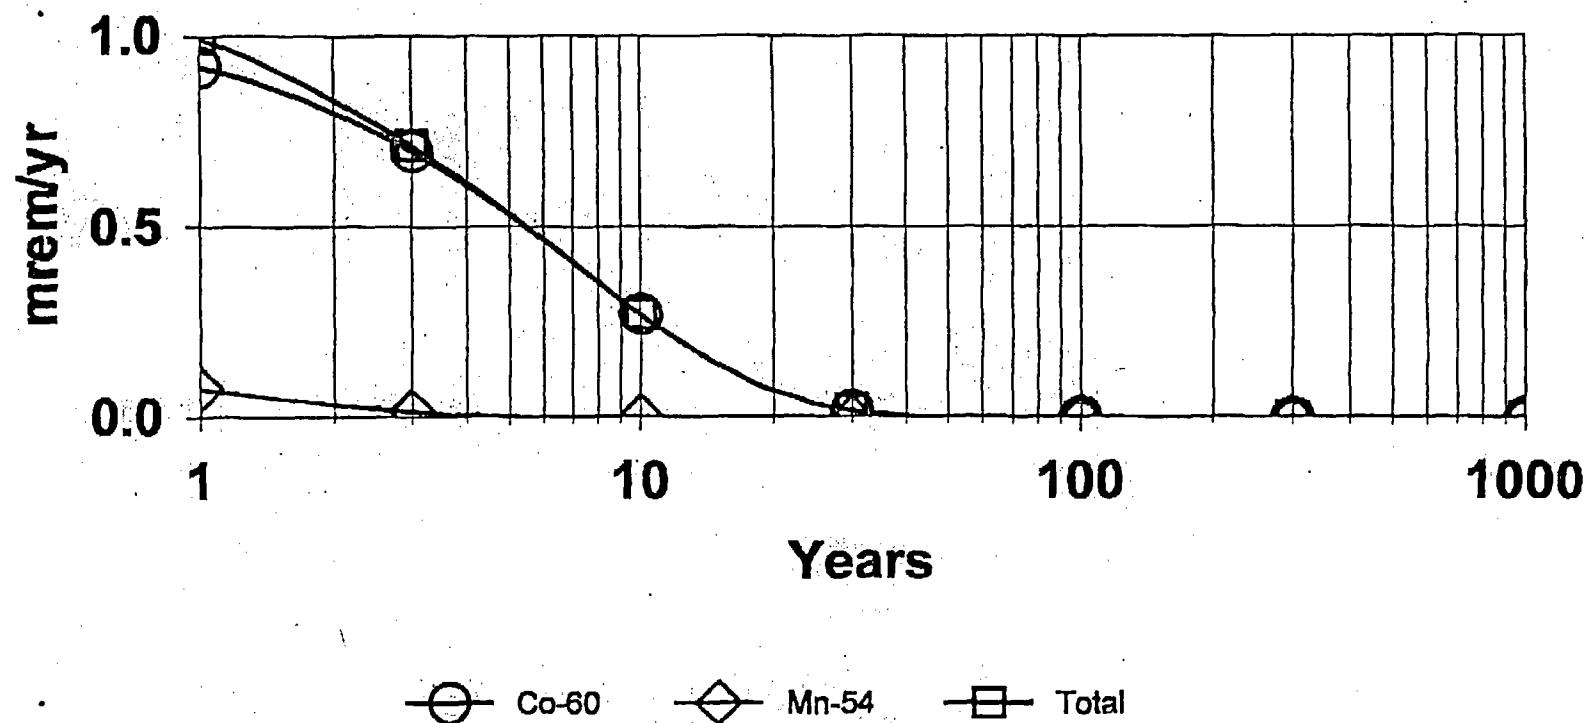
Time Dependent Dose Due to Co-60 and Mn-54

DOSE: All Nuclides Summed, All Pathways Summed

BRAID1.RAD 02/20/2001 14:03 Includes All Pathways

The output of the RESRAD computer code dose calculations are provided as Appendix 1 and are summarized in Table 4. Table 4 presents the dose from each isotope for the average activity and for the bounding condition using the maximum activity measured for each nuclide. The best estimate, based on the average values of Co-60 and Mn-54 result in a maximum dose in the first year of 1.225 mrem. Additional dose in the first year, due to the short lived nuclides, based on their average concentration and dose factor as related to Co-60 are: Co-58, 0.121 mrem, and Te-123m, 0.030 mrem. The total dose during the critical first year is 1.376 mrem. 98.6% of that dose is due to direct radiation from the radioactivity in the soil to the receptor on the surface. Due to the short half lives of all isotopes identified, the dose in subsequent years is a fraction of the first year dose, and is due almost entirely to Co-60. The dose due to Co-60 and Mn-54 during the second year is 0.995 mrem. Contribution from Co-58 and Te-123m are less than 1% during the second year due to their short half-lives. Dose during subsequent years will decrease consistent with the half-life of Co-60. The subsequent year dose values are provided in Appendix A, page 8 of the RESRAD output report. Note that the dose value designated means the integrated dose in the year following the year designated. Figure 2 provides a graph of the dose due to Co-60 and Mn-54 as a function of time. Note that Figure 2 is the standard RESRAD graphic output and does not include the initial year dose estimate. The dose due to Co-58 and Te-123m following the first year is less than 0.01 mrem for each isotope, and essentially zero following the second year.
