**Millstone Power Station
Operational Focus Report
Monday, April 18, 2005**

MILLSTONE NUCLEAR STATUS REPORT FOR 04/18/05

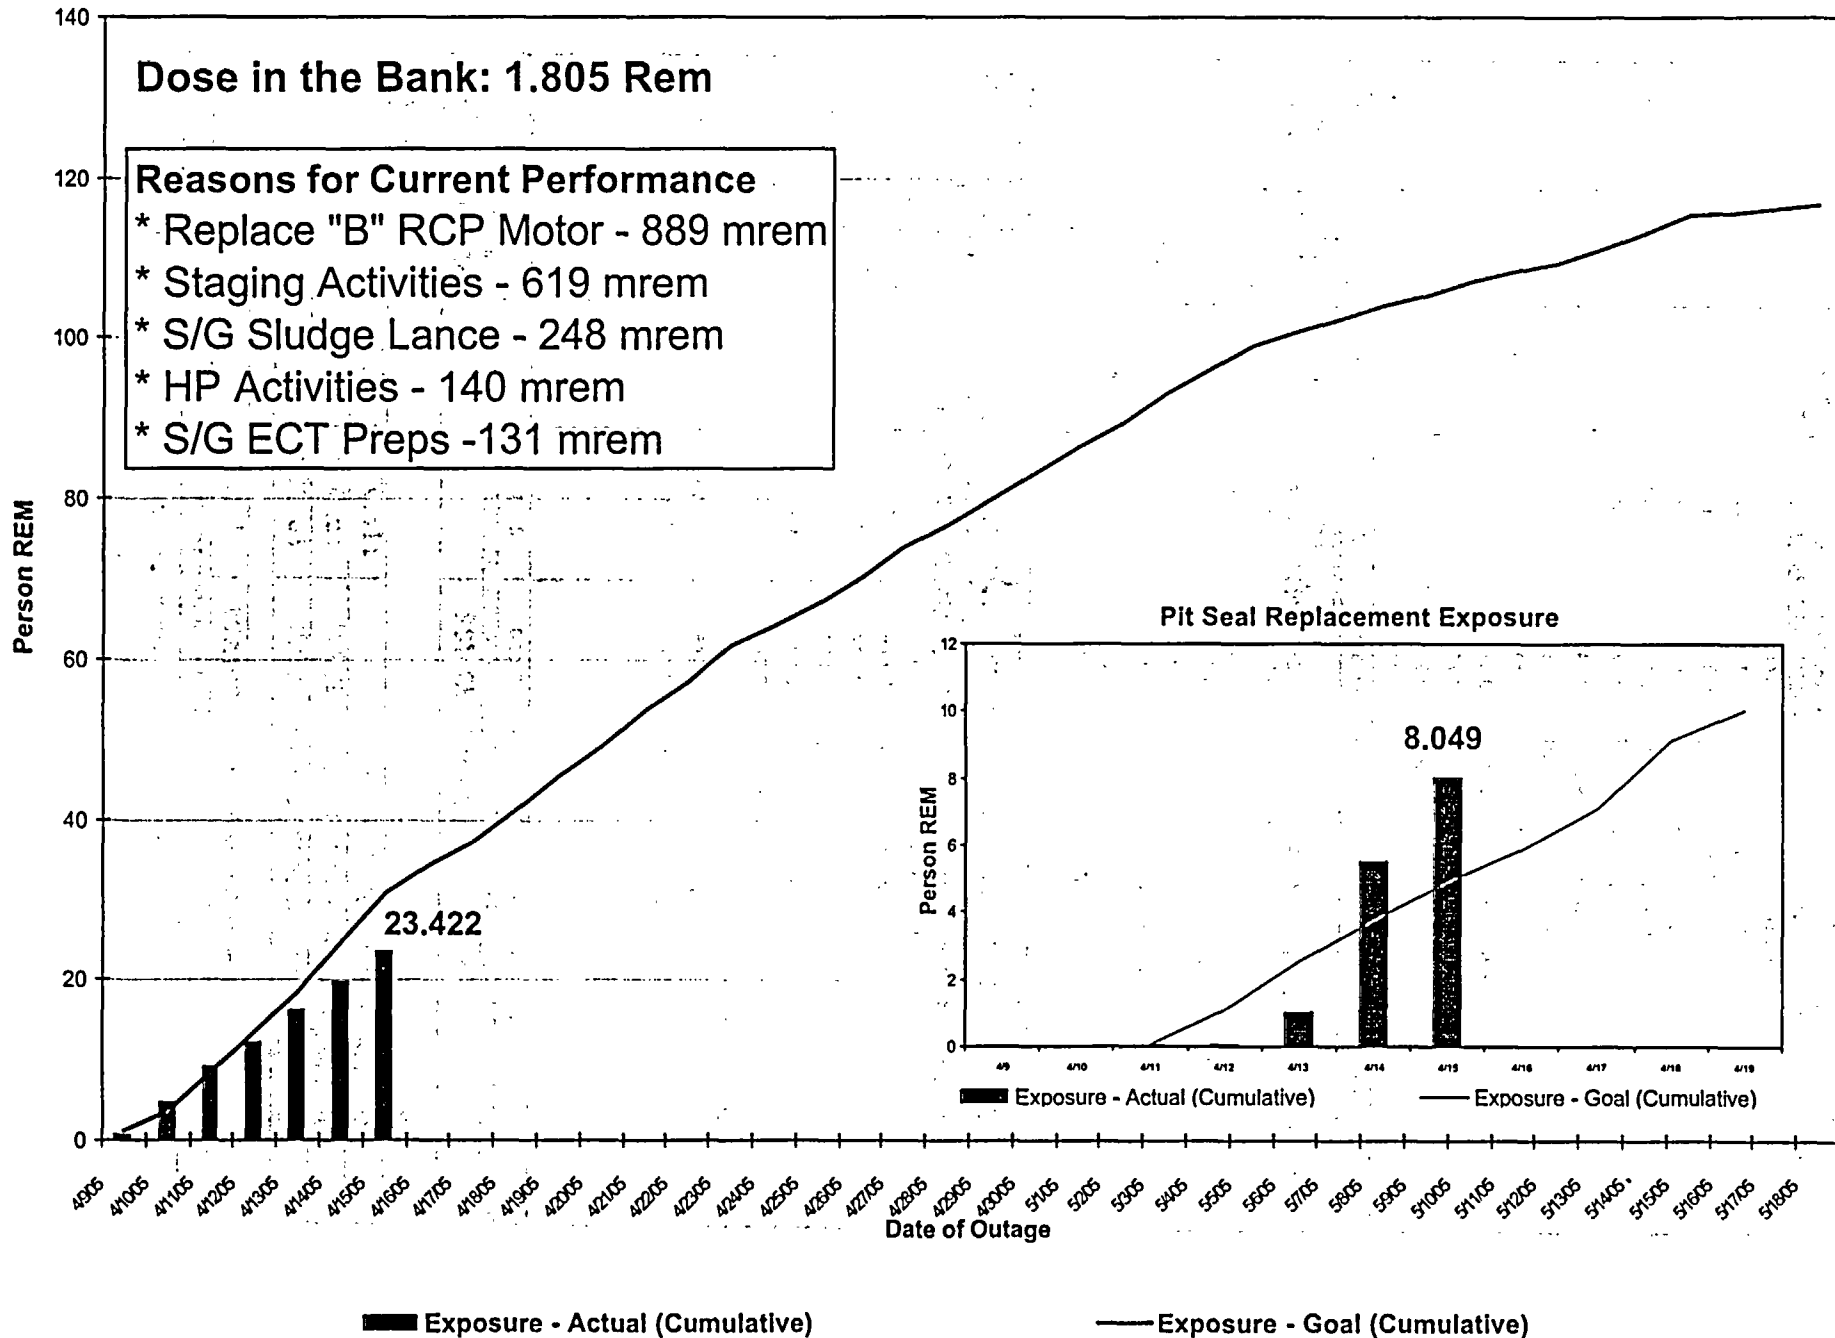
2R16 Exposure vs Goal

**2R16 Daily Exposure Report
143.575 REM**

Total (YTD) Exposure for Units 2 & 3 :	39.248	REM
NBU 2nd Quarter Goal for Millstone Station:	124.000	REM
	32%
