Hemyc (1-Hour) Electrical Raceway Fire Barrier Systems Performance Testing

Conduit and Junction Box Raceways

Project No. 14790-123263

FINAL REPORT

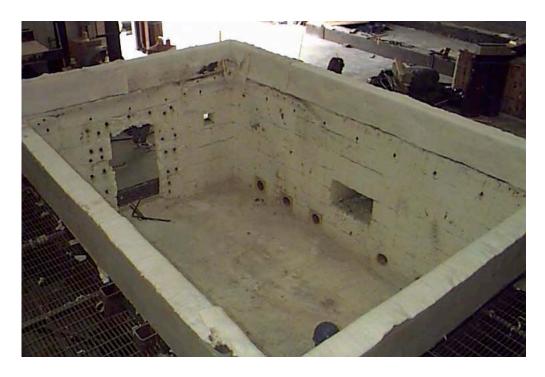
12' x 18' Horizontal Furnace (Overhead View)

The 12' x 18' x 7' deep horizontal test furnace used in these evaluations was designed to allow the specimen to be uniformly exposed to the specified time-temperature conditions. It is fitted with 12 symmetrically-located premixed air/propane gas burners designed to allow an even heat flux distribution across the exposed surface of a horizontal test specimen. Furnace pressures may be maintained at any value from +0.03" W.C. to -0.05" W.C. The furnace consists of a structural steel frame, lined with sheet metal and insulated with a six inch thick layer of ceramic fiber.

The temperature within the furnace is determined to be the mathematical average of thermocouples located symmetrically within the furnace with half positioned twelve inches below the bottom surface of the test deck and the other half located 12" below the bottom of the test specimens. In this manner, an average exposure on the entire assembly can be determined by averaging the readings in real time and adjusting the average temperature to follow the standard time-temperature curve. The materials used in the construction of these thermocouples are those suggested in the E119 test standard. During the performance of a fire exposure test, the furnace temperatures are monitored at least every 15 seconds and displayed for the furnace operator to allow control along the specified time-temperature curve. All data is saved to hard disk at intervals of once per minute unless more often is requested.

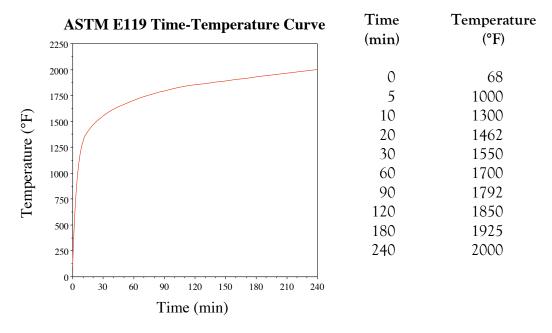
Figure 1 E119 Temperature Exposure

The fire exposure is controlled to conform with the standard time-temperature curve shown in Figure 1, as determined by the tables below:

The furnace interior temperature during a test is controlled such that the area under the time-temperature curve is within 10% of the corresponding area under the standard time-temperature curve for 1 hour or less tests, 7.5% for those less than 2 hours and 5% for those tests of 2 hours or more duration.
