Safety Evaluation Report

Related to the License Renewal of the Millstone Power Station, Units 2 and 3

Docket Nos. 50-336 and 50-423

Dominion Nuclear Connecticut, Inc.

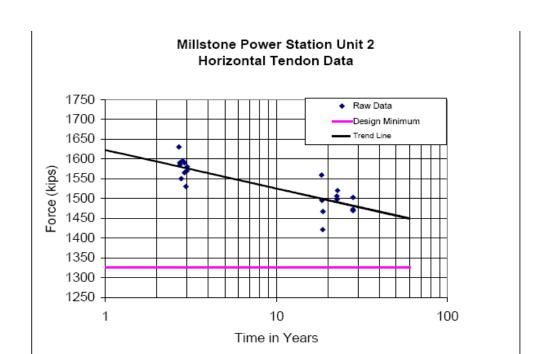
In its January 11, 2005 response, the applicant removed the tables provided in the LRA, and substituted new tables showing measured prestressing forces during tendon inspections for each group of tendons. In response to the staff's follow-up question as to why 3-, 5-, and 10-year data are missing from the tables, the applicant stated that as these tendons went through repeated tensioning and detensioning, the data were not reliable. The measurements taken during the 1-, 15-, 20-, and 25-year inspections were used for developing the trend lines. In Figures 1, 2, and 3 of the revised response (dated January, 11 2005), the applicant provided the trend lines and the measured tendon force data. Figure A, showing the trend line related to horizontal tendons, is reproduced below:

Figure A: Trend Line Relationship with Horizontal Tendons

In RAI 4.5-5, the staff noted that the process used by license renewal applicants with respect to prestressed concrete containments is to assume that the tendon force varies with the logarithm of time (as discussed in RG 1.35.1). The staff indicated that it was not apparent in Figure 4.5-1 what functional relationship had been assumed between the two variables. The applicant was requested to provide additional information regarding the process used in arriving at the trending curves shown in Figure 4.5-1.

In its response, in a letter dated January 11, 2005, the applicant confirmed that it is using procedures for monitoring and trending prestressing force consistent with the recommendations in RG 1.35.1 and NRC Information Notice 99-10. Therefore, the staff finds the process acceptable, as the use of RG 1.35.1 for estimating the target prestressing forces, and Information Notice 99-10 for projecting the actual measured prestressing forces (as illustrated in the figure above), provides the elements needed for an adequate TLAA.
