L-PI-05-074

Prairie Island Nuclear Generating Plant Units 1 and 2
Dockets 50-282 and 50-306
License Nos. DPR-42 and DPR-60

Response to Request for Additional Information Regarding the "Unit 1 Inservice Inspection Summary Report, Interval 3, Period 3, Refueling Outage Dates: 9-10-2004 to 11-23-2004 Fuel Cycle 22: 12-7-2002 to 11-23-2004"

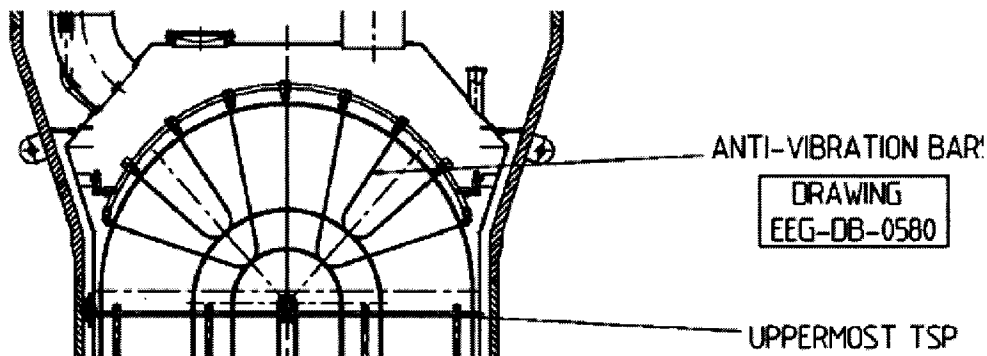
- (a) *The bent portion of the tube bundle is supported by 5 sets (4 V-shaped and one straight) of anti-vibration bars (AVBs), all U-bends (Row 1 included) being supported.*

The AVB assembly is composed of:

Four sets of V-shaped AVBs with the ends of AVBs of each set being linked together by clamps that maintain spacing of AVBs and restrict U-bend out-of-plane motion. The clamped sets of AVB ends are fastened to hoops that maintain in-plane configuration and prevent lift off of AVB system under transient and accident conditions. The V-shaped AVBs penetrate to Rows 27 and 15,

One set of straight AVBs with their upper ends linked together (U-bend out-of-plane) and fitting into slots machined in the uppermost tube support plate (TSP) providing a sliding connection for their lower ends. The straight AVBs provide support for all U-bends in the center of the U-bend.

The rectangular cross-section of the AVBs is approximately 0.5" X 0.3".

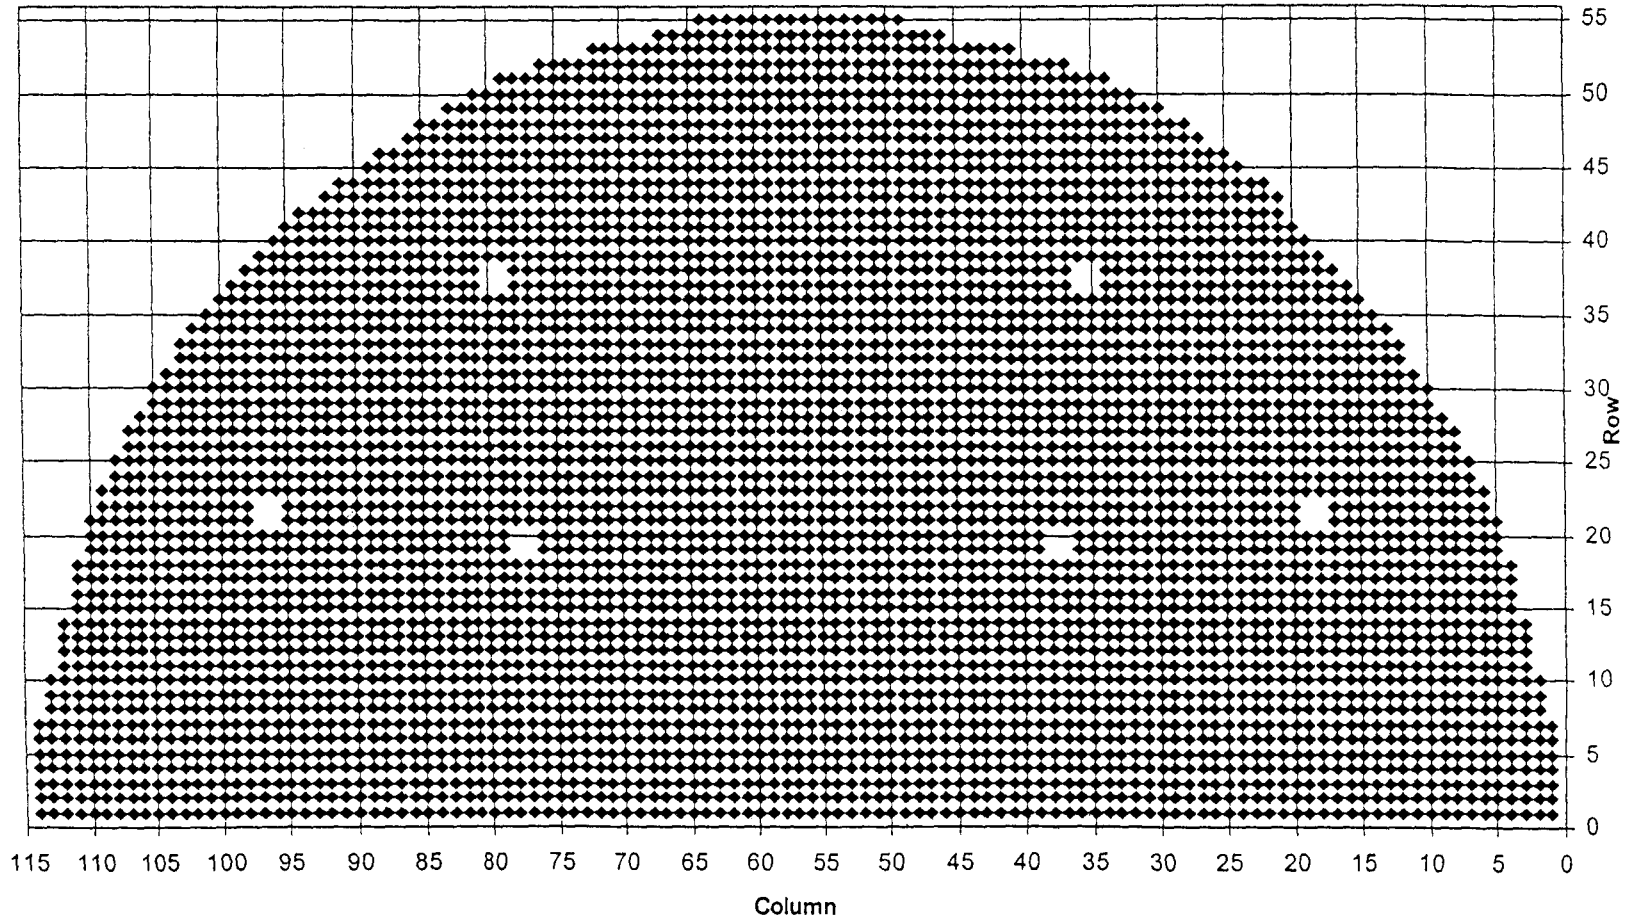
Figure 1: Tubesheet Map

PINGP U1 Model 56/19 Replacement Steam Generator
Cold Leg Tubesheet Map (COL 1 on Manway Side)

- (b) *There were 0 (zero) tubes plugged prior to and during the installation of the replacement steam generators.*
- (c) *The tubesheet minimum thickness without the clad is 21.46 inches. The clad has a minimum of 0.375 inch thickness.*
- (d) *See Figure 1 for the tubesheet map. The 6 no-tube areas are the locations of the tube support plate tie-rods (12 total).*
- (e) *See Figure 2 for the sketch of the steam generator showing the tube support plates. The eight stainless steel tube support plates are designated by number and letter (for cold or hot leg side) from the tubesheet upward.*

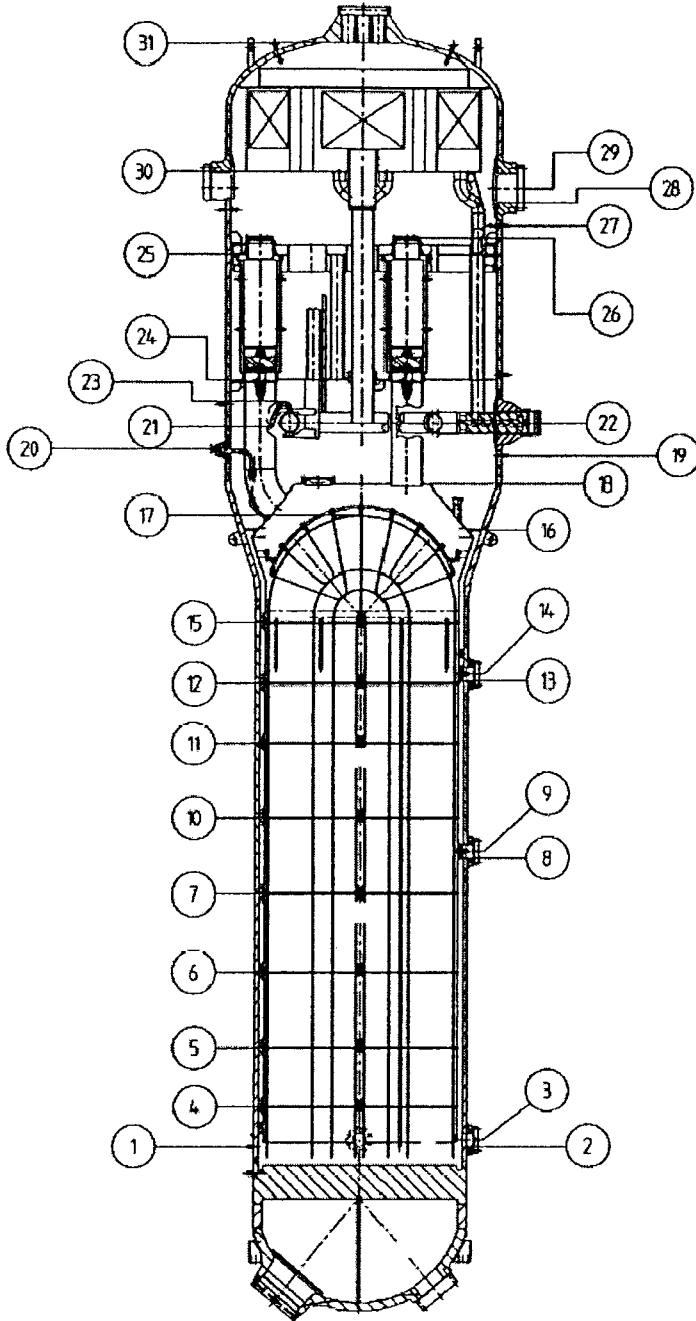
Figure 2: Framatome ANP Model 56/19 Replacement Steam Generator

ITEM	DESIGNATION
	Steam outlet flow venturis
31	Bottom of steam outlet nozzle
30	Bottom of dryer block
29	Secondary manway CL
28	Bottom of secondary manway (ID)
27	Upper NR and WR level tap CL
26	Top of cyclones (Foreign object catcher CL)
25	Upper deck plate (Top)
24	Lower deck plate (Bottom)
23	Top of J-nozzles (Apex)
22	Feedwater nozzle CL
21	Bottom of J-nozzles (outlet)
20	Recirculation nozzle CL
19	Lower NR level tap CL
18	Top of wrapper roof
17	Top of tube bundle (Apex)
16	Foreign object catcher CL
15	TSP 8 CL
14	Hand hole CL
13	Bottom of hand hole (ID)
12	TSP 7 CL
11	TSP 6 CL
10	TSP 5 CL
9	Hand hole CL
8	Bottom of hand hole (ID)
7	TSP 4 CL
6	TSP 3 CL
5	TSP 2 CL
4	TSP 1 CL
3	Hand hole CL
2	Bottom of hand hole (ID)
1	Lower WR level tap CL

<i>Eddy Current Testing Landmark Designation</i>
<i>08H/08C</i>
<i>07H/07C</i>
<i>06H/06C</i>
<i>05H/05C</i>
<i>04H/04C</i>
<i>03H/03C</i>
<i>02H/02C</i>
<i>01H/01C</i>
<i>Top of Tubesheet (TSH/TSC)</i>
<i>Tube End (TEH/TEC)</i>
