RE: Permit to Mine No. 633
In Situ Uranium Wellfield Release Report

Power Resources, Inc Smith Ranch-Highland Uranium Project URANIUM IN SITU WELLFIELD FLUID RELEASE REPORT

18-INCH FLANGE LEAK AT MANHOLE IN MINE UNIT-15

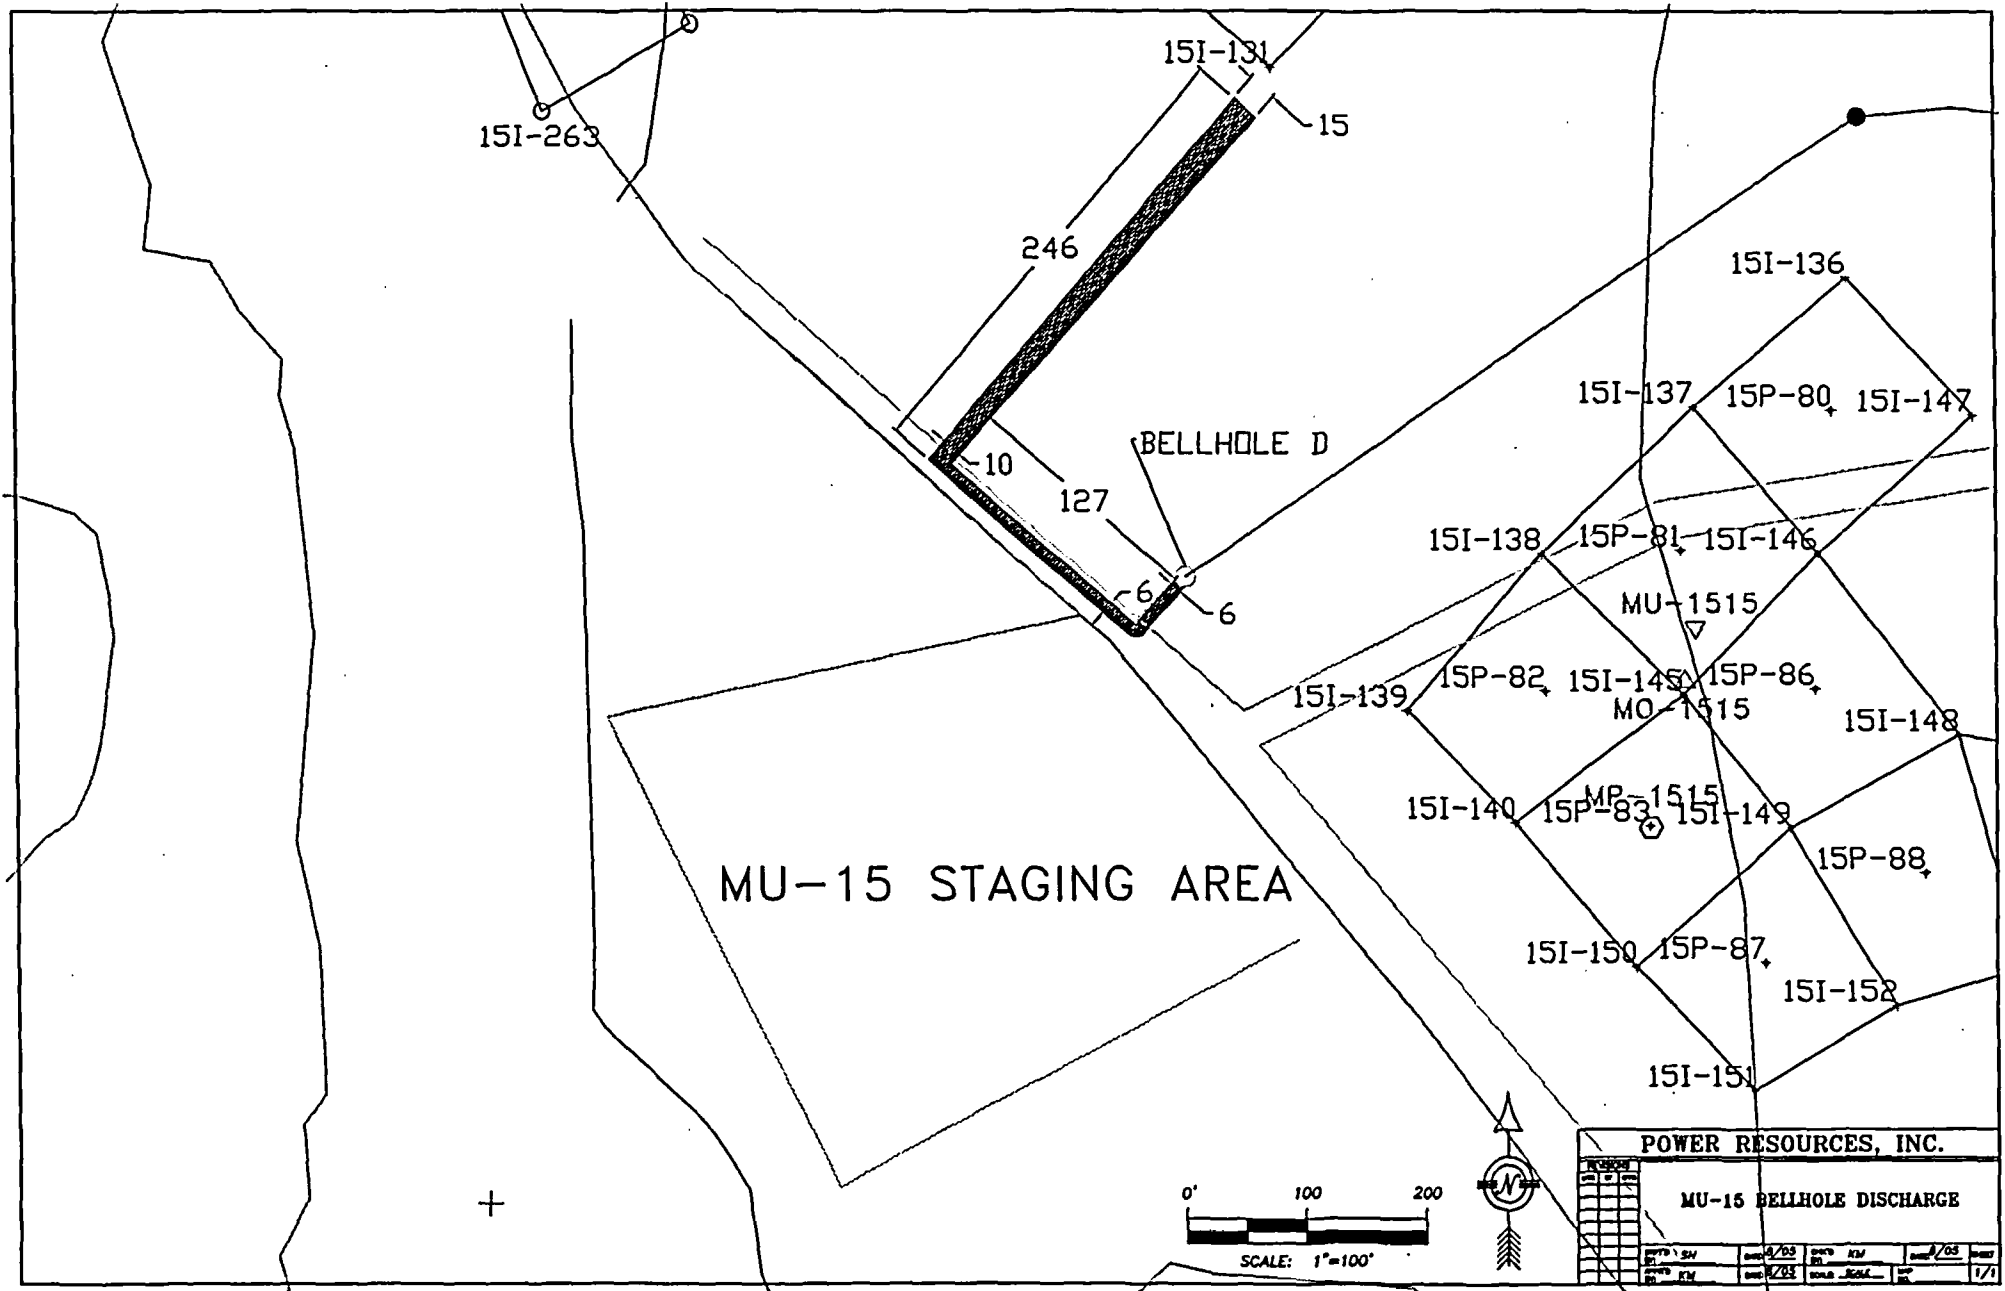
The release occurred when the flange between the 18-inch steel tee and the 18-inch poly trunk line began leaking.

The flange was pulled apart and the steel fitting face was buffed. The flange was then reattached and tightened, and the line was pressure tested prior to being placed back into service.

On August 16, 2005 at approximately 12:30 p.m., personnel discovered a Production Fluid leak from a manhole in Mine Unit-15 near the staging area. The release occurred from a leaking flange between the 18-inch steel tee and the 18-inch poly trunk line. The line was immediately shut down and repairs were completed.
