Regulatory Effectiveness Assessment of Generic Issue 43 and Generic Letter 88-14

U.S. Nuclear Regulatory Commission
Office of Nuclear Regulatory Research
Washington, DC 20555-0001

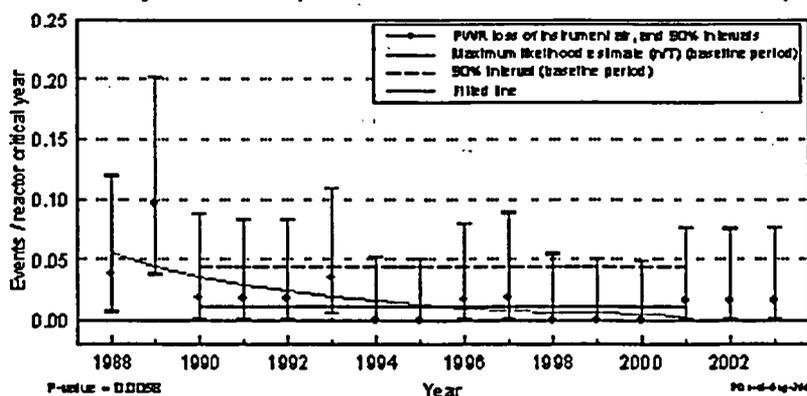
Figure 1. Frequency of PWR initiating events with loss of instrument air

In 2004, Idaho National Engineering and Environment Laboratory (INEEL) analyzed the initiating event frequencies at U.S. nuclear power plants (Ref. 8). As show in Figures 1 and 2, the historical frequency of initiating events with loss of instrument air has decreased for both boiling-water reactors (BWRs) and pressurized-water reactors (PWRs). INEEL concluded that the long-term trend is likely to represent more than mere random variation. Both BWRs and PWRs showed low baseline initiating event frequencies for loss of instrument air, with mean frequencies of 0.0083 and 0.0115 per reactor critical year for BWRs and PWRs, respectively. These baseline initiating event frequencies are significantly lower than the "pre-baseline" frequencies (before 1994 for BWRs and before 1990 for PWRs); however, the INEEL analysis did not provide reasons for the observed frequency changes.

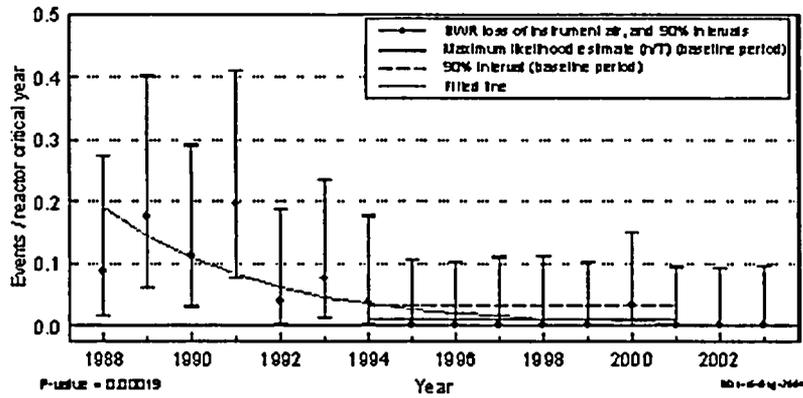
Figure 2. Frequency of BWR initiating events with loss of instrument air

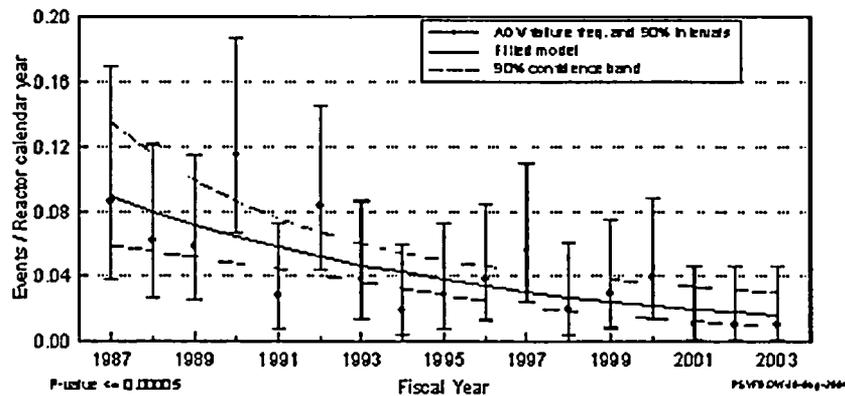
Figure 3. Frequency of failures (events per operating year), as a function of fiscal year

In 2004, INEEL also analyzed the component performance of air-operated valves (AOVs) at U.S. commercial reactors (Ref. 9). That analysis showed statistically significant improving trends for AOV performance in many areas, including overall failure frequency (Fig. 3), frequency of unplanned demands (Fig. 4), and probability of failure on demand (Fig. 5), each of which reduced by a factor of 3 or greater. The INEEL analysis did not provide reasons for the observed performance improvement.

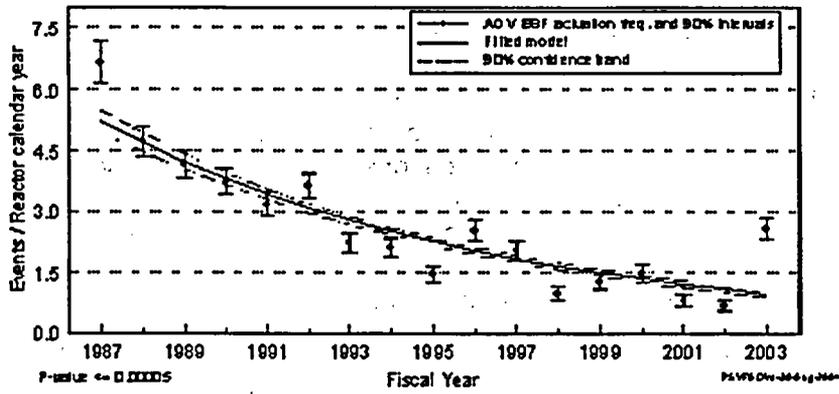
Figure 4. Frequency of unplanned demands (events per operating year), as a function of fiscal year

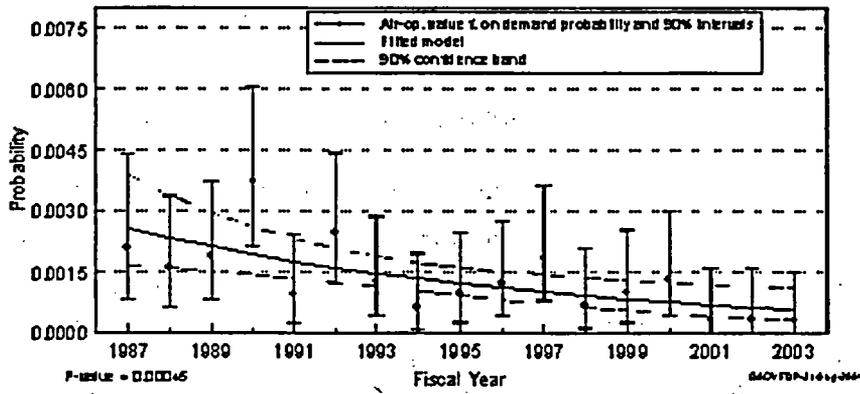
Figure 5. Probability of air-operated valve failures on demand
