Integrated Chemical Effects Test Project: Test #3 Data Report

Los Alamos National Laboratory

**U.S. Nuclear Regulatory Commission
Office of Nuclear Regulatory Research
Washington, DC 20555-0001**

Manuscript Completed: September 2005
Date Published: October 2005

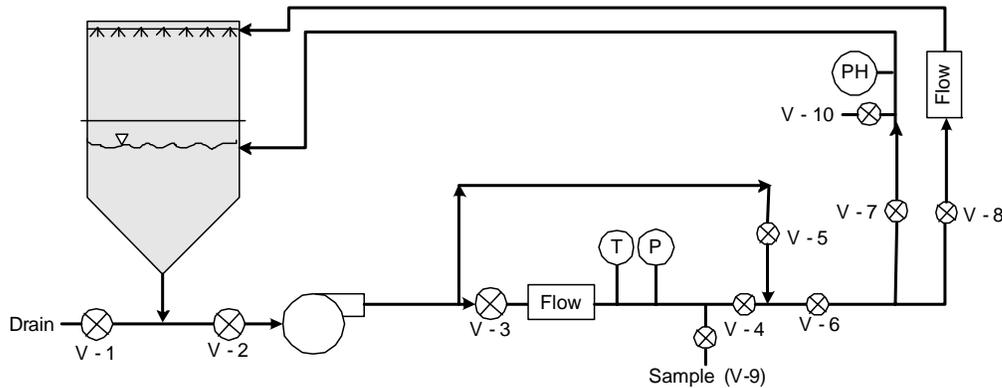
The as-built test loop consists of a test tank, a recirculation pump, 2 flow meters, 10 isolation valves, and pipes that connect the major components, as shown schematically in Figure 2-1. P, T, and pH represent pressure, temperature, and pH probes, respectively.

Figure 2-1. Test loop process flow diagram.

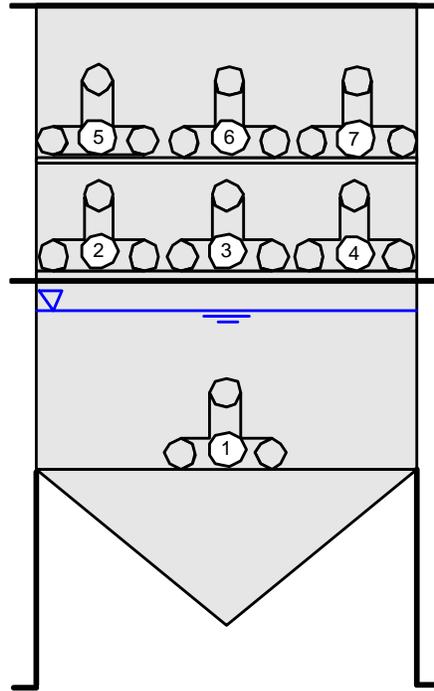
The arrangement of the coupon racks in the test tank is schematically illustrated in Figure 2-2. The figure shows a side view of the ICET tank, with the ends of the seven CPVC racks illustrated. The normal water level is shown with the blue line in the figure. Rack #1 is the only submerged rack, and it sits on angle iron. It is centered in the tank, so that flow from the two headers reaches it equally. Racks #2-#4 are positioned above the water line, supported by angle iron in the tank. Racks #5-#7 are positioned at a higher level, also supported by angle iron. Racks #2-#7 are exposed to spray. In the figure, north is to the right, and south is to the left. Directions are used only to identify such things as rack locations and sediment locations.

Figure 2-2. Coupon rack configuration in the ICET tank. The blue line represents the surface of the test solution.

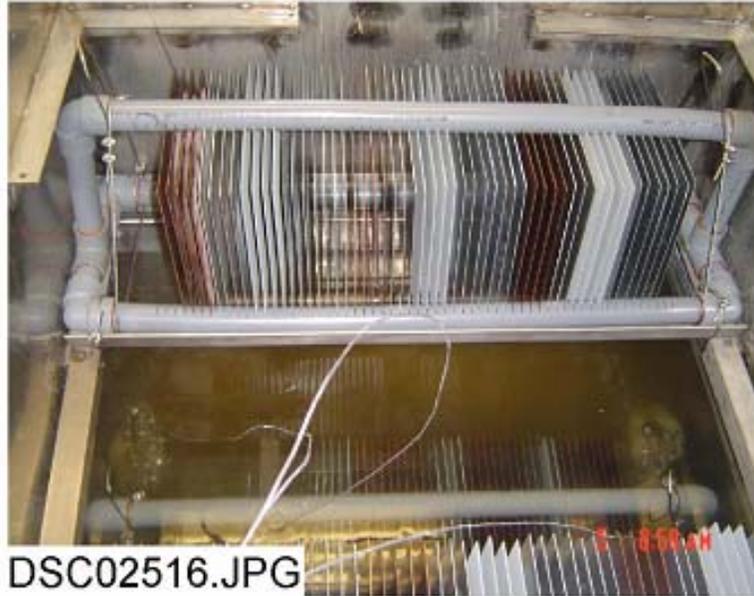
Figure 2-3 shows the configuration of an unsubmerged coupon rack loaded with metal coupons in the ICET tank. The loading pattern of the racks was nearly identical, varying by only one or two coupons. Shown in the figure from left to right, the coupons are arranged as follows: 4 Cu, 4 Al, 4 inorganic zinc (IOZ), 7 GS, 4 Cu, 3 Al, 4 IOZ, 7 GS, 4 Cu, 3 Al, 4 IOZ, and 7 GS.

Figure 2-3. A loaded coupon rack in the ICET tank.

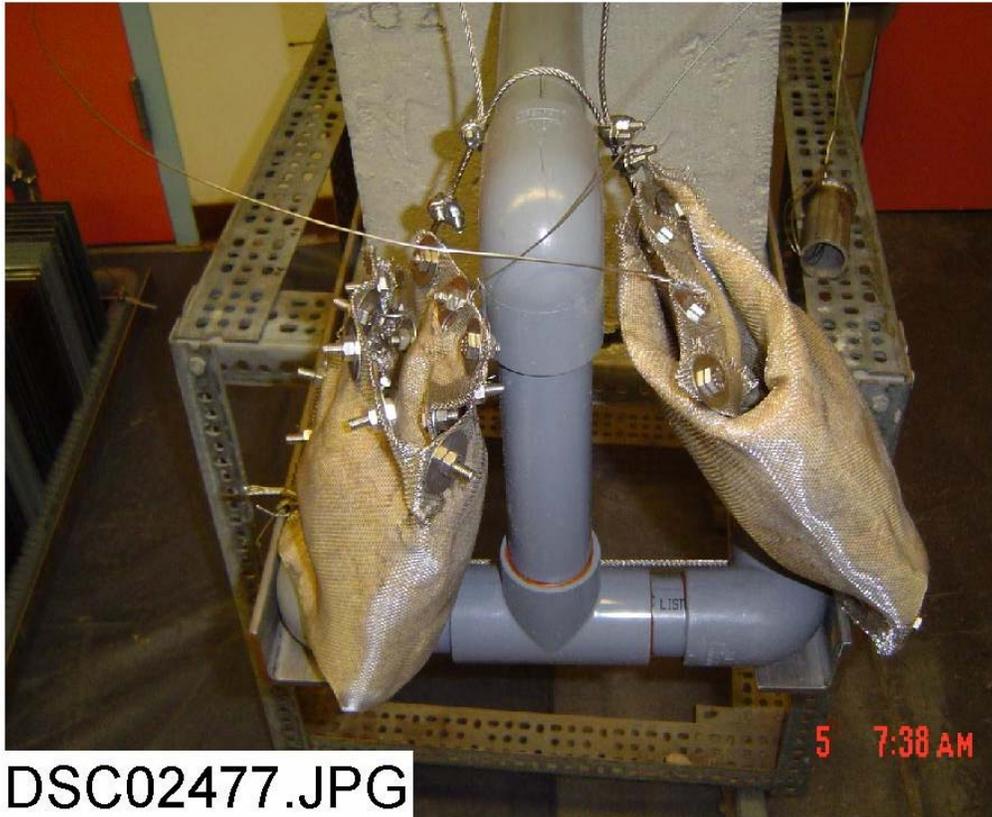
Several fiberglass samples were placed in the ICET tank. Samples were either submerged or held above the water level. The unsubmerged fiberglass samples were positioned so they would be exposed to sprays. The fiberglass samples were contained in SS wire mesh that allowed water flow while confining the fiberglass material. Both loosely-packed and more tightly-packed samples were used. In addition, some submerged fiberglass samples were located where they would be exposed to relatively high-flow conditions, and others were located in quiescent regions of the tank. Figure 2-4 shows the so-called “sacrificial” fiberglass samples in wire mesh pouches attached to the submerged coupon rack (rack 1 in Figure 2-2). Each pouch contains approximately 5 g of fiberglass. Those samples were attached with SS wire and removed from the tank on Days 4, 15, and 30, and examined. As shown in the figure, bigger insulation bags were wrapped around the sacrificial specimens during the test. See Subsection 2.4.1.1 for descriptions of other fiberglass samples.

Figure 2-4. Fiberglass samples attached to coupon rack.

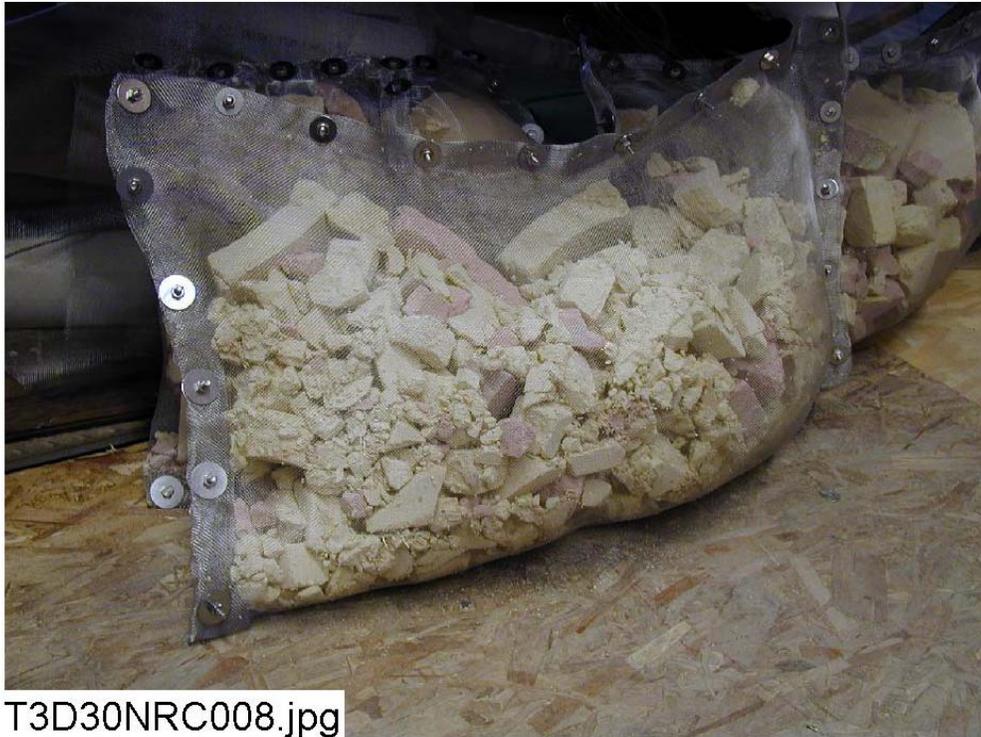
Several cal-sil insulation samples were also placed in the ICET tank. Samples were either submerged or held above the water level. The unsubmerged cal-sil samples were positioned so they would be exposed to sprays. As with the fiberglass samples, all of the cal-sil samples (except for the dust) were contained in SS wire mesh that allowed water flow while confining the cal-sil material. In addition to solid pieces of cal-sil, cal-sil dust (approximately 43.5 lb) was placed in the tank solution before the test began. Both types of samples are shown in Figures 2-5 and 2-6.

Table 2-5. Solid pieces of cal-sil samples in SS mesh.

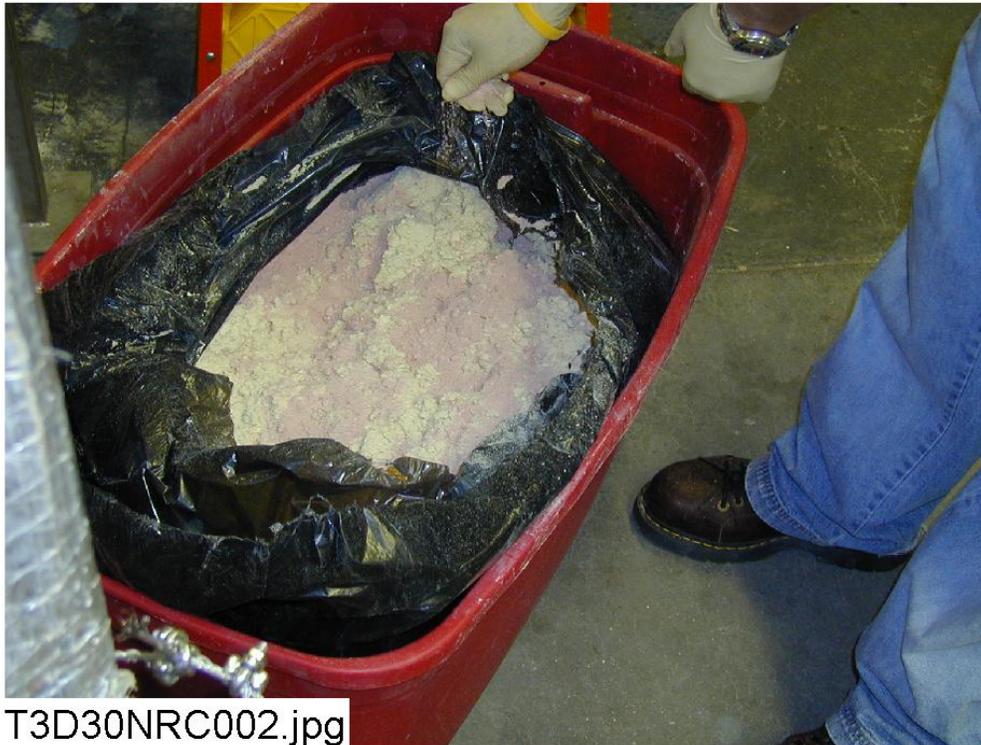
Figure 2-6. Cal-sil dust.

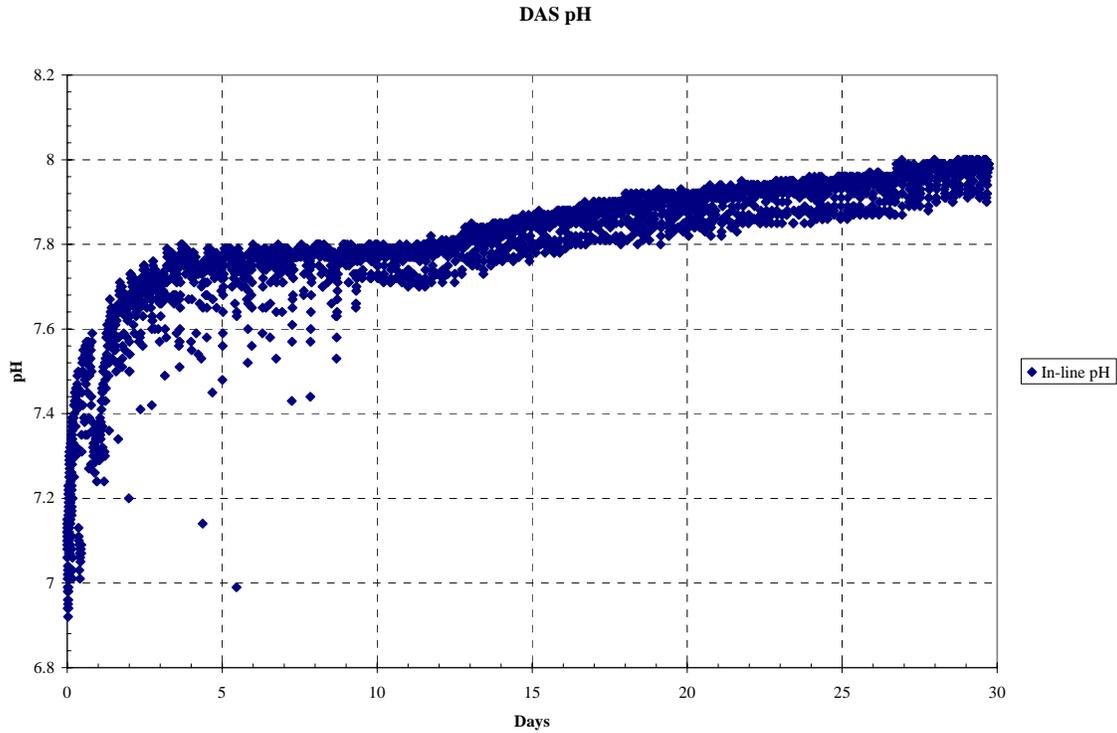
The in-line pH probe tracked the overall bench-top pH readings, but the results have noise and a slight offset. Due to the noise within the raw data, the bench-top pH readings are more reliable. Figure 3-1 shows results from the in-line pH probe.

Figure 3-1. In-line pH measurements.

Four hours into the test, the in-line pH measurement was 7.37, and at Day 30 the pH measurement was 7.92. Figure 3-2 presents the bench-top pH readings. Four hours into the test, the bench-top pH measurement was 7.32, and at Day 30 the pH measurement was 8.05.

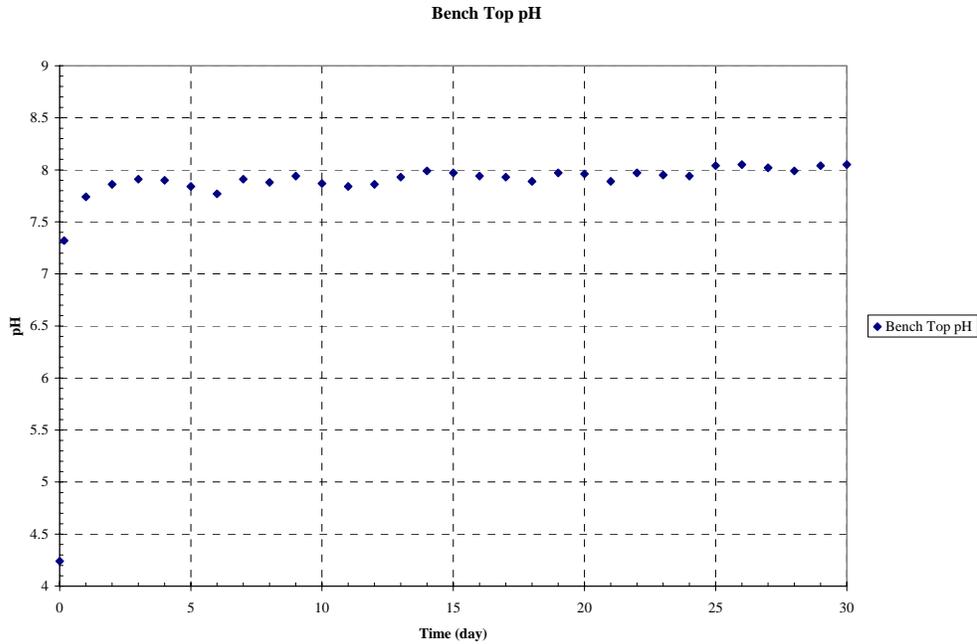
Figure 3-2. Bench-top pH meter results.

pH: Before time zero, 15.45 kg of boric acid and 0.663 g of LiOH were dissolved in the ICET tank. The measured bench-top pH was 4.24, which was similar to the expected value obtained from analytical predictions. Following the addition of the premixed TSP batches, the pH was 7.32. The pH then continued to rise through Day 3 of testing to 7.9. After Day 3, the pH varied in the range of 7.8–8.0.

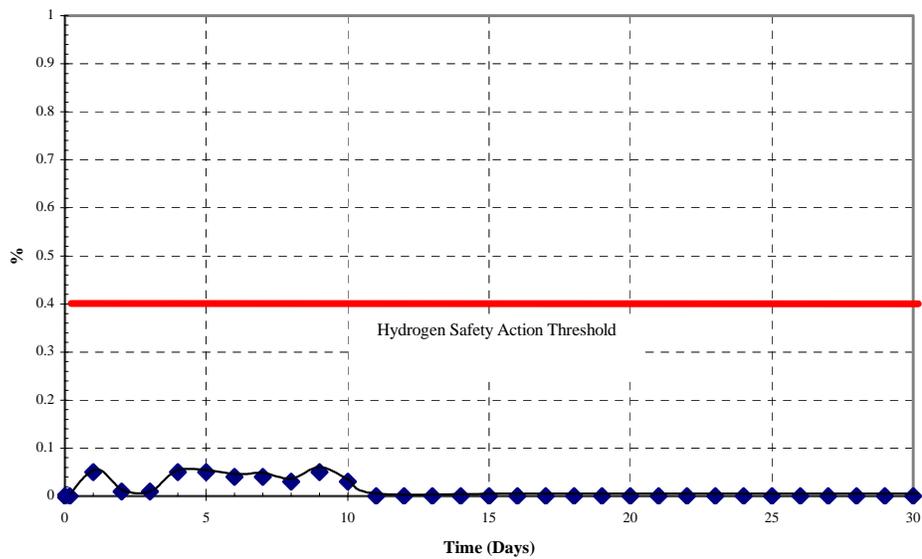
Hydrogen remained at or below 0.05% for Test #3. Figure 3-3 displays the evolution of hydrogen generation throughout the test. A general trend line has been superimposed upon the hydrogen generation data set. Each of the measured values is well below the hydrogen safety action threshold of 0.4%.

Figure 3-3. Hydrogen generation.

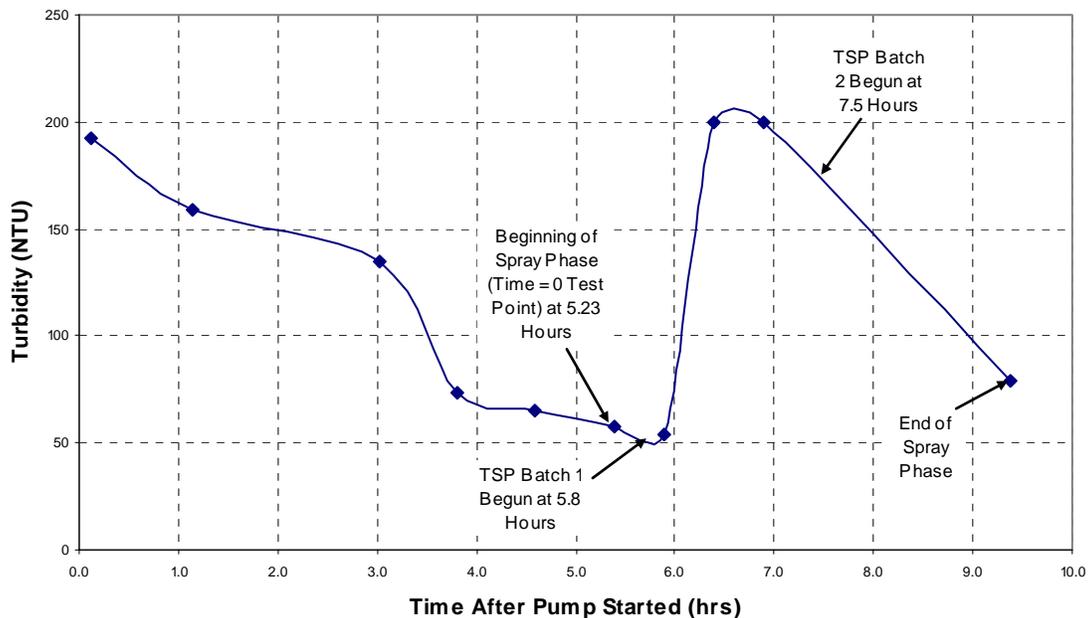
Due to the cloudy nature of the water in the tank after the circulation pump was turned on, additional turbidity values were measured at 60°C over a 9-hour time period, in addition to the regular daily monitoring. Figure 3-4 depicts the evolution of turbidity during that time period. The x-axis on the graph represents the time in hours after the circulation pump was turned on, following cal-sil addition and while the system was heating up. As can be seen, the turbidity gradually decreased from 192 NTU at the 7-minute point to 54 NTU at the 5.9-hour point. Note that the 5.23-hour point on the graph corresponds to the time-zero test point. The spray nozzles were activated at that time. At the 6.4-hour point, the turbidity peaked above 200 NTU. The turbidity decreased to 79 NTU by the end of the spray phase. (Note that the Batch 1 addition began at approximately 5.8 hours on Figure 3-4, and Batch 2 addition began at 7.5 hours.)

Figure 3-4. Day 1 turbidity results.

Turbidity: For the 23°C and 60°C water samples, the baseline turbidity values, which were taken after the latent debris and crushed concrete were added, were 7.3 NTU and 7.5 NTU, respectively. After the addition of cal-sil, the tank solution was observed to become much more turbid. Then with time, the turbidity decreased. Upon the addition of Batch 1 and Batch 2 chemicals, particulates were suspended in solution, and the solution was noticeably cloudier. Figure 3-4 presents the daily turbidity results.

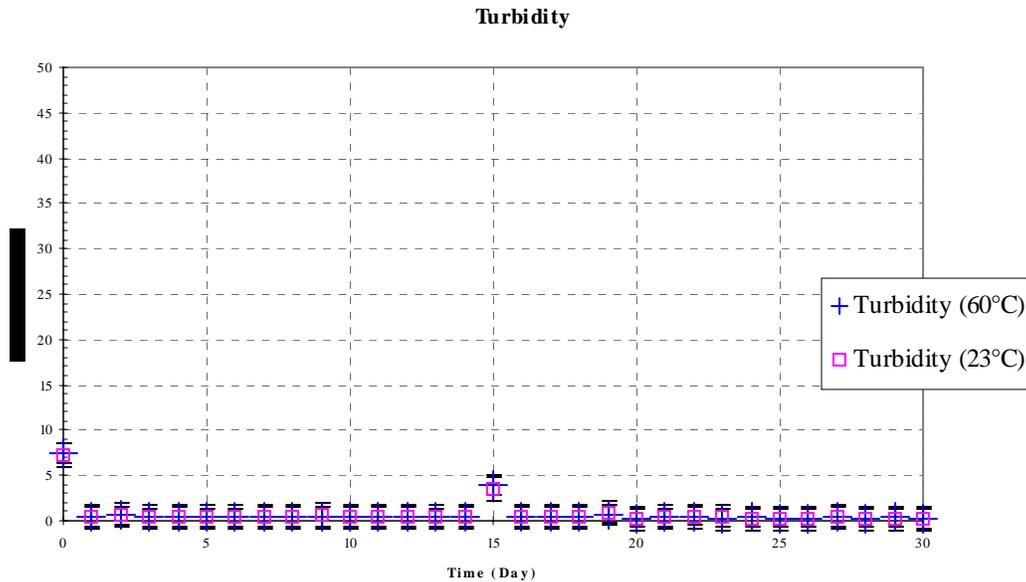
Figure 3-5 depicts the evolution of turbidity at 23°C and 60°C throughout Test #3. The trend of each curve exhibits an initial spike during the addition of Batch 1 chemicals,

followed by a sharp decline to the Day 1 test point and steady behavior from then on. The turbidity values on Day 15 were slightly higher, but no direct cause has been identified. The Day 15 values were 3.9 NTU and 3.5 NTU for the 60°C and 23°C samples, respectively. Thereafter, the turbidity values decreased and remained steady.

Figure 3-5. Daily turbidity results.

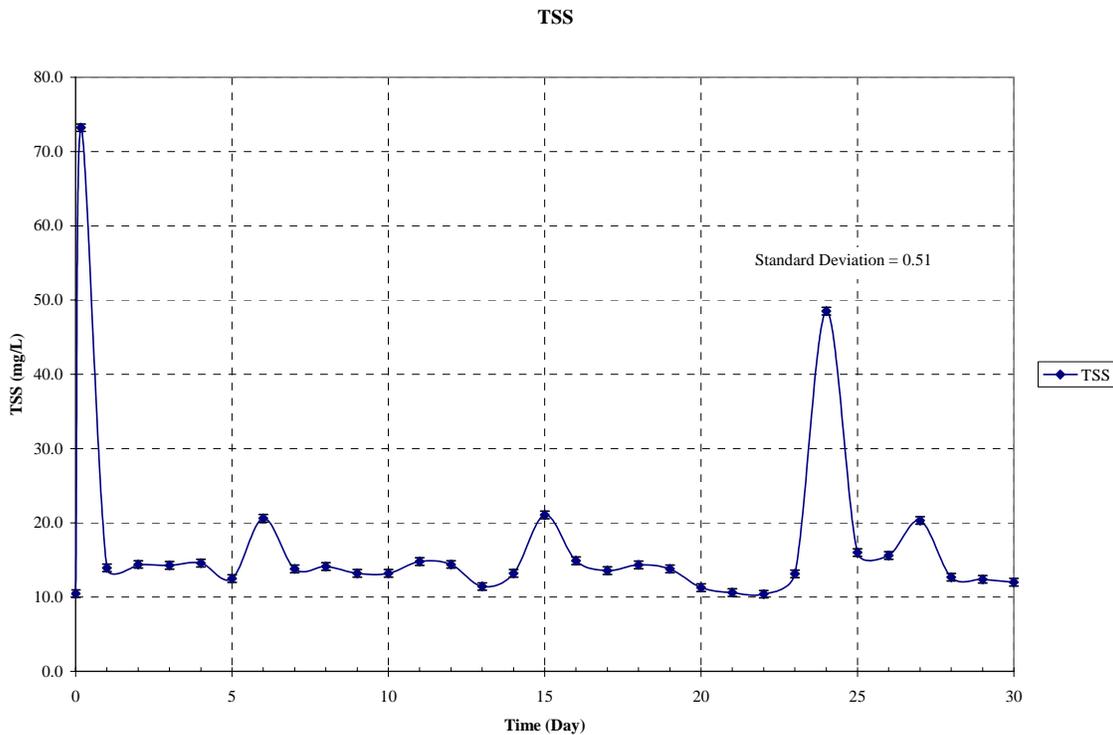
Total Suspended Solids: TSS are measured by filtering a volume of approximately 500 mL through an in-line filter directly at the sample tap. The selected equipment ensures that TSS measurements are not affected by temperature-dependent or time-dependent precipitation reactions that may occur once the process solution is removed from the tank. Figure 3-6 presents Test #3 TSS data as the experiment progressed. The baseline TSS measurement was taken after the addition of latent debris but prior to the Batches 1 and 2 chemical additions. After the addition of the Batch 1 chemicals but prior to the addition of Batch 2 chemicals, a second TSS measurement (not shown on the graph) was taken, and the value was 268 mg/L. Although very high, it appeared to be a reasonable measurement because a large amount of particles was suspended in solution at that time. Four hours into the test, another TSS measurement was taken, and that value was 73.2 mg/L. At that time, fewer particles were seen suspended in solution. After 24 hours, the TSS measurement dropped to 13.9 mg/L, where it leveled out for the rest the test.

Although TSS remained fairly stable over the entirety of the test, TSS measurements from six different days deviated from the trend. The Day 6 TSS measurement was slightly higher at 20.6 mg/L, which was not unexpected because the sample was taken right after the return of excess test solution to the tank. The return of the excess test solution caused some of the particles that were sitting at the bottom of the tank to be become resuspended in the solution, a situation that was reflected in the final measurement. The Day 15 and Days 24–27 measurements were higher than the test

average of approximately 13.4 mg/L that was observed for the majority of the test. The TSS filter weights for these days were confirmed, and there is no direct explanation for these higher values.

Figure 3-6. Test #3 TSS results.

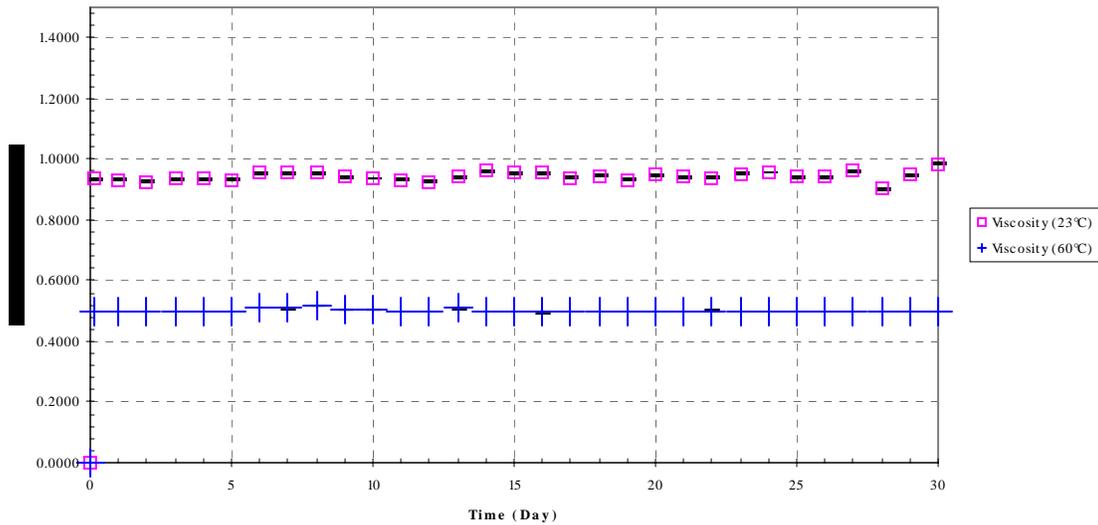
Kinematic Viscosity: Kinematic viscosity was measured with a Cannon-Fenske capillary viscometer. Viscosity was measured on unfiltered samples, each at a temperature of 60°C ± 1.0°C (140°F ± 1.8°F) and 23°C ± 2.0°C (73.4°F ± 3.6°F). Figure 3-7 shows the viscosity results. Water’s viscosity is highly sensitive to temperature, and the allowed temperature range results in a variation of viscosity of 2.9% between 59°C (138.2°F) and 60°C (141.8°F) and 9.3% between 21°C (69.8°F) and 25°C (77.0°F). For this reason, temperature was measured to a 0.1°C accuracy with a National Institute of Standards and Technology (NIST)-traceable thermometer for all viscosity measurements. Also, the measured viscosity values were corrected to common temperatures to facilitate comparisons. The corrected temperatures were 60.0°C (140°F) and 23.0°C (73.4°F).

Viscosity remained relatively constant throughout Test #3. The viscosity at 60.0°C (140°F) remained at a value of approximately 0.49 mm²/s, and the 23.0°C (73.4°F) measurements remained around 0.95 mm²/s. These constant viscosity values are consistent with the steady water conditions in the test. Figure 3-7 shows the viscosity values through the course of the test.

Figure 3-7. Viscosity at 60°C and 23°C.

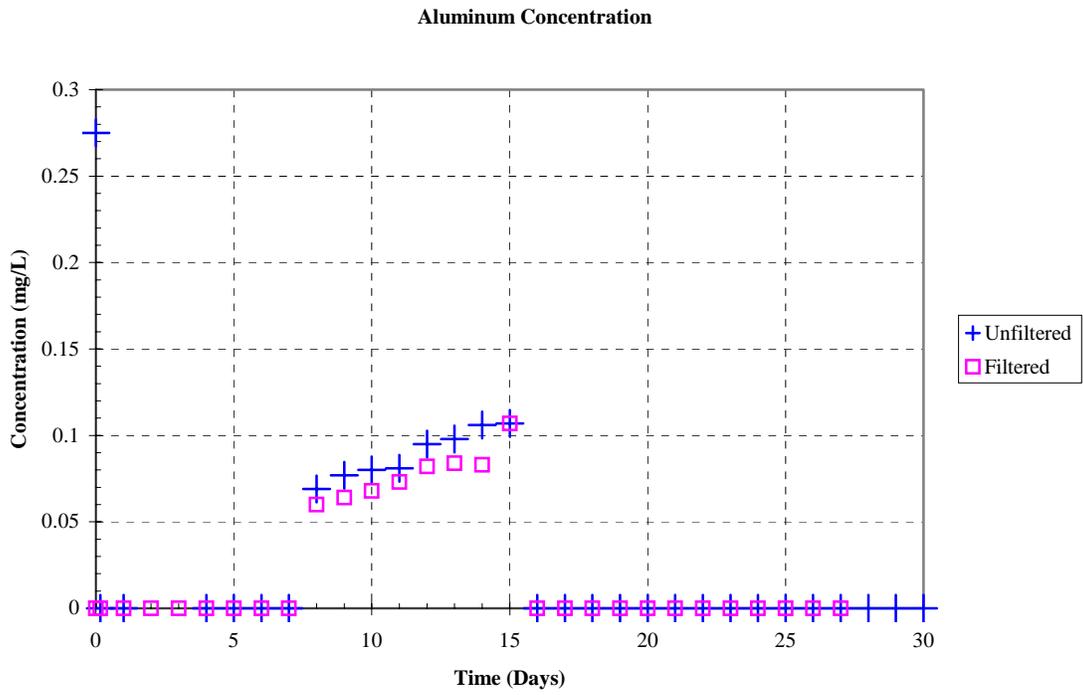
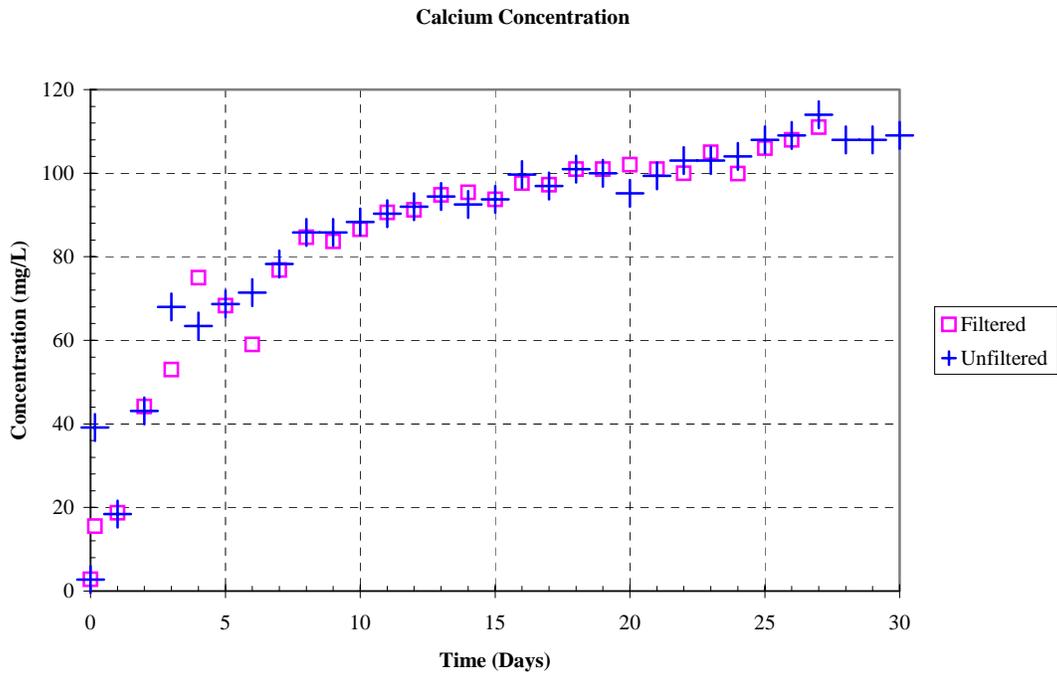
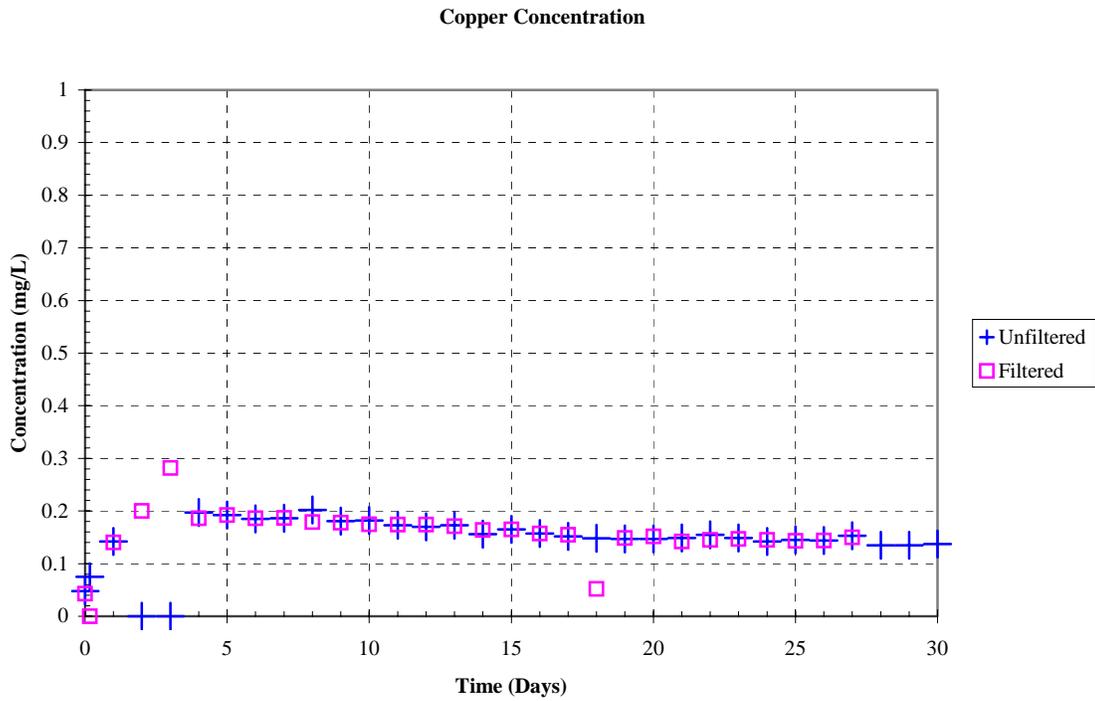
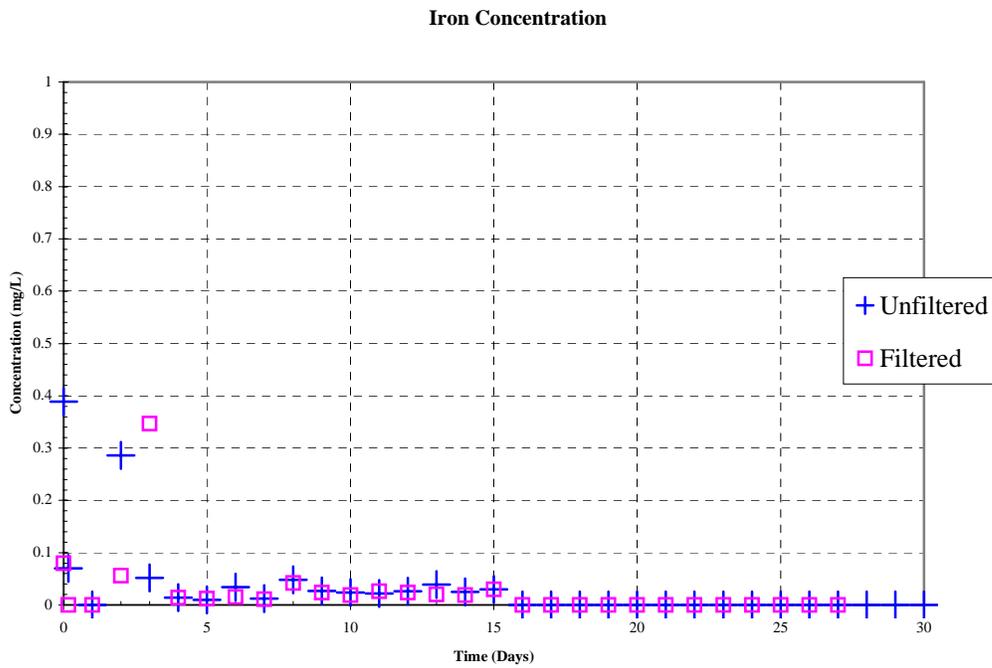
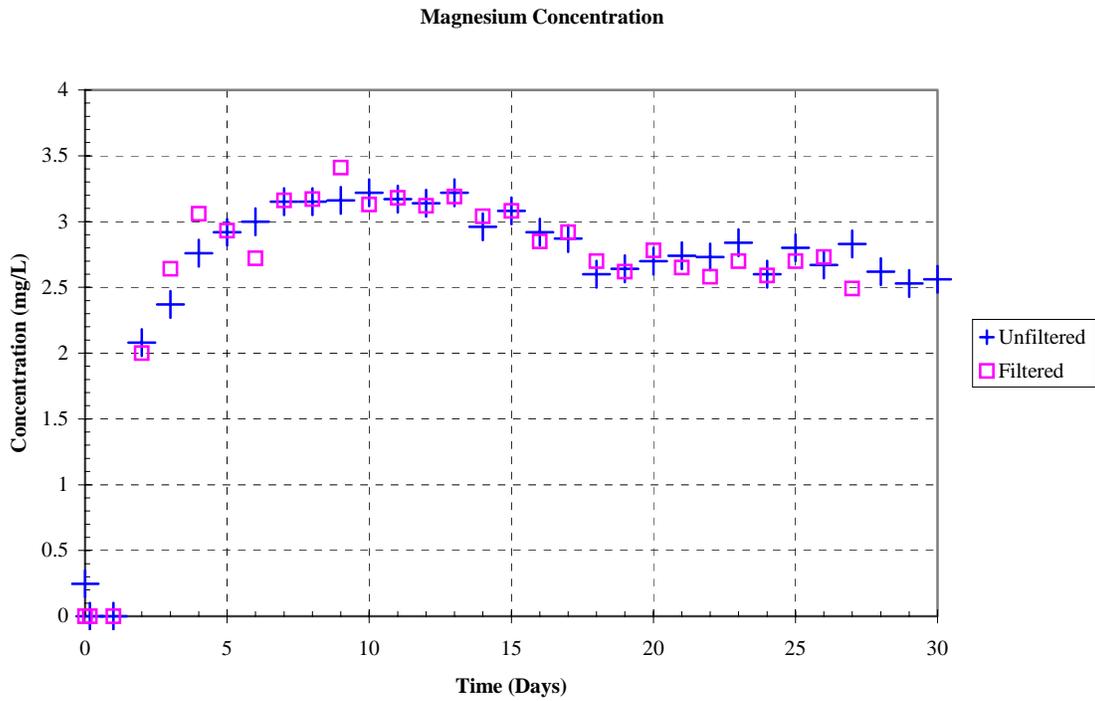
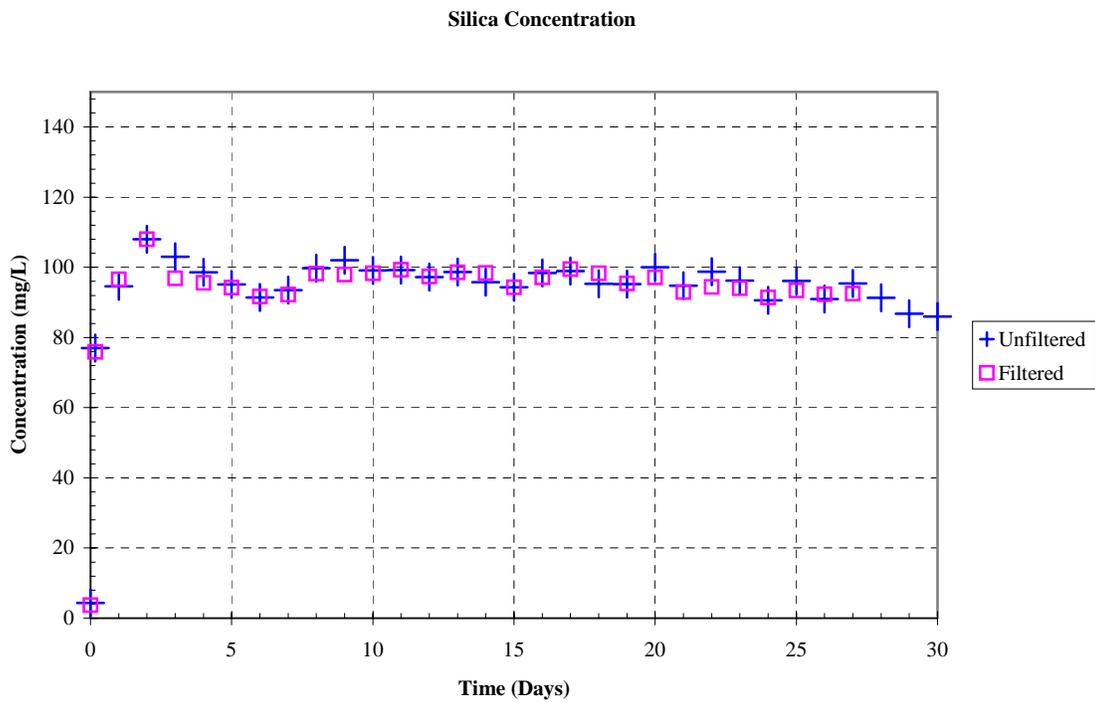
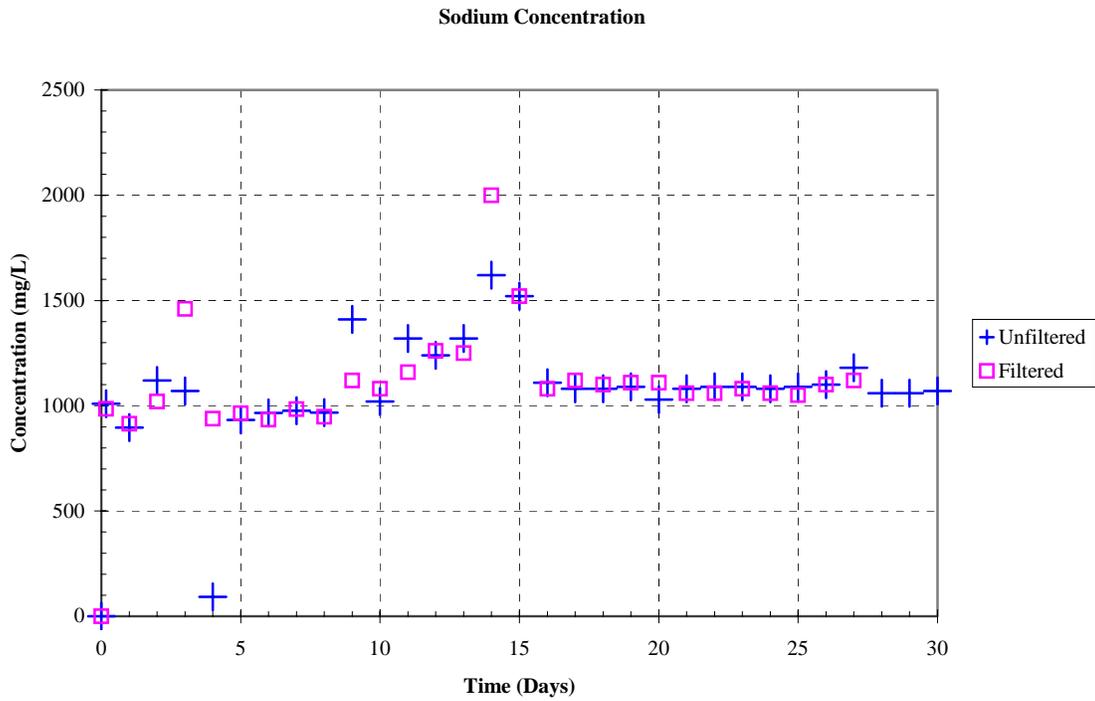
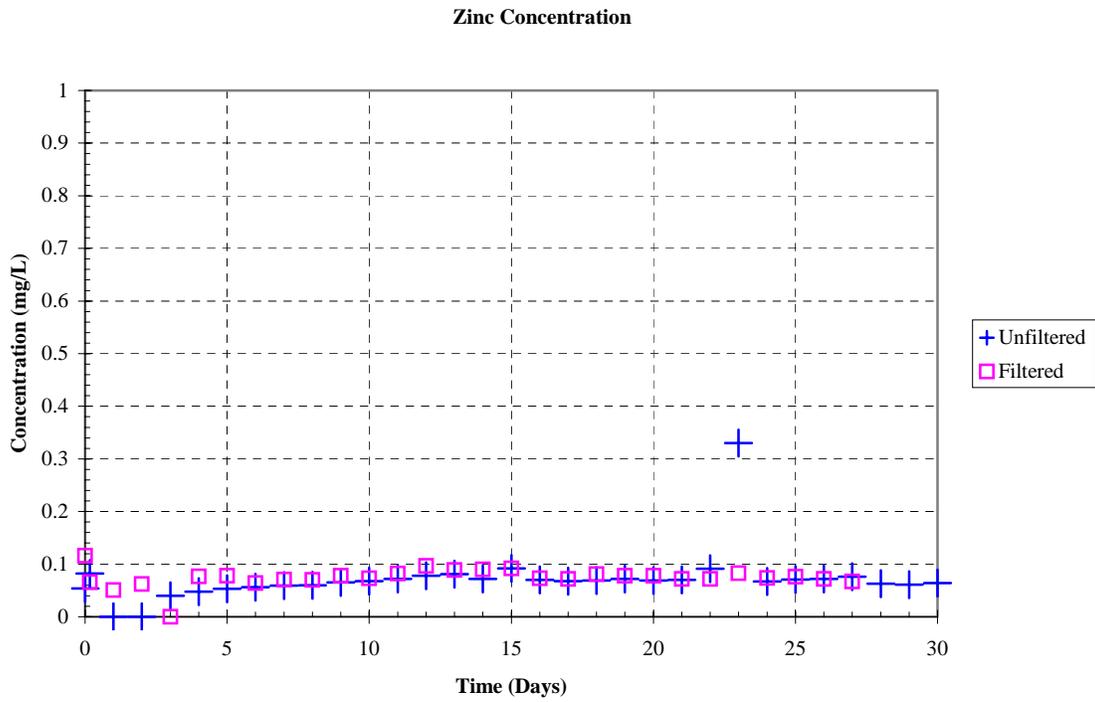
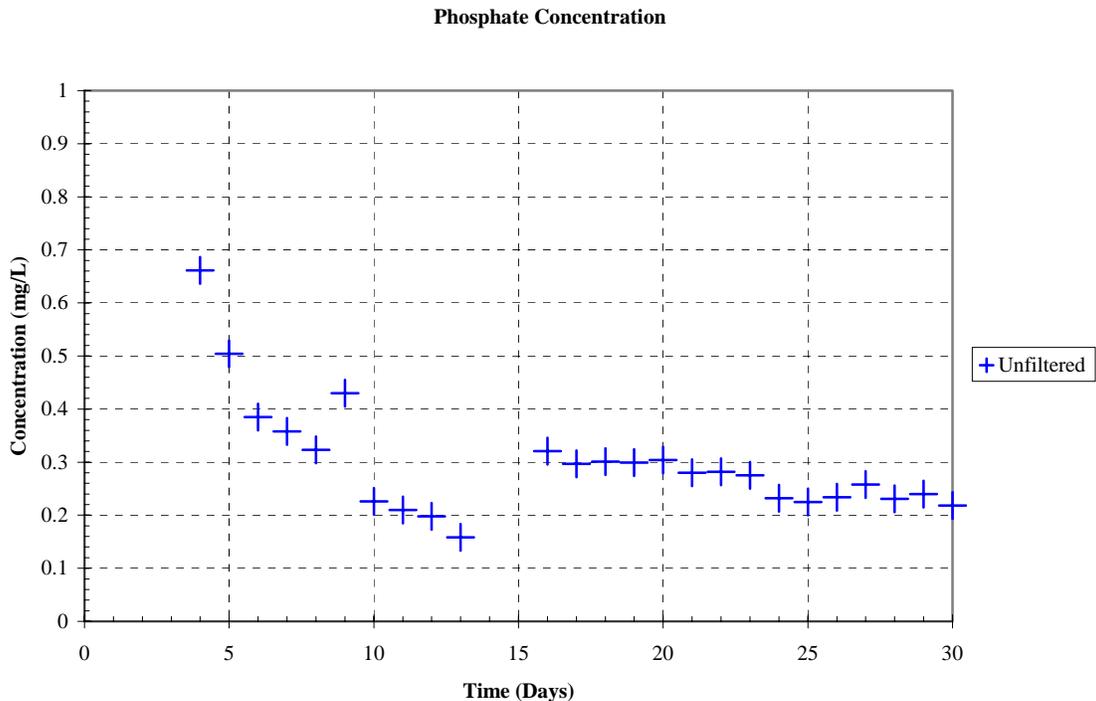
ICP results for Test #3 are displayed in Figures 3-8 through 3-16, which are daily sample results. Table 3-1 contains ICP results for elements that were analyzed on Days 1, 4, 15, and 30. Table 3-1 shows that chloride, boron, lead, lithium, and potassium concentrations remained relatively constant throughout the test. An examination of the figures reveals that phosphate, copper, iron, aluminum, and zinc are present in trace amounts, below 1 mg/L. It also can be seen that calcium, silica, sodium, and magnesium are present in higher concentrations.
