Integrated Chemical Effects Test Project: Test #3 Data Report

Los Alamos National Laboratory

**U.S. Nuclear Regulatory Commission
Office of Nuclear Regulatory Research
Washington, DC 20555-0001**

Manuscript Completed: September 2005
Date Published: October 2005

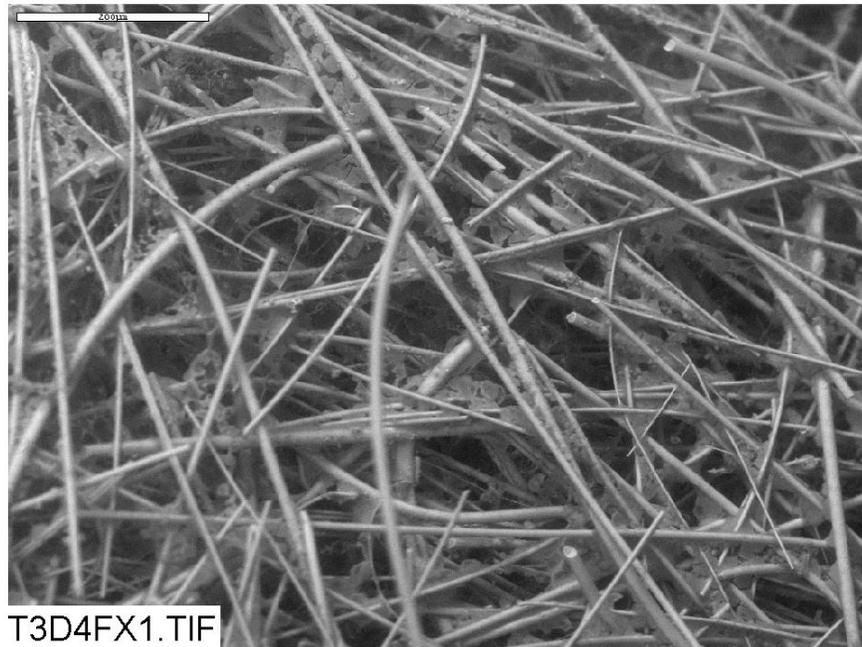
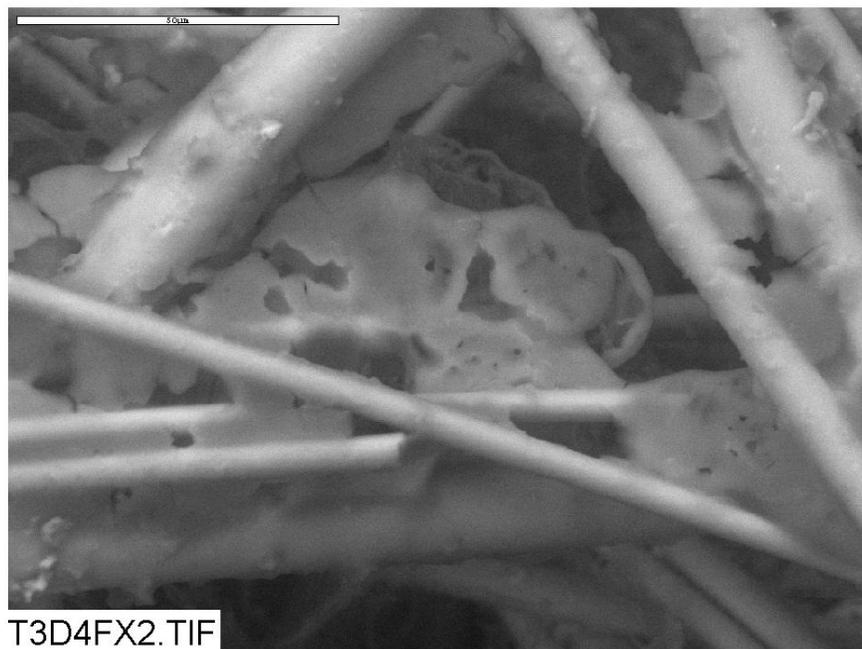
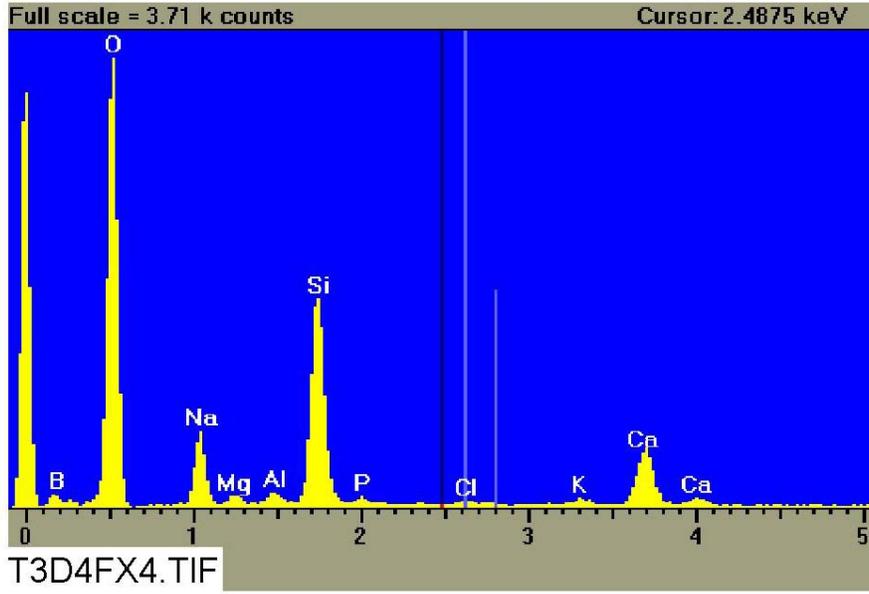
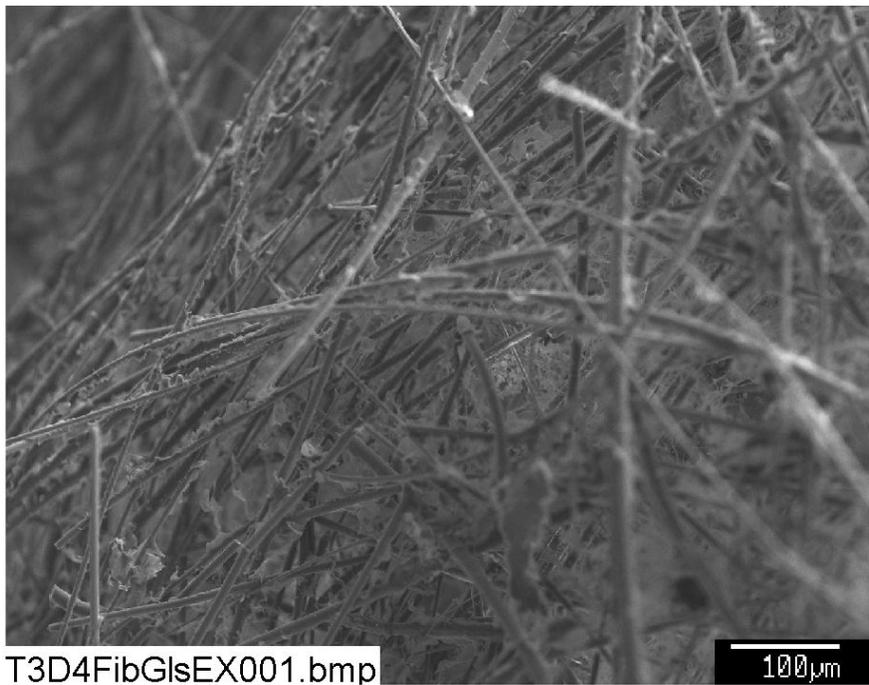
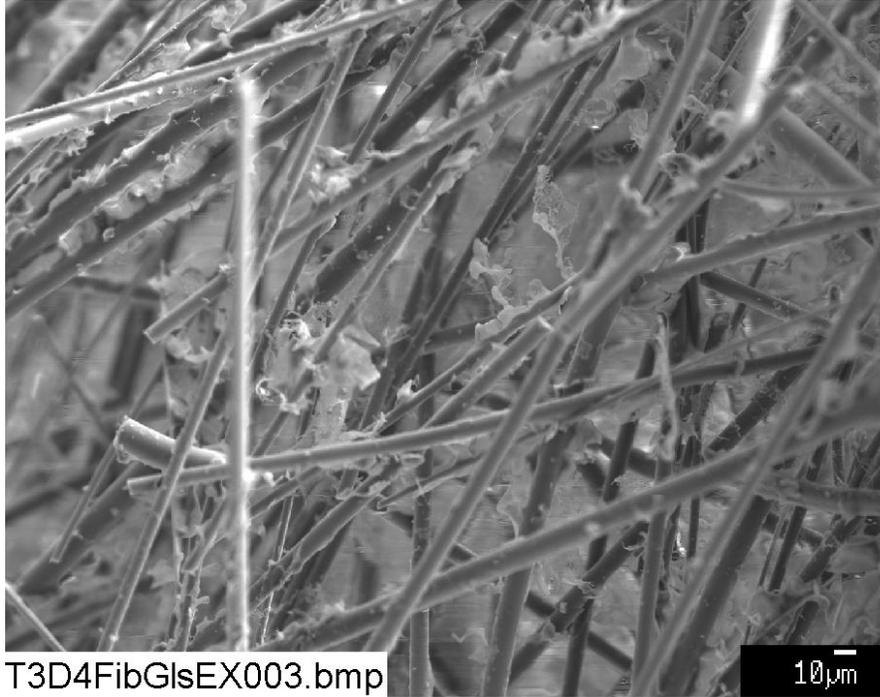
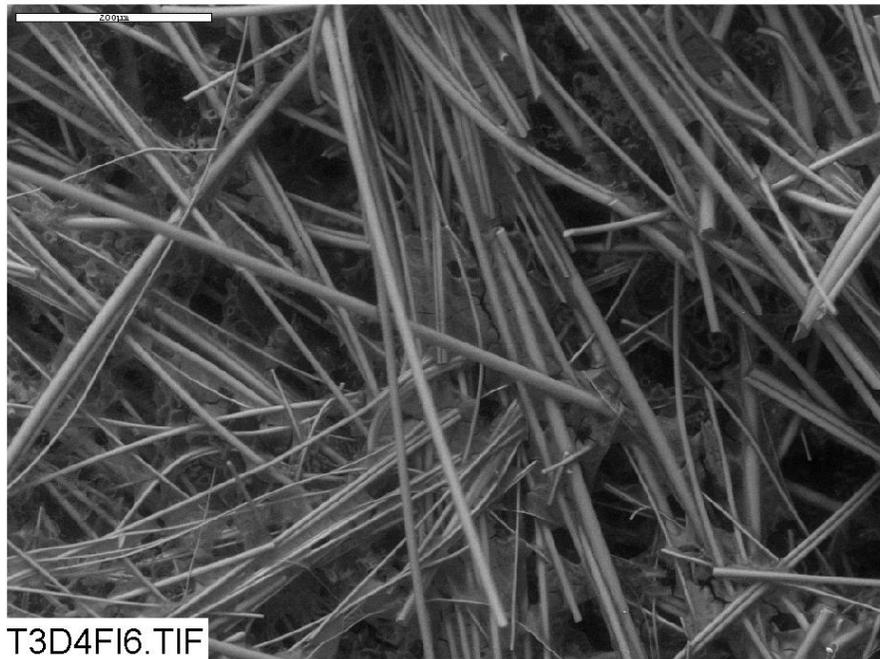
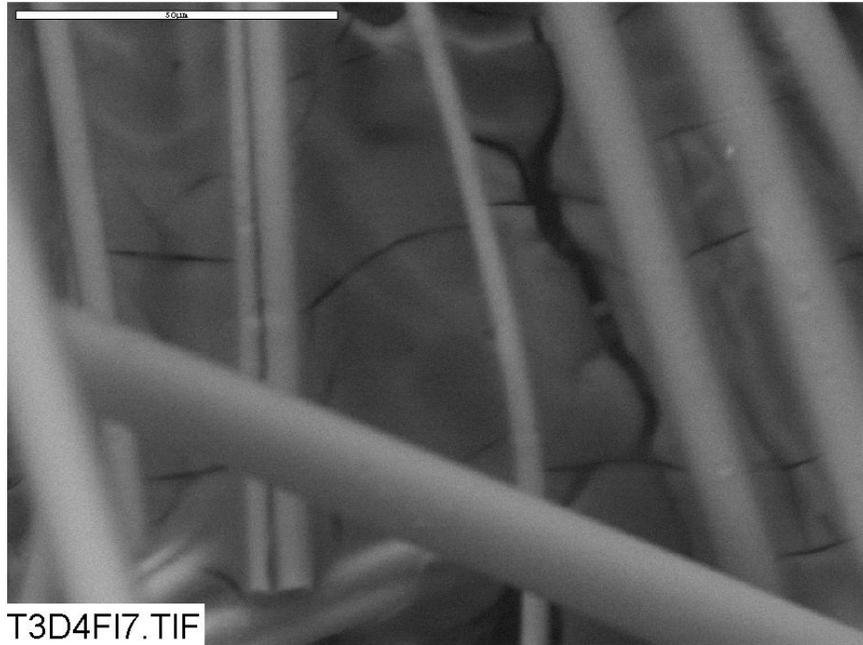
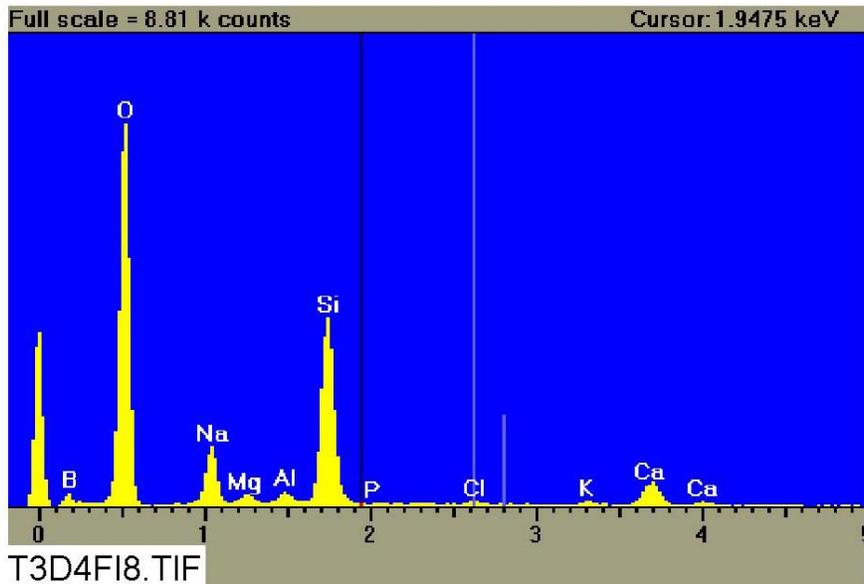
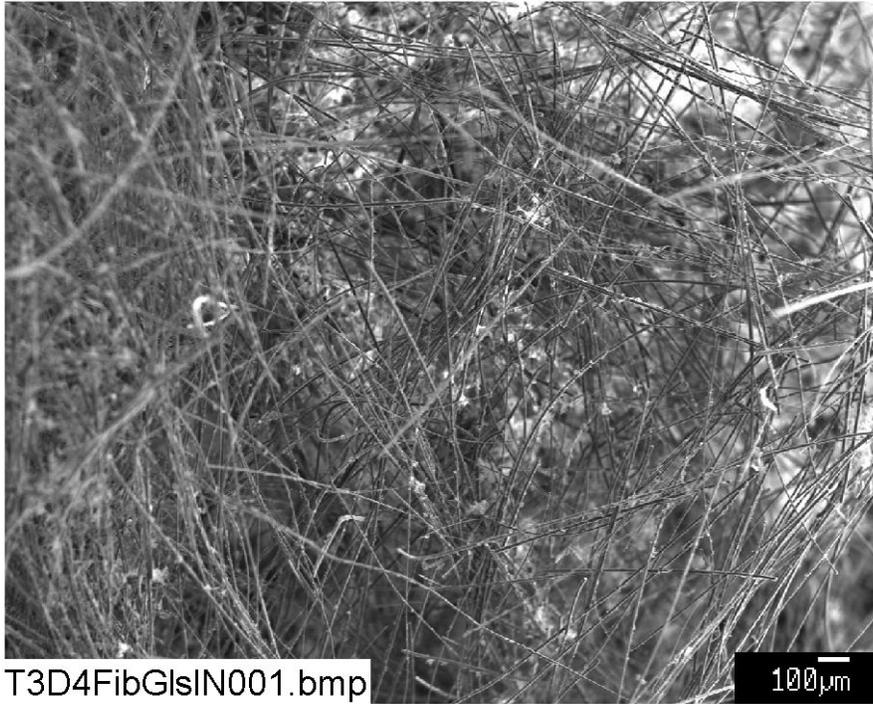
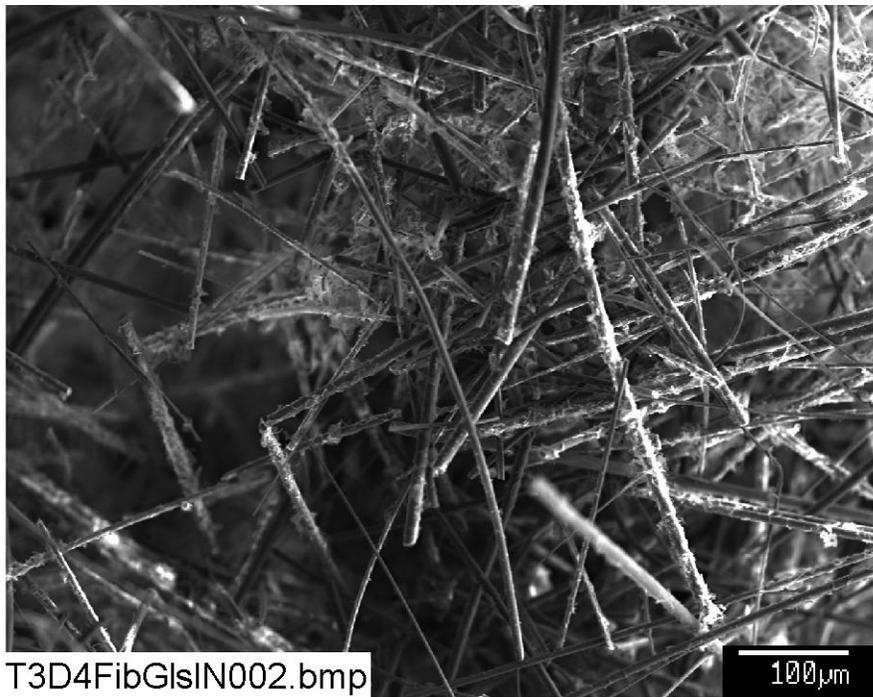
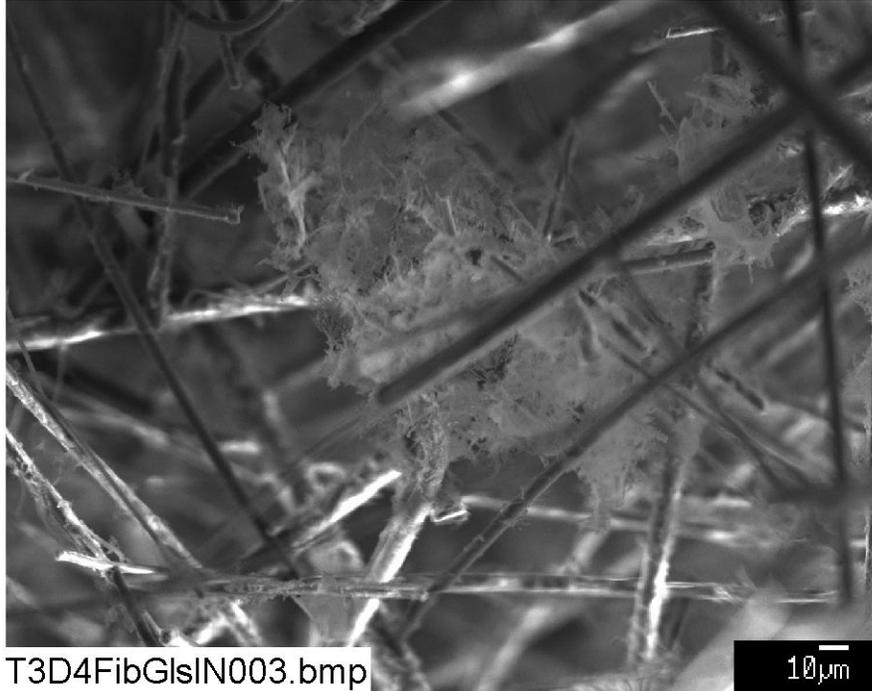
Since there was no significant water flow through the fiberglass samples during the test, particle migration from the solution into the fiberglass interior is insignificant. Based on the ESEM/SEM results, deposits were found on both the exterior and the interior of the low-flow fiberglass samples after test Day 4. Because these deposits formed continuously among glass fibers and even coated the fibers, it is likely that these deposits are of chemical origin instead of being physically attached/retained. Comparing ESEM and SEM results for the same fiberglass sample reveals that some dark deposits were found with ESEM results only. However, when the fiberglass samples were totally dried for SEM analysis, only white flocculence deposits were found, possibly because the fiberglass samples were semidried (partially dehydrated) with ESEM analysis. It is likely that the dark deposits began to precipitate out when the fiberglass samples were partially dehydrated during ESEM analysis. However, these dark deposits were totally precipitated out and dehydrated for SEM analysis. As a result, a significant amount of the white flocculence were found with SEM results. EDS results show that the deposits were commonly composed of O, Si (possible), Na, Ca, and small amounts of Mg, Al, B, and P, whether they were found on the exterior or interior of the fiberglass samples. The uncertainty of Si is due to the fact that x-ray may be scattered and/or penetrate the deposits. As a result, the signal may be reflected to the detector by the fiberglass in addition to the deposits. Therefore, when Si peaks show up, the existence of Si in the deposits cannot be confirmed or excluded. In addition, it should be noted that the deposits contained insignificant amounts of P, which means that the deposits did not have a direct relation to the white particles observed in the tank during TSP injection on the first day of the test.

Comparing interior and exterior fiberglass samples reveals no significant difference in the amount of deposits, again probably because of a chemical origin for the deposits. Chemical precipitation occurs to the same degree on both exterior and the interior fiberglass samples. Figures 3-17 through 3-27 show the Day 4, low-flow fiberglass results.

There were four fiberglass locations in the tank that were examined in this test, including the low-flow area, the high-flow area, the birdcage, and the drain collar. (See Subsection 2.4.1.1 for descriptions of the fiberglass samples.) Both the exterior and the interior of the fiberglass samples from each location were examined. Subsections 3.3.1.1 through 3.3.1.7 give the ESEM/SEM/EDS results according to the location of the fiberglass samples in the tank and the sampling date. The different samples include Day 4 low-flow, Day 15 low-flow, Day 15 high-flow, Day 30 low-flow, Day 30 high-flow, Day 30 drain collar, and Day 30 birdcage. The corresponding figures are Figures 3-17 through 3-77. Additional micrographs of fiberglass samples are presented in Appendices A, B, and C.

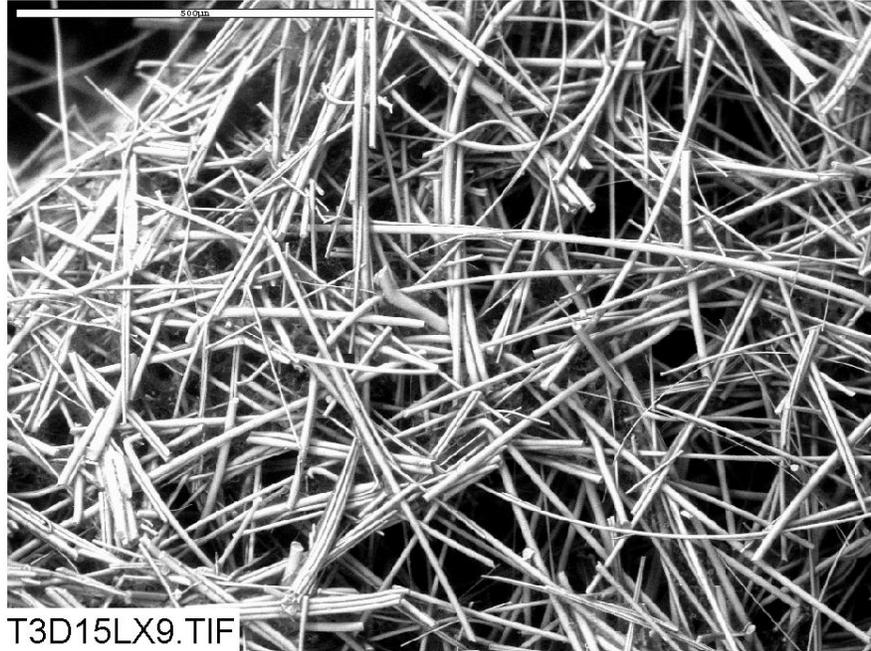
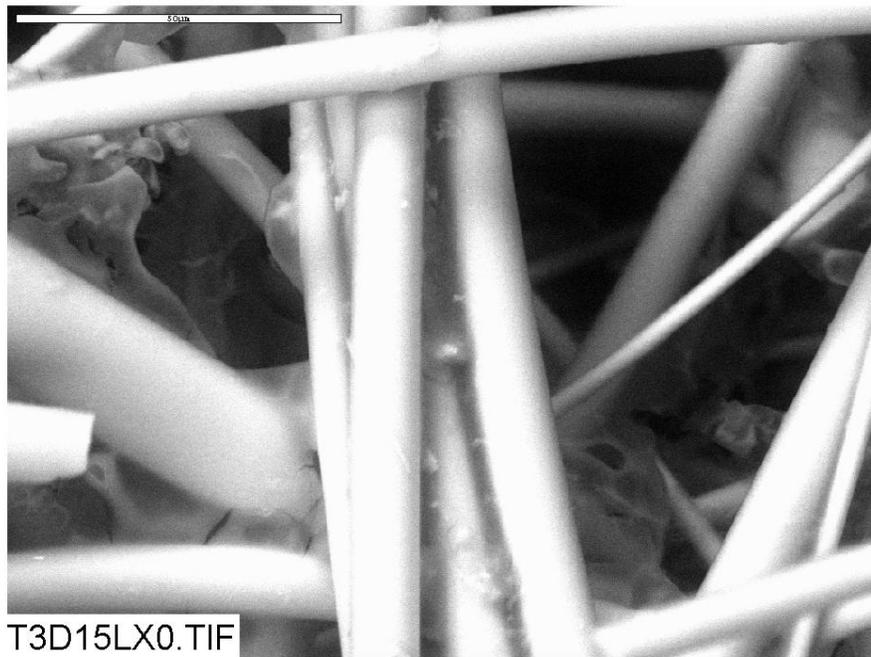
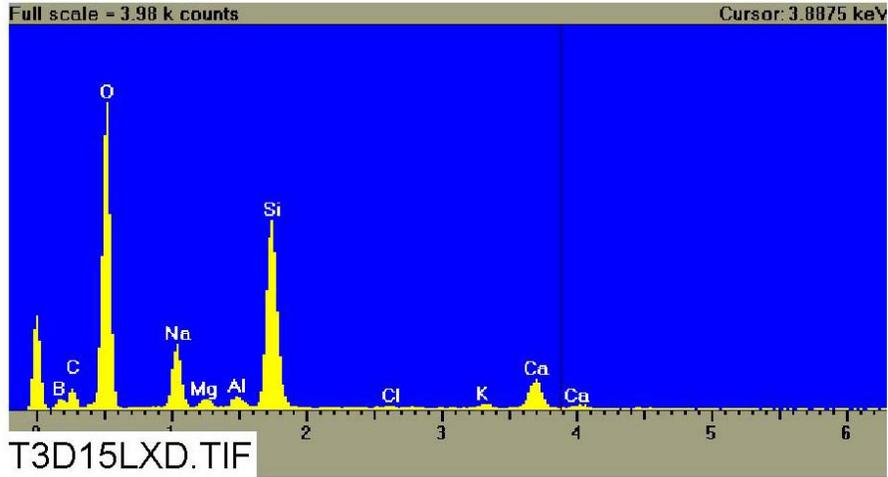
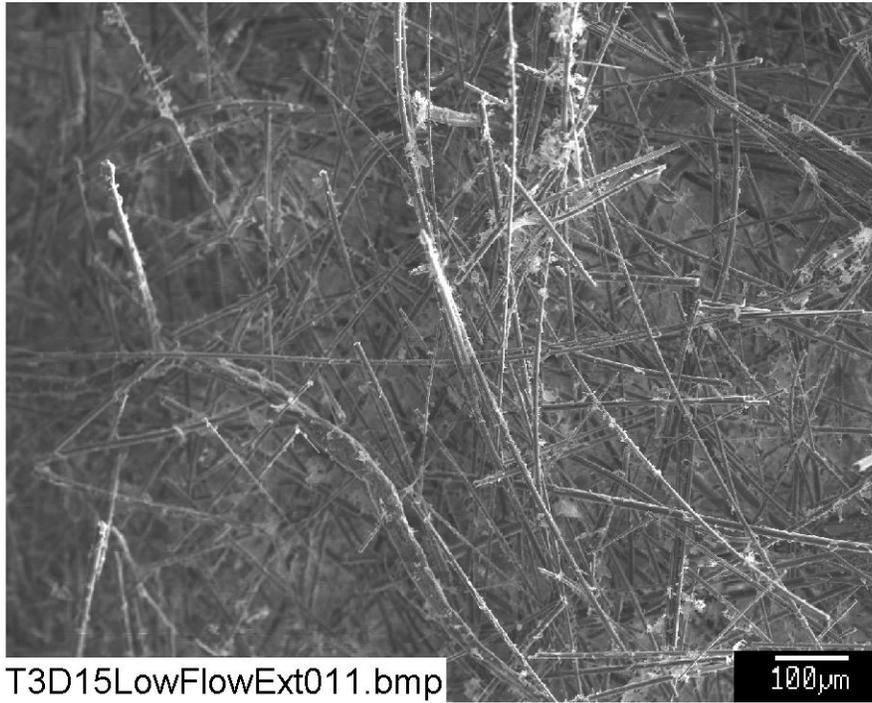
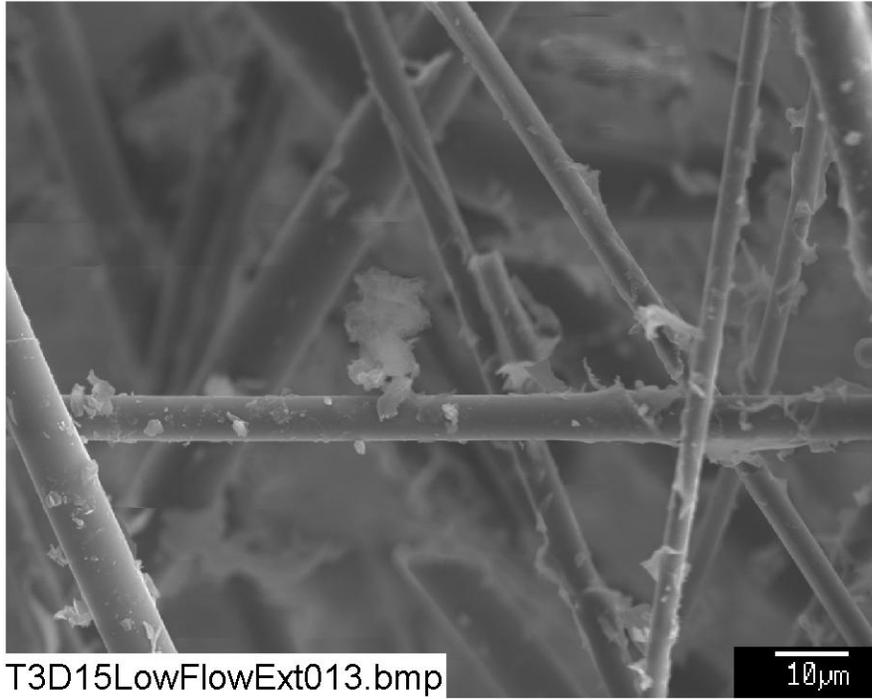
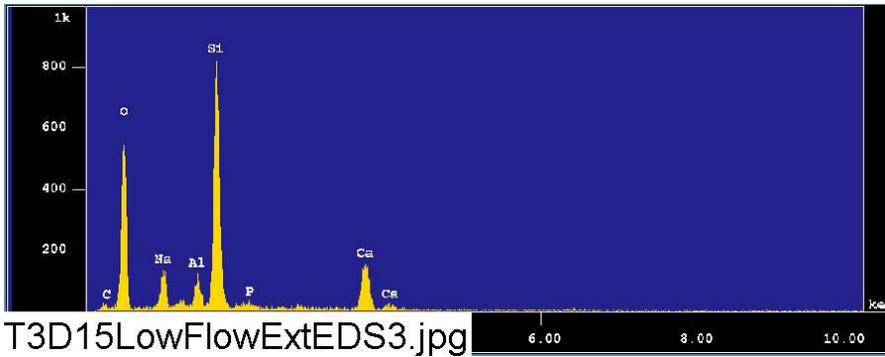
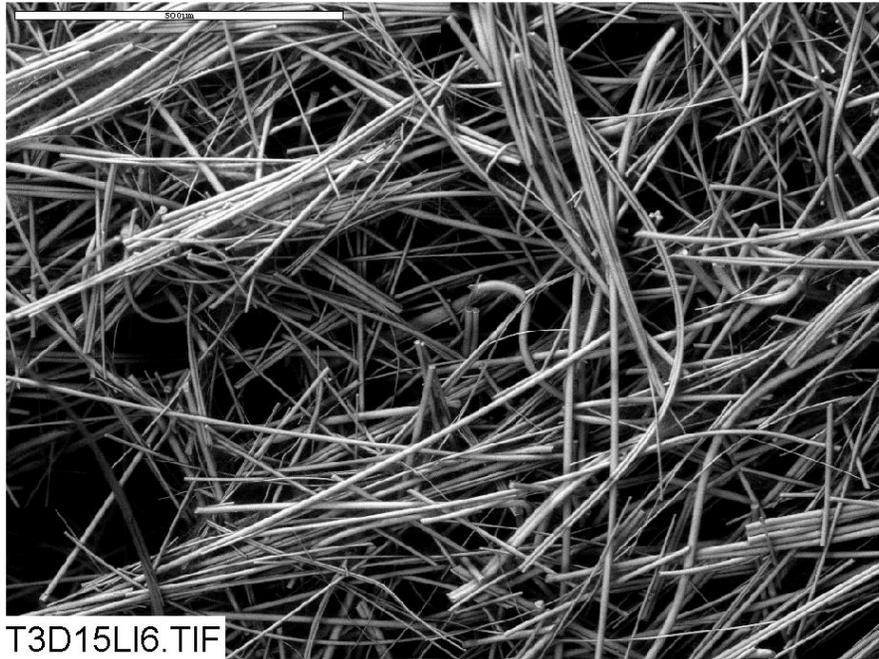
As with Day 4 samples, dark deposits and white flocculence were found with ESEM and SEM results, respectively, on Day 15 low-flow fiberglass samples. There was no significant increase in the amount of deposits on Day 15 samples compared with Day 4 samples. Comparing the amount of deposits on the exterior and the interior Day 15 low-flow fiberglass samples revealed no significant difference. Again, EDS results show that the deposits on both of the exterior and the interior samples were commonly composed of O, Si (possible), Na, Ca, and small amounts of Mg, Al, B, and P, suggesting the deposits' likely chemical origin. Figures 3-28 through 3-38 show the Day 15 low-flow fiberglass results.

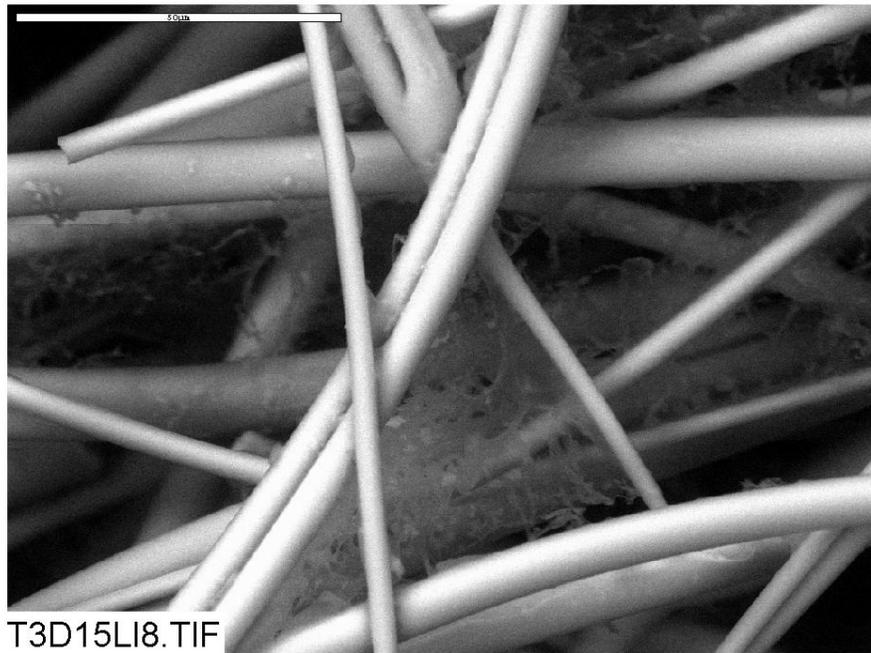
Figure 3-35. ESEM image of a Test# 3 Day 15 low-flow interior fiberglass sample, magnified 1000 times. (T3D15LI8)

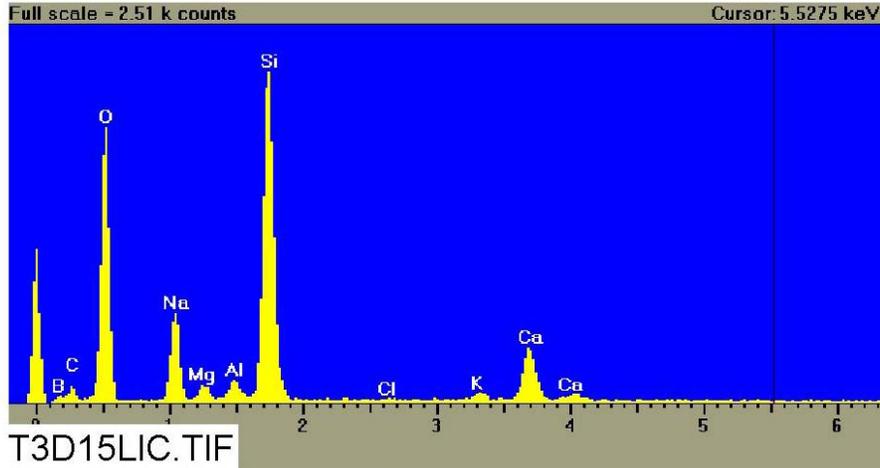
Figure 3-36. EDS counting spectrum for the flocculent deposits between the fibers on the ESEM image shown in Figure 3-35. (T3D15LIC)

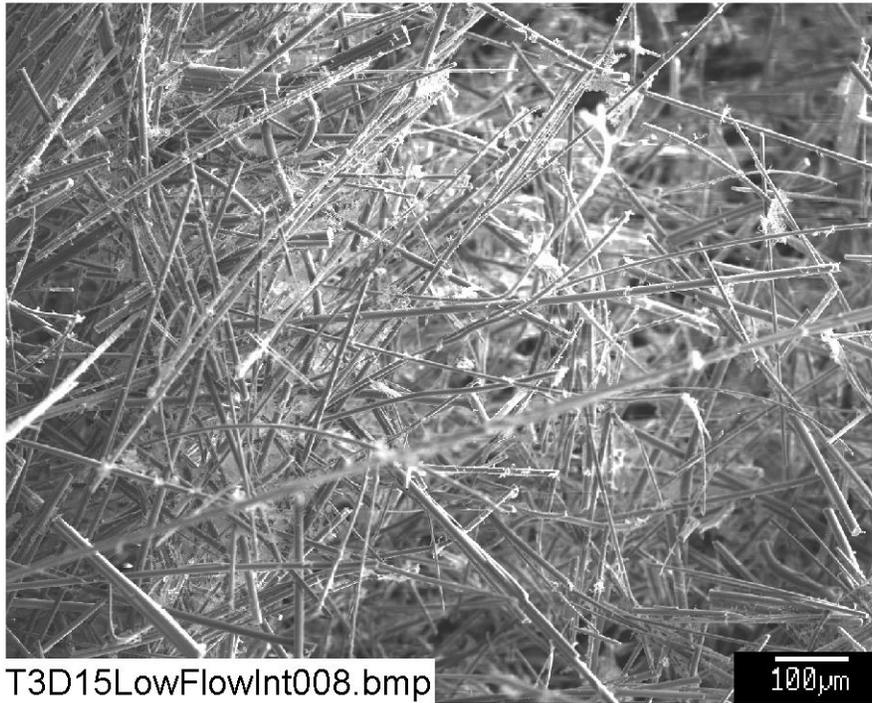
Figure 3-37. SEM image of a Test #3 Day 15 low-flow interior fiberglass sample, magnified 100 times. (T3D15LowFlowInt008)

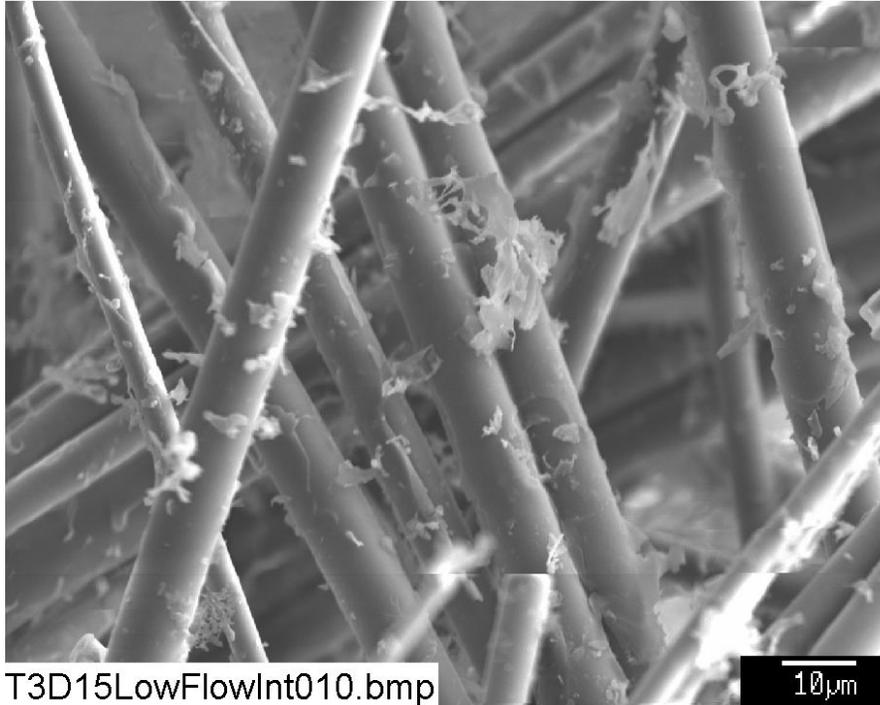
Figure 3-38. SEM image of a Test #3 Day 15 low-flow interior fiberglass sample, magnified 1000 times. (T3D15LowFlowInt010)

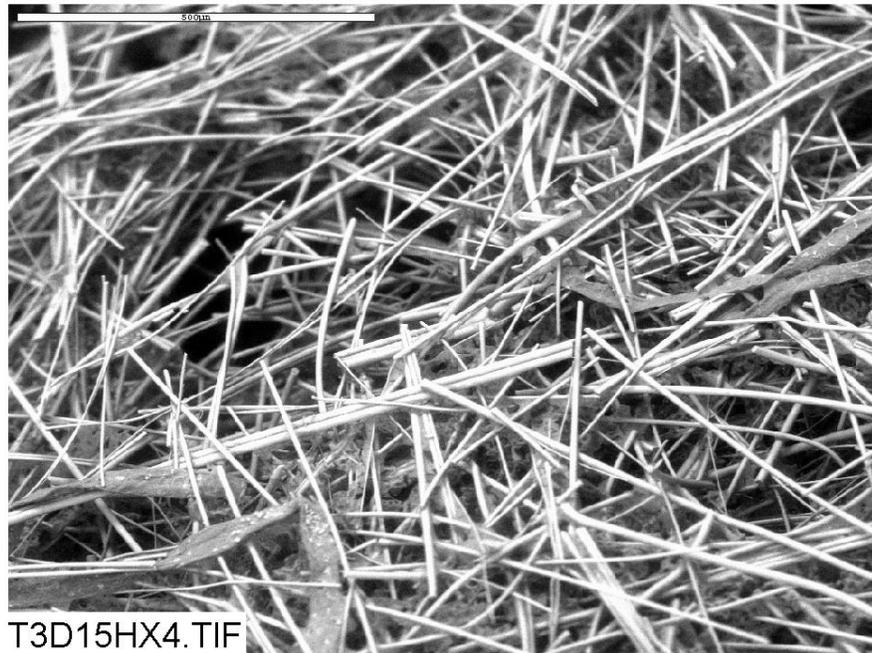
Figure 3-39. ESEM image of a Test #3 Day 15 high-flow exterior fiberglass sample, magnified 110 times. (T3D15HX4, 4/22/05)

No significant difference was found between Day 15 high-flow and low-flow fiberglass samples, except for some large flat fibers found on the Day 15 high-flow exterior fiberglass samples (see lower left corner of Figure 3-39). These large flat fibers, which were likely from the submerged cal-sil samples (see Appendix H), were physically attached/retained on the exterior of the fiberglass samples. No large flat fibers were found in the interior of the fiberglass samples. Again, dark deposits and white flocculence were found with ESEM and SEM results, respectively, on Day 15 high-flow fiberglass samples. There was no significant difference in the amount of deposits on the exterior and interior fiberglass samples. Similarly, EDS results verified that the deposits on the exterior and interior samples were commonly composed of O, Si (possible), Na, Ca, and small amount of Mg, Al, B, and P, suggesting the deposits' likely chemical origin. Figures 3-39 through 3-50 show the Day 15 high-flow fiberglass results.

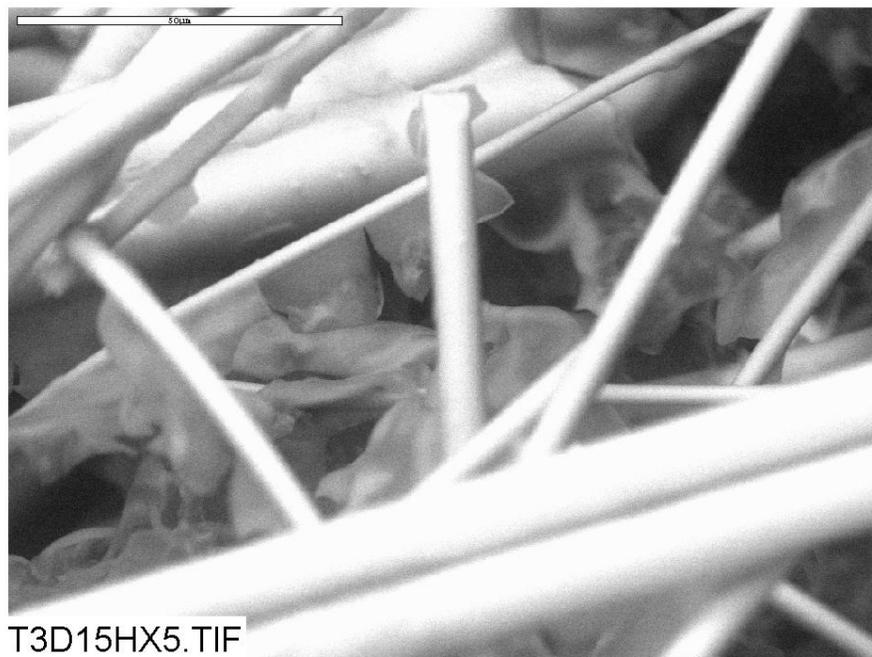
Figure 3-40. ESEM image of a Test #3 Day 15 high-flow exterior fiberglass sample, magnified 1000 times. (T3D15HX5, 4/22/05)

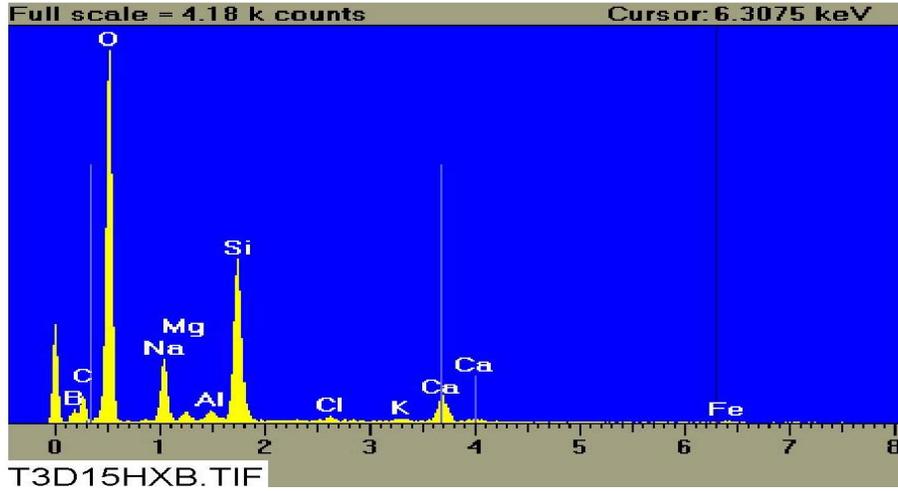
Figure 3-41. EDS counting spectrum for the deposits between the fibers on the ESEM image shown in Figure 3-40. (T3D15HIB, 4/22/05)

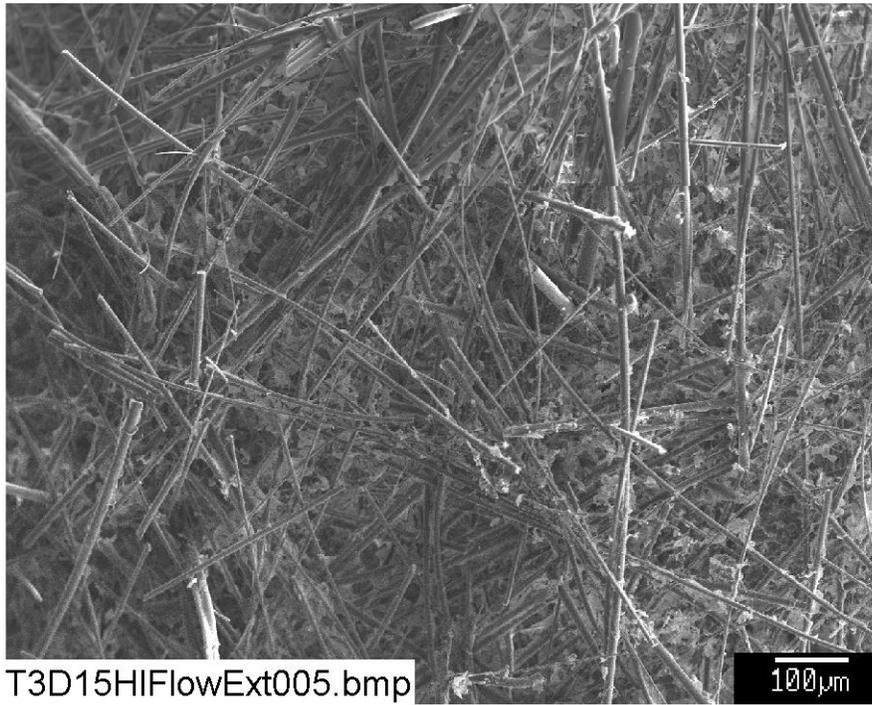
Figure 3-42. SEM image of a Test #3 Day 15 high-flow exterior fiberglass sample, magnified 100 times. (T3D15HIFlowExt005, 4/22/05)

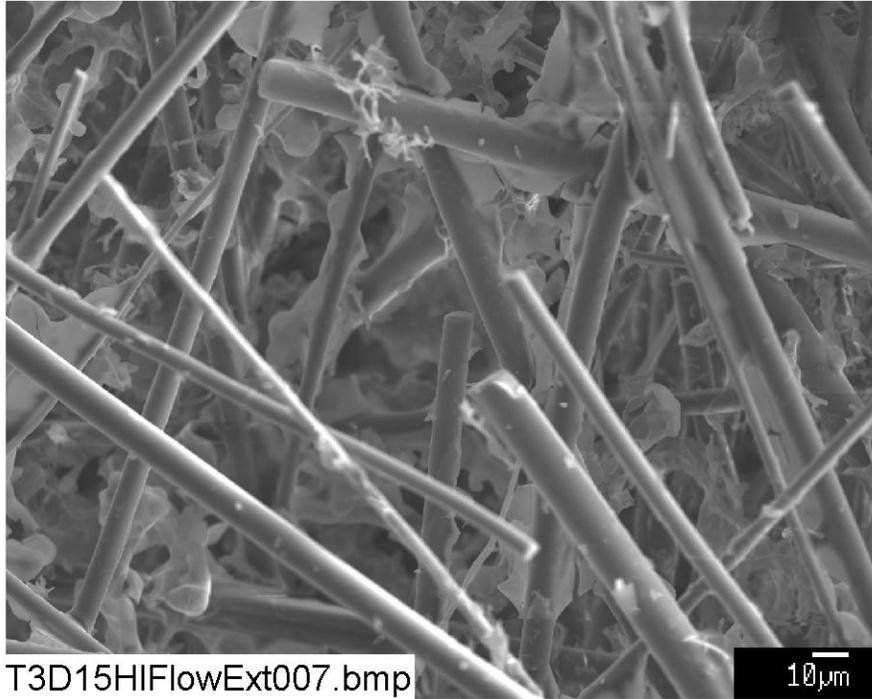
Figure 3-43. SEM image of a Test #3 Day 15 high-flow exterior fiberglass sample, magnified 500 times. (T3D15HiFlowExt007, 4/22/05)

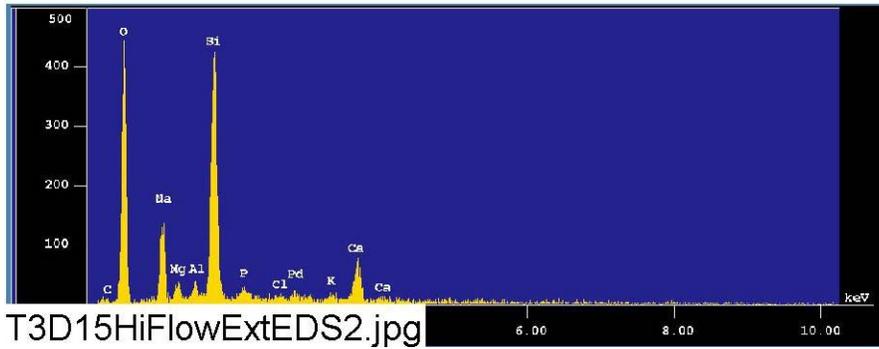
Figure 3-44. EDS counting spectrum for the flocculent deposits between the fibers on the SEM image shown in Figure 3-43. (T3D15HiFlowExtEDS2, 4/22/05)

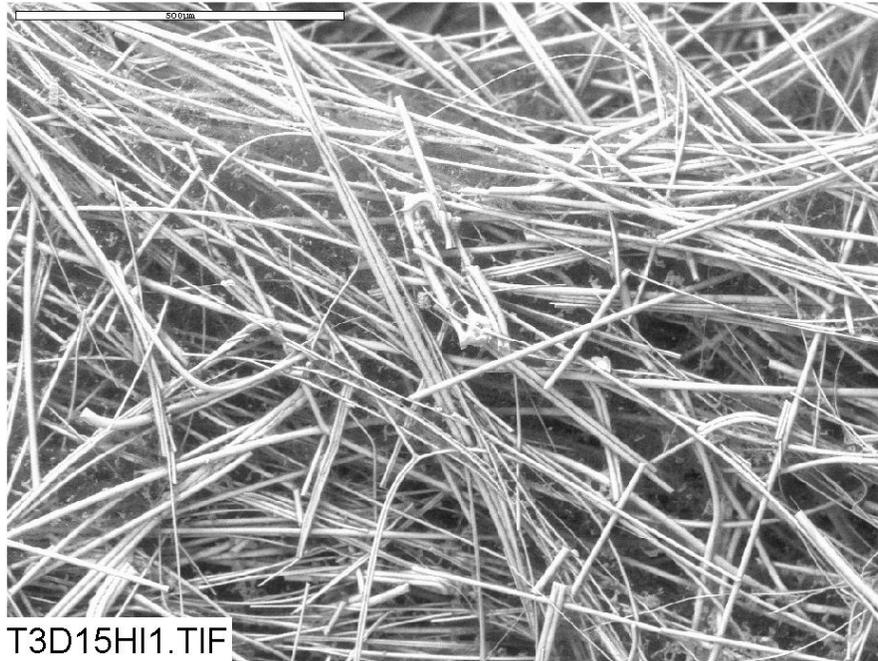
Figure 3-45. ESEM image of a Test #3 Day 15 high-flow interior fiberglass sample, magnified 100 times. (T3D15HI1, 4/22/05)

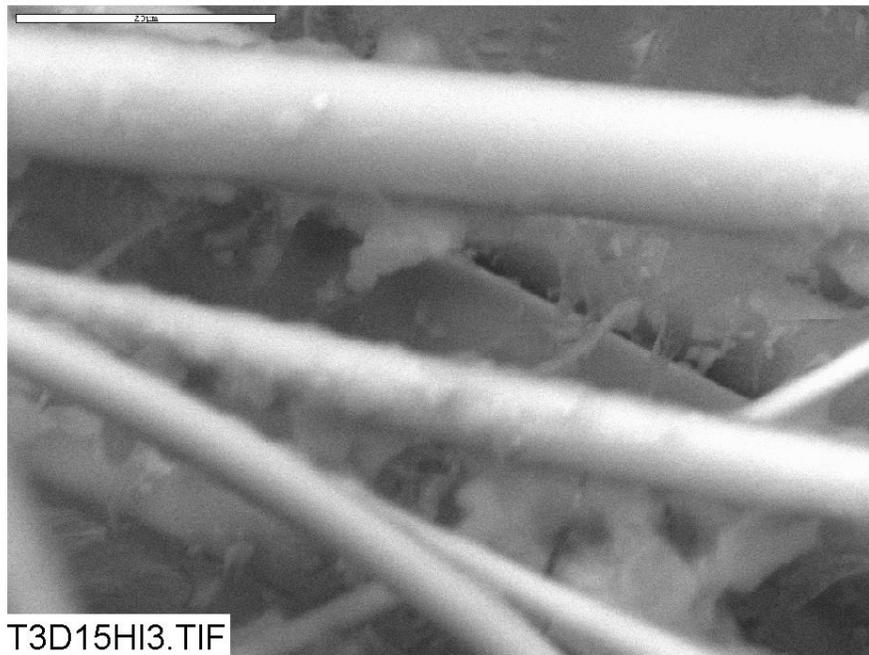
Figure 3-46. ESEM image of a Test #3 Day 15 high-flow interior fiberglass sample, magnified 2000 times. (T3D15HI3, 4/22/05)

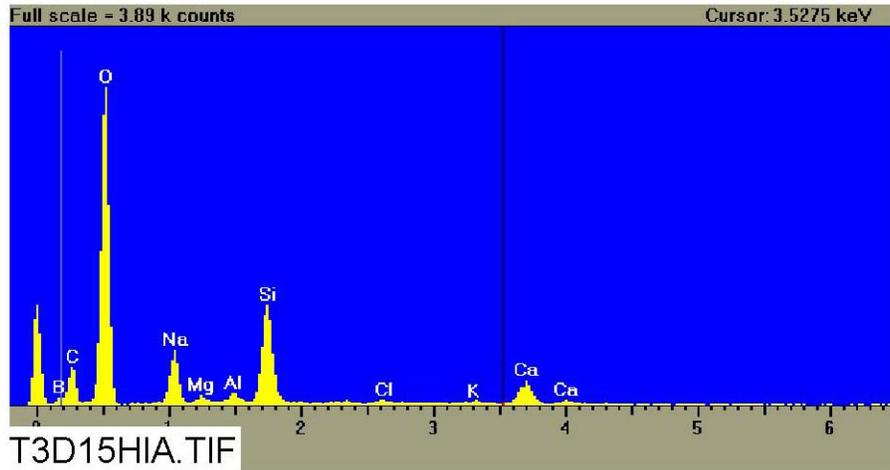
Figure 3-47. EDS counting spectrum for the flocculent deposits between the fibers on the ESEM image shown in Figure 3-46. (T3D15HIA, 4/22/05)

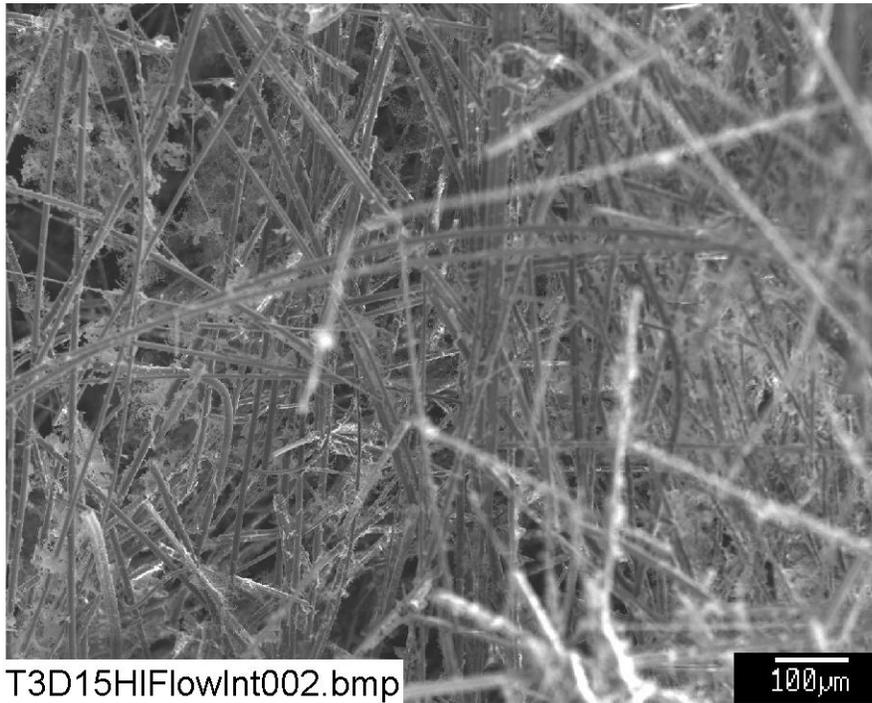
Figure 3-48. SEM image of a Test #3 Day 15 high-flow interior fiberglass sample, magnified 100 times. (T3D15HIFlowInt002, 4/22/05)

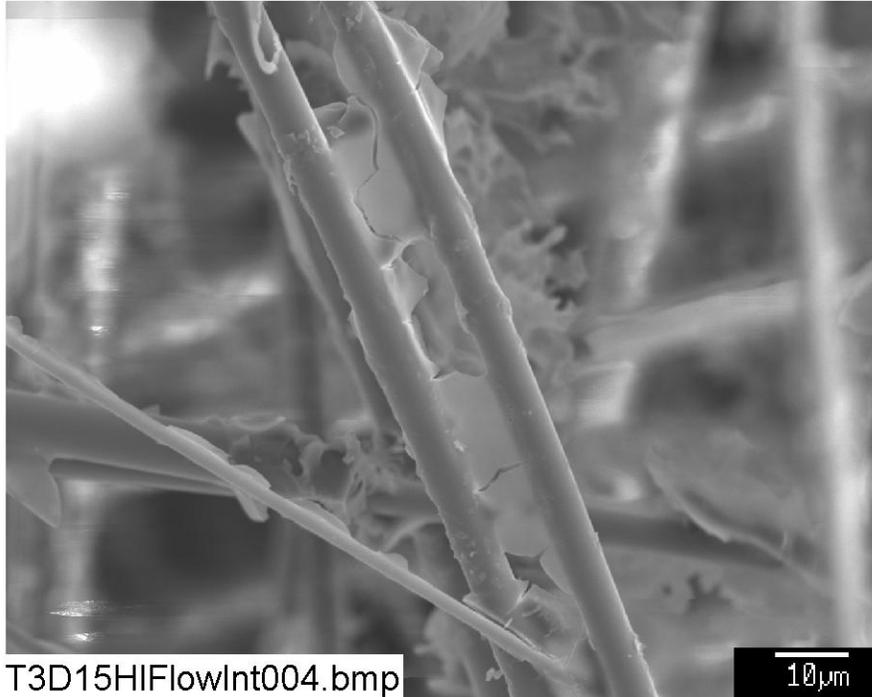
Figure 3-49. SEM image of a Test #3 Day 15 high-flow interior fiberglass sample, magnified 1000 times. (T3D15HiFlowInt004, 4/22/05)

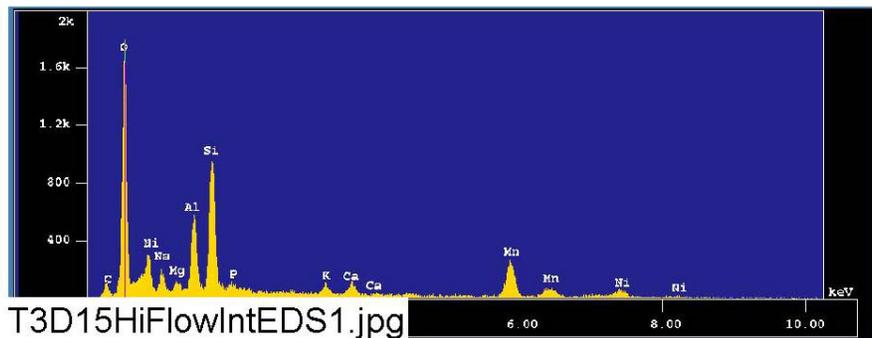
Figure 3-50. EDS counting spectrum for the flocculent deposits between the fibers on the SEM image shown in Figure 3-49. (T3D15HiFlowIntEDS1, 4/22/05)

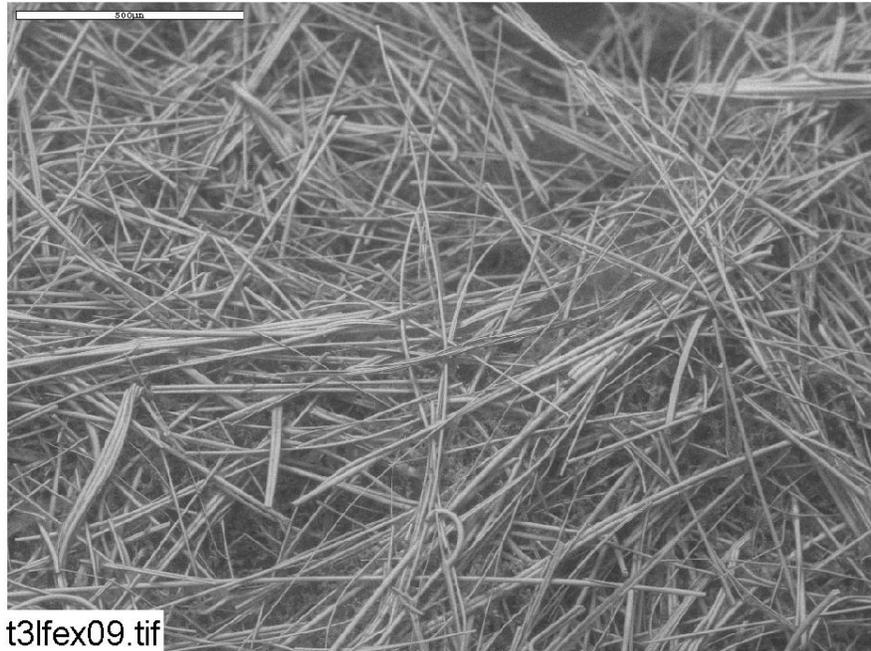
Figure 3-51. ESEM image of a Test #3 Day 30 exterior low-flow fiberglass sample, magnified 70 times. (t3lfex09, 5/6/05)

Comparing Day 30 low-flow fiberglass samples with Day 4 and Day 15 low-flow fiberglass samples revealed deposits that are similar in property and amount. In addition, there was no significant difference in the amount of deposits found in exterior and interior Day 30 low-flow fiberglass samples. Figures 3-51 through 3-54 show the Day 30 low-flow fiberglass results.

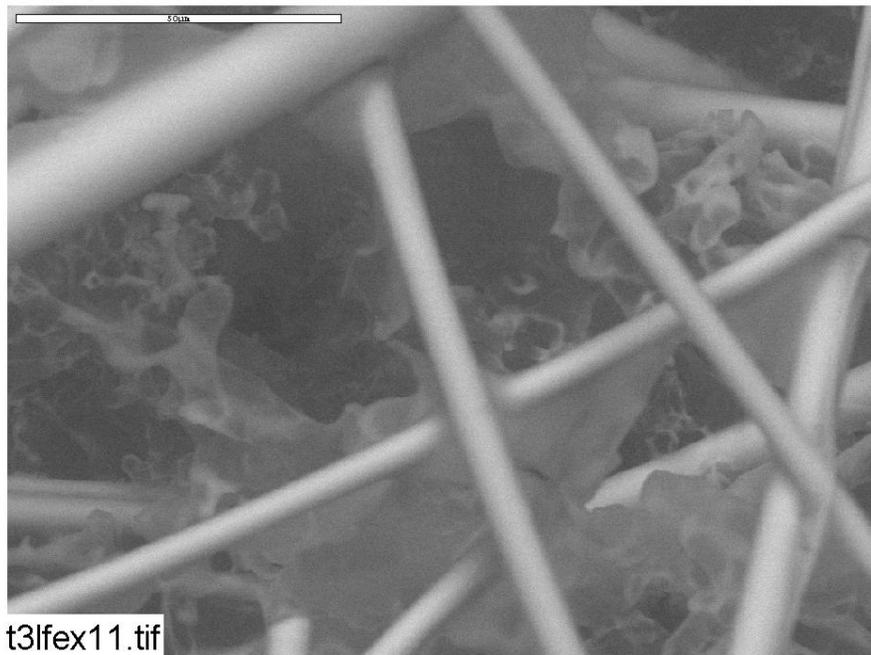
Figure 3-52. ESEM image of a Test #3 Day 30 exterior low-low fiberglass sample, magnified 1000 times. (t3lfex11, 5/6/05)

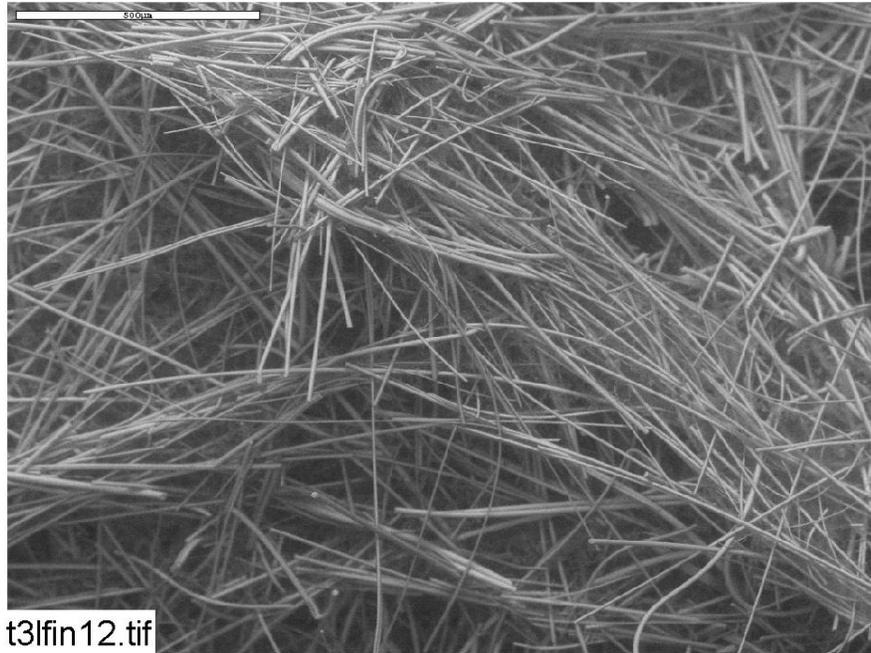
Figure 3-53. ESEM image of a Test #3 Day 30 interior low-flow fiberglass sample, magnified 70 times. (t3lfin12, 5/6/05)

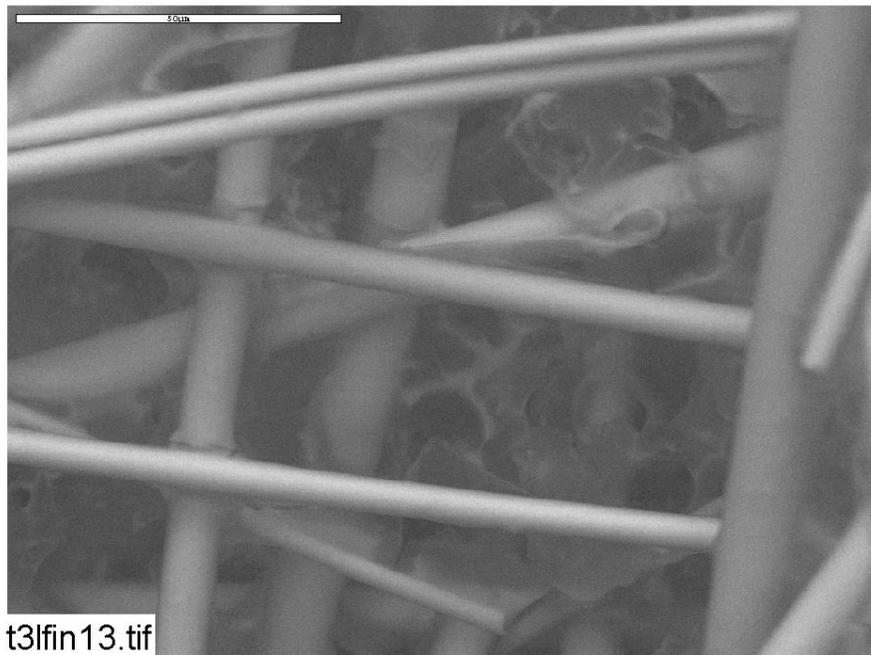
Figure 3-54. ESEM image of a Test #3 Day 30 interior low-flow fiberglass sample, magnified 1000 times. (t3lfin13, 5/6/05)
