Integrated Chemical Effects Test Project: Test #3 Data Report

Los Alamos National Laboratory

**U.S. Nuclear Regulatory Commission
Office of Nuclear Regulatory Research
Washington, DC 20555-0001**

Manuscript Completed: September 2005
Date Published: October 2005

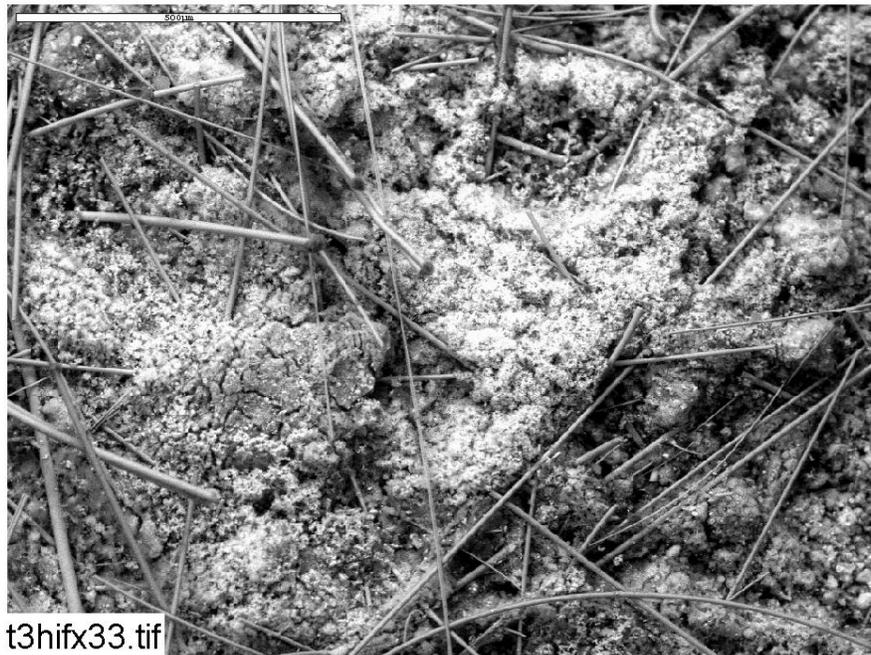
Figure 3-55. ESEM image of a Test #3 Day 30 exterior high-flow fiberglass sample, magnified 100 times. (t3hifx33, 5/11/05)

Compared with other high- and low-flow fiberglass samples, Day 30 high-flow exterior samples contained a significant amount of particulates. As opposed to the exterior samples, the interior samples were relatively clean, suggesting that the particulate deposits were physically attached/retained on the fiberglass exterior. EDS results show that the particulate deposits were composed of a significant amount of P, which is different from the previous fiberglass samples. The deposits' high P, Ca, and O content suggests that the deposits were $\text{Ca}_3(\text{PO}_4)_2$, which relates to the white gel (cream) formed during the injection of TSP. That $\text{Ca}_3(\text{PO}_4)_2$ was likely precipitated out from the testing solution, followed by sedimentation/transportation onto the Day 30 high-flow fiberglass exterior. Figures 3-55 through 3-59 show the Day 30 high-flow fiberglass results.

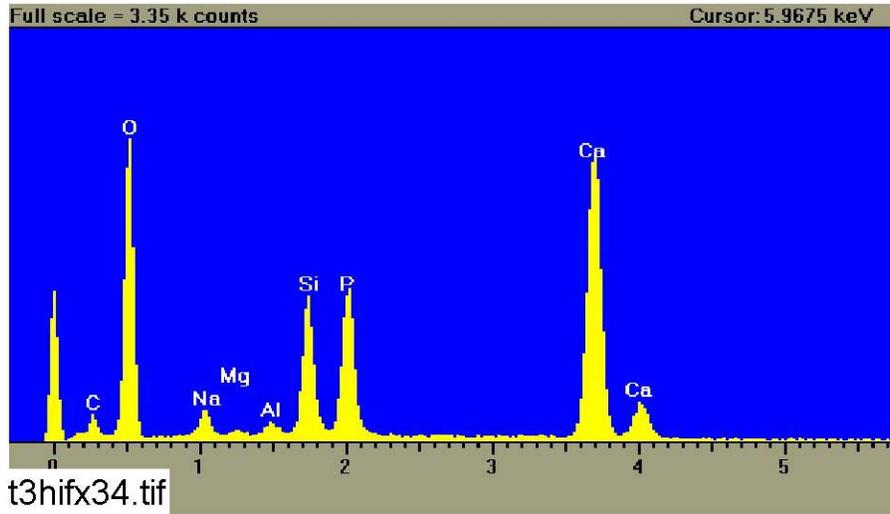
Figure 3-56. EDS counting spectrum for the large masses of particulate deposits shown in Figure 3-55. (t3hifx34, 5/11/05)

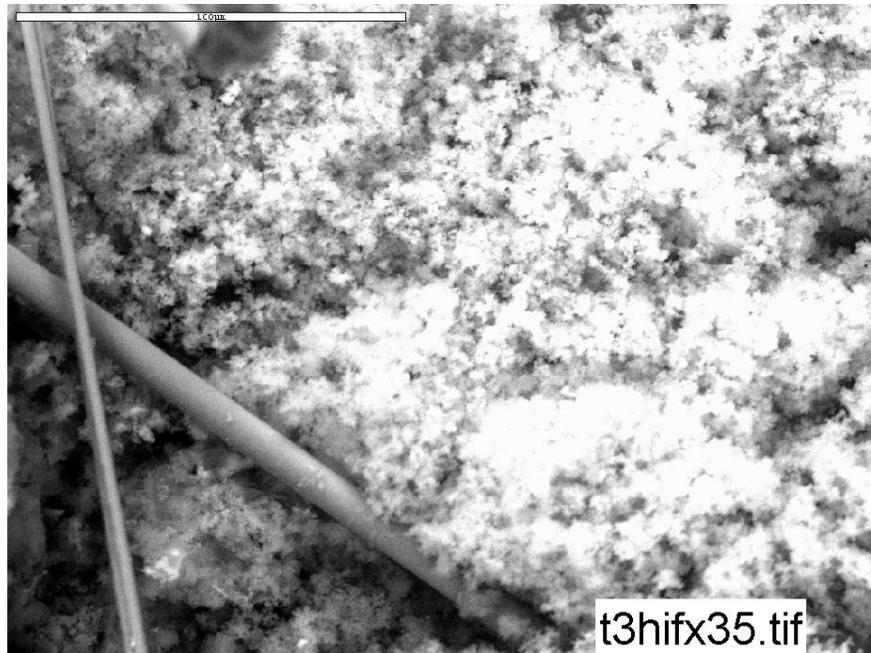
Figure 3-57. ESEM image of a Test #3 Day 30 exterior high-flow fiberglass sample, magnified 600 times. (t3hifx35, 5/11/05)

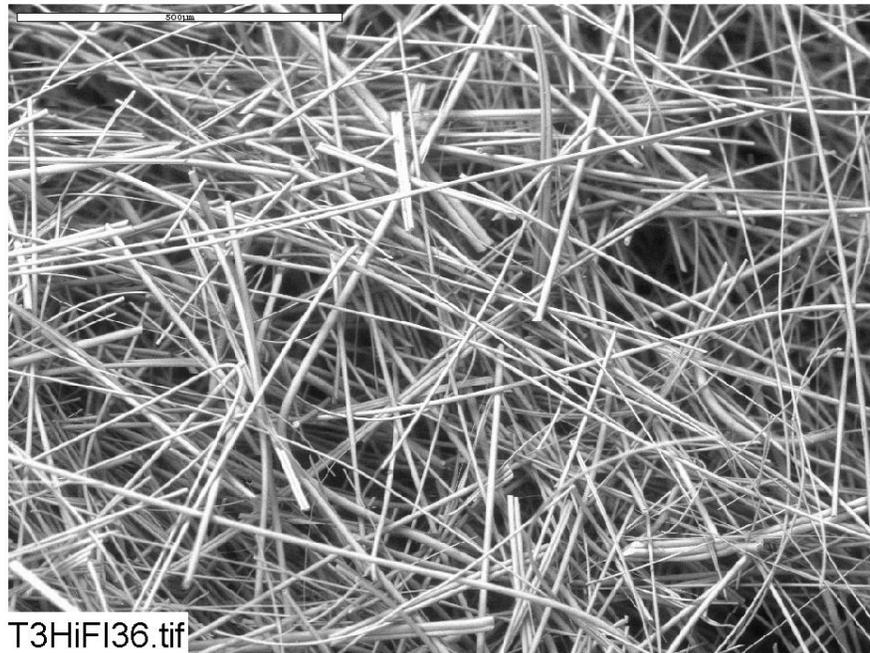
Figure 3-58. ESEM image of a Test #3 Day 30 interior high-flow fiberglass sample, magnified 100 times. (T3HiF136, 5/11/05)

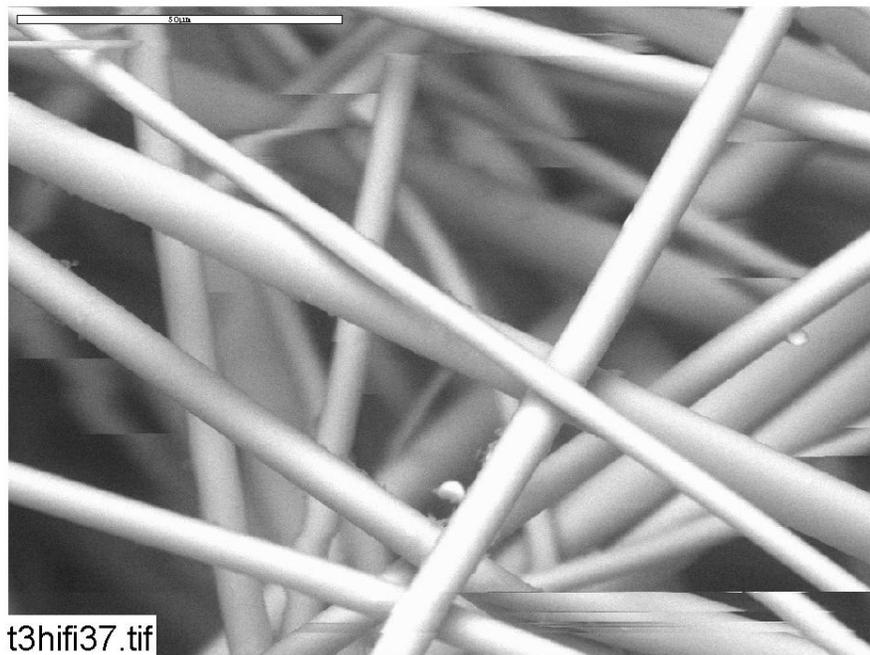
Figure 3-59. ESEM image of a Test #3 Day 30 interior high-flow fiberglass sample, magnified 1000 times. (t3hifi37, 5/11/05)

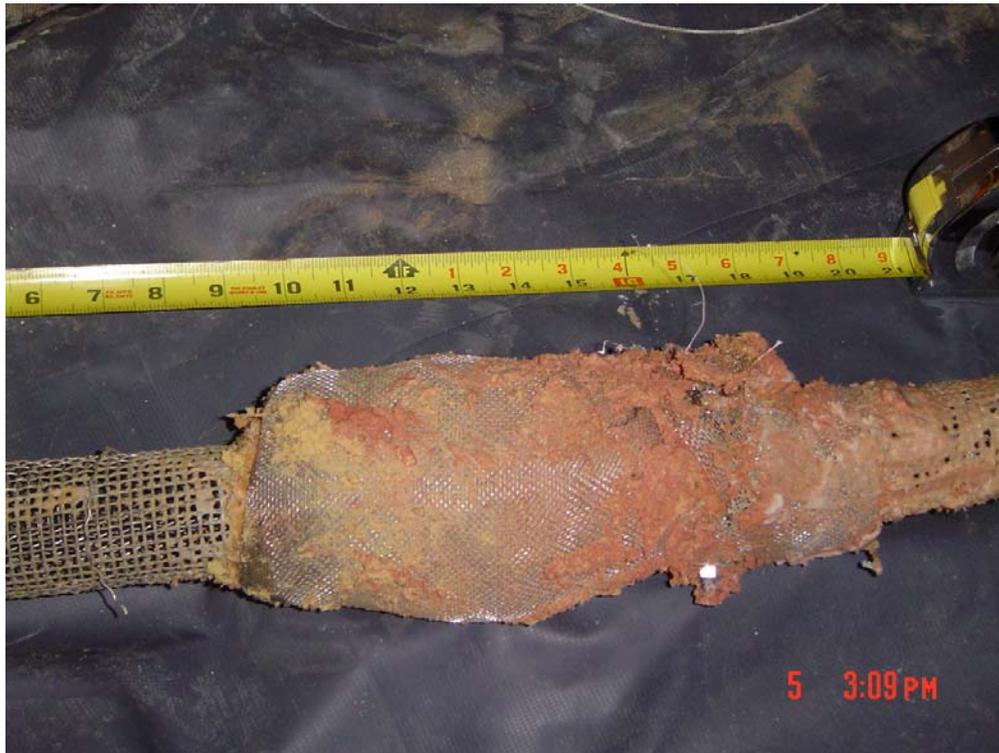
Figure 3-60. Drain screen collar removed from the tank.

Figure 3-60 shows the drain collar after it was removed from the tank. When the tank was drained, the drain collar was totally surrounded by sediment. Both the exterior fiberglass sample that was farthest from the drain screen and the exterior sample that was next to the drain screen have very significant amounts of particulate deposits. Inspection revealed the development of a continuous coating on the drain collar exterior, including particulate deposits that were likely physically retained or attached. The amount of deposits on the drain collar exterior was greater than on high- and low-flow fiberglass samples. The ESEM images showed that two types of material were retained; an amorphous material that appeared darker in the ESEM images and a lighter granular material. The EDS results indicate that these materials had different P and Si content. The lighter particulate deposits (see Figure 3-62) have a higher percentage of P and a lower percentage of Si than the dark deposits, suggesting that light particulate deposits are likely composed of $\text{Ca}_3(\text{PO}_4)_2$ precipitates and dark deposits of cal-sil particles. Both kinds of deposits could have been transported and/or deposited/retained on the drain collar fiberglass exterior. As opposed to what was found on the exterior sample, no significant deposits were found in the drain collar interior sample, suggesting that that almost all of the particulate deposits were physically retained at the fiberglass exterior. The result is consistent with findings for the Day 30 high-flow fiberglass samples. Figures 3-61 through 3-70 show the drain Day 30 drain collar fiberglass results.

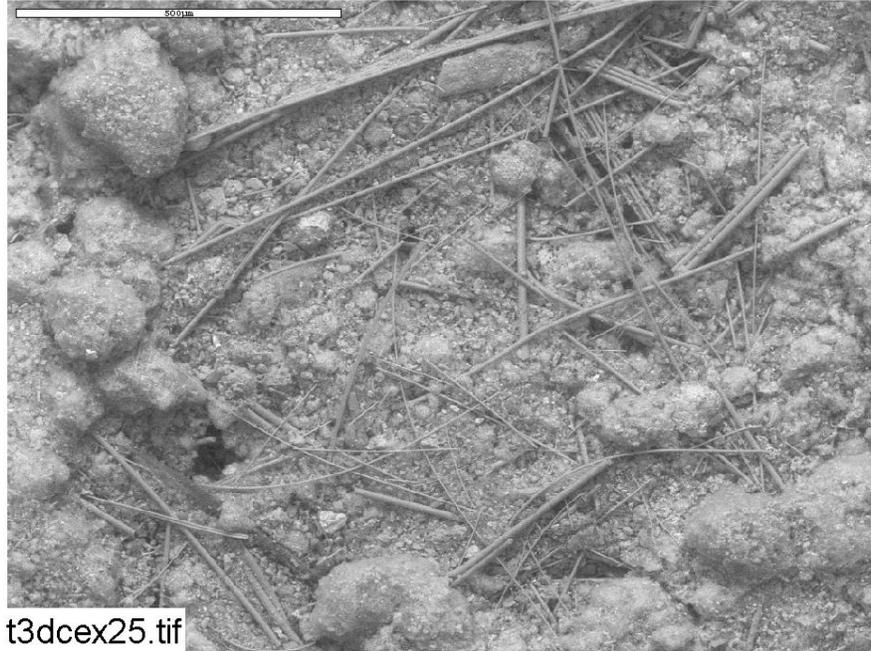
Figure 3-61. ESEM image of a Test #3 Day 30 exterior fiberglass sample on the drain collar (away from the drain screen), magnified 100 times. (t3dcex25, 5/6/05)

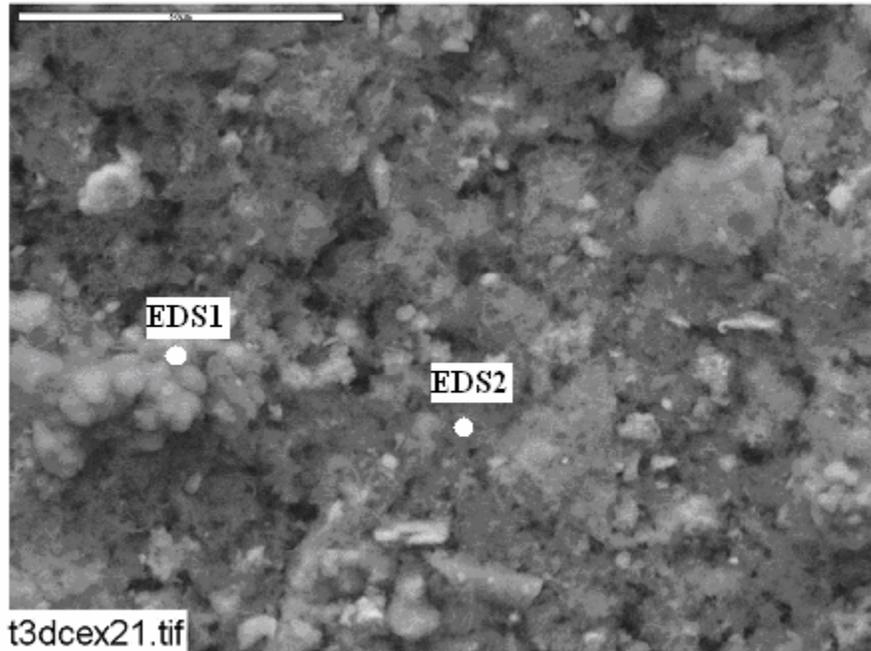
Figure 3-62. ESEM image of a Test #3 Day 30 exterior fiberglass sample on the drain collar (away from the drain screen), magnified 1000 times. (t3dcex21, 5/6/05)

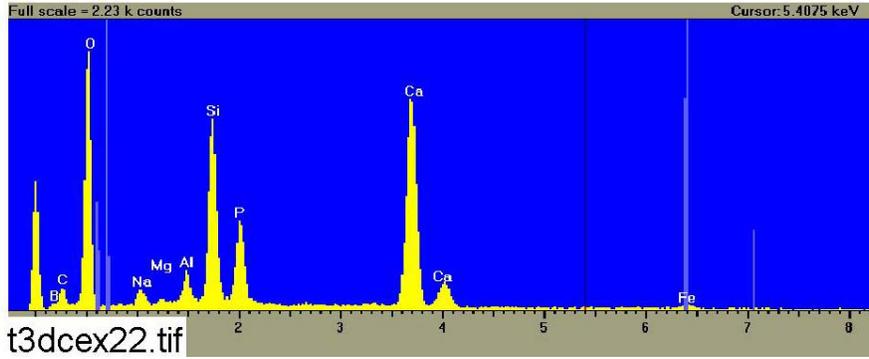
Figure 3-63. EDS counting spectrum for the light particulate deposits (EDS1) shown in Figure 3-62. (t3dcex22, 5/6/05)

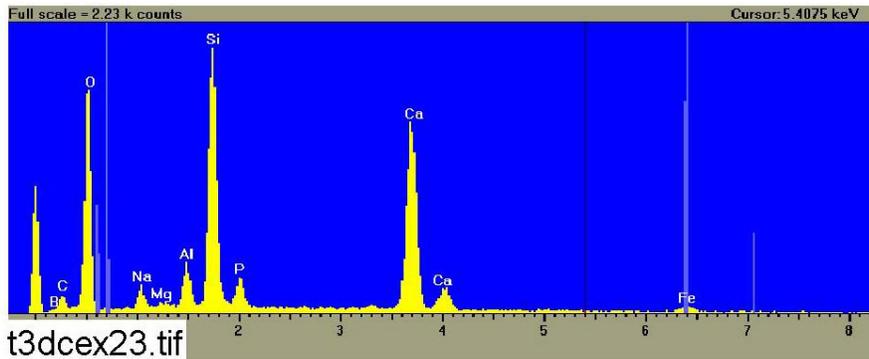
Figure 3-64. EDS counting spectrum for the dark deposits (EDS2) shown in Figure 3-62. (t3dcex23, 5/6/05)

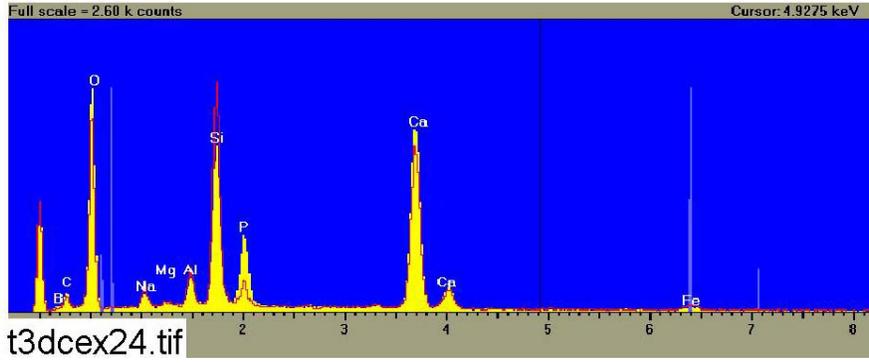
Figure 3-65. Comparison of EDS counting spectra between Figure 3-63 (yellow) and Figure 3-64 (red). (t3dcex24, 5/6/05)

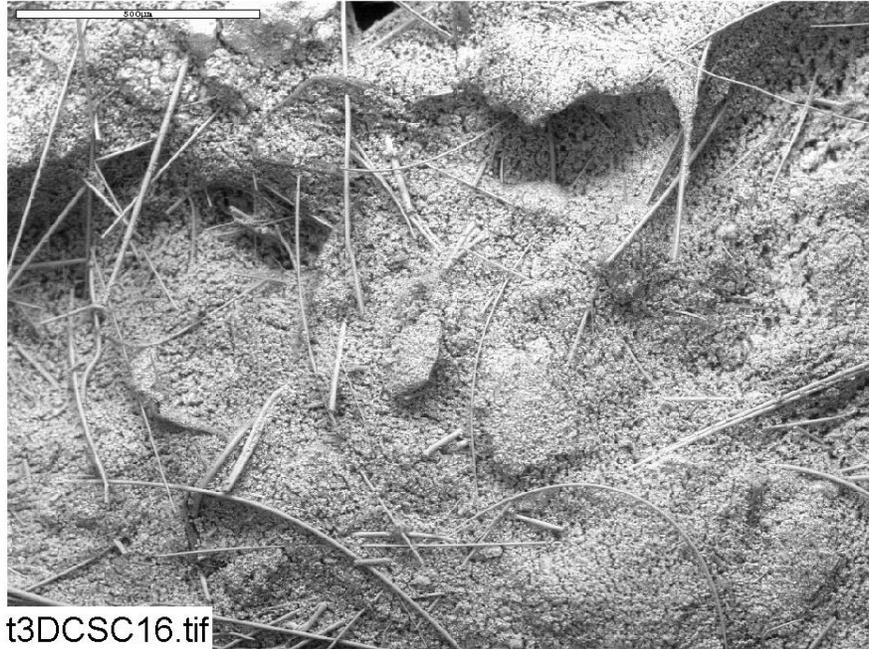
Figure 3-66. ESEM image of a Test #3 Day 30 exterior fiberglass sample on the drain collar (adjacent to the drain screen), magnified 100 times. (t3DCSC16, 5/6/05)

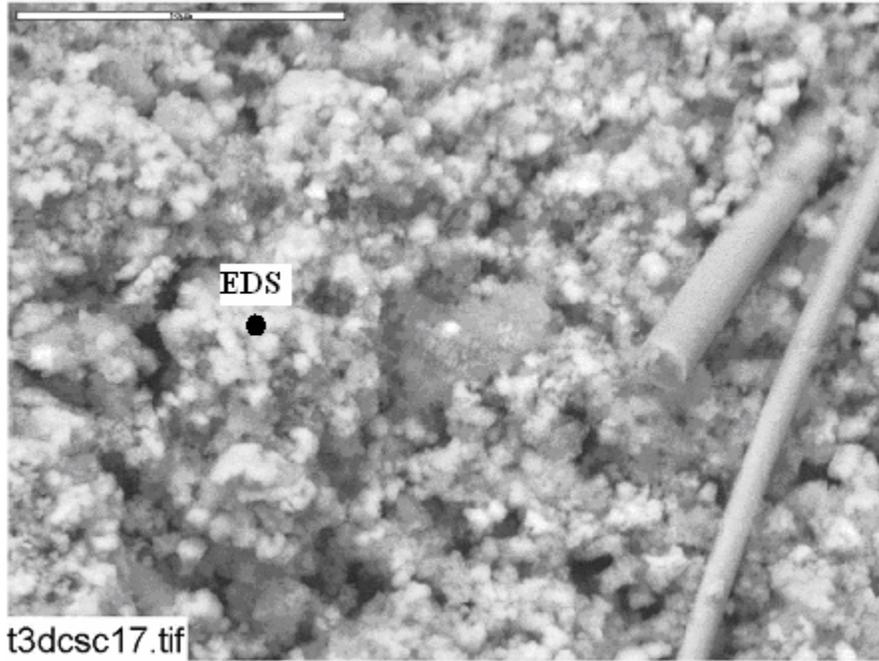
Figure 3-67. ESEM image of a Test #3 Day 30 exterior fiberglass sample on the drain collar (adjacent to the drain screen), magnified 1000 times. (t3dcsc17, 5/6/05)

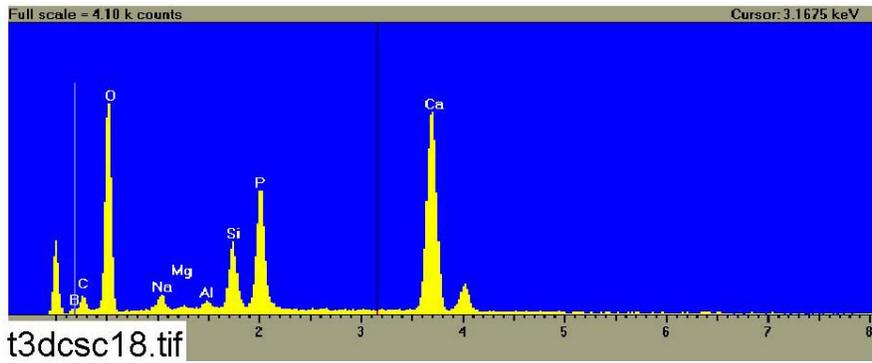
Figure 3-68. EDS counting spectrum for the particulate deposits shown in Figure 3-67. (t3dcsc18, 5/6/05)

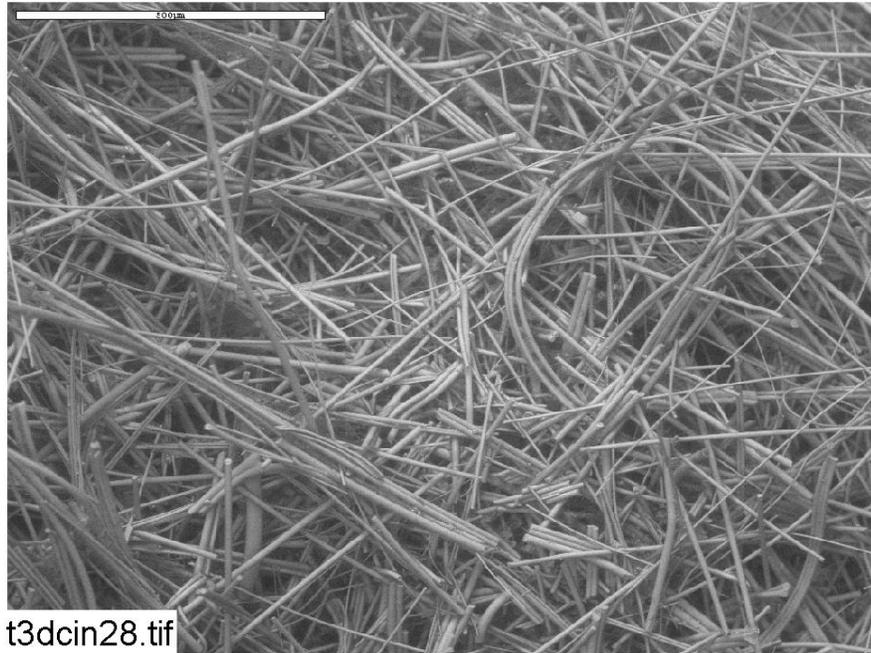
Figure 3-69. ESEM image of a Test #3 Day 30 interior fiberglass sample on the drain collar, magnified 100 times. (t3dcin28, 5/6/05)

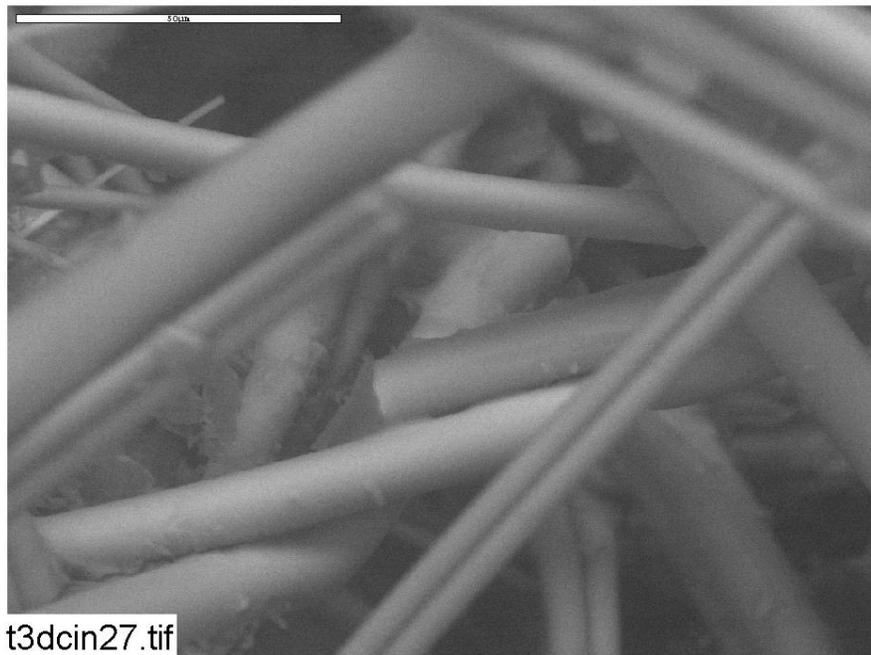
Figure 3-70. ESEM image of a Test #3 Day 30 interior fiberglass sample on the drain collar, magnified 1000 times. (t3dcin27, 5/6/05)

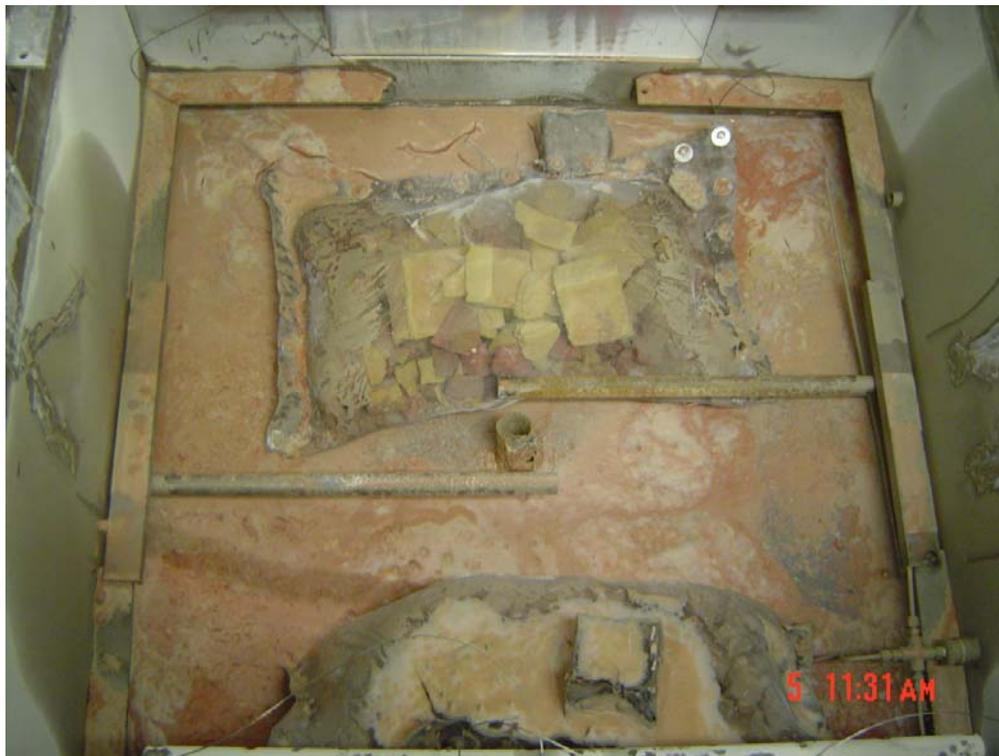
Figure 3-71. Tank bottom after the test fluid was drained.

The test fluid was drained from the tank at the end of the 30-day test. Figure 3-71 shows the bottom of the tank after the tank was emptied. The birdcage is the cube in the center bottom of the figure, covered on its top with and sitting in light-colored gel-like material. For the Day 30 fiberglass sample within the birdcage, SEM images indicate large deposits (Figure 3-72) as well as a continuous coating (Figure 3-74) over the exterior of the fiberglass. The amount of particulate deposits within the birdcage was greater than on high- and low-flow fiberglass samples. The EDS result shows that the large particulate deposits had higher P and lower Si percentages than did the continuous coating shown in Figure 3-74. As with the particulate deposits on the drain collar, the large deposits are likely composed of $\text{Ca}_3(\text{PO}_4)_2$ precipitates, while the continuous coating was likely cal-sil particles. Both kinds of deposits were physically transported and/or deposited/retained on the birdcage fiberglass exterior. Compared with the exterior sample, the interior sample was relatively clean. Only small amounts of deposits were found. These deposits were similar to the deposits observed on high- and low-flow interior samples, which were likely caused by chemical precipitation during the drying process. Again, this result suggests that almost all of the particulate deposits were physically retained at the fiberglass exterior, consistent with conditions on the Day 30 high-flow and drain-collar fiberglass samples. Figures 3-72 through 3-79 show the Day 30 birdcage fiberglass results.

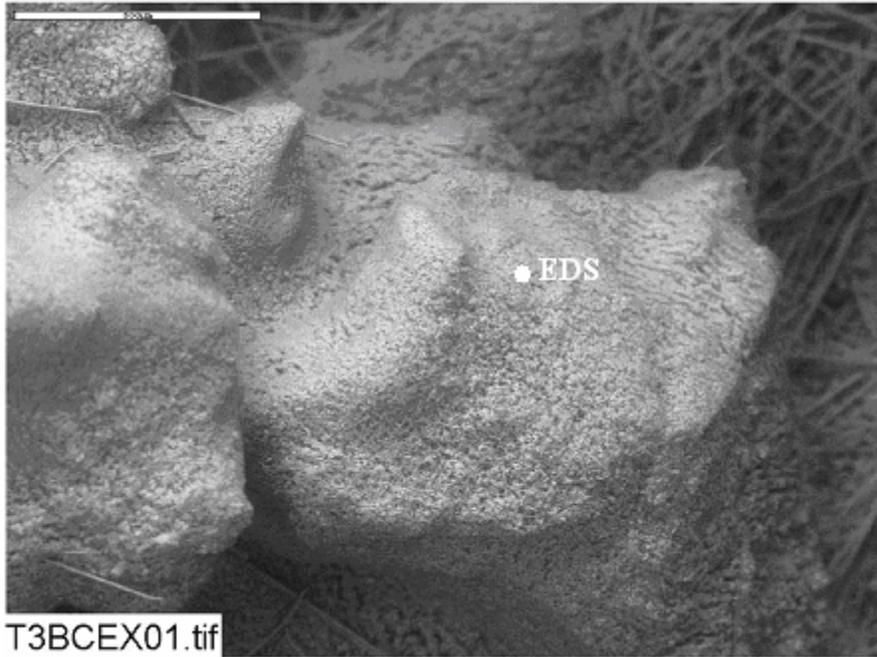
Figure 3-72. ESEM image of a Test #3 Day 30 exterior fiberglass sample within the birdcage, magnified 80 times. (T3BCEX01, 5/6/05)

Figure 3-125. Comparison of EDS counting spectra for Figure 3-124 (yellow: the gel-like materials shown in figure 3-123) and Figure 3-73 (red: the large deposits taken from the birdcage exterior shown in Figure 3-72). (t3geled7, 5/6/05)

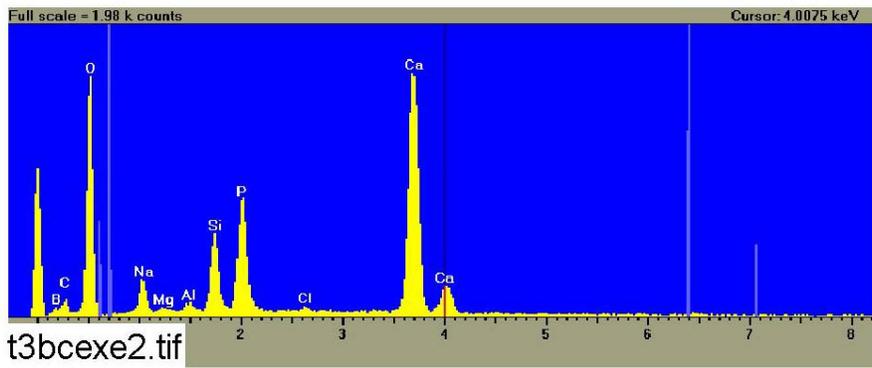
Figure 3-73. EDS counting spectrum for the large deposits shown in Figure 3-72. (t3bcexe2, 5/6/05)

Figure 3-77. Comparison of EDS counting spectra of Figure 3-76 (red) and Figure 3-73 (yellow). (t3bcexe3, 5/6/05)

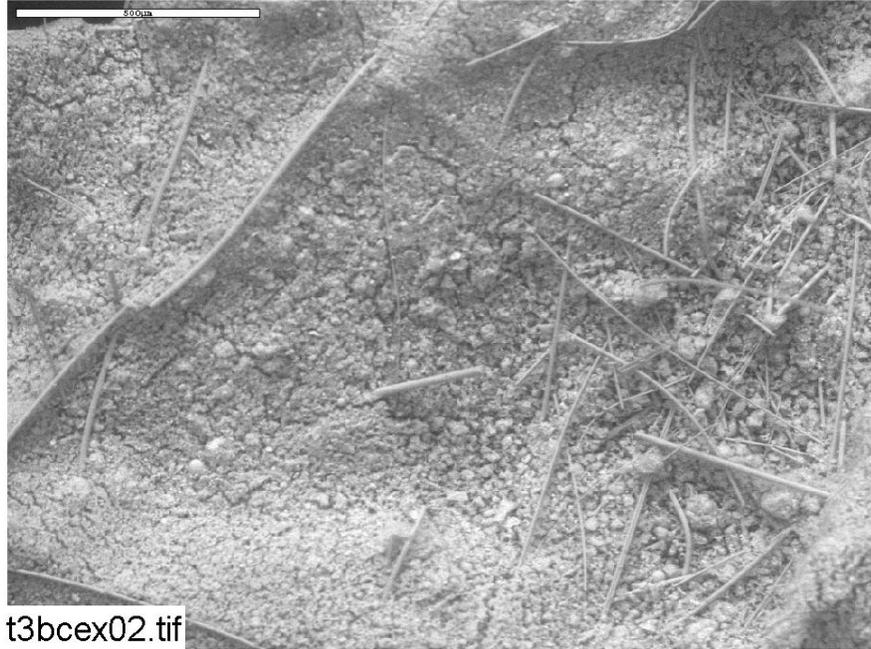
Figure 3-74. ESEM image of a Test #3 Day 30 exterior fiberglass sample within the birdcage, magnified 80 times. (t3bcex02, 5/6/05)

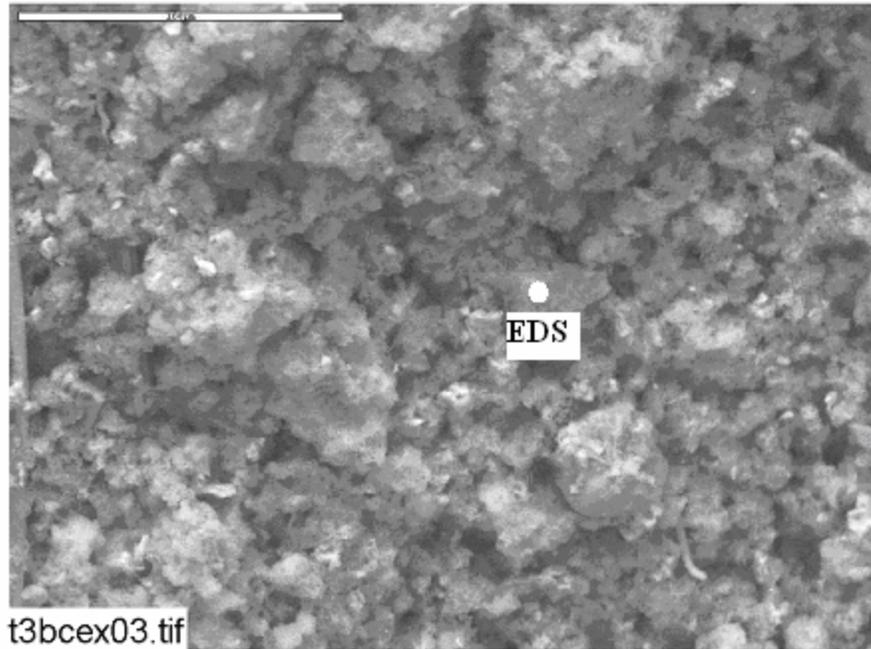
Figure 3-75. ESEM image of a Test #3 Day 30 exterior fiberglass sample within the birdcage, magnified 500 times. (t3bcex03, 5/6/05)

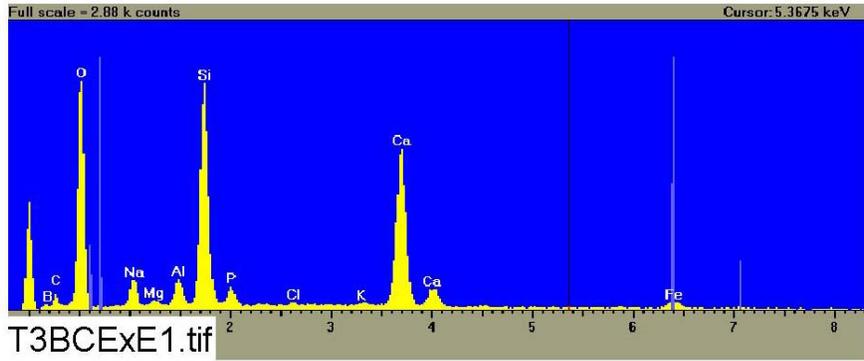
Figure 3-76. EDS counting spectrum for the deposits shown in Figure 3-75. (T3BCExE1, 5/6/05)

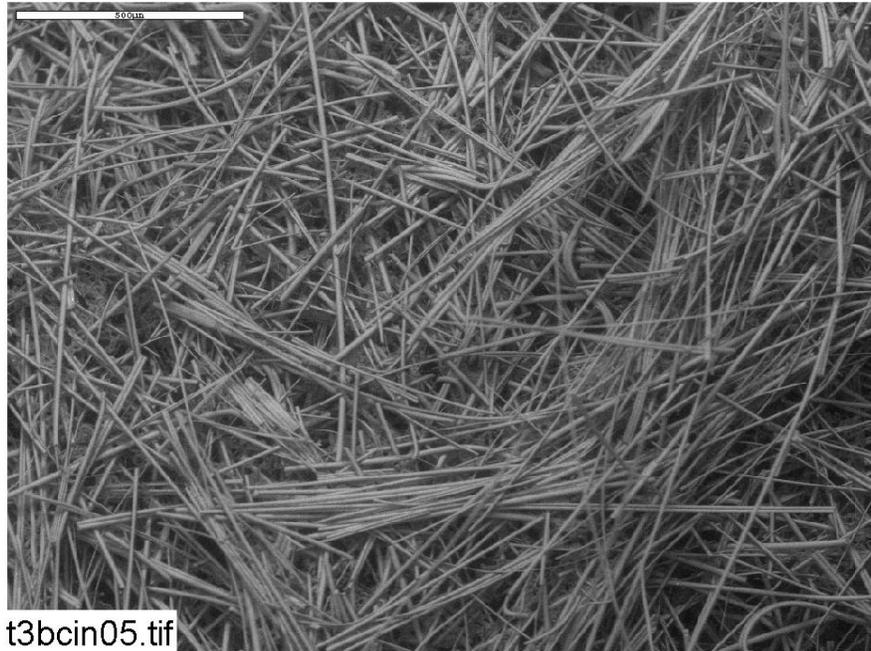
Figure 3-78. ESEM image of a Test #3 Day 30 interior fiberglass sample within the birdcage, magnified 80 times. (t3bcin05, 5/6/05)

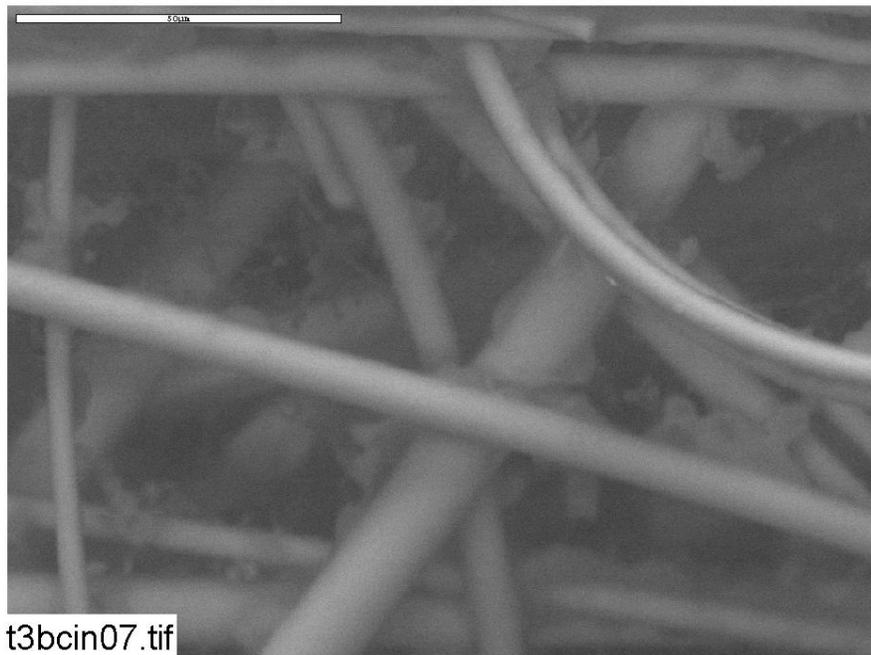
Figure 3-79. ESEM image of a Test #3 Day 30 interior fiberglass sample within the birdcage, magnified 1000 times. (t3bcin07, 5/6/05)

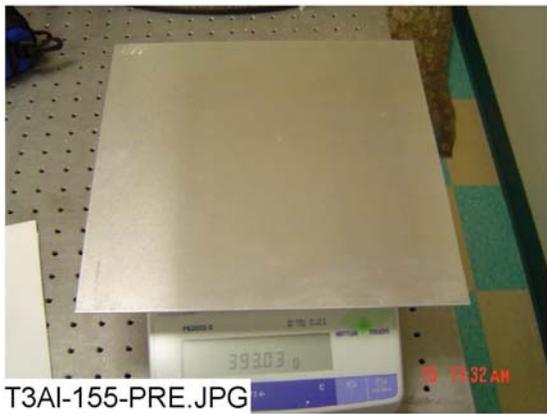
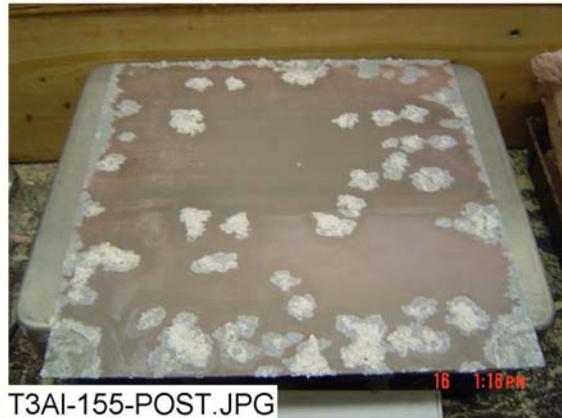
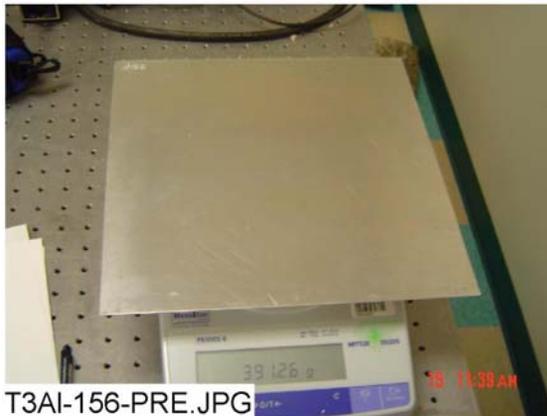
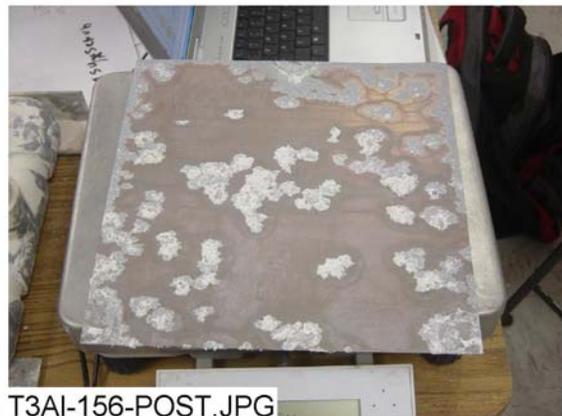
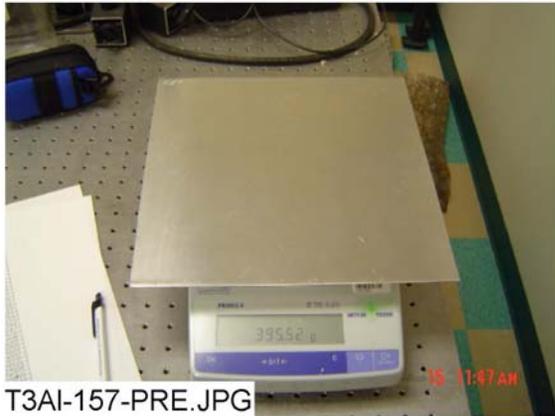
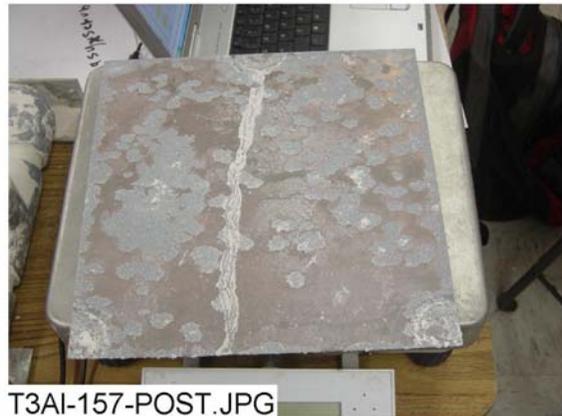
Figure 3-80. Al-155, submerged, pre-test.

Figure 3-81. Al-155, submerged, post-test.

Figure 3-82. Al-156, submerged, pre-test.

Figure 3-83. Al-156 submerged, post-test.

Figure 3-84. Al-157, submerged, pre-test.

Figure 3-85. Al-157, submerged, post-test.

There are three submerged aluminum coupons in each test. Figures 3-80 through 3-85 display the pre- and post-test pictures of those coupons that were in Test #3. Each post-test aluminum coupon exhibits a pattern of white particulate deposition. In addition, each post-test coupon is a light reddish-brown, which may be attributable to copper's leaching into the test solution. The particulate deposition patterns for post-test aluminum coupons 155 and 156 are similar. However, the deposition pattern for the post-test Al-157 possesses a grayish tint, and a stream of white deposition runs from the rack contact point at the top to the bottom of the coupon. The relative spatial location of these coupons, given in order from the west side of the tank to the east side of the tank, is as follows: Al-155, Al-156, and Al-157. The concentration of particles increases slightly from the western-most coupon to the eastern-most coupon.

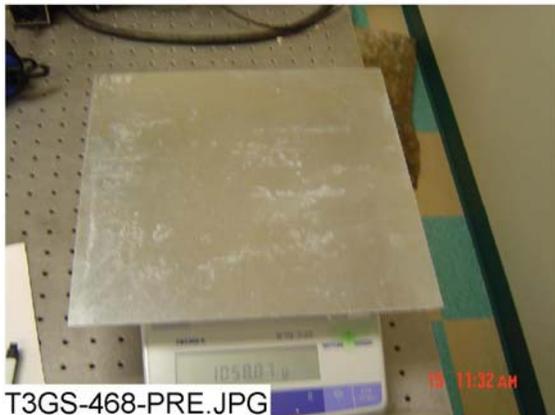
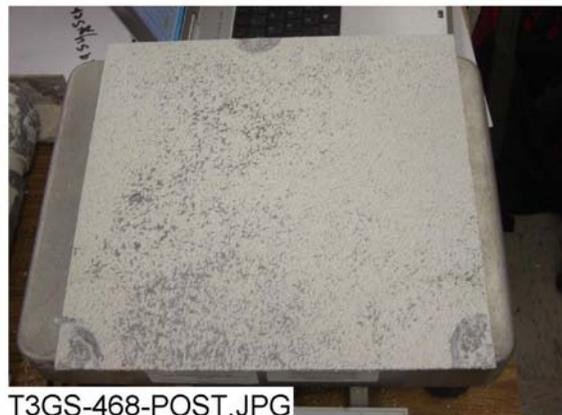
Figure 3-86. GS-468, submerged, pre-test.

Figure 3-87. GS-468, submerged, post-test.

The galvanized steel coupons exhibited nearly identical patterns of dense gray particle deposition. Figures 3-86 and 3-87 present the pre- and post-test pictures of one submerged galvanized steel coupon. There were no observable differences in post-test appearance based on the coupon's location in the rack.

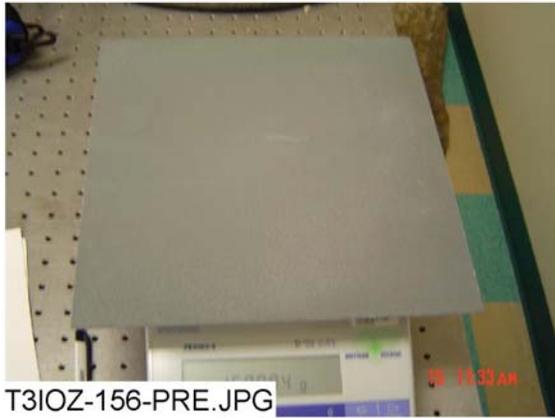
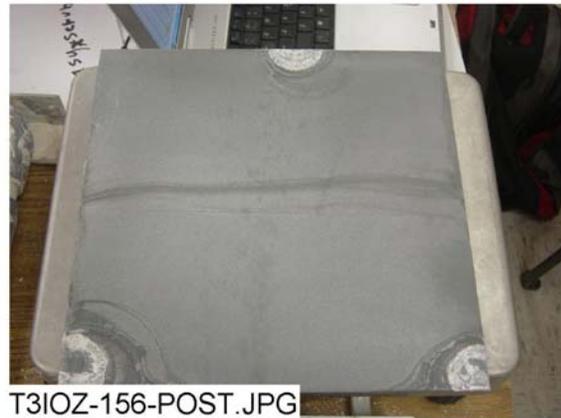
Figure 3-88. IOZ-156, submerged, pre-test.

Figure 3-89. IOZ-156, submerged, post-test.

Figures 3-88 and 3-89 present the pre- and post-test pictures of a typical submerged IOZ-coated steel coupon. Each post-test coated steel coupon exhibited a similar pattern of white particle deposition.

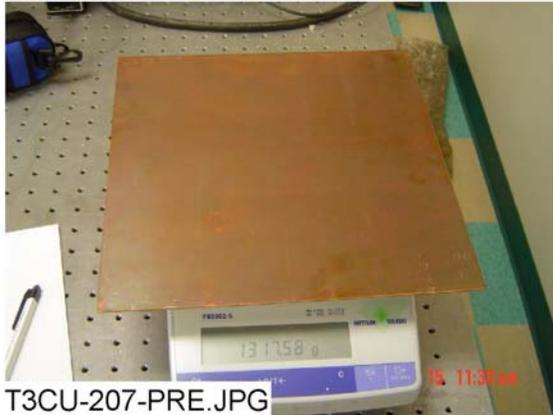
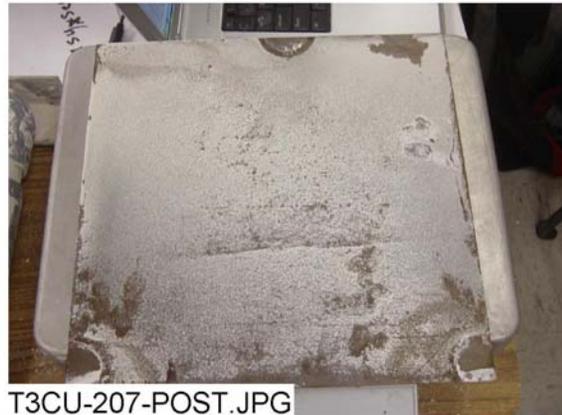
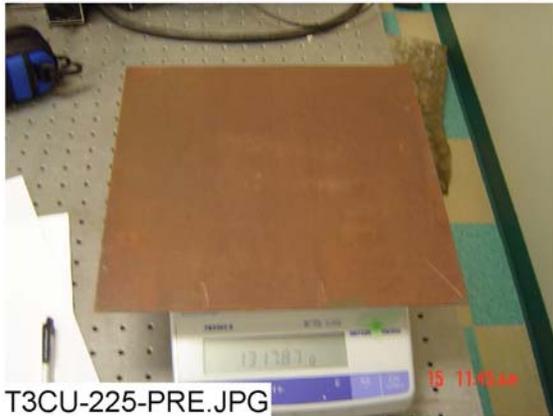
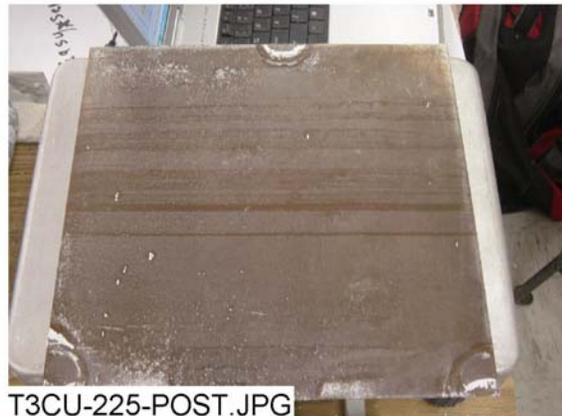
Figure 3-90. CU-207 submerged, pre-test.

Figure 3-91. CU-207, submerged, post-test.

Figure 3-92. CU-225, submerged, pre-test.

Figure 3-93. CU-225, submerged, post-test.

Figures 3-90 through 3-93 present the pre- and post-test pictures of two submerged copper coupons. The patterns of white deposition are different for these post-test coupons. The CU-207 post-test coupon is almost completely covered with a dense collection of white deposits. The CU-225 post-test coupon, in contrast, exhibits faint horizontal streak-lines of white deposits. The CU-207 coupon was located on the west side of the tank in relation to the CU-225 coupon. The CU-207 coupon gained 1.2 g, while the CU-225 coupon lost 0.1 g.

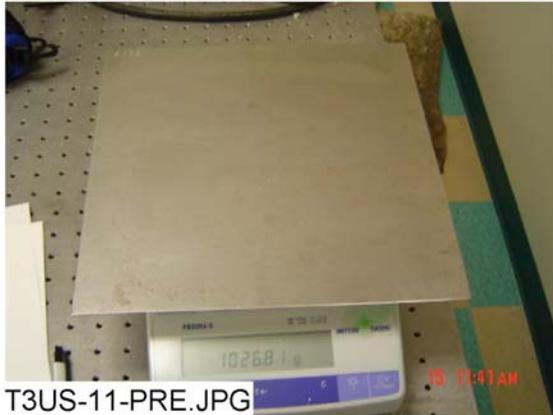
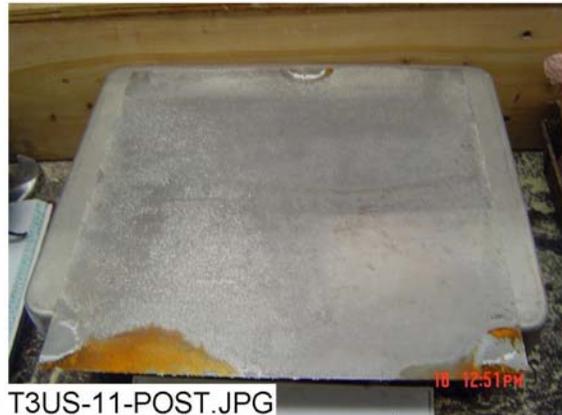
Figure 3-94. US-11, submerged, pre-test.

Figure 3-95. US-11, submerged, post-test.

Figures 3-94 and 3-95 present the pre- and post-test pictures of the single submerged carbon steel coupon. It has a light coating of white deposits over a large portion of the surface area. Also, there is observable rust along the bottom edge of the coupon. The rust deposits are mainly congregated near the lower corners of the coupon, near the rack's contact points. Differences in corrosion or deposits at the location of the coupon rack contact points may have been due to stagnant solution conditions that may have limited mass transfer to or from the surface and caused local differences in solution composition. Coupon US-11 lost 1.1 g.

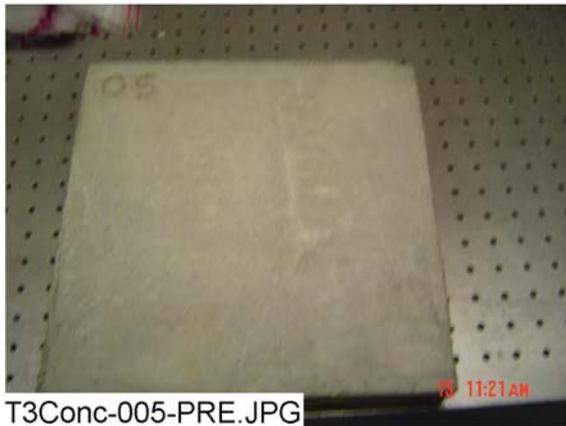
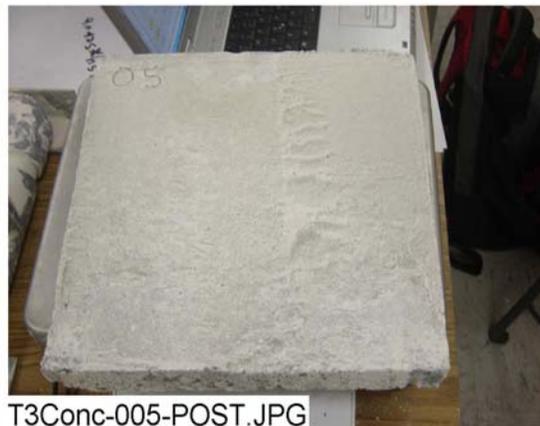
Figure 3-96. Conc-005, submerged, pre-test.

Figure 3-97. Conc-005, submerged, post-test.

Figures 3-96 and 3-97 present the pre- and post-test pictures of the submerged concrete coupon. The post-test concrete coupon exhibits an enhanced gray compared with the pre-test coupon. The concrete coupon gained 180.5 g, which is estimated to be primarily water absorption.

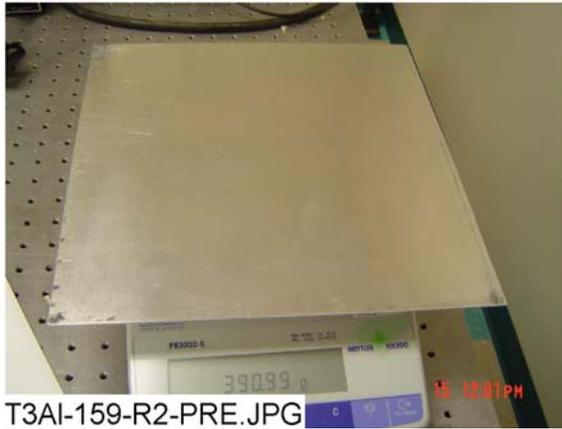
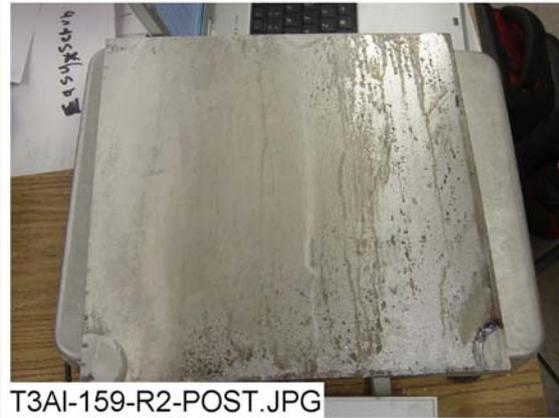
Figure 3-98. Al-159, unsubmerged, pre-test.

Figure 3-99. Al-159, unsubmerged, post-test.

Figures 3-98 and 3-99 show the pre- and post-test pictures of a typical unsubmerged aluminum coupon. The coupons exhibit a light pattern of deposition. Also, each post-test coupon has coarser texture and a less-lustrous surface.

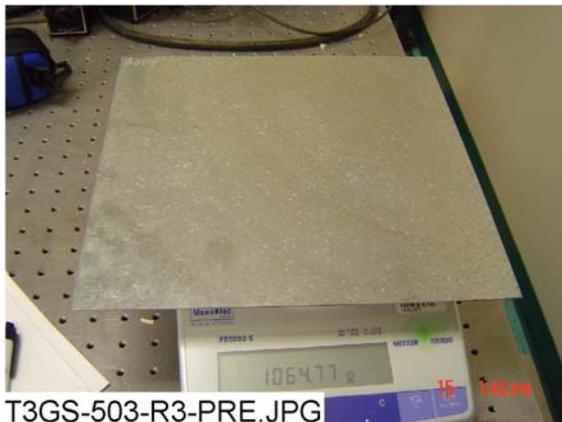
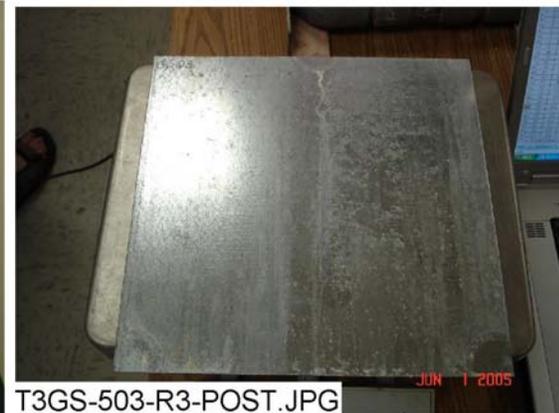
Figure 3-100. GS-503, unsubmerged, pre-test.

Figure 3-101. GS-503, unsubmerged, post-test.

Figures 3-100 and 3-101 show the pre- and post-test pictures of a typical unsubmerged galvanized steel coupon. Each post-test galvanized steel coupon exhibited a similar light deposition.

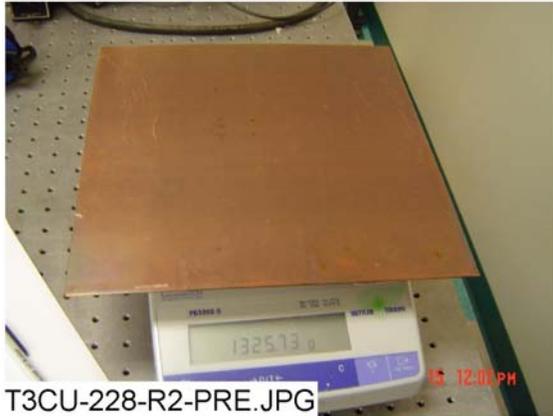
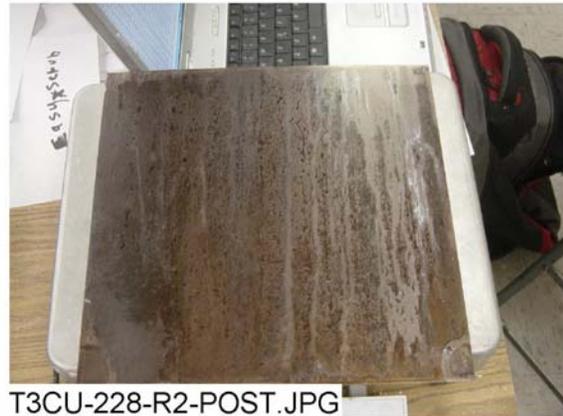
Figure 3-102. CU-228, unsubmerged, pre-test.

Figure 3-103. CU-228 unsubmerged, post-test.

Figures 3-101 and 3-102 present the pre- and post-test pictures of a typical unsubmerged copper coupon. Each post-test copper coupon exhibited a similar pattern of streak-like deposition.

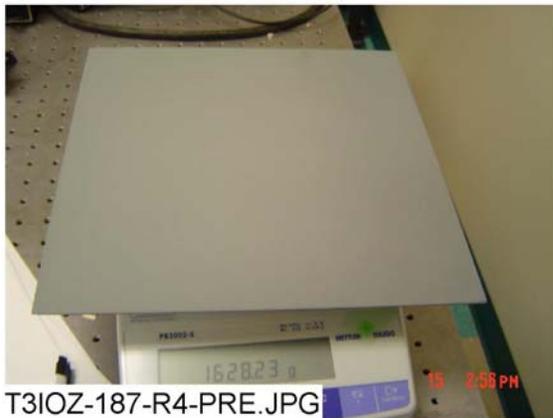
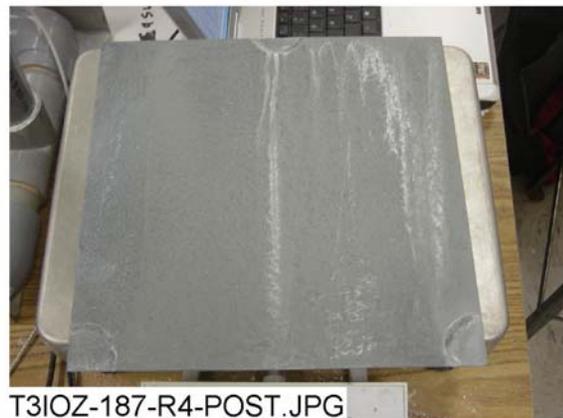
Figure 3-104. IOZ-187, unsubmerged, pre-test.

Figure 3-105. IOZ-187, unsubmerged, post-test.

Figures 3-104 and 3-105 present the pre- and post-test pictures of a typical unsubmerged IOZ-coated steel coupon. Each post-test coated steel coupon exhibited a similar pattern of deposition.

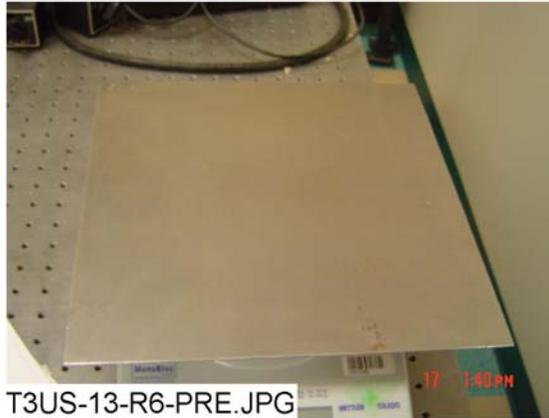
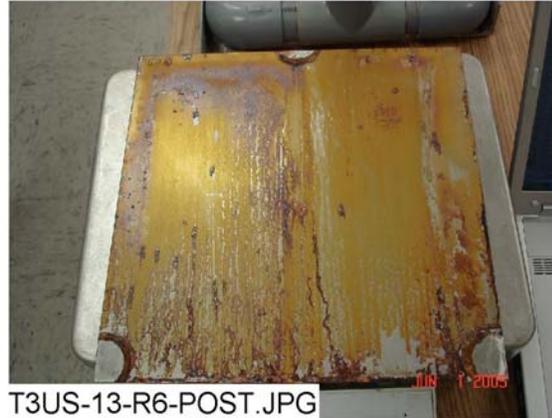
Figure 3-106. US-13, unsubmerged, pre-test.

Figure 3-107. US-13, unsubmerged, post-test.

Figures 3-106 and 3-107 present the pre- and post-test pictures of a typical unsubmerged carbon steel coupon. The post-test carbon steel coupons turned reddish-brown and exhibited slight corrosion around the edges.
