Integrated Chemical Effects Test Project: Test #3 Data Report

Los Alamos National Laboratory

**U.S. Nuclear Regulatory Commission
Office of Nuclear Regulatory Research
Washington, DC 20555-0001**

Manuscript Completed: September 2005
Date Published: October 2005

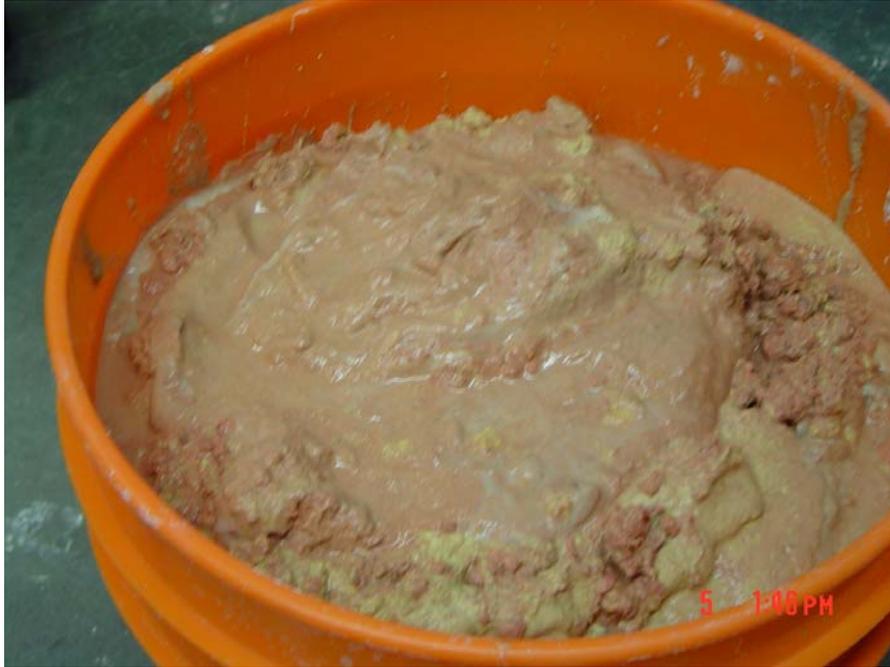
Figure 3-108. Sediment removed from the tank. Some gel appears on the top.

Sediment was collected from the tank bottom after the test solution was drained. It consisted of two main macroscopic quantities, a particulate sediment on the bottom covered in many places with a whitish-pink gel-like material. Figure 3-108 shows this sediment. In addition, Figure 3-109 shows SS mesh holding insulation samples after it was pulled from the tank bottom. The pink and yellow particulate sediment covers much of the mesh, and the gel-like material is seen above it and is being pointed to in the figure.

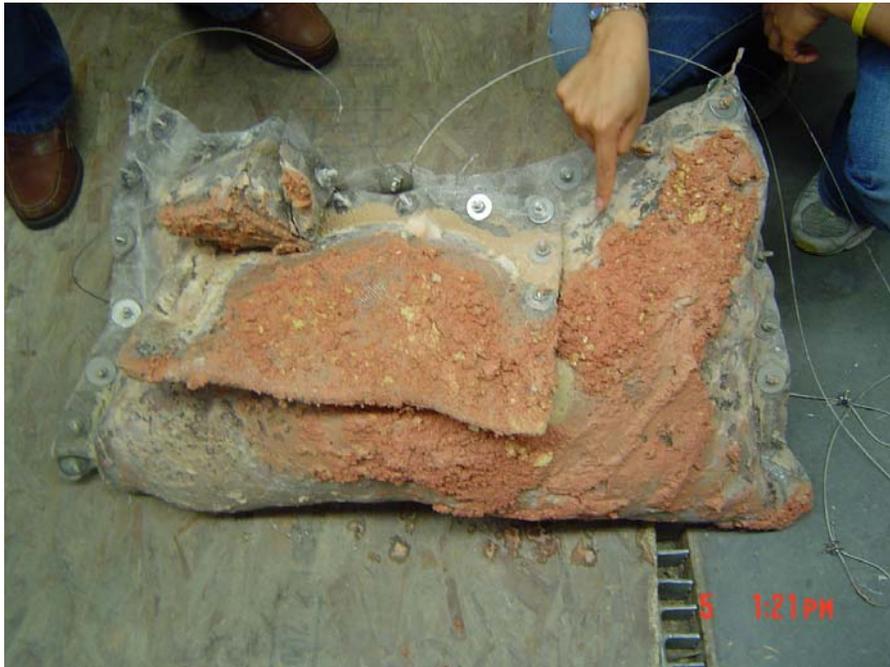
Figure 3-109. Samples removed from the tank bottom.

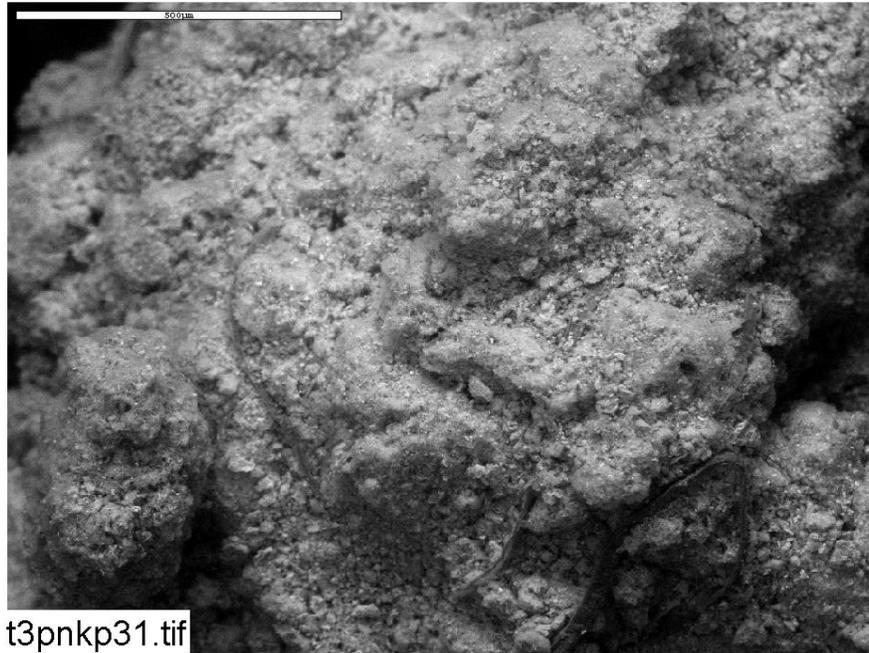
Figure 3-110. ESEM image of a Test #3 Day 30 pink sediment, magnified 100 times. (t3pnkp31, 5/6/05)

The particulate sediment samples were identified and classified by their color: pink or yellow. The yellow or pink sediments were large enough (pea-sized or larger) to be visually seen and picked up from the bulk sediment. The pink sediment likely originated from baked cal-sil debris and the yellow sediment from unbaked cal-sil debris. ESEM/EDS and XRD/XRF analysis provided the information on the morphology and composition of these sediments. EDS results show that there is no significant compositional difference between the yellow and pink sediments. Both contain significant amounts of Si, Ca, and O. XRF results consistently show that Si and Ca are the major elements in the mixed sediments. However, P (present in phosphorus pentoxide, P_2O_5) is less than 2% of the total mass, possibly because Test #3 precipitates containing P make up a smaller portion of the total debris than do particles originating from cal-sil.

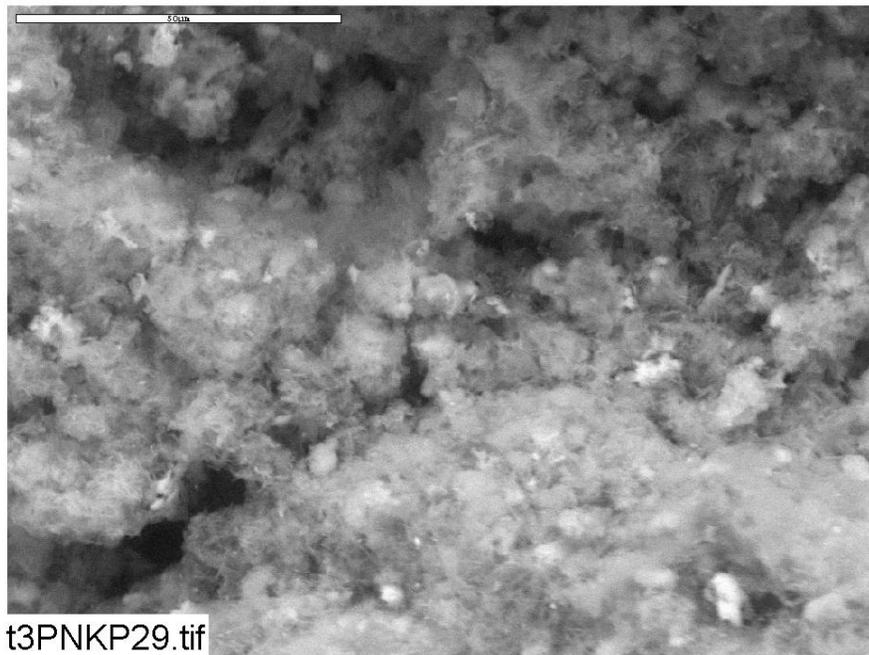
Table 3-111. ESEM image of a Test #3 Day 30 pink sediment, magnified 1000 times. (t3PNKP29, 5/6/05)

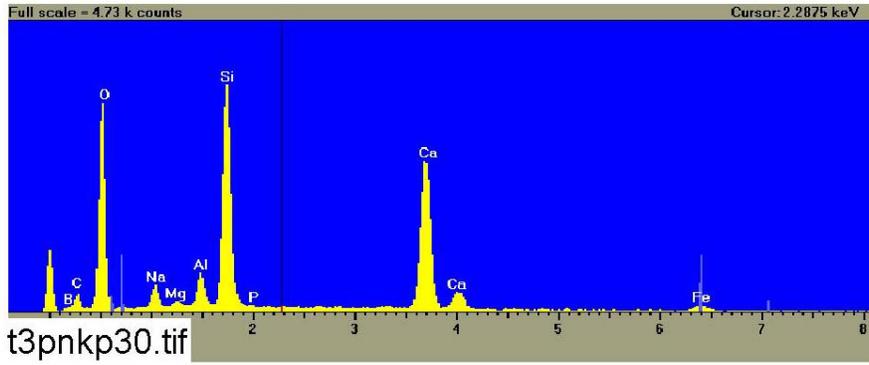
Table 3-112. EDS counting spectrum for the sediment shown in Figure 3-111. (t3pnkp30, 5/6/05)

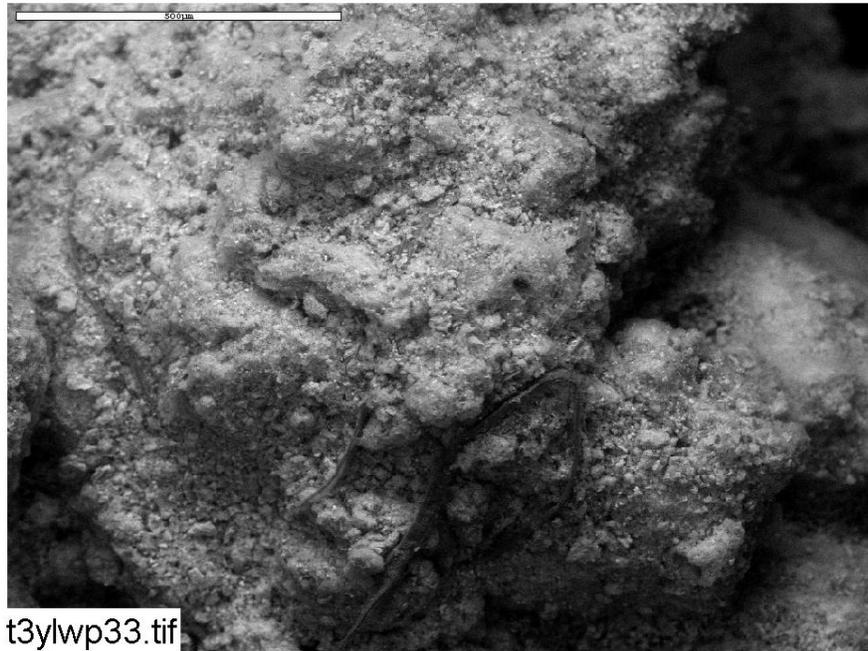
Figure 3-113. ESEM image of a Test #3 Day 30 yellow sediment, magnified 100 times. (t3ylwp33, 5/6/05)

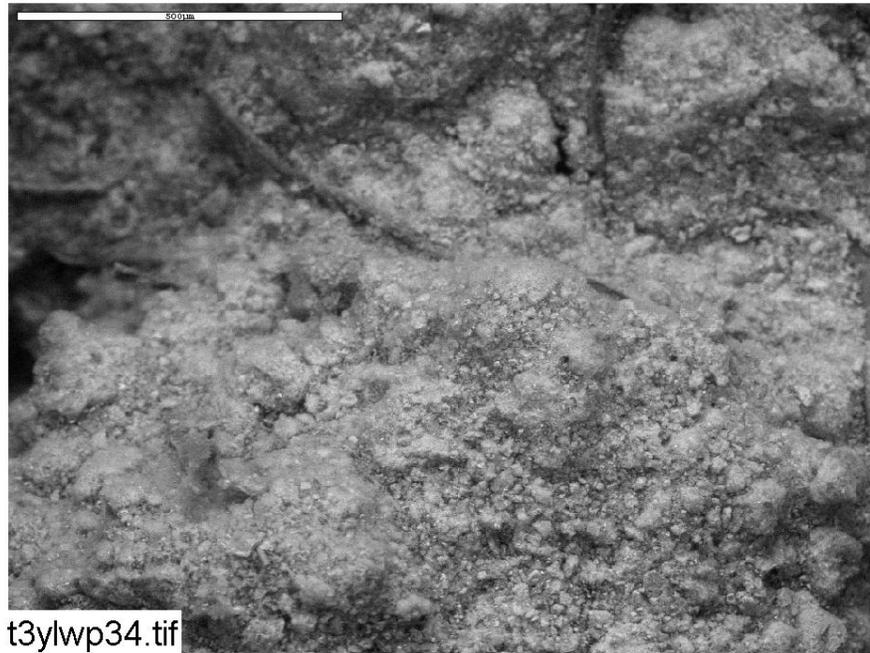
Figure 3-114. ESEM image of a Test #3 Day 30 yellow sediment, magnified 100 times. (t3ylwp34, 5/6/05)

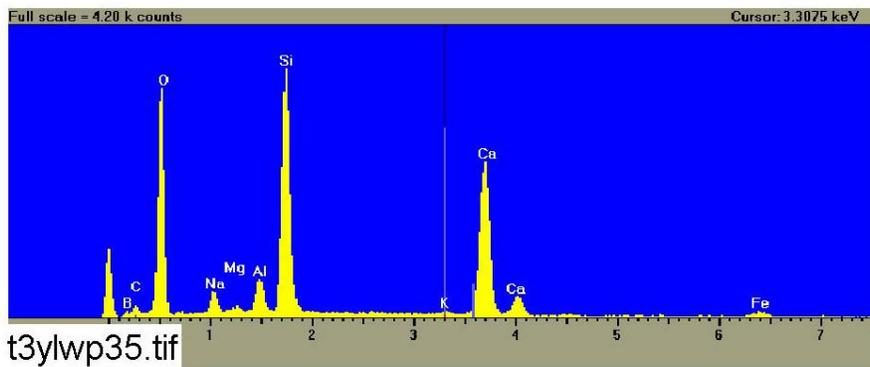
Figure 3-115. EDS counting spectrum for the particles shown in Figure 3-114. (t3ylwp35, 5/6/05)

Figure 3-116. Comparison of EDS counting spectra for pink sediment
(yellow, t3pnkp30) and yellow sediment (red, t3ylwp35). (t3ylwp36, 5/6/05)..... 86

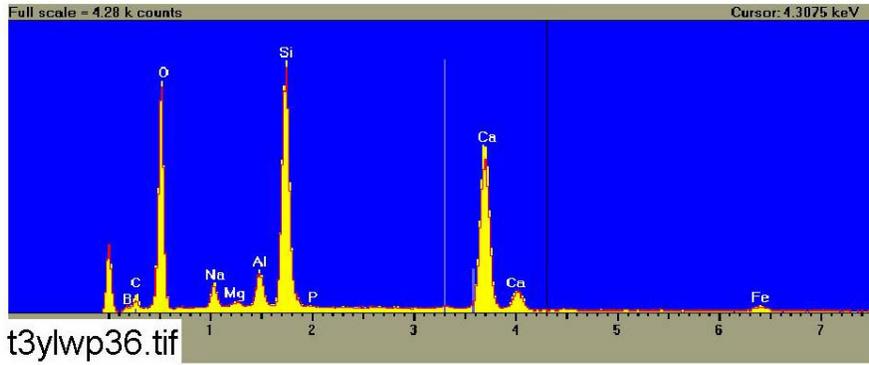
Figure 3-116. Comparison of EDS counting spectra for pink sediment (yellow, t3pnkp30) and yellow sediment (red, t3ylwp35). (t3ylwp36, 5/6/05)

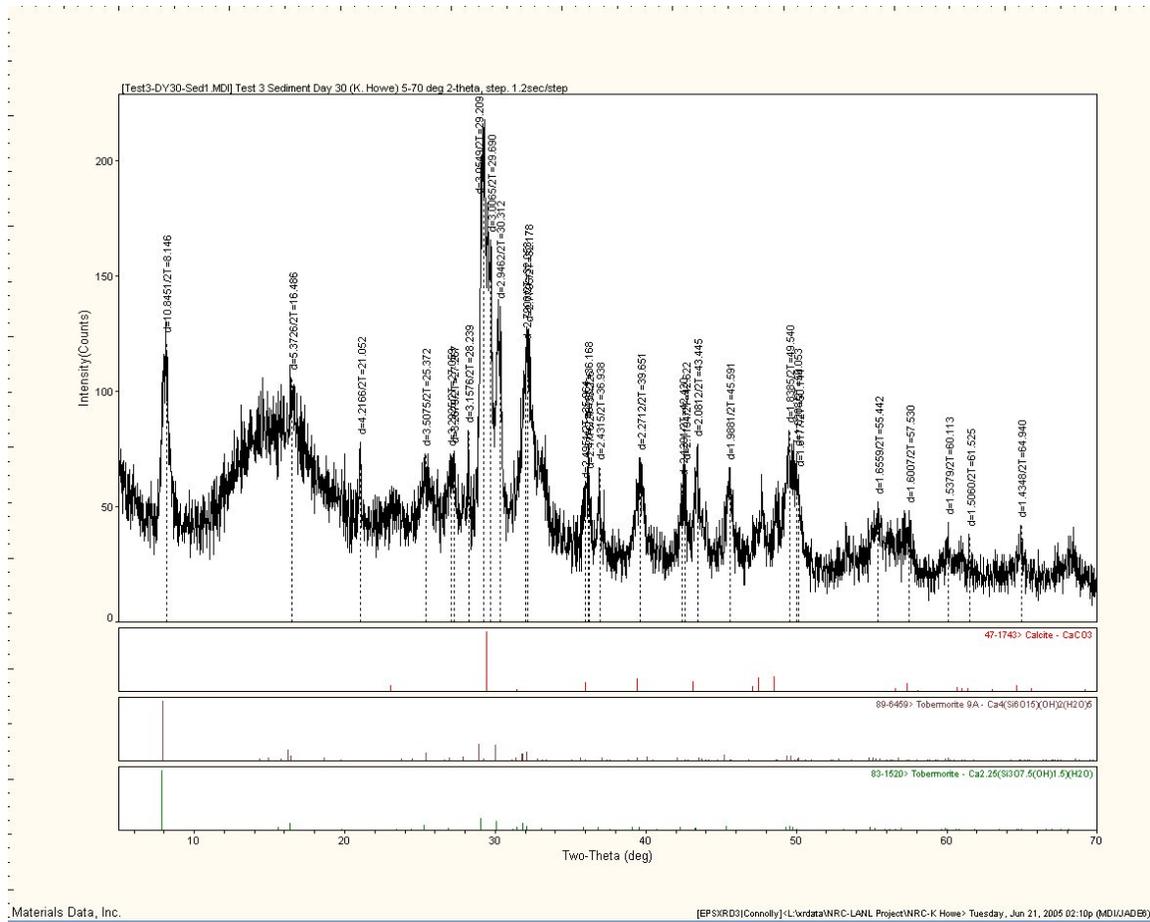
Figure 3-117. XRD results for Test #3 Day 30 mixed sediment.

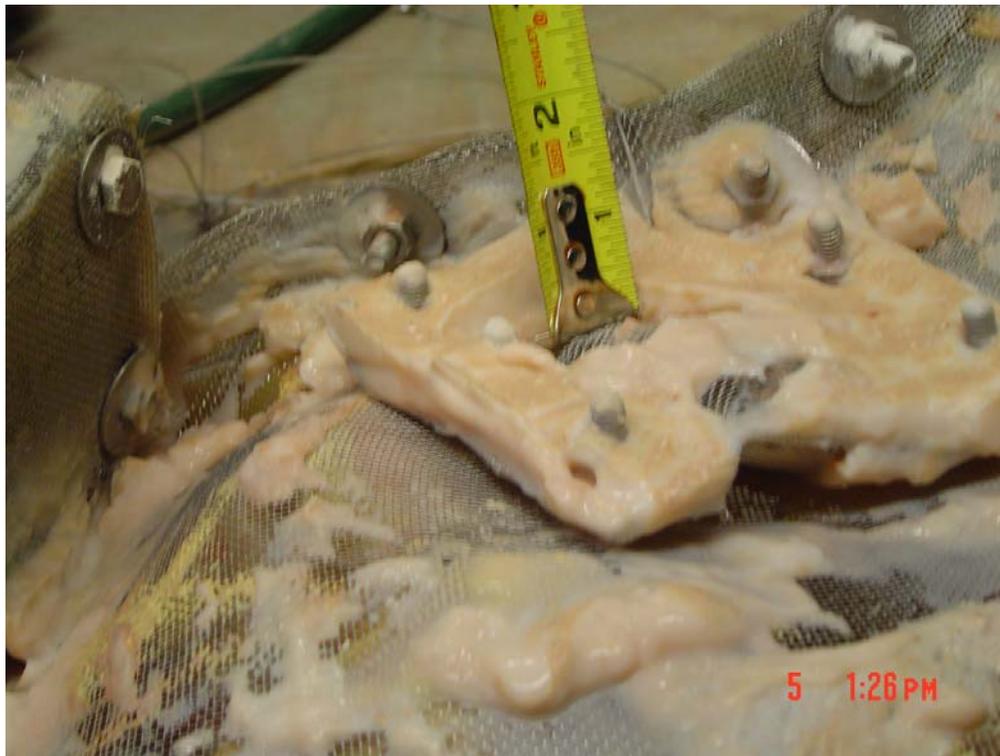
Figure 3-118. Gel-like material covering stainless steel mesh on the bottom of the test tank.

In ICET Test #3, one significant phenomenon is the presence of white gel-like precipitates in the test solution, especially during and after the injection of TSP on the first day of the test. When Test #3 was shut down, deposits of the pinkish-white gel-like precipitates were observed on the top of the birdcage and on other objects on the tank's bottom. Figures 3-118 and 3-119 show the gel-like precipitates.

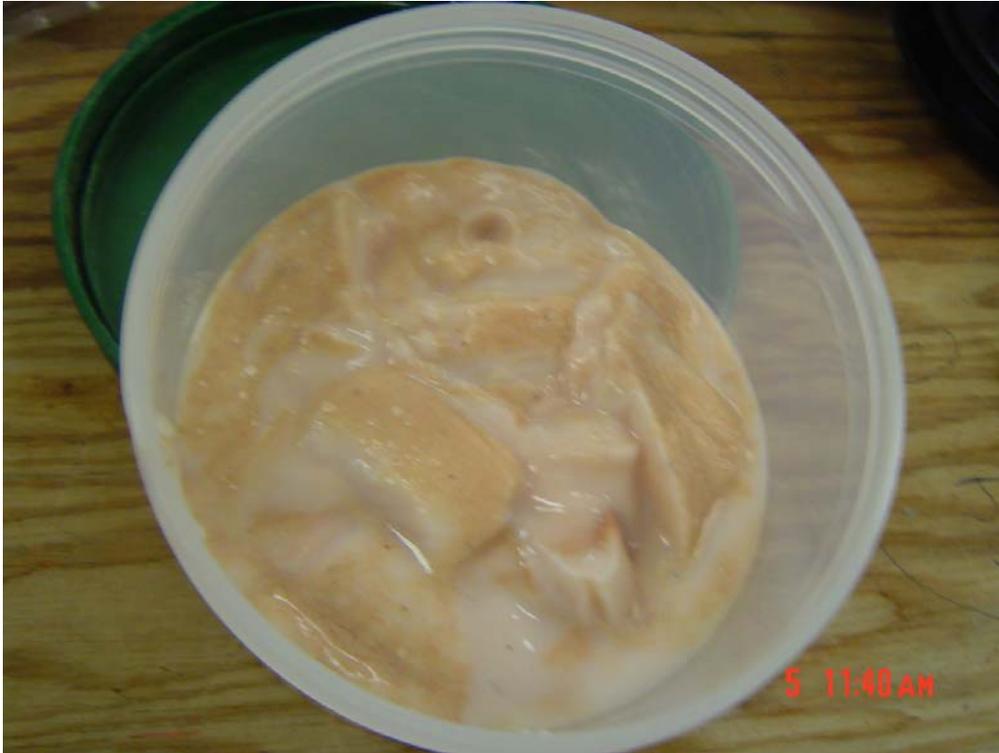
Figure 3-119. Gel-like material recovered from the bottom of the test tank.

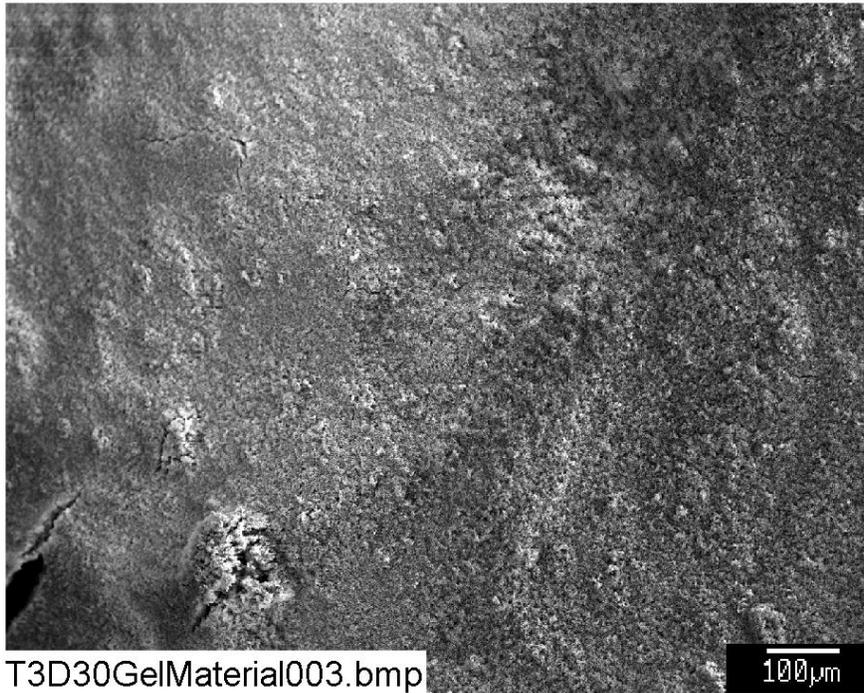
Figure 3-120. SEM image of a Test #3 Day 30 white gel-like material from the top of the birdcage, magnified 100 times. (T3D30GelMaterial003, 5/9/05)

Figures 3-120 through 3-126, Table 3-7, and Table 3-8 provide SEM/ESEM/EDS and XRD/XRF analysis results. The complete set of Day 30 gel analyses is contained in Appendix G.

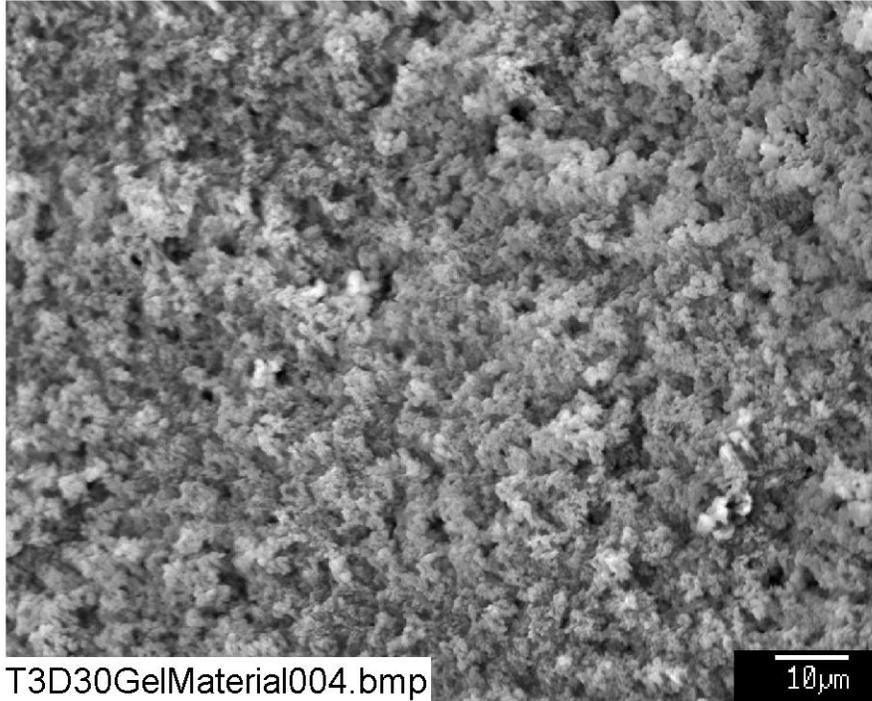
Figure 3-121. SEM image of a Test #3 Day 30 white gel-like material from the top of the birdcage, magnified 1000 times. (T3D30GelMaterial004, 5/9/05)

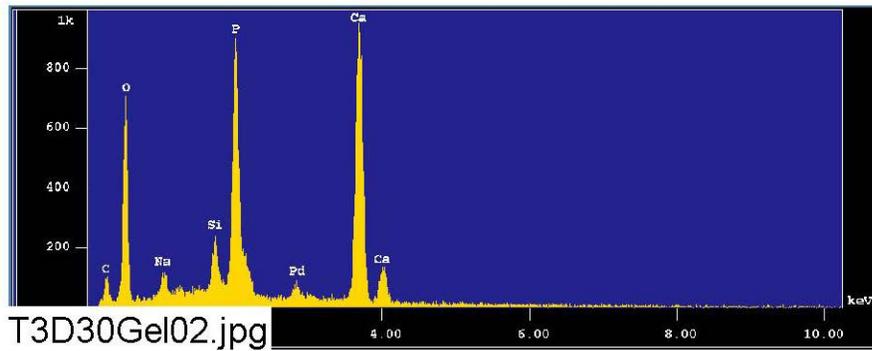
Figure 3-122. EDS counting spectrum for the white, gel-like material (whole image) shown in Figure 3-121. (T3D30Gel02, 5/9/05)

The results from the chemical composition analysis for Figure 3-122 are given in Table 3-7.

Element	Mass%	Atomic%	ZAF	Z	A	F
C	4.355	7.8616	3.7318	1.0194	3.6611	0.9999
O	45.521	61.6928	1.9361	0.9721	1.9917	1.0000
Na	1.639	1.5456	1.4989	1.0256	1.4614	1.0000
Si	2.072	1.5994	1.1451	0.9756	1.1812	0.9937
P	13.776	9.6435	0.8415	1.1708	0.7203	0.9978
Ca	32.638	17.6571	0.9890	0.9947	0.9943	1.0000

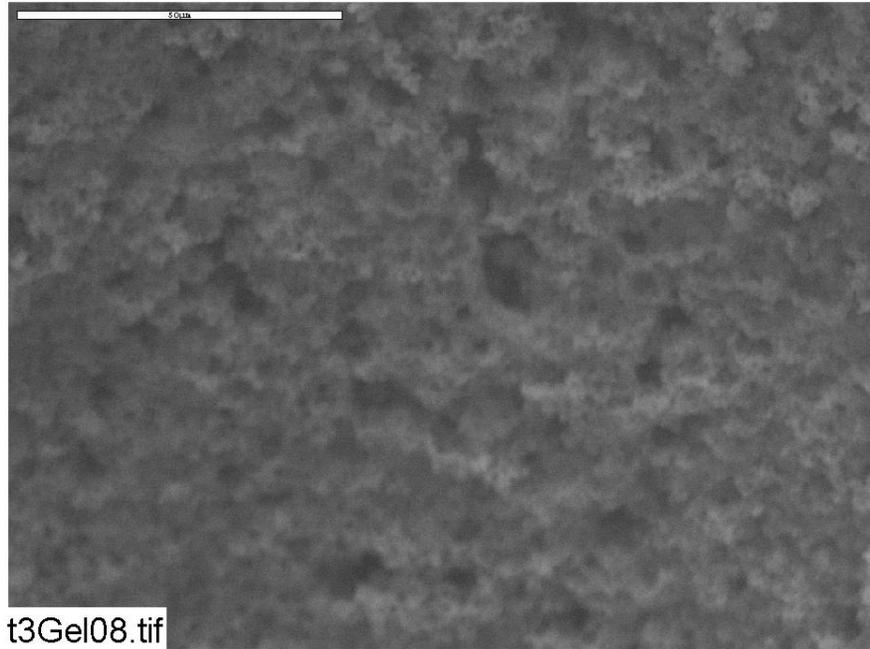
Figure 3-123. ESEM image of a Test #3 Day 30 white gel-like material from the top of the birdcage, magnified 1000 times. (t3Gel08, 5/6/05)

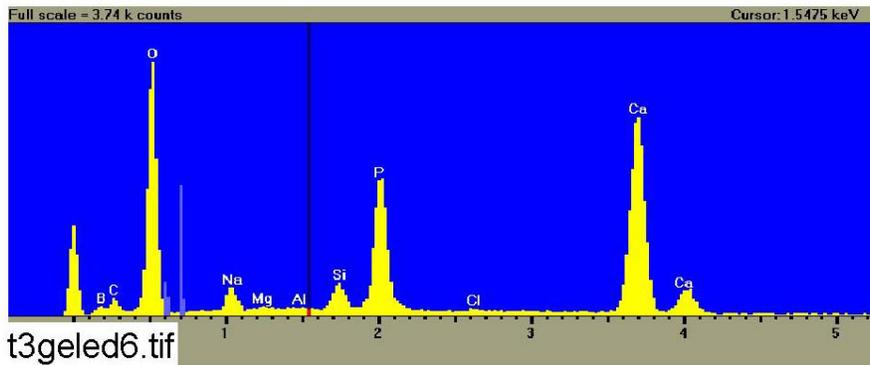
Figure 3-124. EDS counting spectrum for the white, gel-like material shown in Figure 3-123. (t3geled6, 5/6/05)

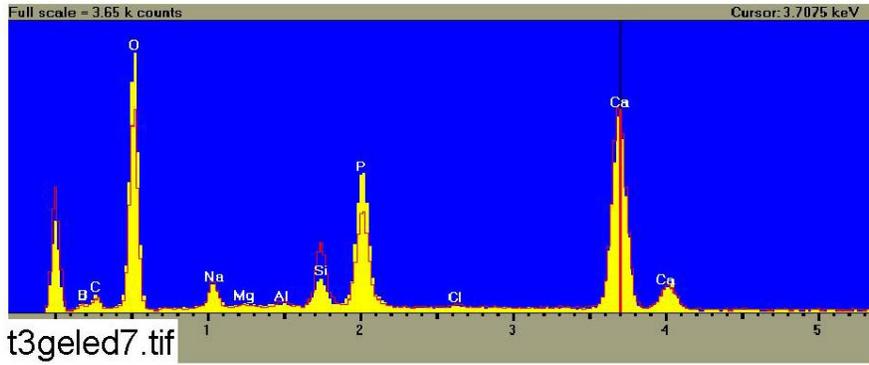
Figure 3-125. Comparison of EDS counting spectra for Figure 3-124 (yellow: the gel-like materials shown in figure 3-123) and Figure 3-73 (red: the large deposits taken from the birdcage exterior shown in Figure 3-72). (t3geled7, 5/6/05)

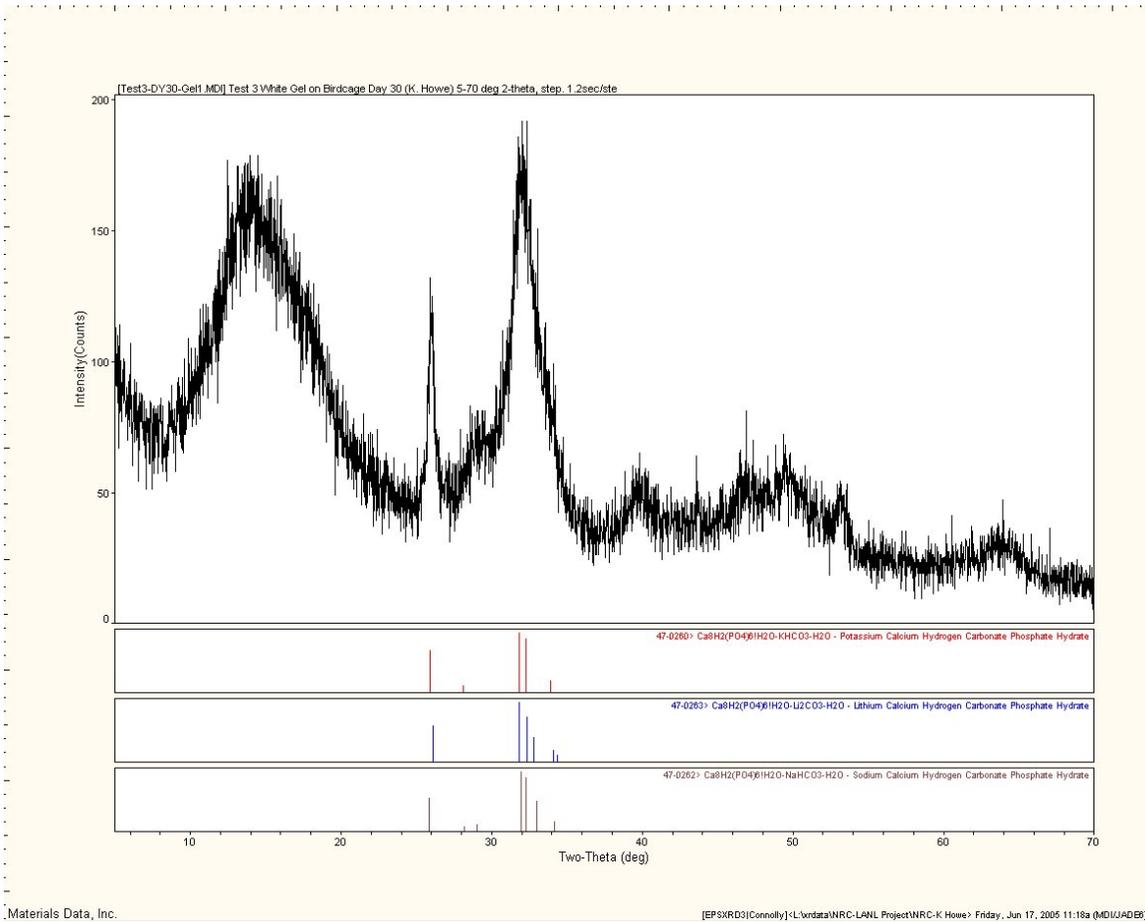
Figure 3-126. XRD results for a Test #3 Day 30 white, gel-like sample.
