## Appendix C3

# ESEM/EDS Data for Test #3 Day-30 Drain Collar Fiberglass

Laboratory session from May 6, 2005.  
 Test #3 Day-30 Drain Collar Fiberglass.

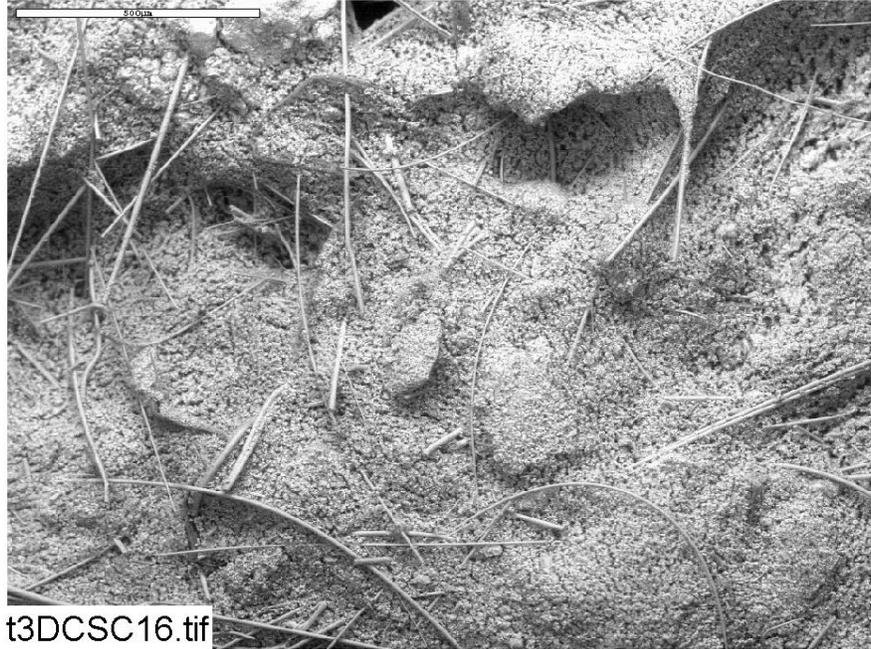
**Figure C3-1: ESEM image magnified 100 times for a Test #3 Day-30 exterior fiberglass sample on the drain collar (adjacent to the drain screen). (t3DCSC16)**

Image:	t3DCSC16	100 ×		Figure C3-1
	t3dcsc17	1000 ×	Particles	Figure C3-2
EDS:	t3dcsc18		EDS on particles	Figure C3-3
Image:	t3dcsc19	70 ×		Figure C3-4

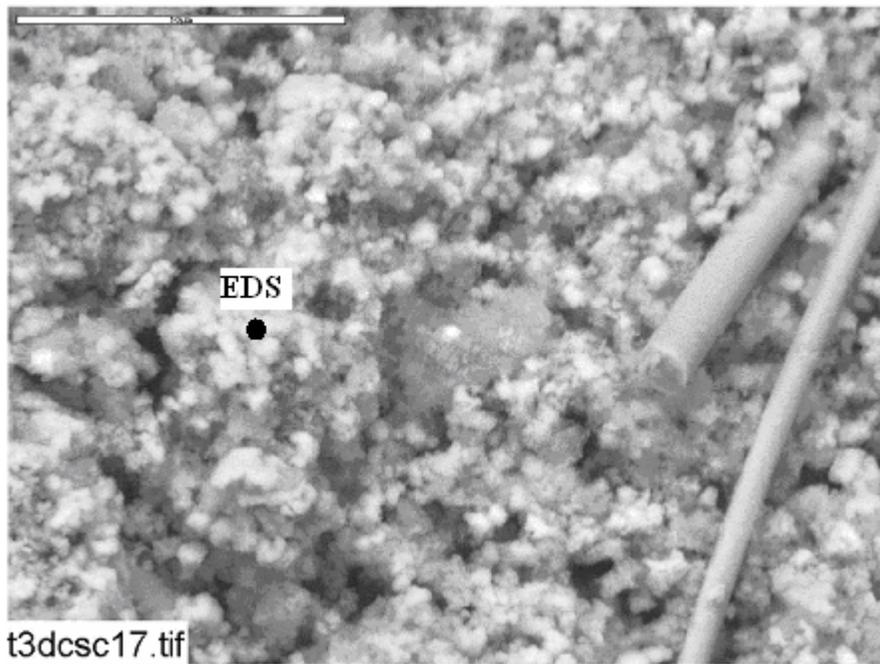
**Figure C3-2: ESEM image magnified 1000 times for a Test #3 Day-30 exterior fiberglass sample on the drain collar (adjacent to the drain screen). (t3dcsc17)**

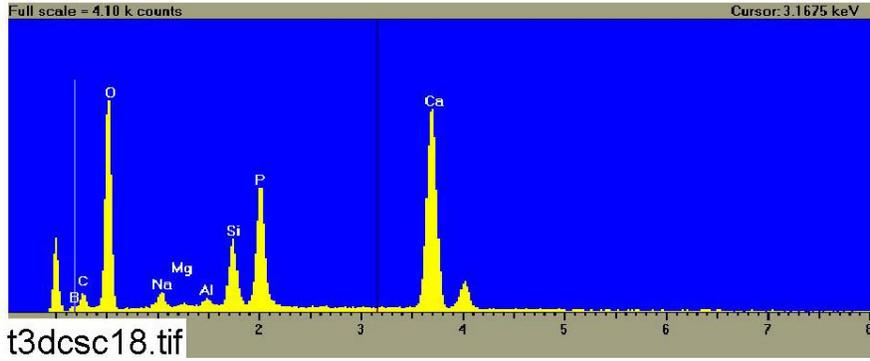
**Figure C3-3: EDS counting spectrum for the particulate deposits shown in Figure C3-2. (t3dcsc18)**

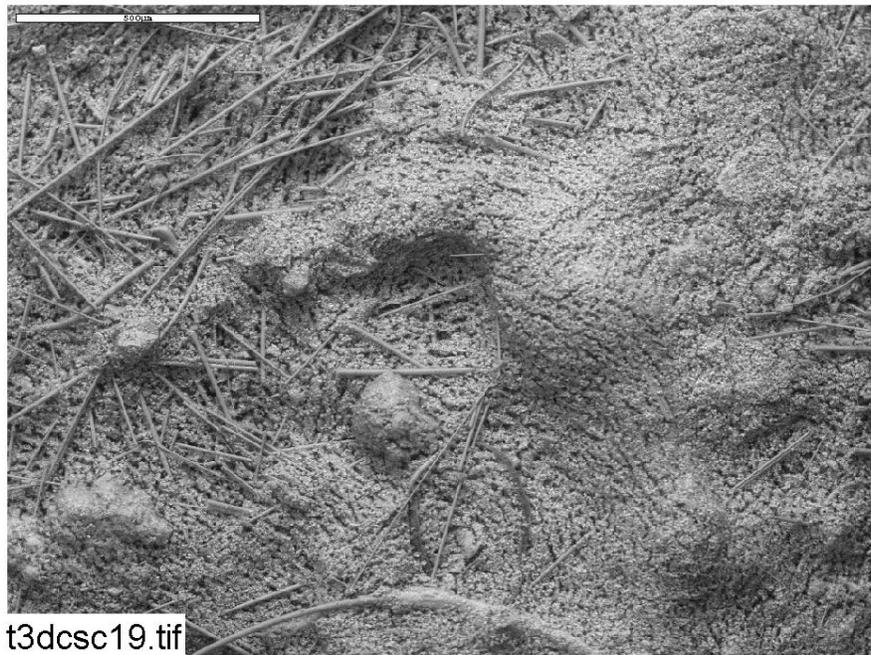
**Figure C3-4: ESEM image magnified 70 times for a Test #3 Day-30 exterior fiberglass sample on the drain collar (adjacent to the drain screen). (t3dcsc19)**

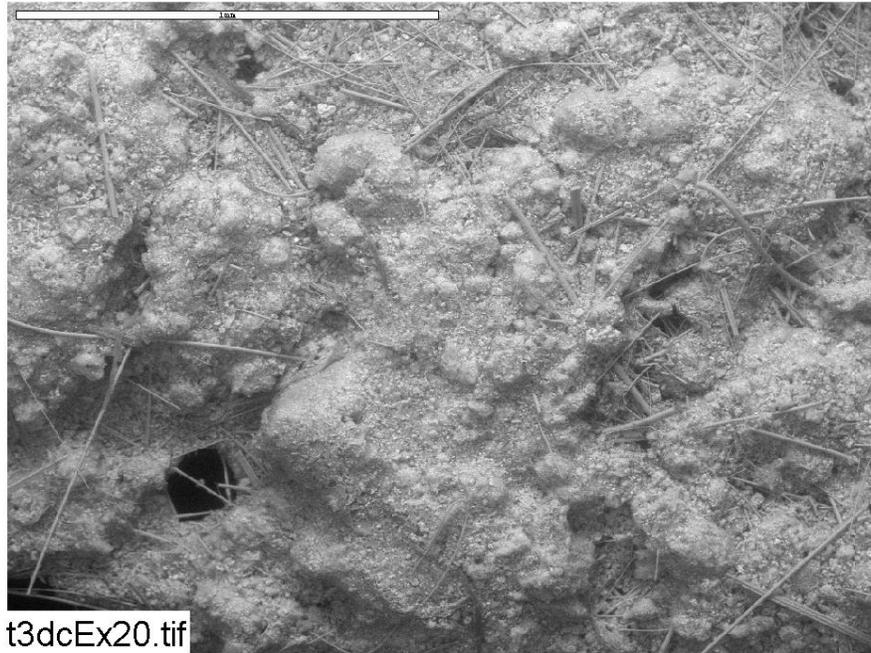
**Figure C3-5: ESEM image magnified 70 times for a Test #3 Day-30 exterior fiberglass sample on the drain collar (away from the drain screen). (t3dcEx20)**

Image:	t3dcEx20	70 ×		Figure C3-5
	t3dcex21	1000 ×		Figure C3-6
EDS:	t3dcex22		EDS on white bright particles shown in 21	Figure C3-7
	t3dcex23		EDS on dark particles shown in 21	Figure C3-8
	t3dcex24		Comparing t3dcex22 & t3dcex23	Figure C3-9
Image:	t3ccex25	100 ×		Figure C3-10

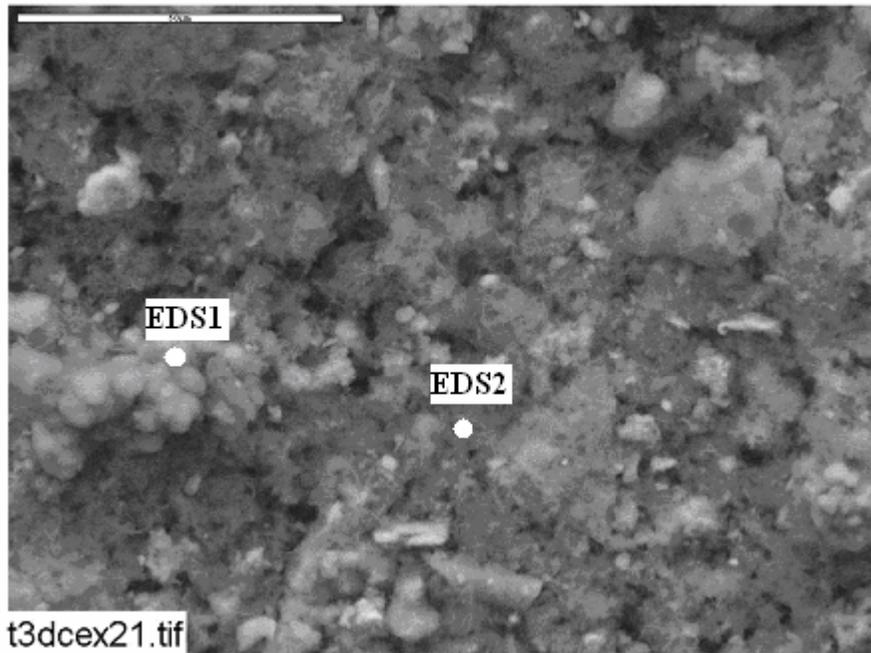
**Figure C3-6: ESEM image magnified 1000 times for a Test #3 Day-30 exterior fiberglass sample on the drain collar (away from the drain screen). (t3dcex21)**

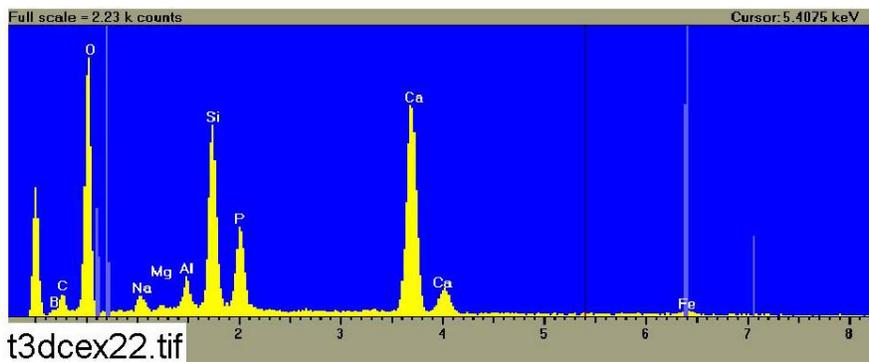
**Figure C3-7: EDS counting spectrum for the light particulate deposits (EDS1) shown in Figure C3-6. (t3dcex22)**

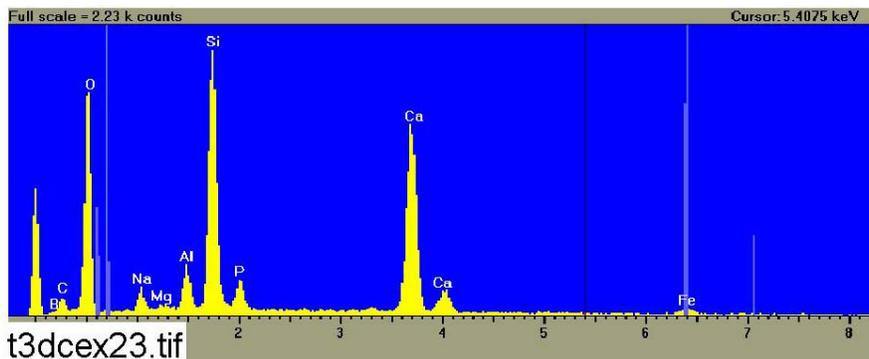
**Figure C3-8: EDS counting spectrum for the dark deposits (EDS2) shown in Figure C3-6. (t3dcex23)**

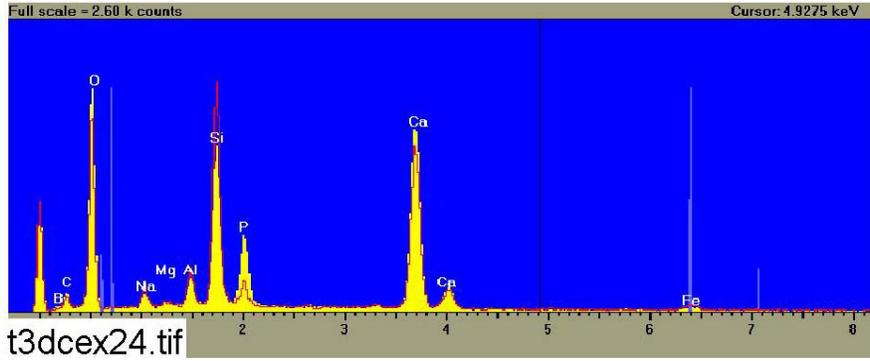
**Figure C3-9: Comparison of EDS counting spectra between Figure C3-7 (yellow) and Figure C3-8 (red). (t3dcex24)**

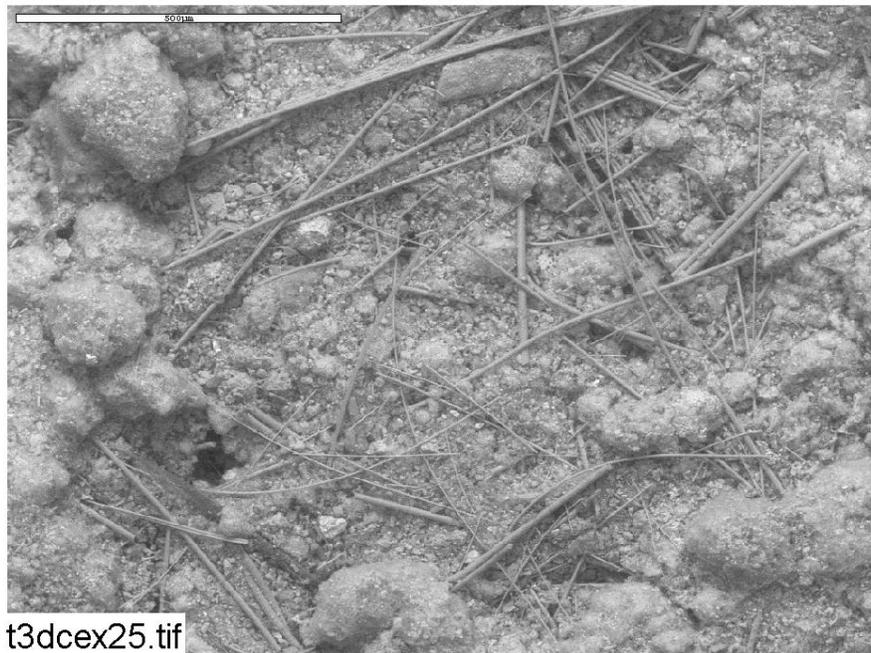
**Figure C3-10: ESEM image magnified 100 times for a Test #3 Day-30 exterior fiberglass sample on the drain collar (away from the drain screen). (t3dcex25)**

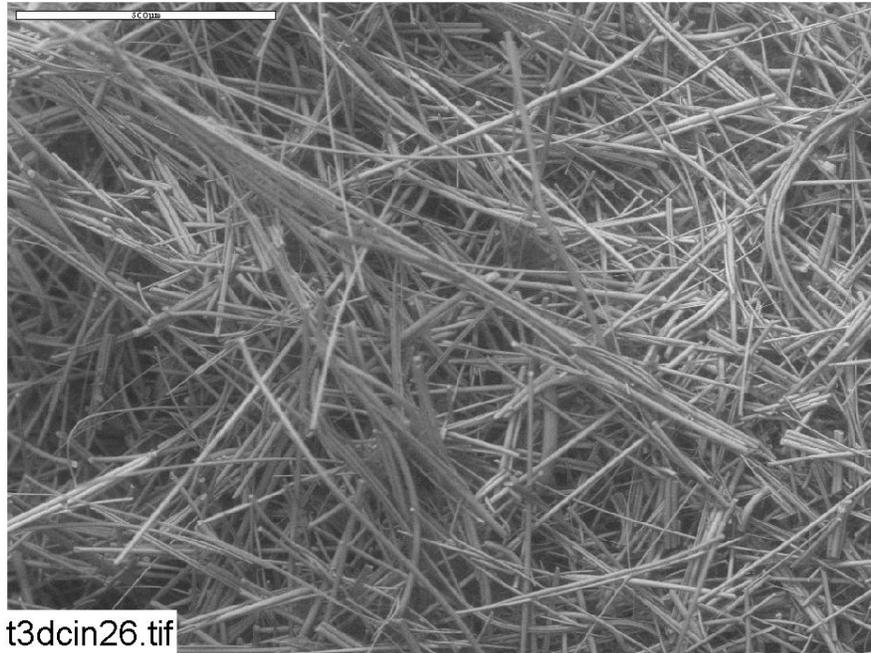
**Figure C3-11: ESEM image magnified 80 times for a Test #3 Day-30 interior fiberglass sample on the drain collar. (t3dcin26)**

Image:	t3dcin26	80 ×		Figure C3-11
	t3dcin27	1000 ×		Figure C3-12
	t3dcin28	100 ×		Figure C3-13

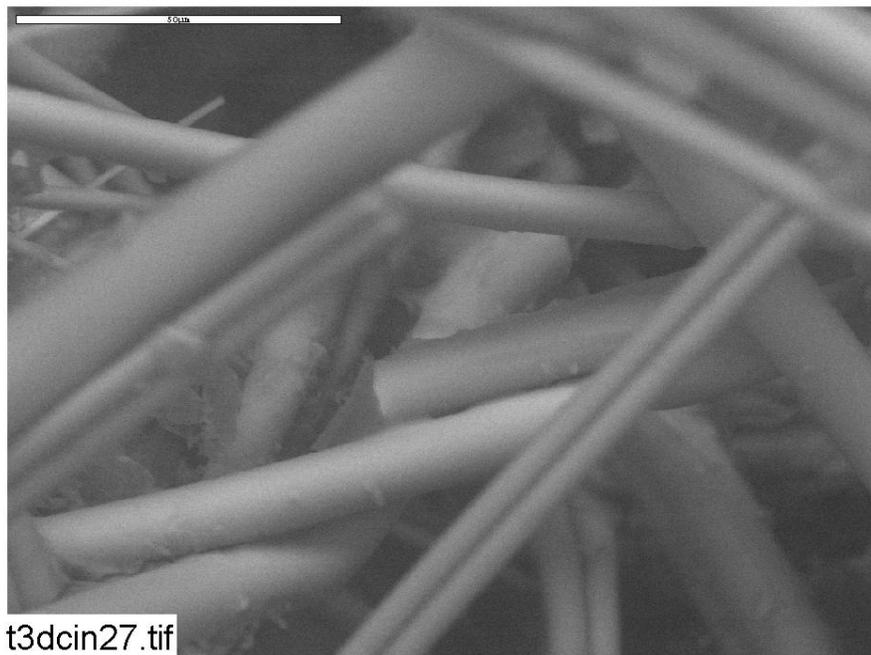
**Figure C3-12: ESEM image magnified 1000 times for a Test #3 Day-30 interior fiberglass sample on the drain collar. (t3dcin27)**

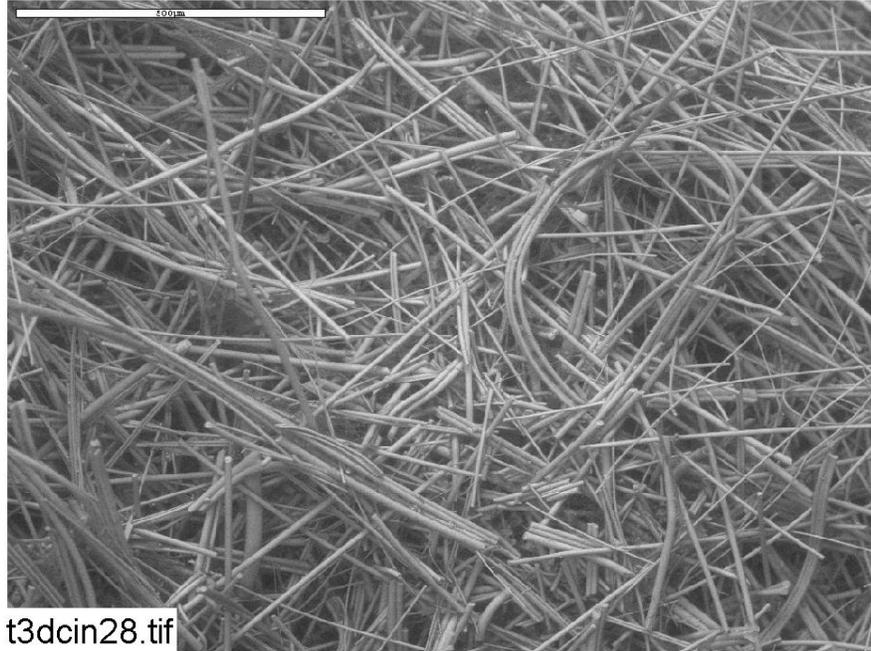
**Figure C3-13: ESEM image magnified 100 times for a Test #3 Day-30 interior fiberglass sample on the drain collar. (t3dcin28)**
