Palisades Nuclear Plant
Docket 50-255
License No. DPR-20

Response to NRC Requests for Additional Information Relating to License Renewal
dated October 24, 2005

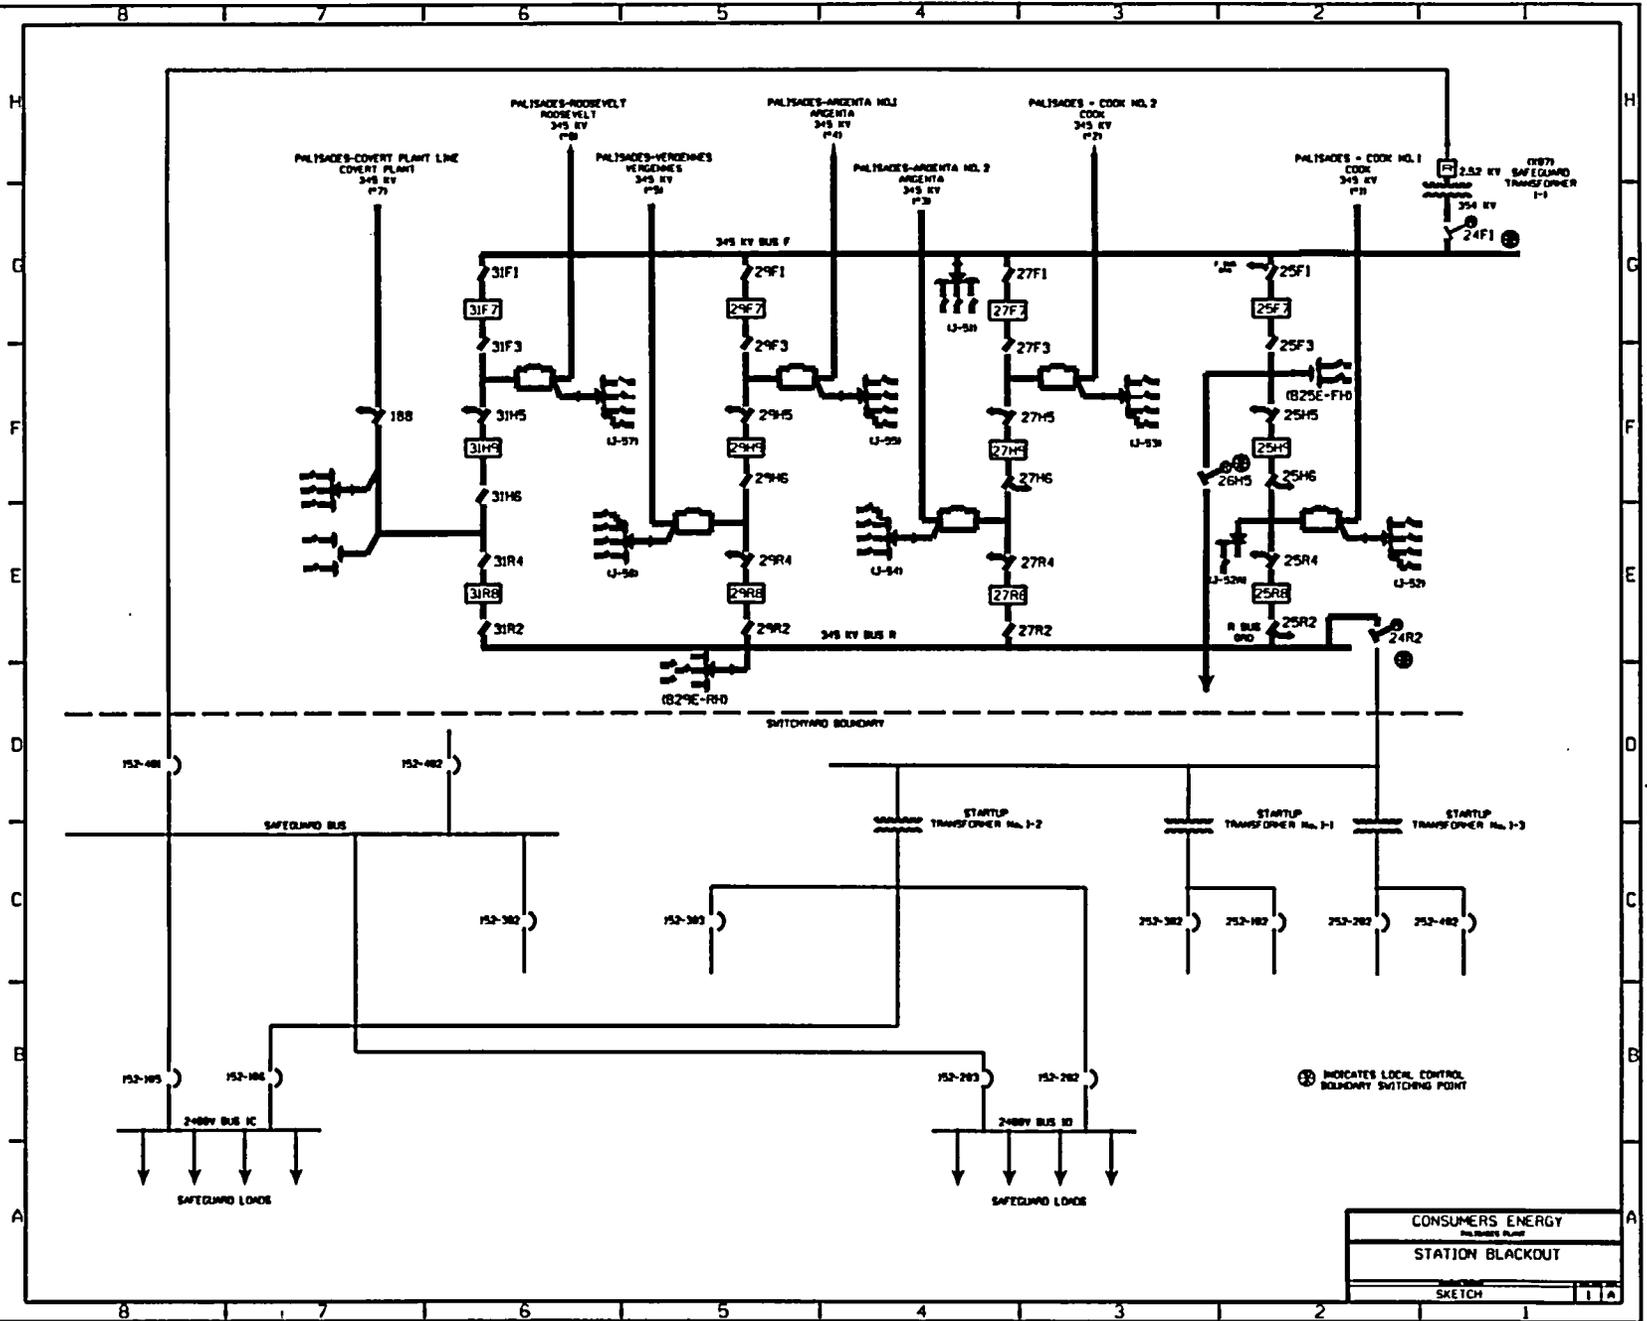
A simplified sketch of information extracted from LR-WD-1421-31 and LR-WD-950-A is included below to illustrate the boundary between the transmission system (including switchyard F and R buses) and the plant electrical systems. The transmission system is shown in black, and the two plant system connections from the transmission system in the switchyard to the plant electrical distribution buses, which are in scope of license renewal, are shown in red.

THIS DRAWING IS COLOR
CODED FOR LICENSE
RENEWAL.

BLACK=TRANSMISSION SYSTEM
RED=STATION BLACKOUT

As noted in the NMC response to RAI 2.5-1, in a letter dated August 27, 2005, "The motor operated disconnects are normally closed and can be operated remotely or manually." For an SBO event recovery, the motor operated disconnects would not have to be operated. As discussed in the response to RAI 2.5.9-1 above, the connection of the transmission system with the plant electrical distribution systems are made through circuit breakers. However, even if MOD operation were desired because of some abnormal condition (e.g., if the SBO occurred with a transformer out of service for maintenance), the MOD can be manually operated in accordance with plant procedures. Therefore, battery cables and connections for the MODs are not required for MOD operation, so they do not meet any license renewal scoping criteria, and are not included in scope.
