**SUSQUEHANNA STEAM ELECTRIC STATION  
PROPOSED AMENDMENT NO. 282 TO  
FACILITY OPERATING LICENSE NPF-14:  
PROPOSED CHANGE TO TECHNICAL SPECIFICATION 2.1.1.2  
MCPR SAFETY LIMIT  
AS-LEFT CORE LOADING PATTERN  
PLA-5982**

# SUSQUEHANNA UNIT 1 CYCLE 14 POST-MAINTENANCE OUTAGE REFERENCE CORE LOADING PATTERN

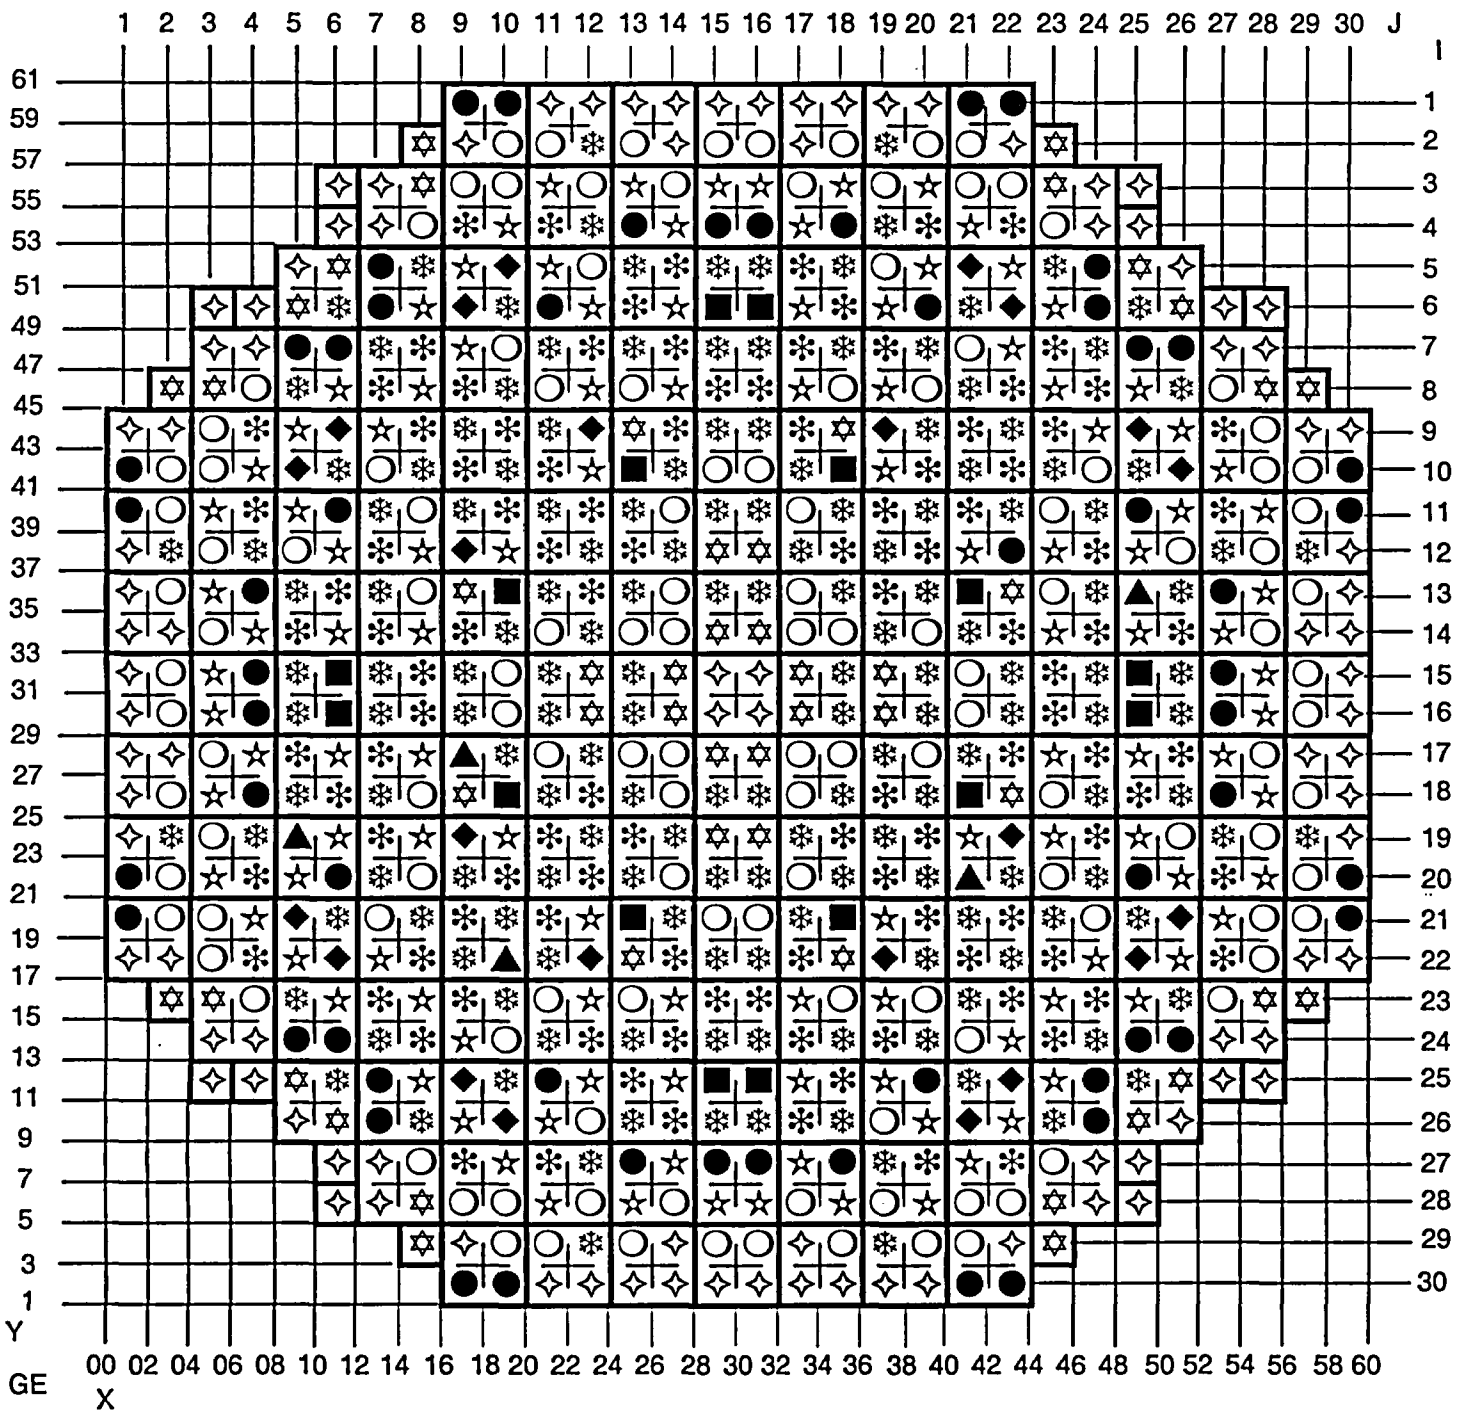
☆ SQA-11 12GdZ/1Gd7 TWICE BURNED (3.44)

☆ SQA-13 14GdZ FRESH (4.12)

☆ SQA-11 13GdZ TWICE BURNED (3.86)

○ SQA-12 12GdZ/1Gd7 ONCE BURNED (3.97)

● SQA-11 12GdZ/1Gd7 TWICE BURNED (3.44)  
(REINSERT)

☆ SQA-12 13Gd6/12GdZ ONCE BURNED (3.75)

▲ SQA-10 12Gd6-1Gd3/12Gd7-1Gd3  
TWICE BURNED(3.94) (REINSERT)

■ SQA-12 13Gd6/12GdZ ONCE BURNED (3.75) (SHUFFLED)

◆ SQA-12 12GdZ/1Gd7 ONCE BURNED (3.97) (SHUFFLED)

The attachment to this letter provides the as-left core loading pattern for SSES Unit 1 which results from fuel rechanneling and shuffle activities recently completed during the current maintenance outage.

Since the reinserted twice-burned bundles are lower in reactivity than the bundles they replaced, there is no loss of shutdown margin. These bundles are designated as SQA-10 and SQA-11 on the attached as-left core-loading pattern.

As a result of fuel bundle rechanneling, shuffle activities, and control rod stroking, control cell friction in the core has been reduced. All control cells exhibiting friction prior to the shutdown and those susceptible to future friction have been addressed through channel replacements, fuel shuffling, or by reinserting previously discharged fuel. Visual inspection and bundle measurement results were consistent with pre-outage expectations and the MCPR Safety Limit in Reference 1 is valid for the core-loading pattern shown in the attachment.
