Integrated Chemical Effects Test Project: Test #4 Data Report

Los Alamos National Laboratory

**U.S. Nuclear Regulatory Commission
Office of Nuclear Regulatory Research
Washington, DC 20555-0001**

A 30-day test was conducted in the Integrated Chemical Effects Test (ICET) project test apparatus. The test simulated the chemical environment present inside a pressurized water reactor containment water pool after a loss-of-coolant accident. The initial chemical environment contained 15.41 kg of boric acid, 8.47 kg of sodium hydroxide, 0.663 g of lithium hydroxide, and 212 mL of hydrochloric acid. An additional amount of sodium hydroxide (614 g) was added with the spray beginning at time zero and lasting until 30 minutes into the test. The test was conducted for 30 days at a constant temperature of 60°C (140°F). The materials tested within this environment included representative amounts of submerged and unsubmerged aluminum, copper, concrete, zinc, carbon steel, and insulation samples (80% calcium silicate and 20% fiberglass). Representative amounts of concrete dust and latent debris were also added to the test solution. Water was circulated through the bottom portion of the test cham

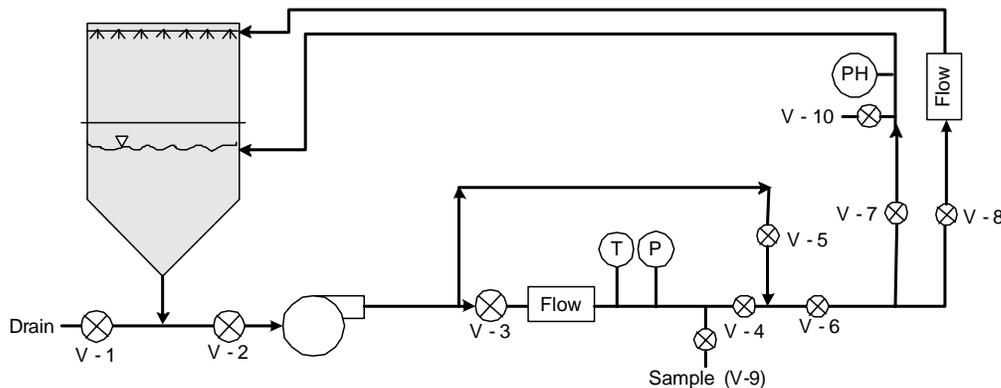
The as-built test loop consists of a test tank, a recirculation pump, 2 flow meters, 10 isolation valves, and pipes that connect the major components, as shown schematically in Figure 2-1. P, T, and pH represent pressure, temperature, and pH probes, respectively.

Figure 2-1. Test loop process flow diagram.

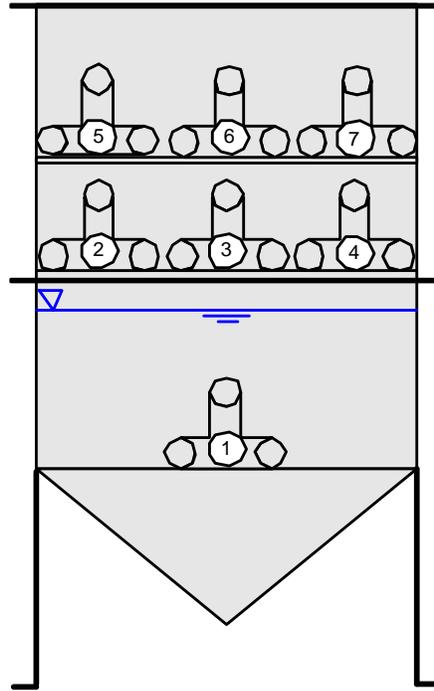
The arrangement of the coupon racks in the test tank is schematically illustrated in Figure 2-2. The figure shows a side view of the ICET tank, with the ends of the seven CPVC racks illustrated. The normal water level is indicated by the blue line in the figure. Rack #1 is the only submerged rack, and it sits on angle iron. It is centered in the tank so that flow from the two headers reaches it equally. Racks #2–#4 are positioned above the water line, supported by angle iron in the tank. Racks #5–#7 are positioned at a higher level, also supported by angle iron. Racks #2–#7 are exposed to spray. In the figure, north is to the right, and south is to the left. Directions are used only to identify such things as rack locations and sediment locations.

Figure 2-2. Coupon rack configuration in the ICET tank. The blue line represents the surface of the test solution.

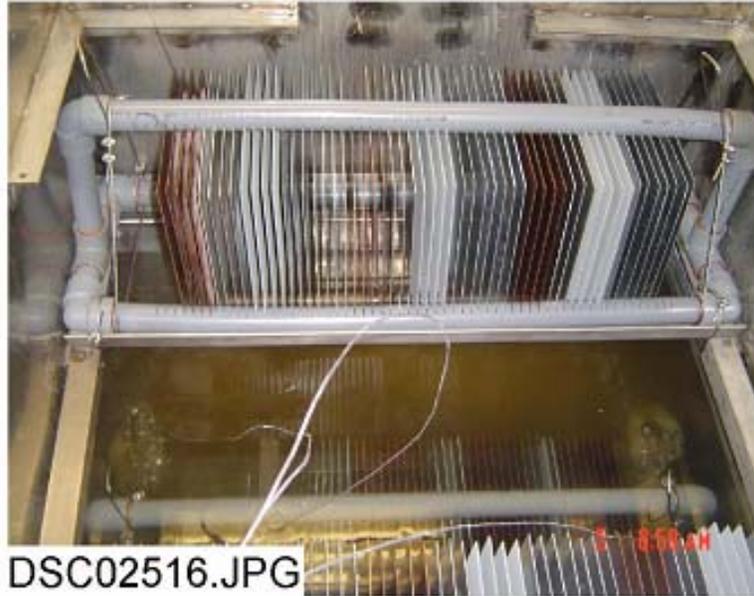
Figure 2-3 shows the configuration of a typical unsubmerged coupon rack loaded with metal coupons in the ICET tank. The loading pattern of the racks was nearly identical, varying by only one or two coupons. Shown in the figure from left to right, the coupons are arranged as follows: 4 Cu, 4 Al, 4 inorganic zinc (IOZ), 7 GS, 4 Cu, 3 Al, 4 IOZ, 7 GS, 4 Cu, 3 Al, 4 IOZ, and 7 GS.

Figure 2-3. A typical loaded coupon rack in the ICET tank.

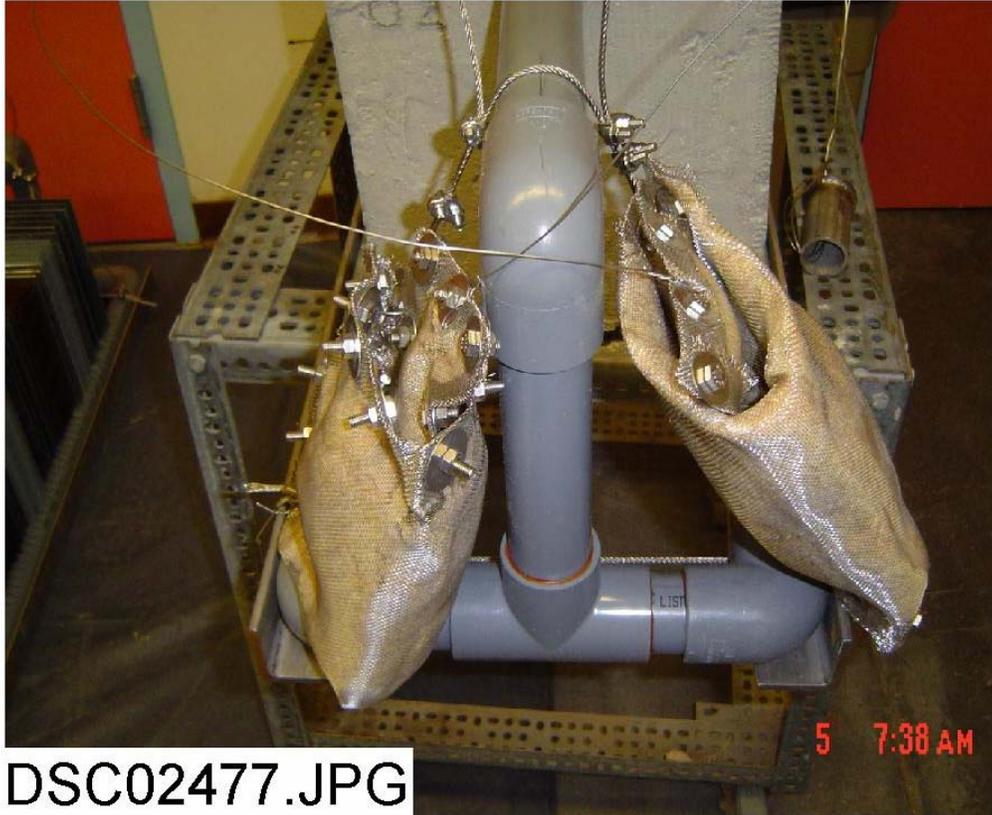
Several fiberglass samples were placed in the ICET tank. Samples were either submerged or held above the water level. The unsubmerged fiberglass samples were positioned so they would be exposed to sprays. The fiberglass samples were contained in SS wire mesh that allowed water flow while confining the fiberglass material. Both loosely packed and more tightly packed samples were used. In addition, some submerged fiberglass samples were located where they would be exposed to relatively high-flow conditions (in front of the flow header, attached to the submerged coupon rack), and others were located in quiescent regions of the tank (behind the flow header). Figure 2-4 shows what the so-called “sacrificial” fiberglass samples look like in wire mesh pouches attached to the submerged coupon rack (rack 1 in Figure 2-2). Each pouch contains approximately 5 g of fiberglass. Those samples were attached with SS wire; removed from the tank on Days 5, 15, and 30; and examined. As shown in the figure, bigger insulation bags were wrapped around the sacrificial specimens during the test. See Subsection 2.4.1.1 for descriptions of other fiberglass samples.

Figure 2-4. Fiberglass samples attached to a submerged coupon rack.

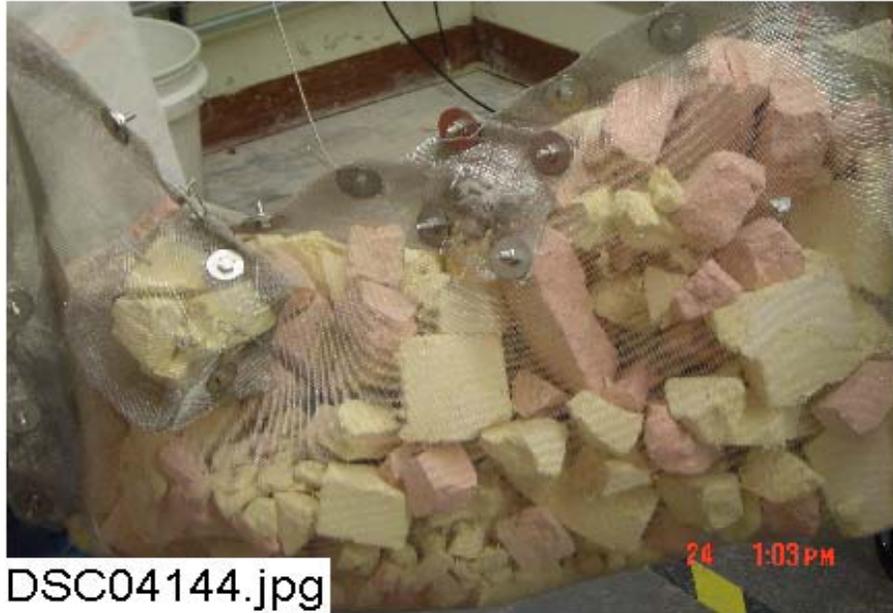
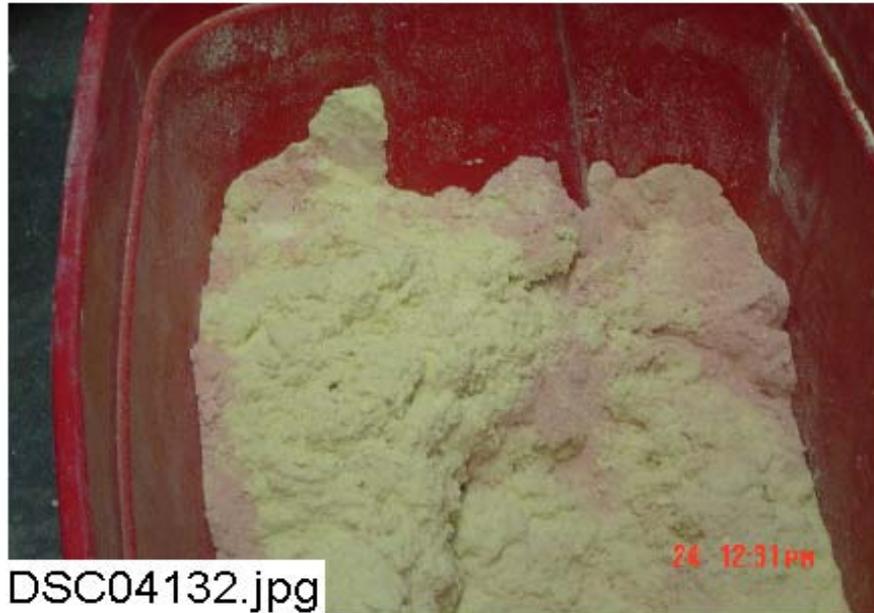
Several cal-sil insulation samples were also placed in the ICET tank. Samples were either submerged or held above the water level. The unsubmerged cal-sil samples were positioned so they would be exposed to sprays. As with the fiberglass samples, all of the cal-sil samples (except for the dust) were contained in SS wire mesh that allowed water flow while confining the cal-sil material. In addition to solid pieces of cal-sil, cal-sil dust (approximately 43.5 lb) was placed in the tank solution before the test began. Both types of samples are shown in Figures 2-5 and 2-6.

Figure 2-5. Solid pieces of cal-sil samples in SS mesh.

Figure 2-6. Cal-sil dust.

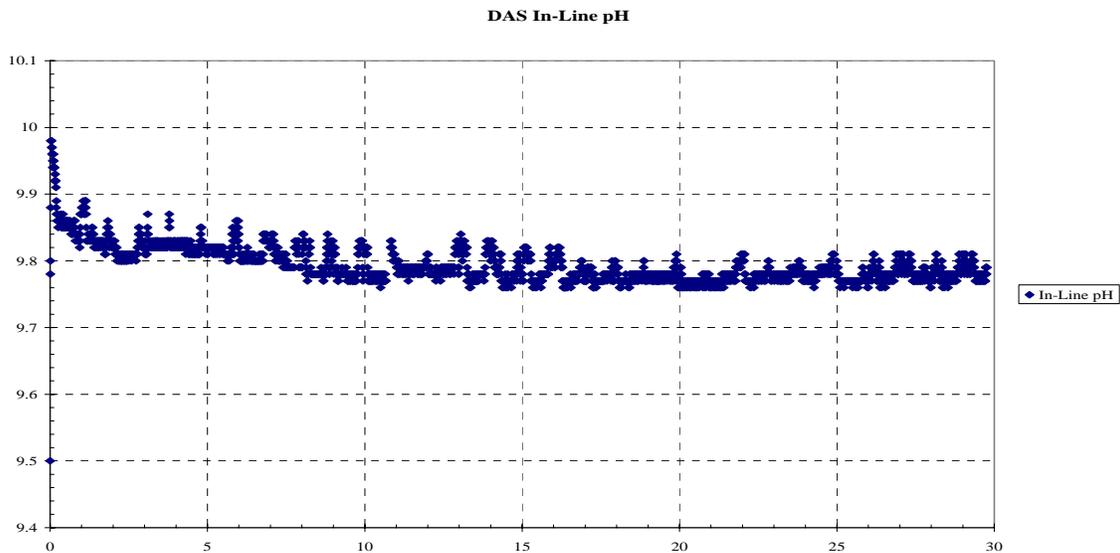
The in-line pH probe produced the data in Figure 3-1. At four hours, the in-line pH measurement was 9.9 and at Day 30, it was 9.8. The bench-top pH measurements, which are calibrated daily, are presented in Figure 3-2. At 4 hours, the bench-top pH measurement was 9.8 and at Day 30, it was also 9.8.

Figure 3-1. In-line pH measurements.

pH: Before time zero, 15.14 kg of boric acid, 8.47 kg of sodium hydroxide, 212 ml of 12.24 N hydrochloric acid solution, and 0.663 g of lithium hydroxide were dissolved into the ICET tank solution. The measured bench-top pH was 9.5. During the addition of the sodium hydroxide solution during the first 30 minutes, the pH rose to 9.8 and remained at that value through the spray cycle. The pH declined for the first 2 days to a value of 9.6, which was the predicted value for a solution in complete equilibrium with the atmosphere. After the second day the pH began to rise to a high value of 9.9 on Day 8. The pH varied between 9.7 and 9.9 from Day 9 to the end of the test. This can be seen in Figures 3-1 and 3-2.

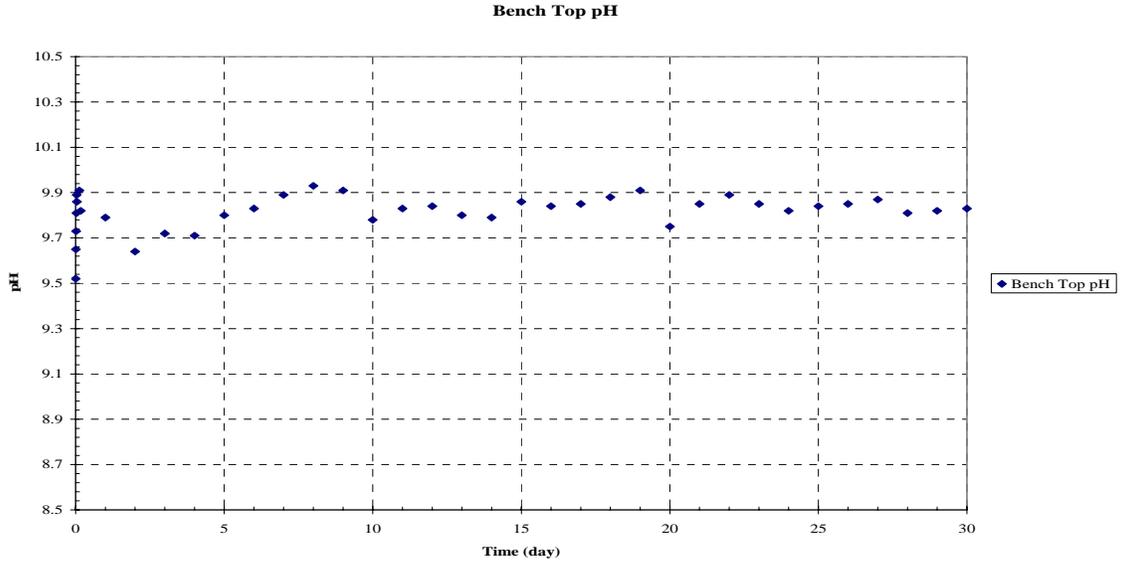
Figure 3-2. Bench-top pH meter results.

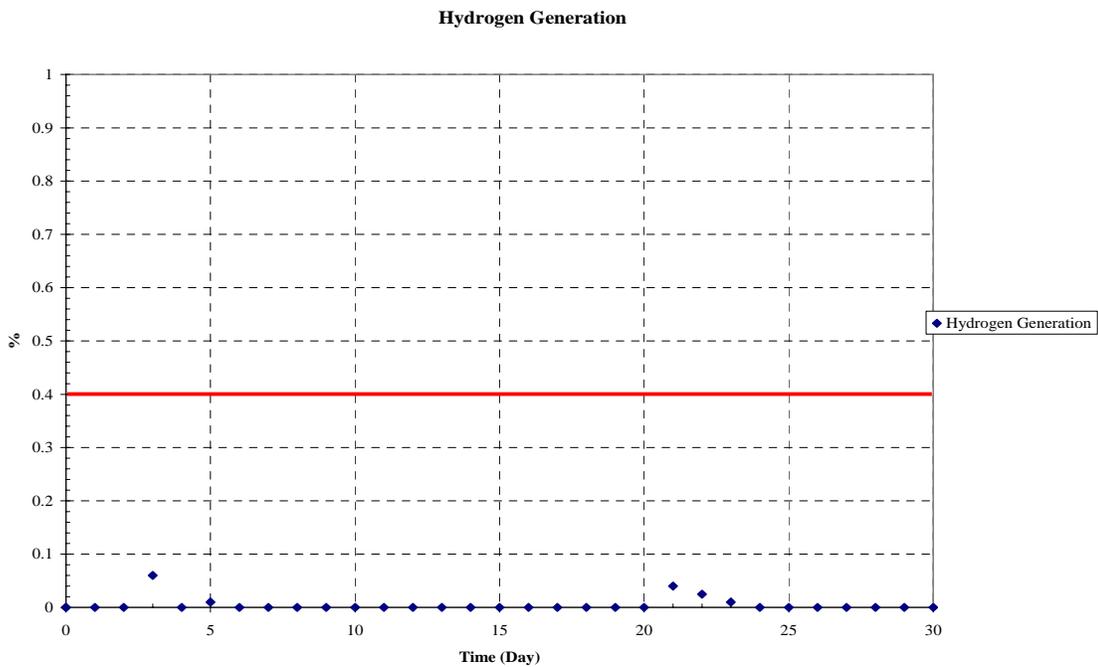
Hydrogen remained at or below 0.05 percent for the duration of the test as shown in Figure 3-3. All of the measured values are well below the hydrogen safety action threshold of 0.4 percent.

Figure 3-3. Hydrogen generation.

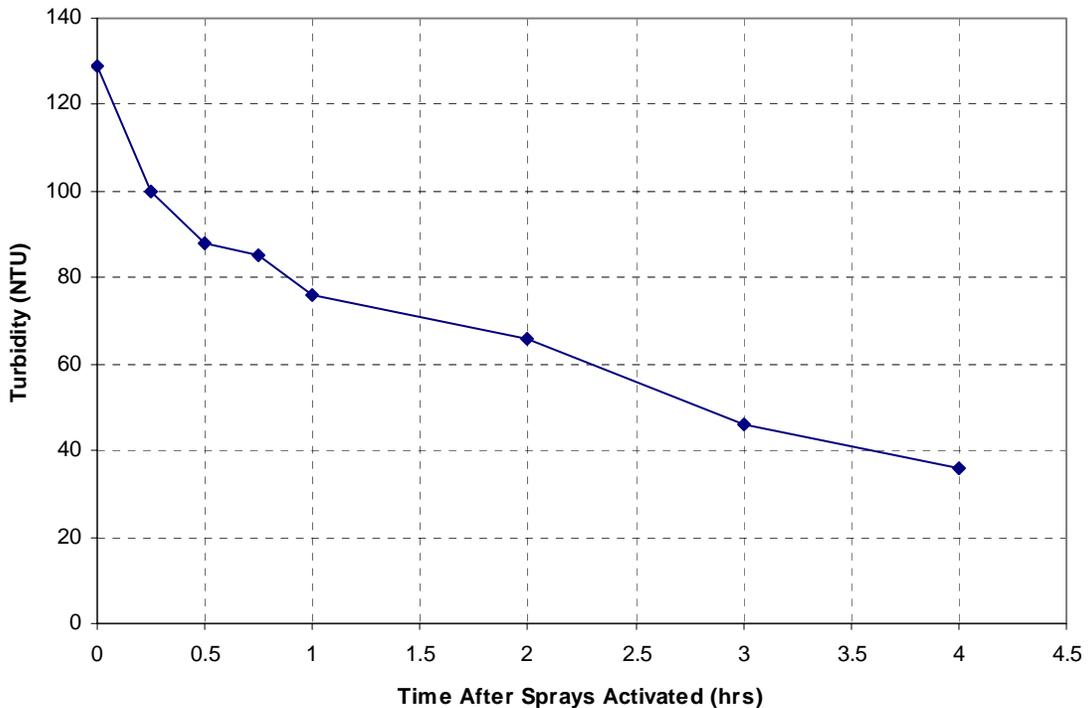
Due to the cloudy nature of the water in the tank after the recirculation pump was turned on, turbidity values were measured at 60°C over the initial 4-hour spray phase which were in addition to regular daily monitoring. Figure 3-4 shows the turbidity during this time period. The x-axis on the graph represents the time in hours after the spray nozzles were turned on. As can be seen, the turbidity gradually decreased from 129 NTU at the time-zero point to 36 NTU at the 4-hour point.

Figure 3-4. Day 1 turbidity results.

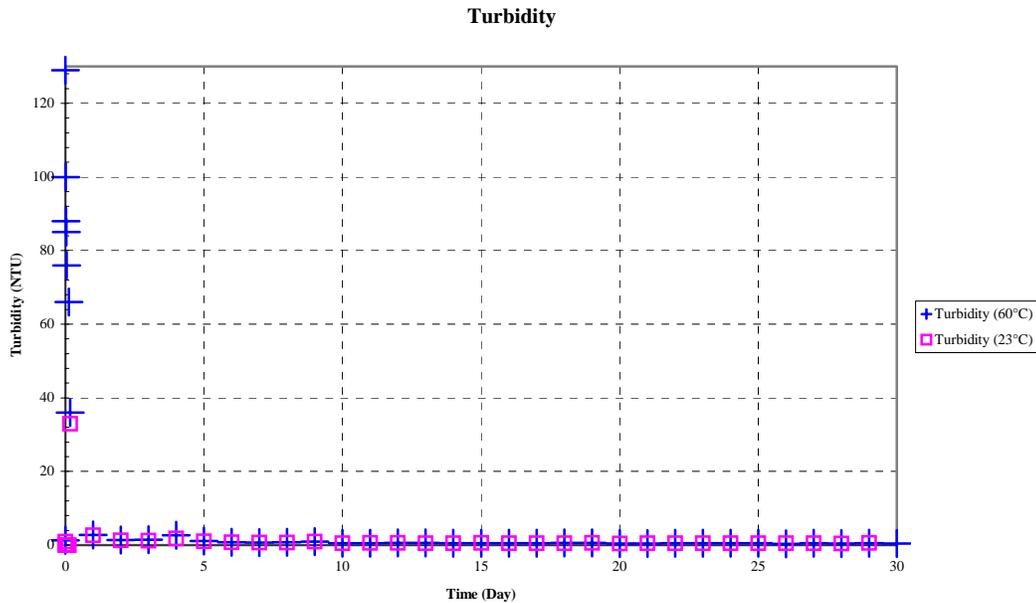
Figure 3-5 contains the daily turbidity values at 23°C and 60°C throughout the test. The trend of each curve exhibits an initial spike at the beginning of the spray cycle, followed by a sharp decline during the first four hours of the test. The turbidity results continued to decline and remained low from Day 1 until Day 30. During the last three weeks of

testing, the turbidity values for the 23°C and 60°C samples averaged 0.54 NTU and 0.56 NTU, respectively.

Figure 3-5. Daily turbidity results.

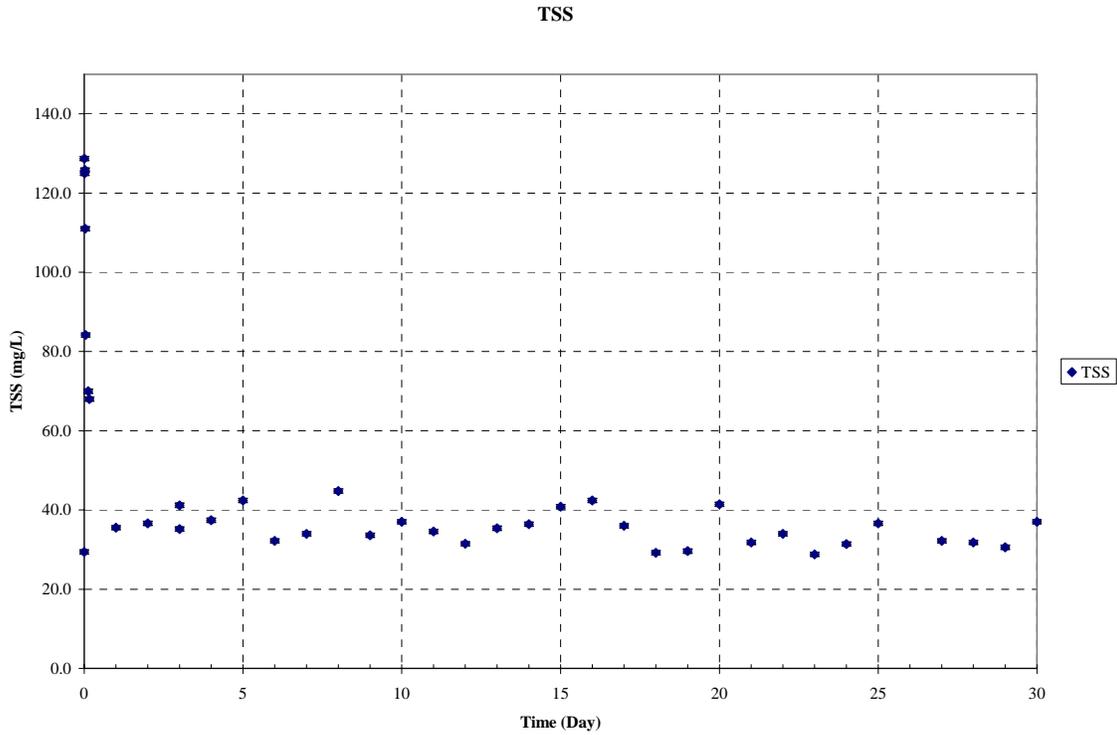
Total Suspended Solids: Total suspended solids (TSS) are measured by running a volume of approximately 500 mL through an in-line filter directly at the sample tap. The selected equipment assures that TSS measurements are not affected by temperature-dependent or time-dependent precipitation reactions that may occur once the process solution is removed from the tank. Figure 3-6 presents Test #4 TSS data as the experiment progressed. The baseline TSS measurement, taken prior to time zero, was 29.4 mg/L. Further TSS measurements were taken throughout the spray cycle. At the start of the spray cycle, the TSS measurement was at its highest value of 128.7 mg/L. At four hours, the TSS measurement had dropped to 68.0 mg/L. Following the spray cycle and beginning at 24 hours, the TSS measurements were performed daily. After 24 hours, TSS measurements varied approximately 16 mg/L over the 30-day test period, from a low of 28.8 mg/L to a high of 44.8 mg/L.

Figure 3-6. Test #4 TSS results.

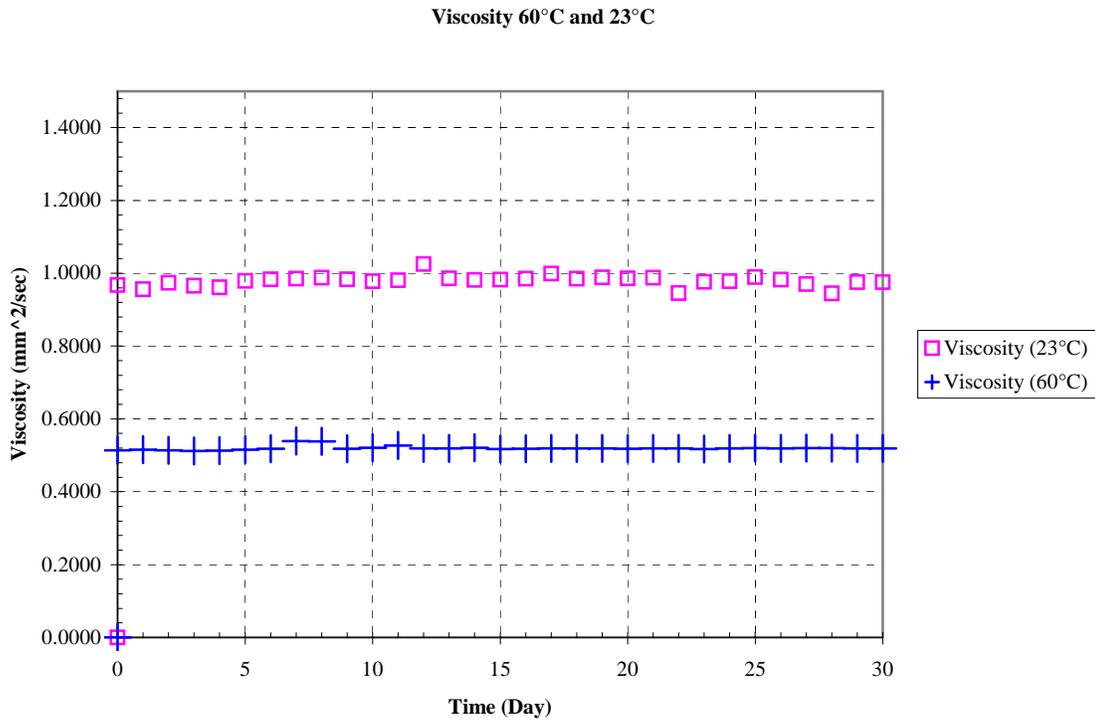
Kinematic Viscosity: Kinematic viscosity was measured with a Cannon-Fenske capillary viscometer. Viscosity was measured on unfiltered samples, each at a temperature of $60^{\circ}\text{C} \pm 1.0^{\circ}\text{C}$ ($140^{\circ}\text{F} \pm 1.8^{\circ}\text{F}$) and $23^{\circ}\text{C} \pm 2.0^{\circ}\text{C}$ ($73.4^{\circ}\text{F} \pm 3.6^{\circ}\text{F}$). Viscosity of water is highly sensitive to temperature, and the allowed temperature range results in a variation of viscosity of 2.9 percent between 59°C (138.2°F) and 61°C (141.8°F), and a 9.3 percent variation between 21°C (69.8°F) and 25°C (77.0°F). For this reason, temperature was measured to 0.1°C accuracy with a NIST-traceable thermometer for all viscosity measurements, and the measured viscosity values were corrected to a common temperature to facilitate comparisons. The corrected temperatures were 60.0°C (140°F) and 23.0°C (73.4°F). The measured viscosity is shown in Figure 3-7. The values were steady throughout the test.

Figure 3-7. Viscosity at 60°C and 23°C.

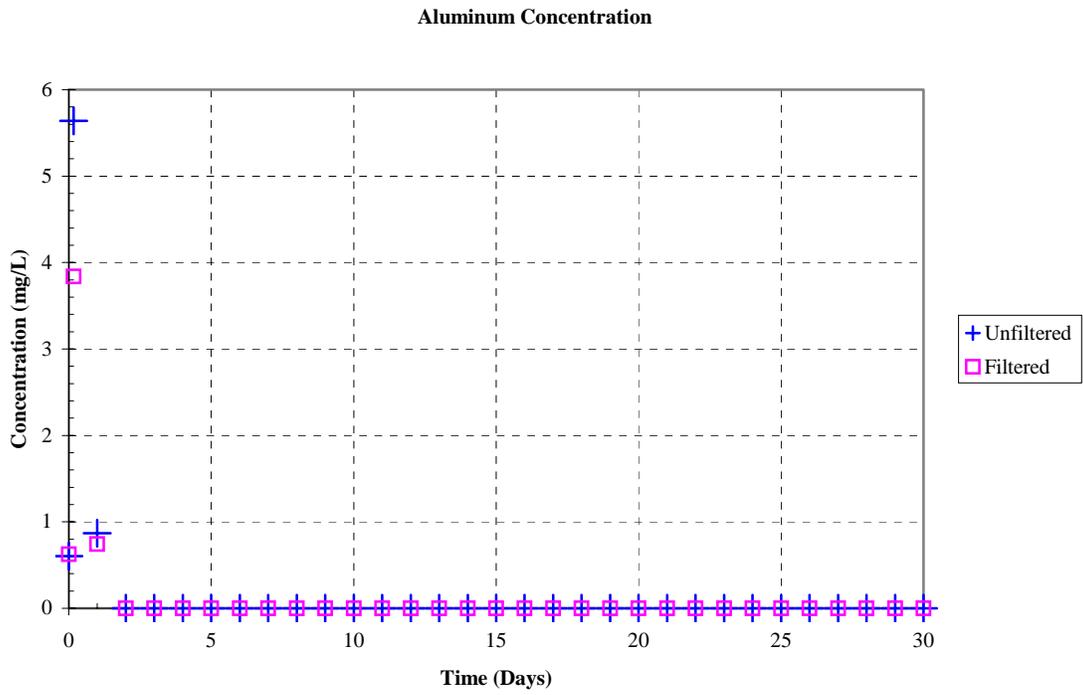
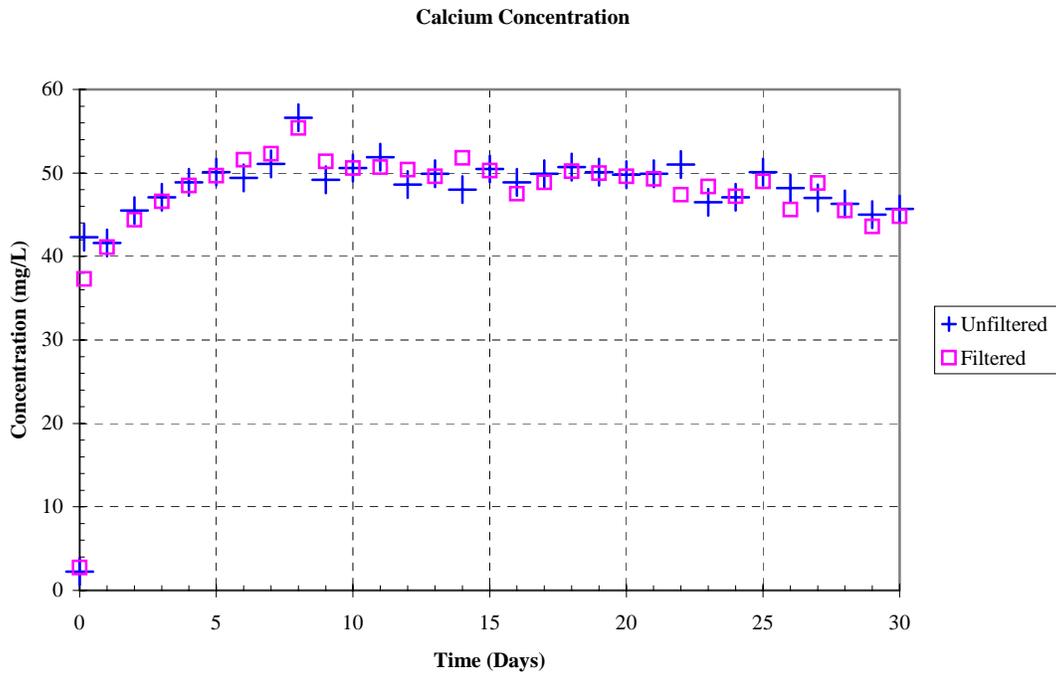
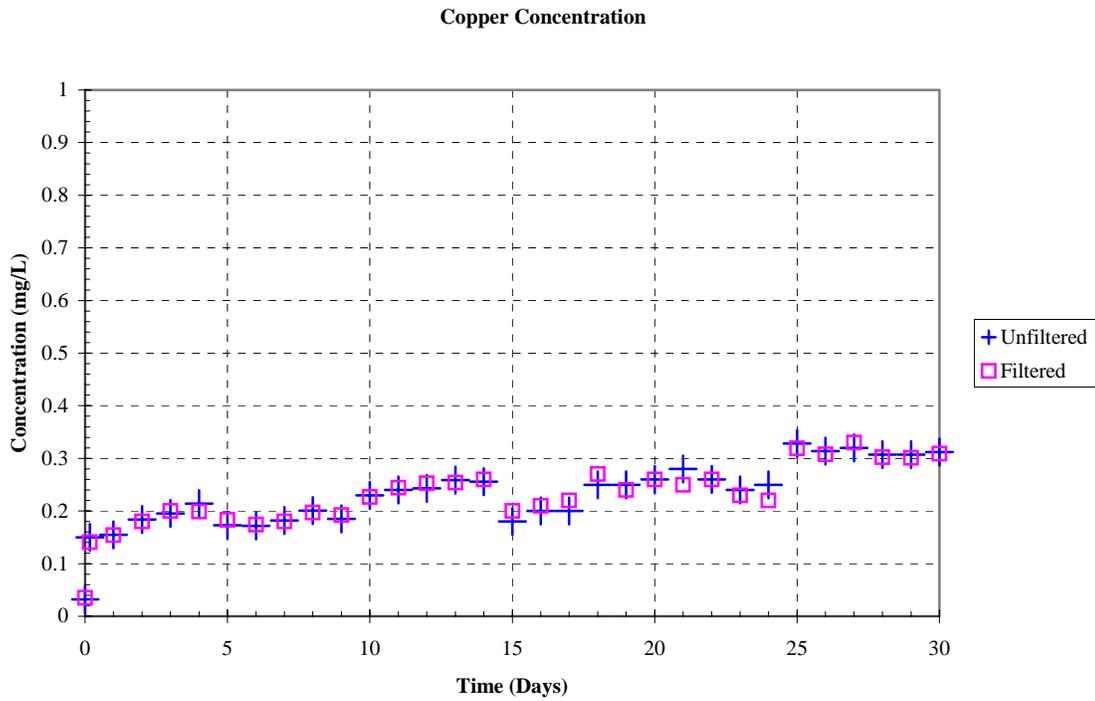
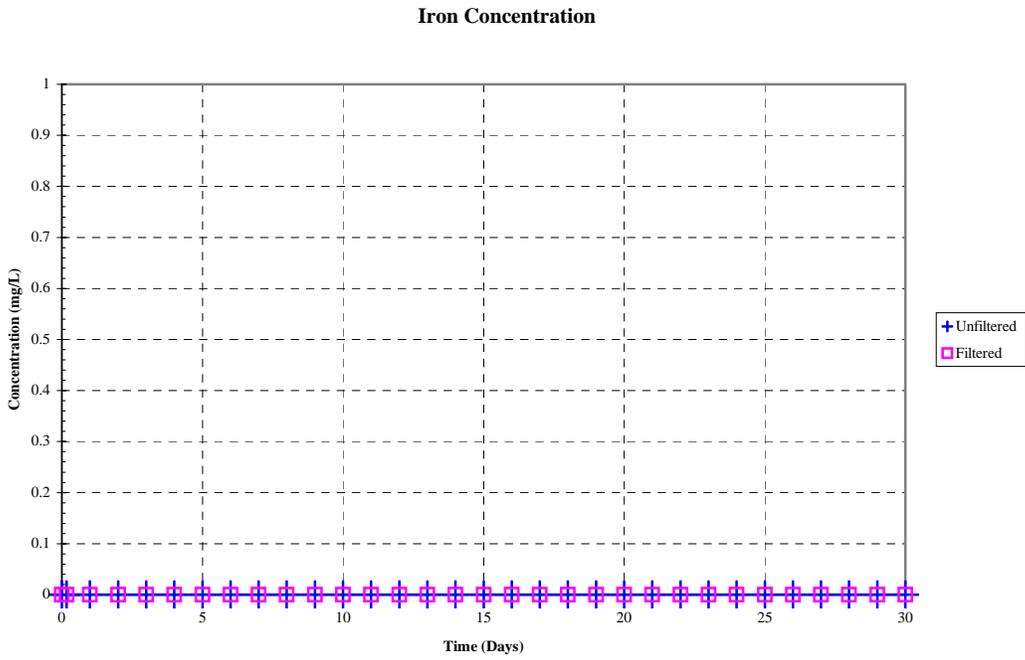
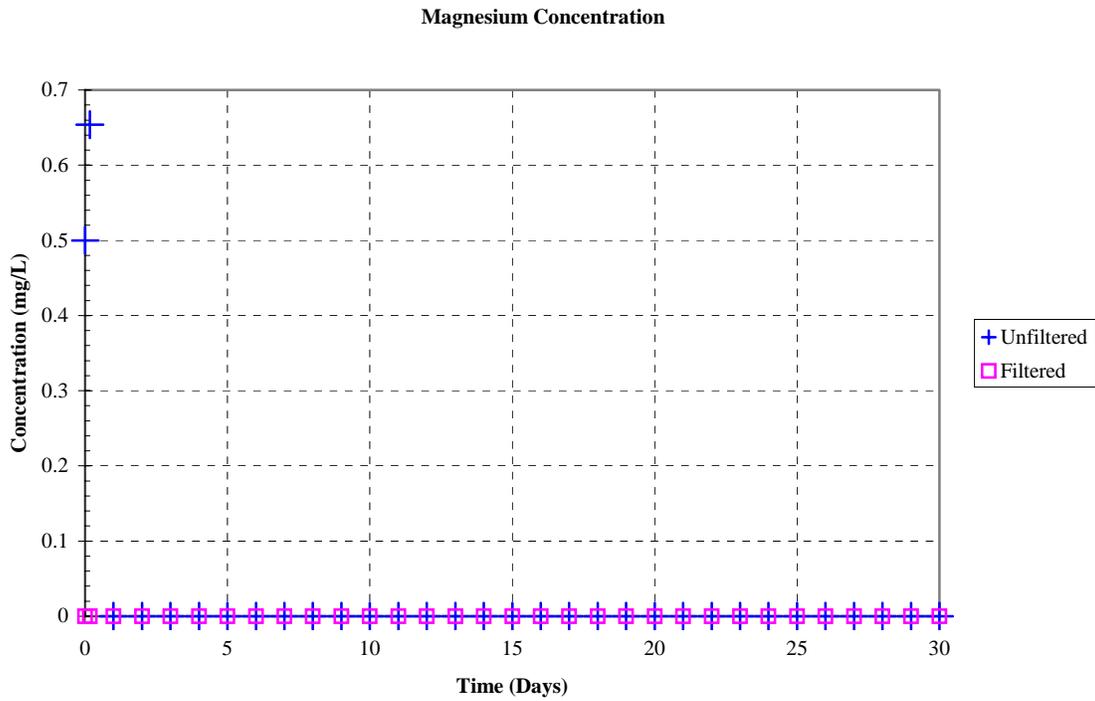
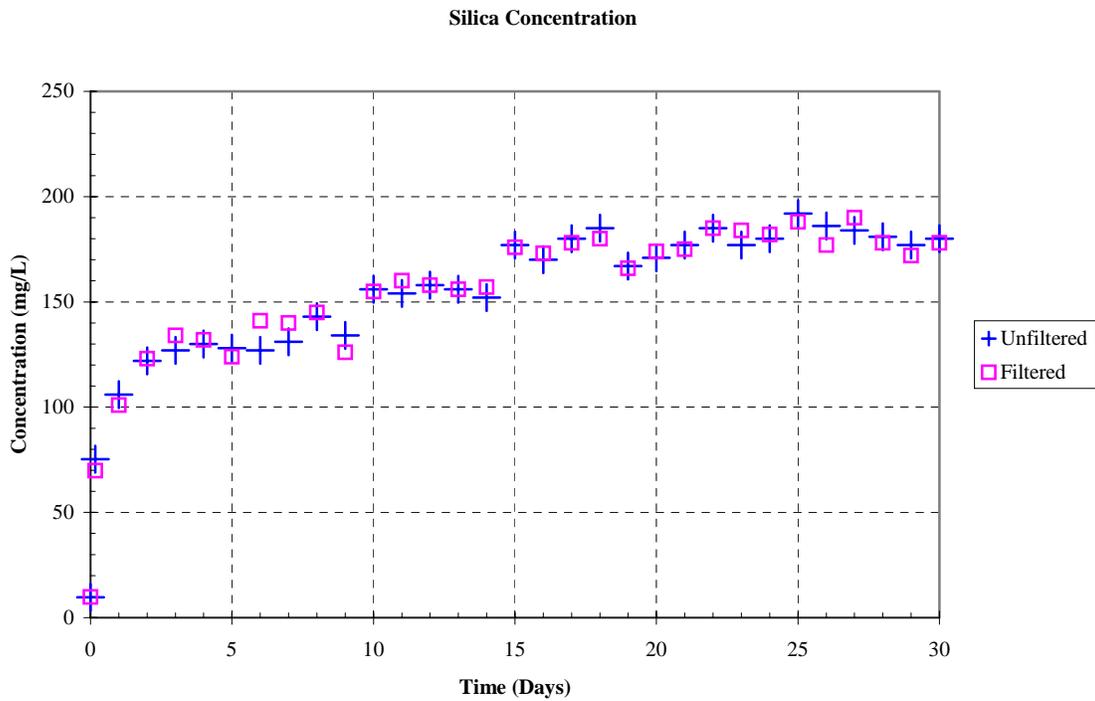
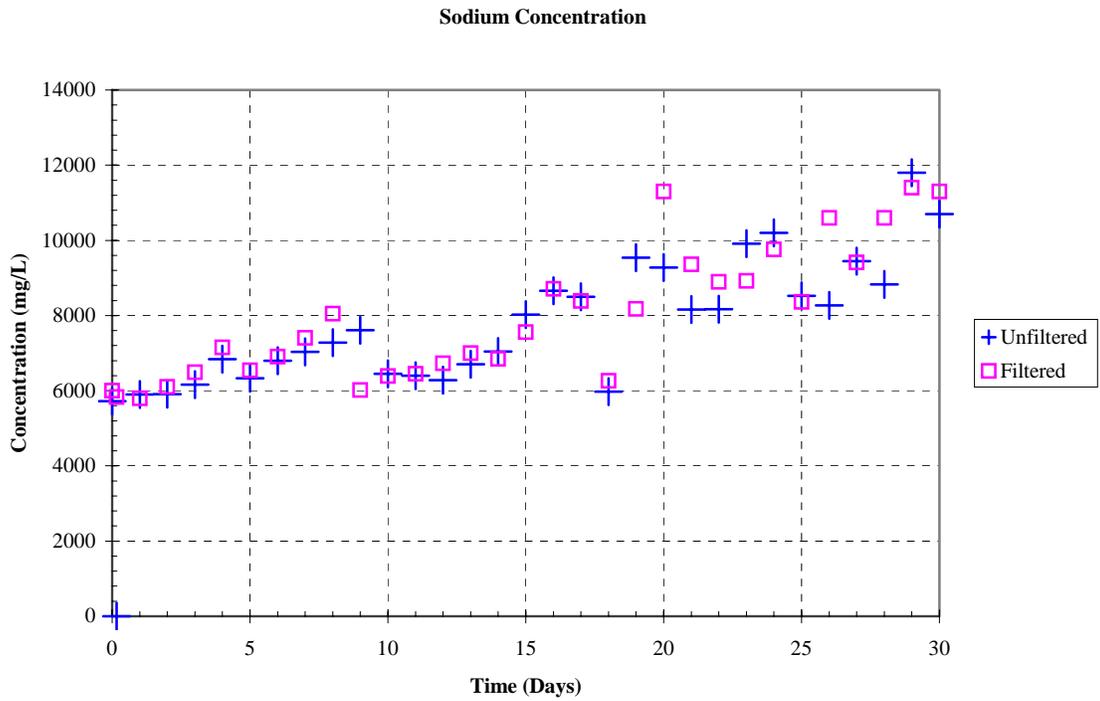
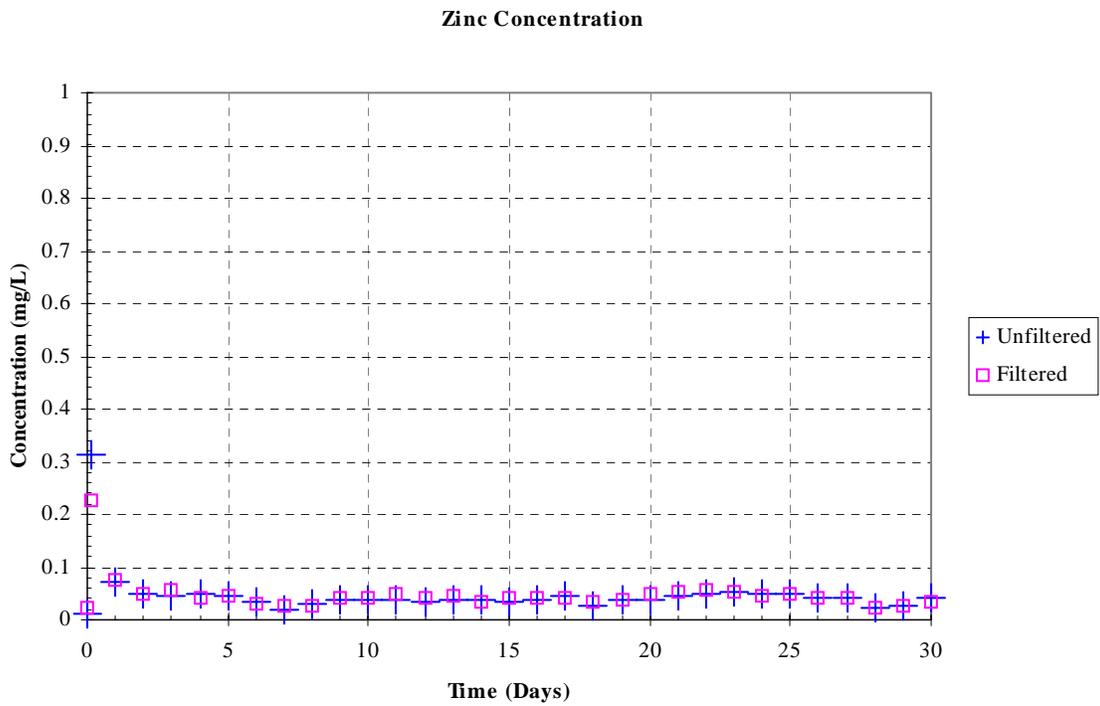
ICP results for Test #4 are displayed in Figures 3-8 through 3-15, which are daily sample results. Table 3-1 contains ICP results for elements that were analyzed on Days 1, 17, and 30. Table 3-1 shows the chloride, boron, lead, lithium, and potassium concentrations. An examination of the figures reveals that aluminum, copper, iron, magnesium, and zinc were present in trace amounts, below 1 mg/L. It also can be seen that calcium, silica, and magnesium are present in higher concentrations.

Figure 3-8. Aluminum concentration.

Figure 3-9. Calcium concentration.

Figure 3-10. Copper concentration.

Figure 3-11. Iron concentration.

Figure 3-12. Magnesium concentration.

Figure 3-13. Silica concentration.

Figure 3-14. Sodium concentration.

Figure 3-15. Zinc concentration.

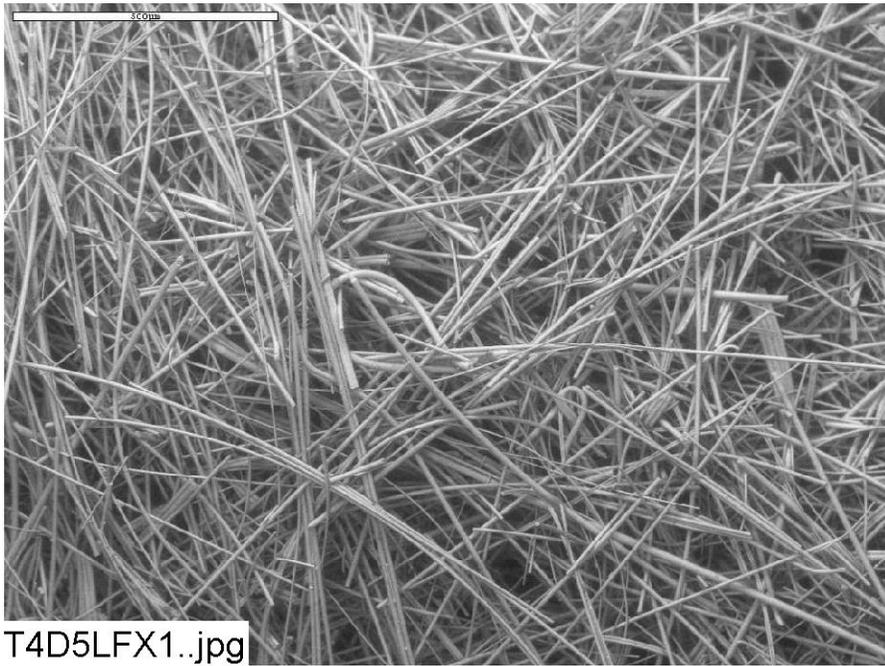
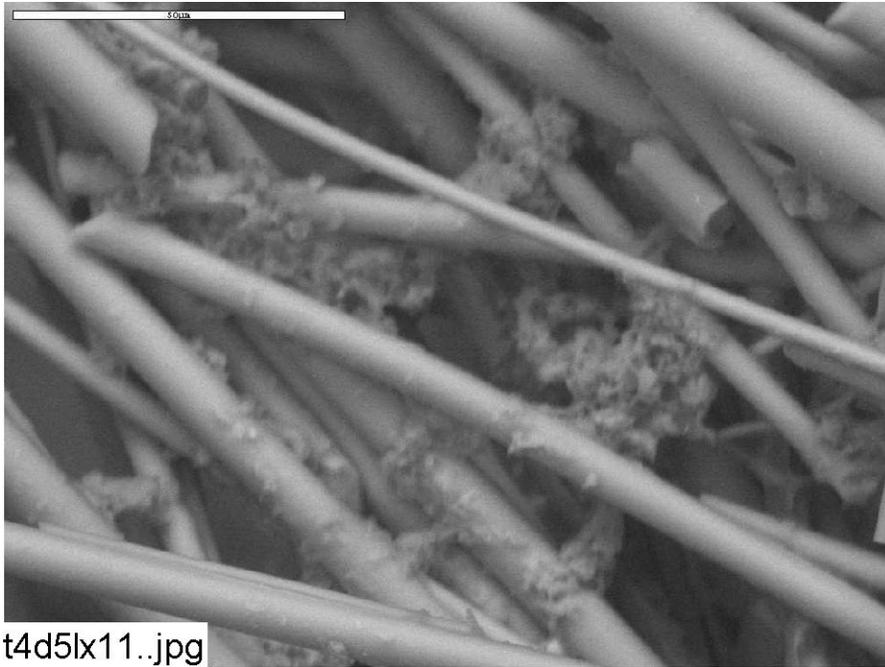
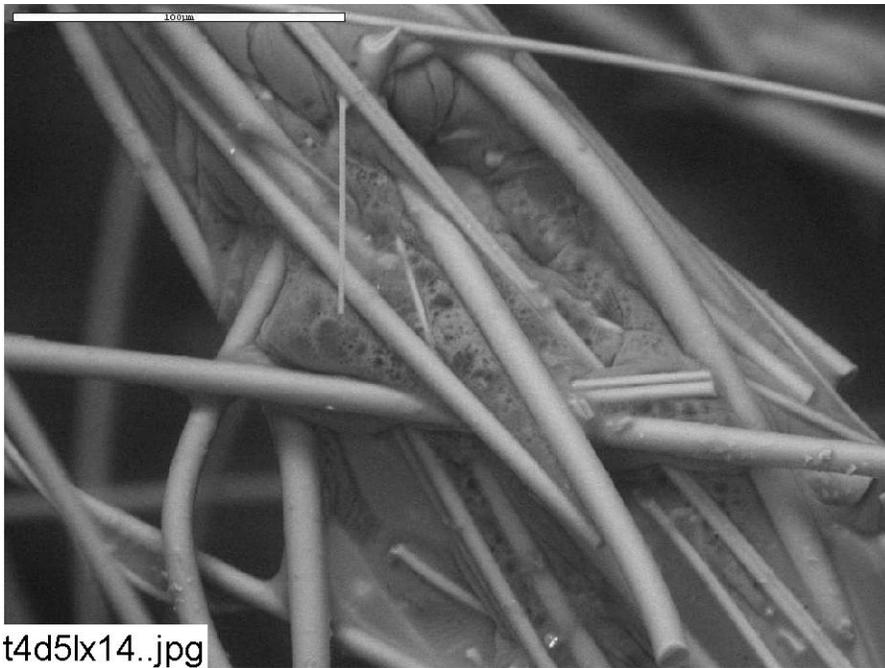
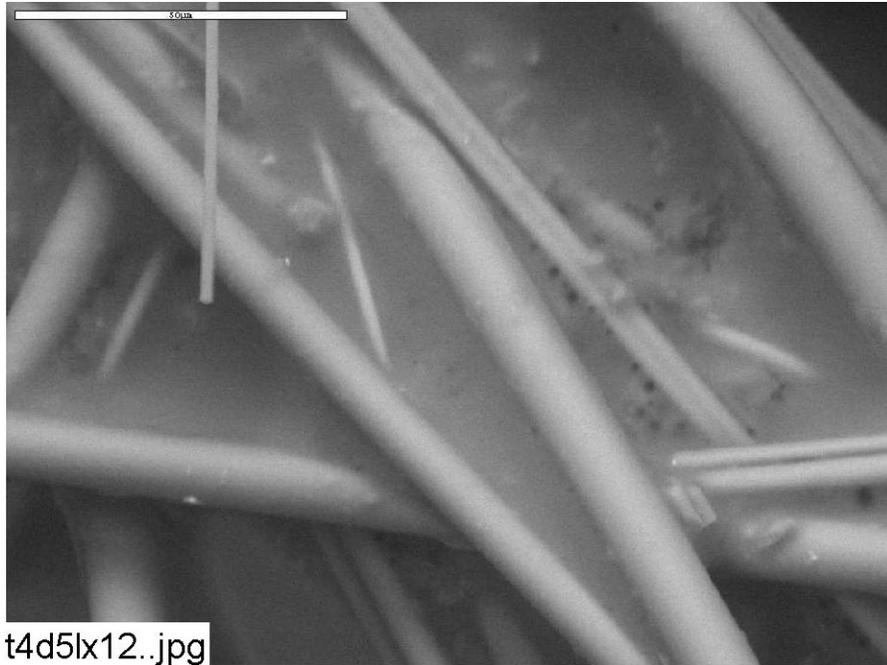
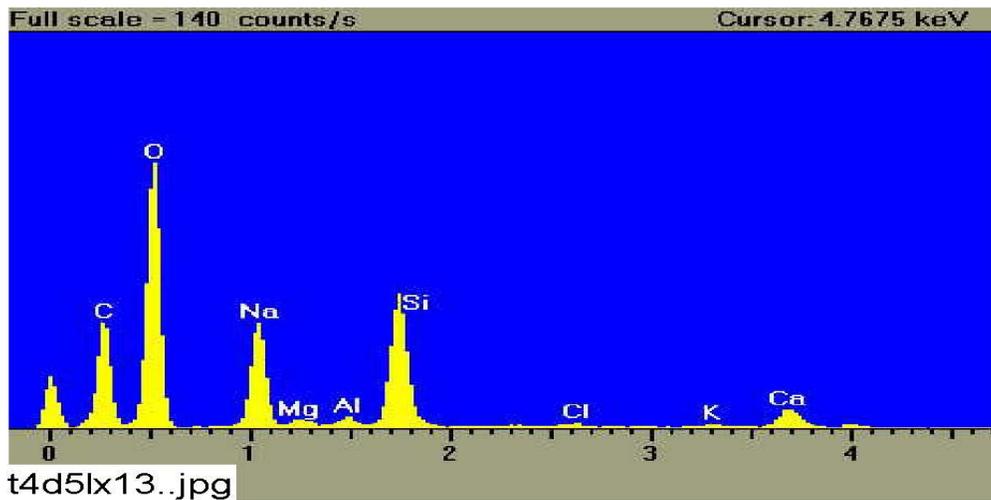
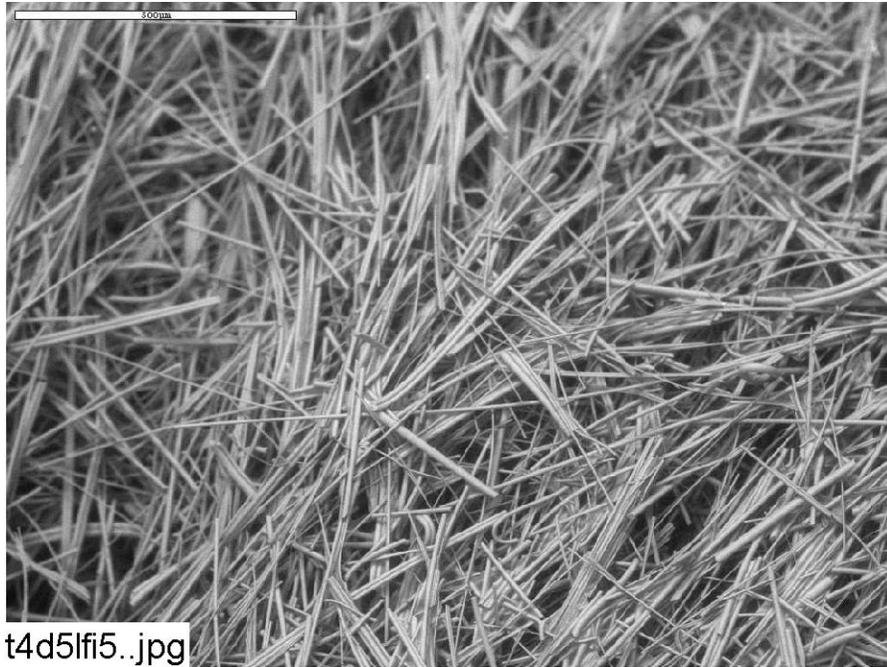
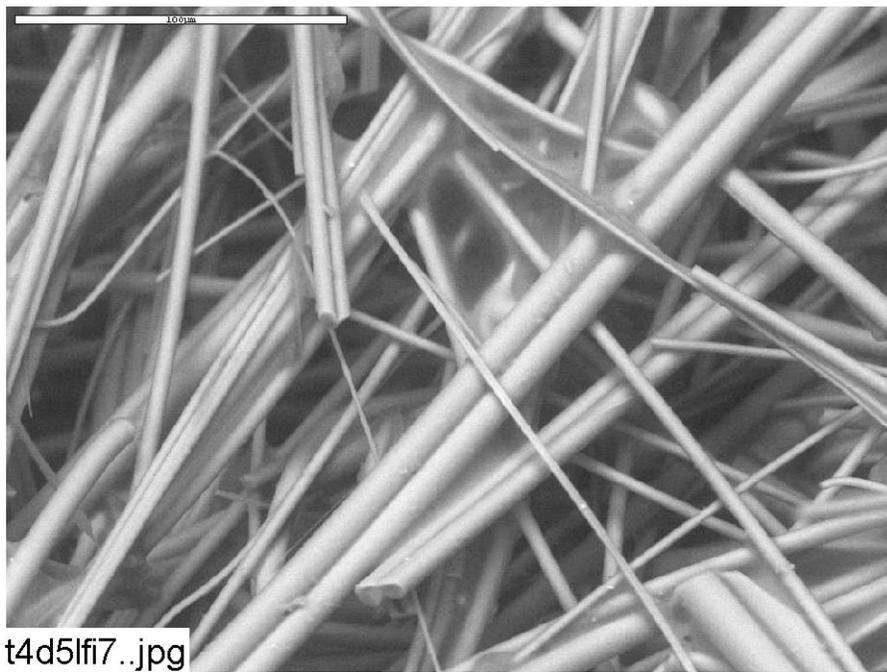
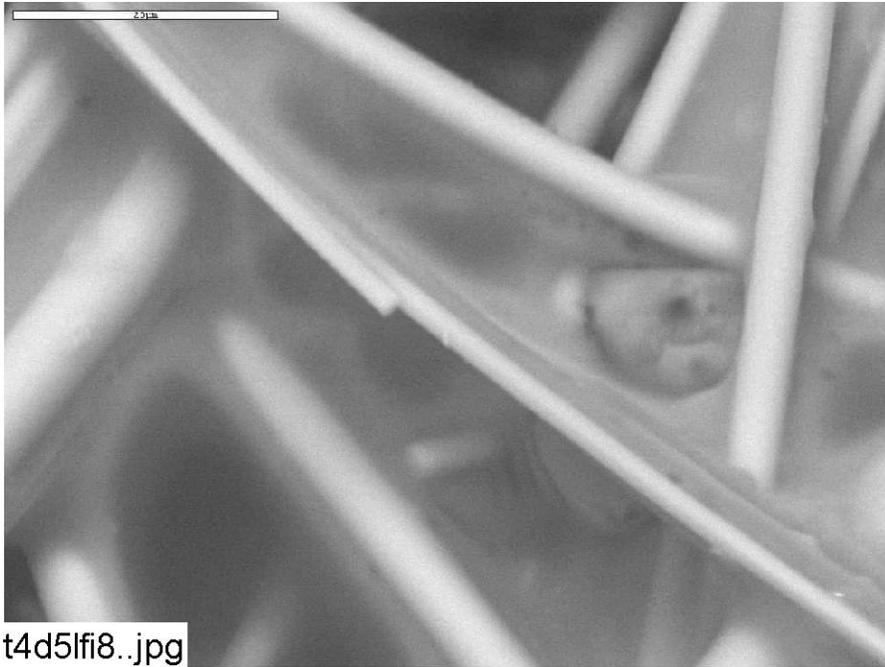
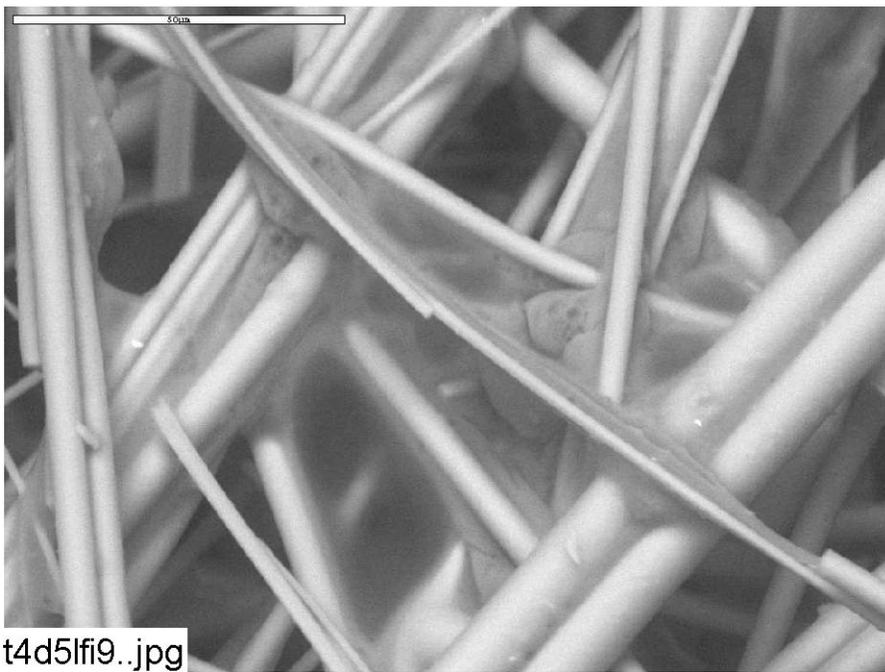
Since there was no significant water flowing through the fiberglass samples during the test, the migration of particulate deposits from the solution into the fiberglass interior is insignificant. Based on the ESEM results, some deposits were found after 5 days of the test on both the exterior and the interior of the low-flow fiberglass samples. In these deposits, a few particulates were found on the fiberglass exterior only (see Figure 3-17). However, most of the deposits were formed continuously like a film among glass fibers and coatings on the fibers. Therefore, these deposits are likely of chemical origin instead of being physically attached/retained. EDS results indicated that the film was composed of C, O, Na, Ca, Mg, Al, and possibly Si. Comparing the amount of the film on the

fiberglass revealed no significant difference between the interior and exterior samples. Again, this fact may be explained by the likely chemical origin of the deposits, since chemical precipitation would occur to a similar degree on both the exterior and the interior fiberglass samples if the concentrations were similar. Figures 3-16 through 3-24 show the Day 4 low-flow fiberglass results.

Figure 3-16. Environmental SEM image magnified 80 times for a Test #4 Day 5 low-flow exterior fiberglass sample. (T4D5LFX1.jpg)

Figure 3-17. Environmental SEM image magnified 1000 times for a Test #4 Day 5 low-flow exterior fiberglass sample. (t4d5lx11.jpg)

Figure 3-18. Environmental SEM image magnified 500 times for a Test #4 Day 5 low-flow exterior fiberglass sample. (t4d5lx14.jpg)

Figure 3-19. Environmental SEM image magnified 1000 times for a Test #4 Day 5 low-flow exterior fiberglass sample. (t4d5lx12.jpg)

Figure 3-20. EDS counting spectrum for the film between the fibers shown in Figure 3-19. (t4d5lx13.jpg)

Figure 3-21. Environmental SEM image magnified 80 times for a Test #4 Day 5 low-flow interior fiberglass sample. (t4d5lf15.jpg)

Figure 3-22. Environmental SEM image magnified 500 times for a Test #4 Day 5 low-flow interior fiberglass sample. (t4d5lf17.jpg)

Figure 3-23. Environmental SEM image magnified 2000 times for a Test #4 Day 5 low-flow interior fiberglass sample. (t4d5lf18.jpg)

Figure 3-24. Environmental SEM image magnified 1000 times for a Test #4 Day 5 low-flow interior fiberglass sample. (t4d5lf19.jpg)
