Integrated Chemical Effects Test Project: Test #4 Data Report

Los Alamos National Laboratory

**U.S. Nuclear Regulatory Commission
Office of Nuclear Regulatory Research
Washington, DC 20555-0001**

A 30-day test was conducted in the Integrated Chemical Effects Test (ICET) project test apparatus. The test simulated the chemical environment present inside a pressurized water reactor containment water pool after a loss-of-coolant accident. The initial chemical environment contained 15.41 kg of boric acid, 8.47 kg of sodium hydroxide, 0.663 g of lithium hydroxide, and 212 mL of hydrochloric acid. An additional amount of sodium hydroxide (614 g) was added with the spray beginning at time zero and lasting until 30 minutes into the test. The test was conducted for 30 days at a constant temperature of 60°C (140°F). The materials tested within this environment included representative amounts of submerged and unsubmerged aluminum, copper, concrete, zinc, carbon steel, and insulation samples (80% calcium silicate and 20% fiberglass). Representative amounts of concrete dust and latent debris were also added to the test solution. Water was circulated through the bottom portion of the test cham

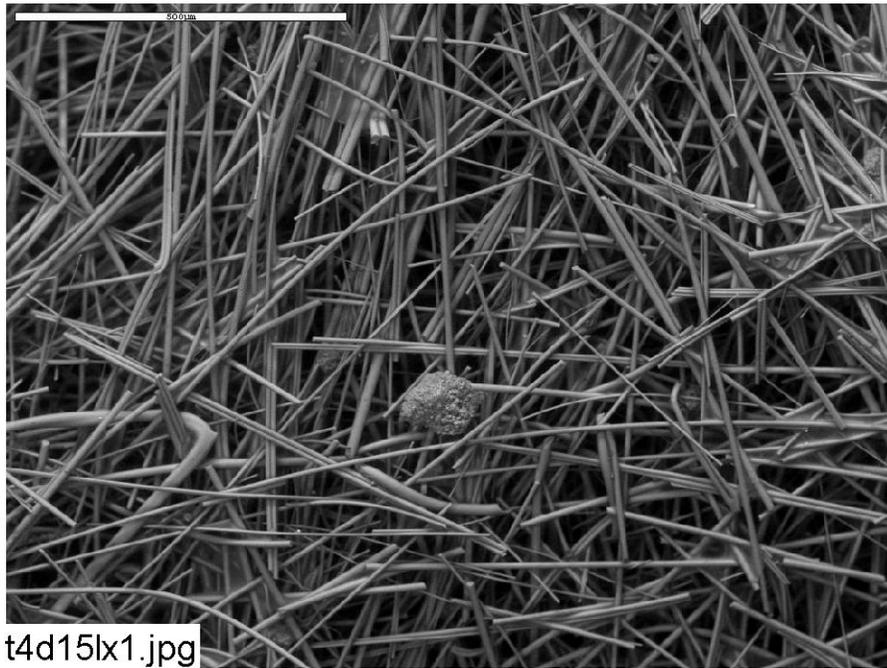
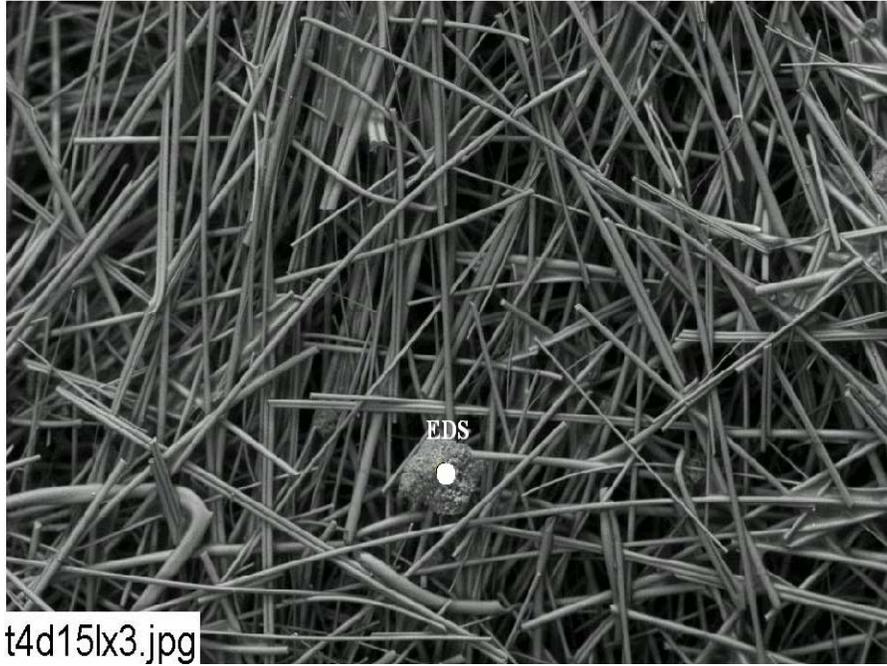
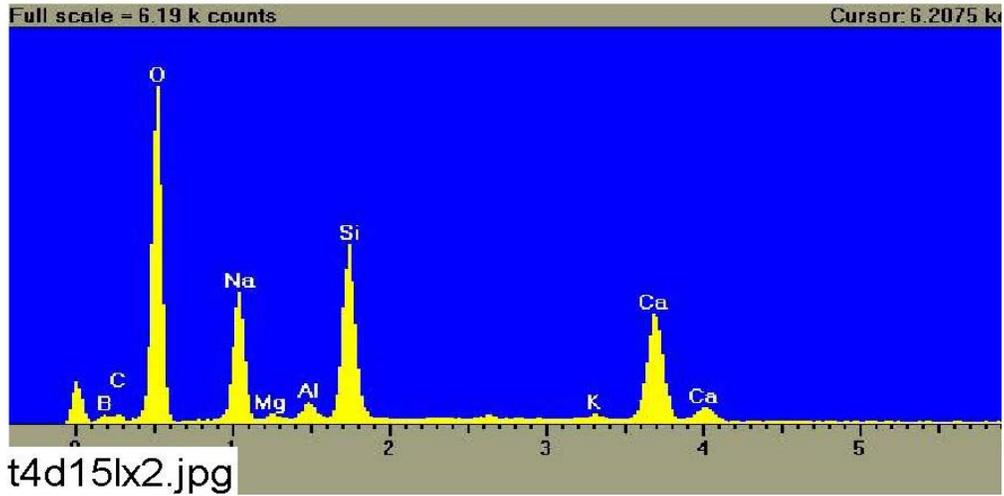
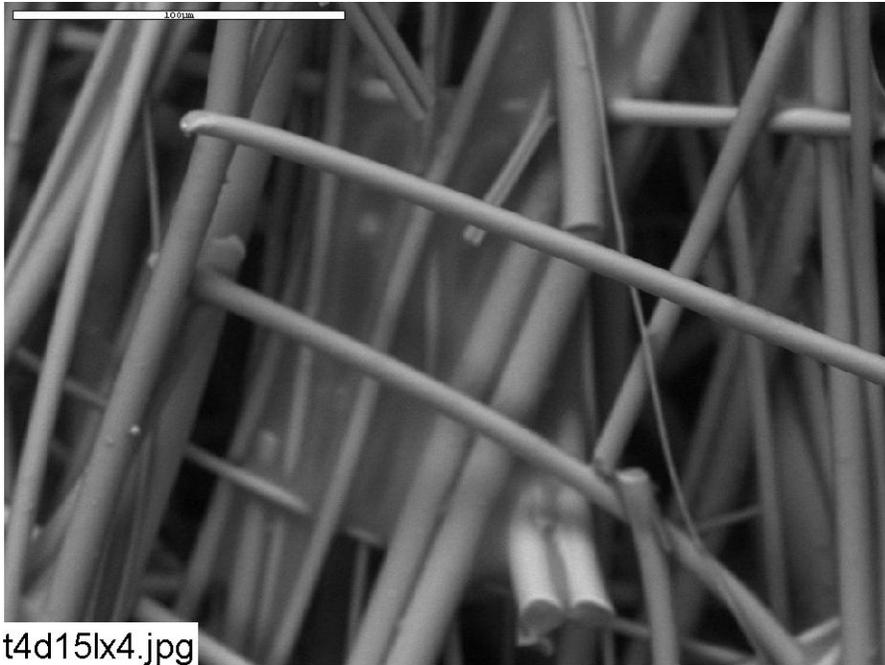
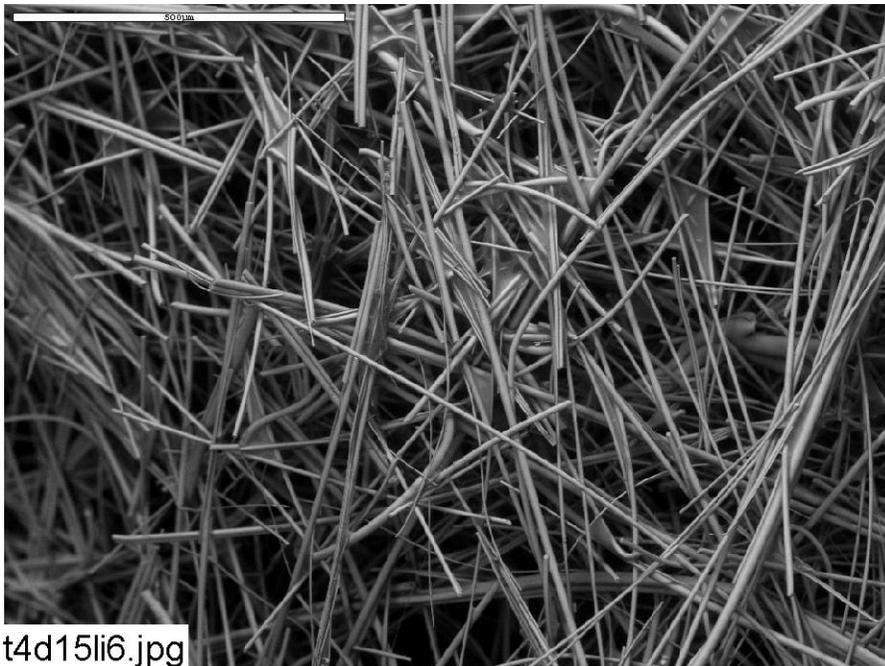
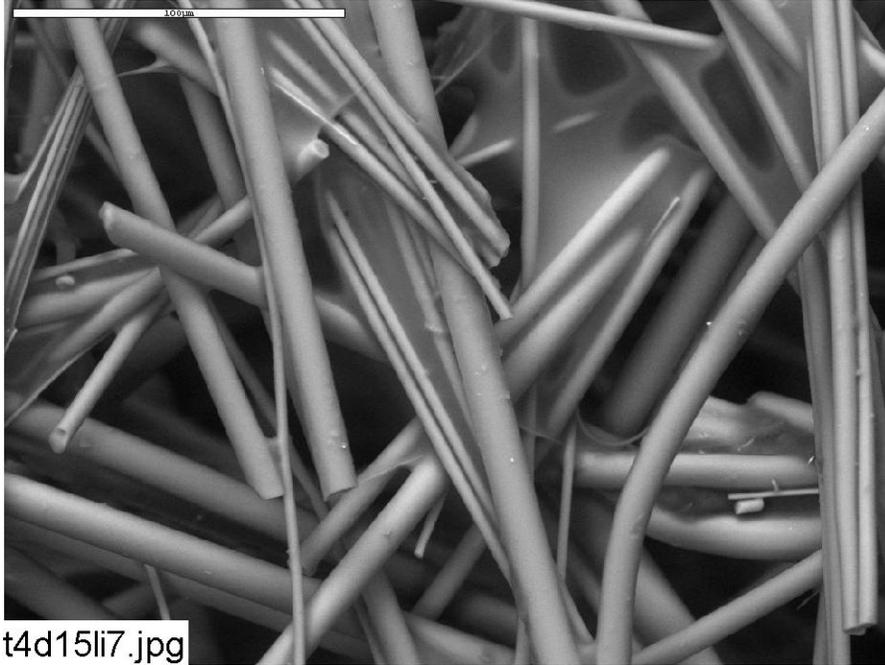
Similar to the Day 5 samples, a few particulate deposits were found on the fiberglass exterior. EDS analysis shows that the particulate deposits were mainly composed of O, Na, Ca, Al, Mg, B, C, K, and possibly Si. However, the film deposits were prevalent on both the exterior and the interior fiberglass samples. There was no significant increase in the amount of deposits on Day 15 samples compared to Day 5 samples. Comparing the amount of the film deposits on the exterior and the interior Day 15 low-flow fiberglass samples, the difference was insignificant. Figures 3-25 through 3-30 show the Day 15 low-flow fiberglass results.

Figure 3-25. Environmental SEM image magnified 100 times for a Test #4 Day 15 exterior low-flow fiberglass sample. (t4d15lx1.jpg)

Figure 3-26. Annotated environmental SEM image magnified 100 times for a Test #4 Day 15 exterior low-flow fiberglass sample. (t4d15lx3.jpg)

Figure 3-27. EDS counting spectrum for the particulate deposit on fiberglass shown in Figure 3-26. (t4d15lx2.jpg)

Figure 3-28. Environmental SEM image magnified 500 times for a Test #4 Day 15 exterior low-flow fiberglass sample. (t4d15lx4.jpg)

Figure 3-29. Environmental SEM image magnified 100 times for a Test #4 Day 15 interior low-flow fiberglass sample. (t4d15li6.jpg)

Figure 3-30. Environmental SEM image magnified 500 times for a Test #4 Day 15 interior low-flow fiberglass sample. (t4d15li7.jpg)

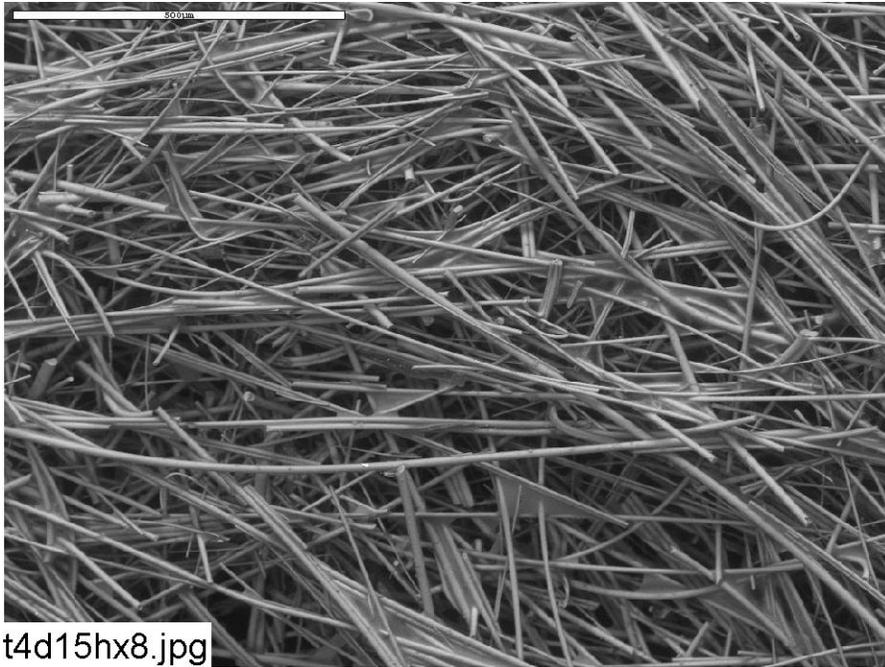
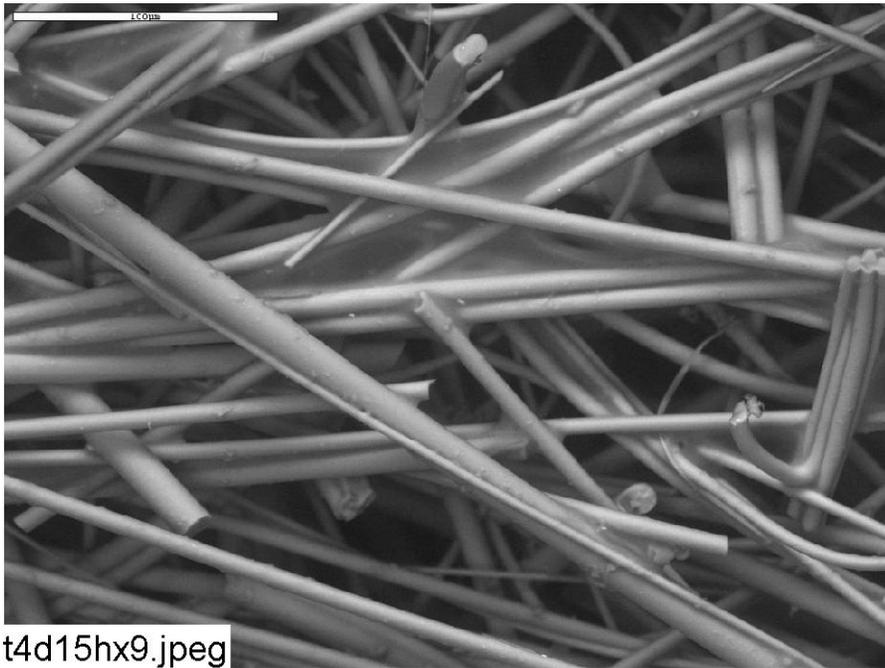
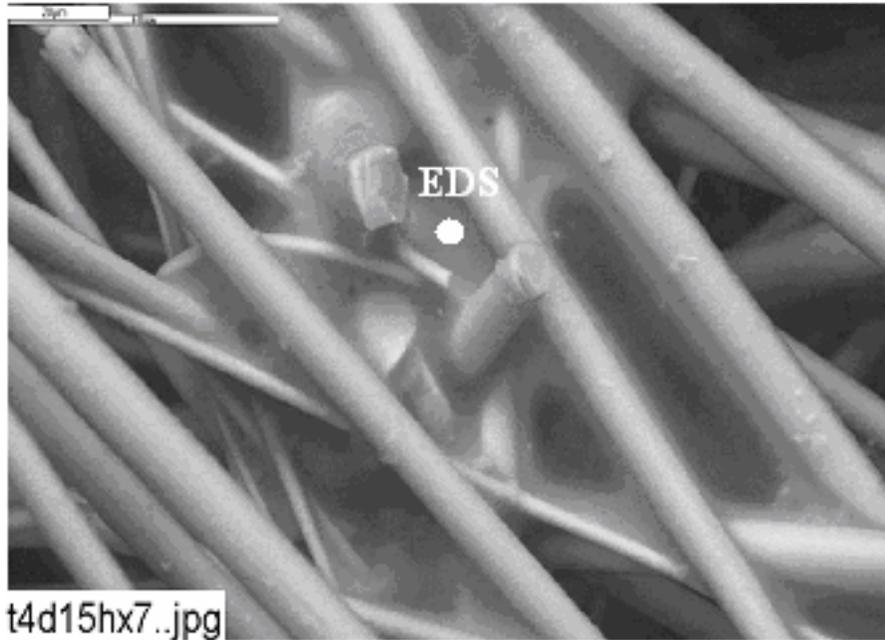
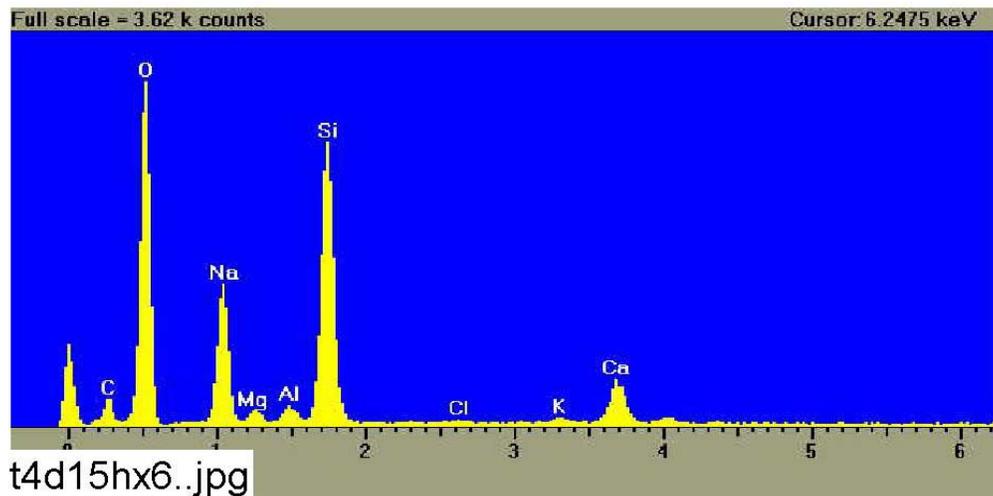
No significant difference was found between Day 15 high-flow and low-flow fiberglass samples. The film deposits were prevalent on both the exterior and interior fiberglass samples. Consistently, EDS analysis indicates that the film was composed of O, Na, Ca, C, Mg, Al, K, and possibly Si. There was no significant difference regarding the amount of the film deposits between the exterior and the interior fiberglass samples, suggesting the likely chemical origin of the film. In addition, no particulate deposits were observed on either the exterior or interior fiberglass samples. Figures 3-31 through 3-36 show the Day 15 high-flow fiberglass results.

Figure 3-31. Environmental SEM image magnified 100 times for a Test #4 Day 15 exterior high-flow fiberglass sample. (t4d15hx8.jpg)

Figure 3-32. Environmental SEM image magnified 400 times for a Test #4 Day 15 exterior high-flow fiberglass sample. (t4d15hx9.jpeg)

Figure 3-33. Environmental SEM image magnified 750 times for a Test #4 Day 15 exterior high-flow fiberglass sample. (t4d15hx7.jpg)

Figure 3-34. EDS counting spectrum for the spot on the film between the fibers shown in Figure 3-33. (t4d15hx6.jpg)

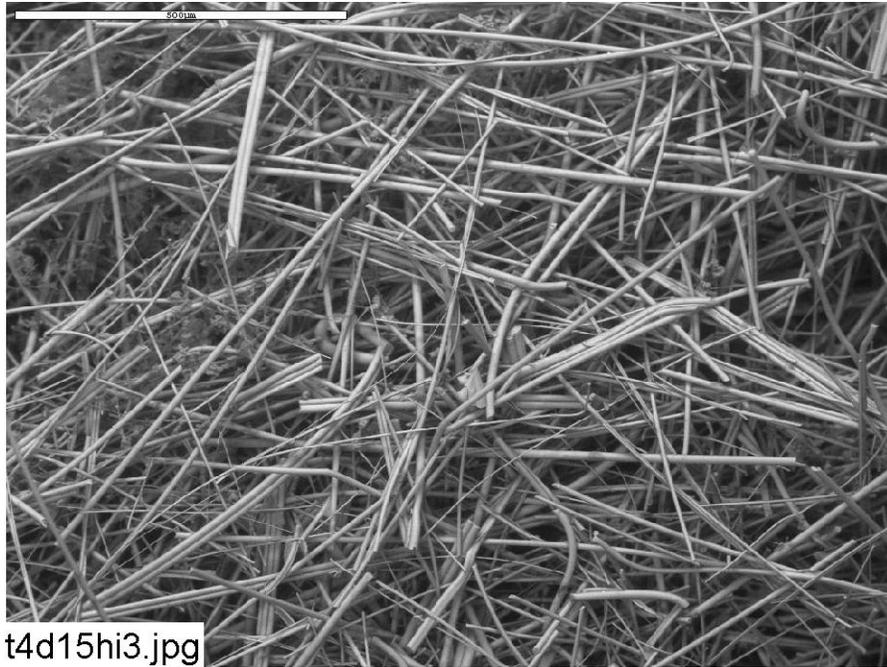
Figure 3-35. Environmental SEM image magnified 100 times for a Test #4 Day 15 interior high-flow fiberglass sample. (t4d15hi3.jpg)

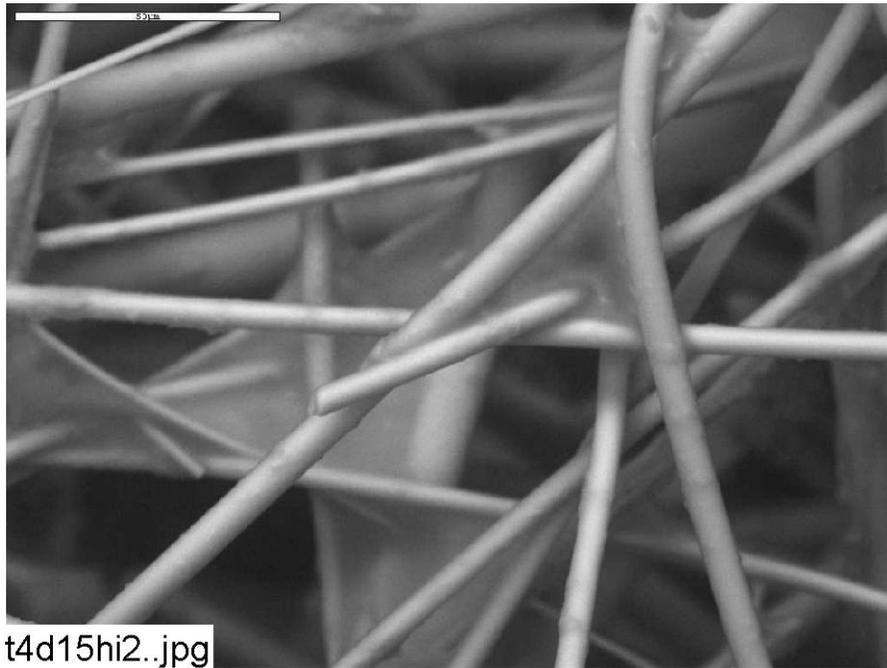
Figure 3-36. Environmental SEM image magnified 800 times for a Test #4 Day 15 interior high-flow fiberglass sample. (t4d15hi2.jpg)

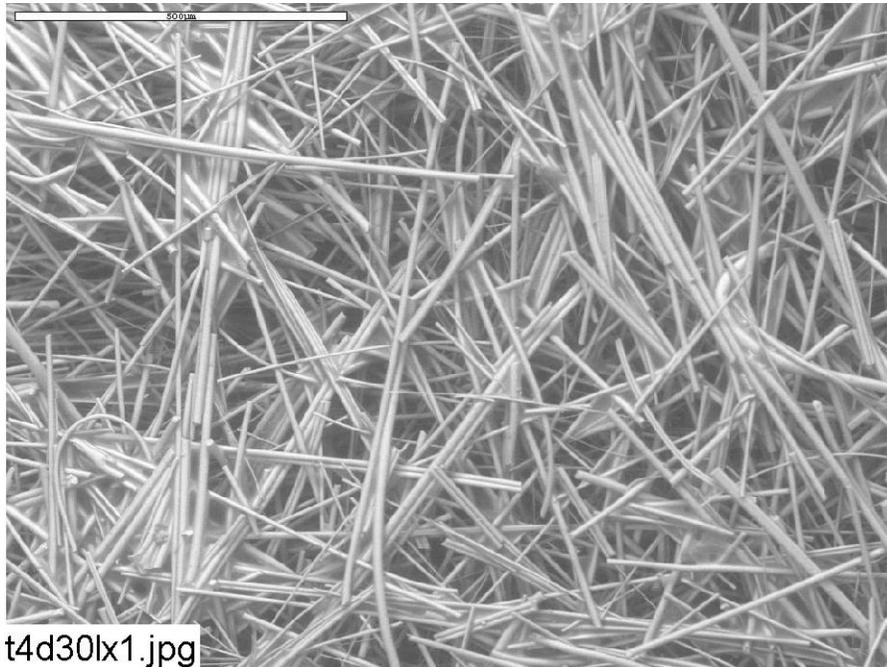
Figure 3-37. Environmental SEM image magnified 100 times for a Test #4 Day 30 exterior low-flow fiberglass sample. (t4d30lx1.jpg)

A similar amount and composition of the film deposits were found with Day 30 low-flow fiberglass samples compared to Day 5 and Day 15 low-flow fiberglass samples. No significant difference was found regarding the amount of the film deposits between the exterior and the interior Day 30 low-flow fiberglass samples. As with the Day 5 and 15 samples, the film was composed of O, Na, Ca, Mg, Al, C, K, and possibly Si. Besides the film, a coating was found on the glass fibers (see Figure 3-39). The coating was likely formed by chemical precipitation. EDS analysis shows the coating had the same composition as the film, suggesting both are likely of chemical origin. Figures 3-37 through 3-43 show the Day 30 low-flow fiberglass results.

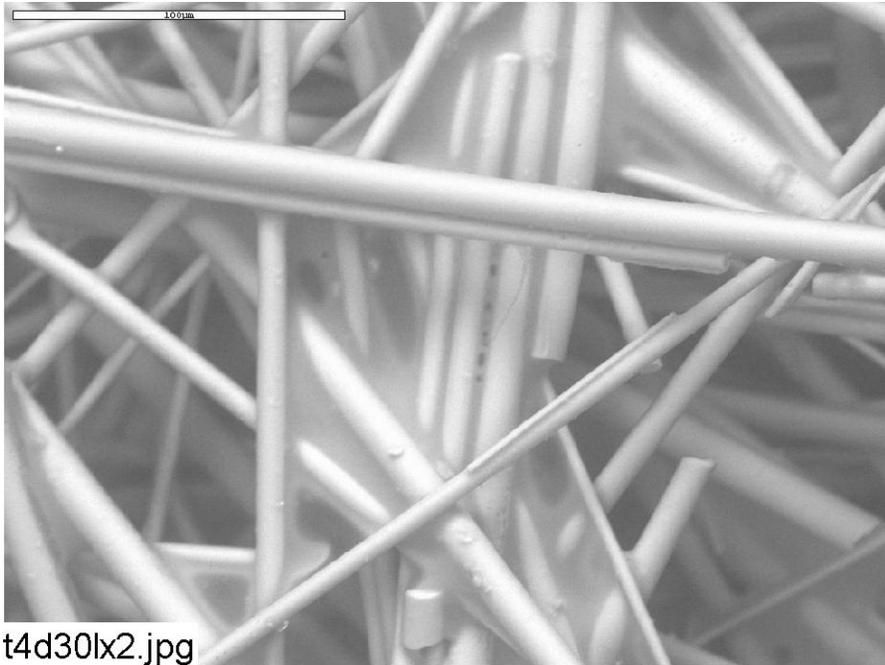
Figure 3-38. Environmental SEM image magnified 500 times for a Test #4 Day 30 exterior low-flow fiberglass sample. (t4d30lx2.jpg)

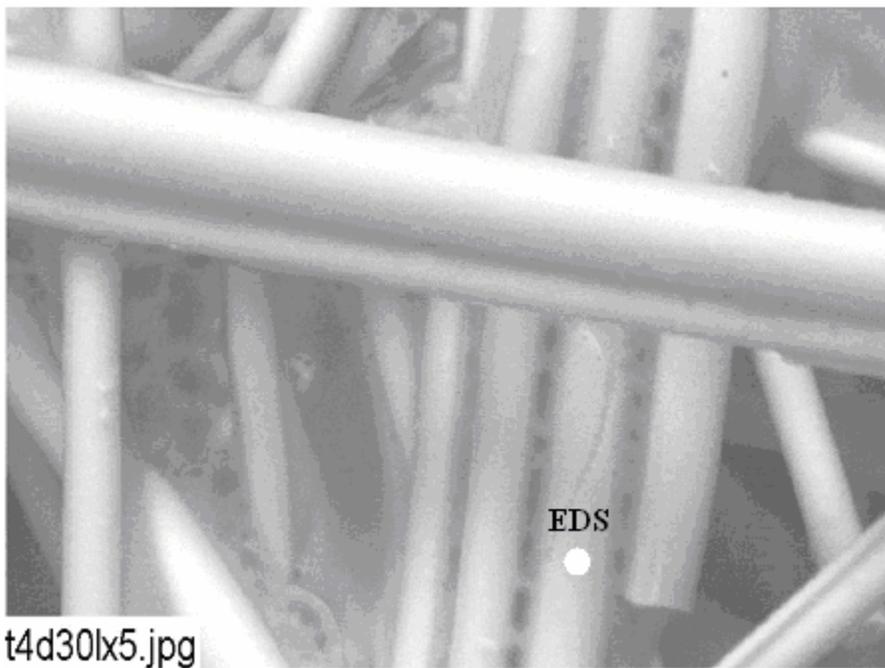
Figure 3-39. Environmental SEM image magnified 1000 times for a Test #4 Day 30 low-flow fiberglass sample. (t4d30lx5.jpg)

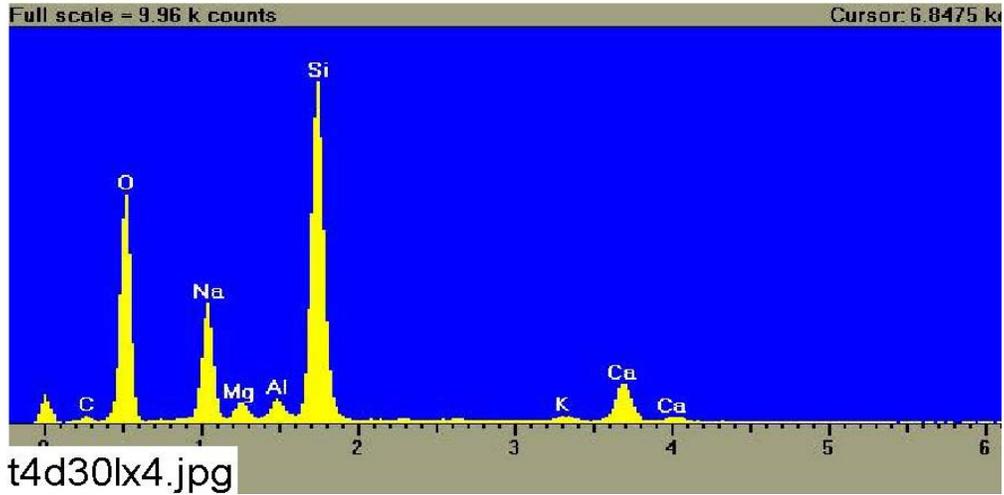
Figure 3-40. EDS counting spectrum for the spot of coating substance on the fiberglass shown in Figure 3-39. (t4d30lx4.jpg)

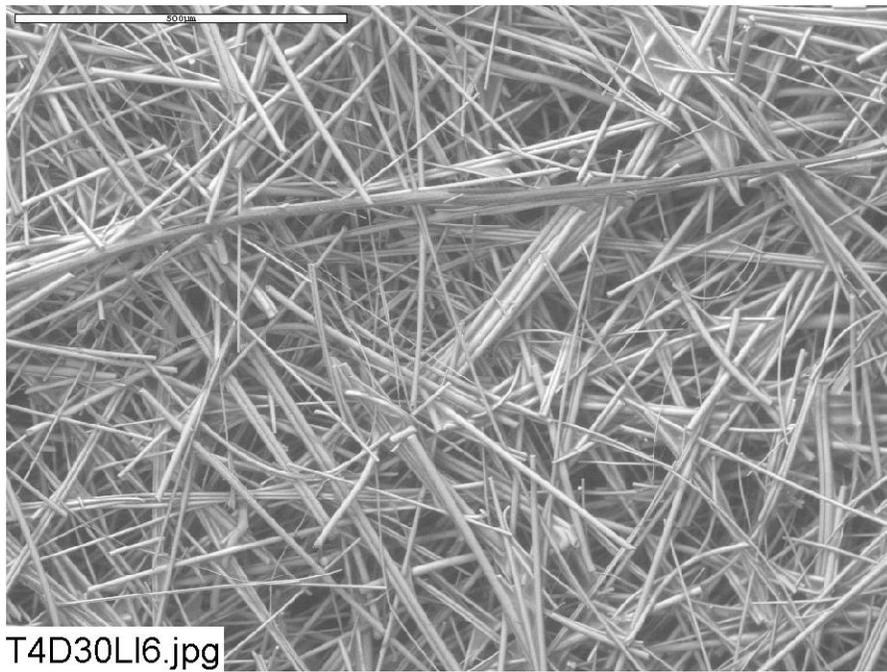
Figure 3-41. Environmental SEM image magnified 100 times for a Test #4 Day 30 interior low-flow fiberglass sample. (T4D30LI6.jpg)

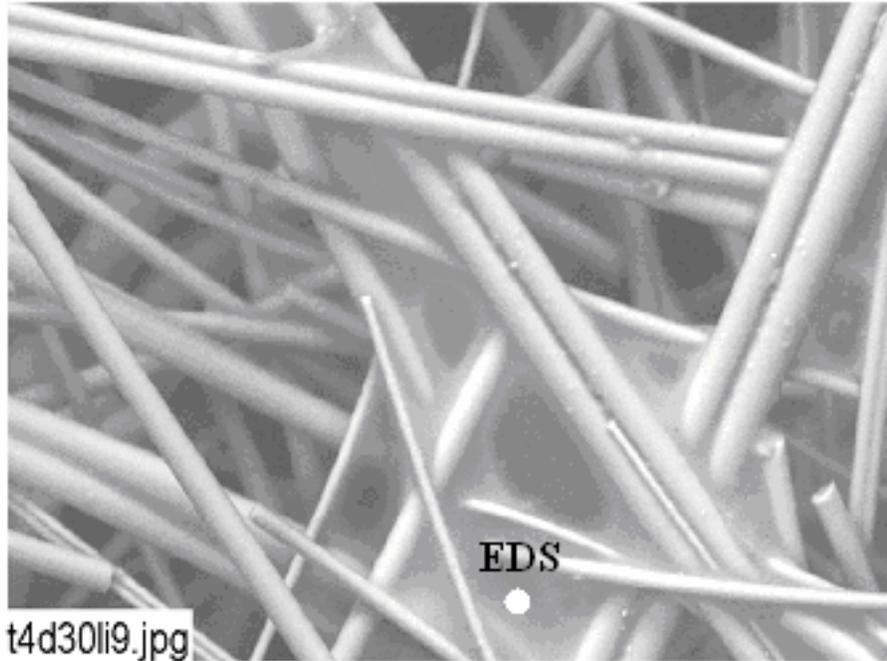
Figure 3-42. Environmental SEM image magnified 500 times for a Test #4 Day 30 interior low-flow fiberglass sample. (t4d30li9.jpg)

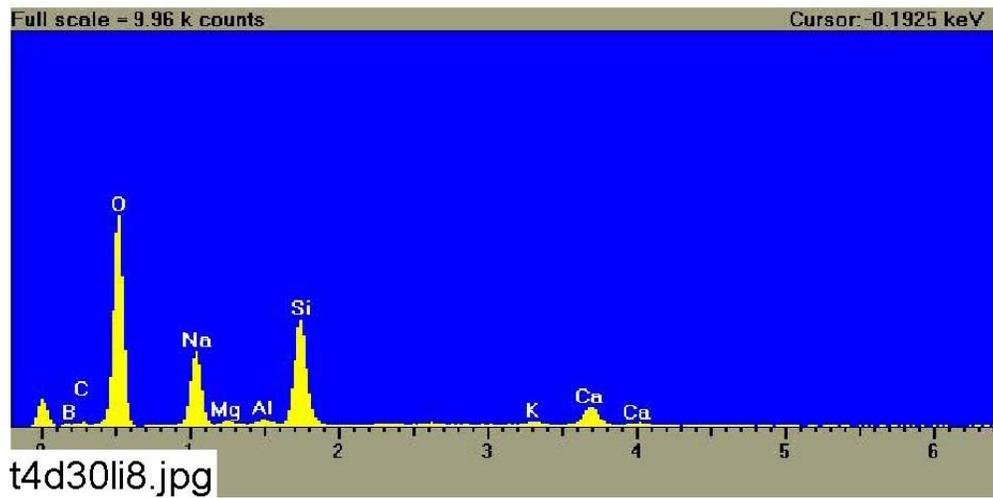
Figure 3-43. EDS counting spectrum for the film on the fiberglass shown in Figure 3-42. (t4d30li8.jpg)

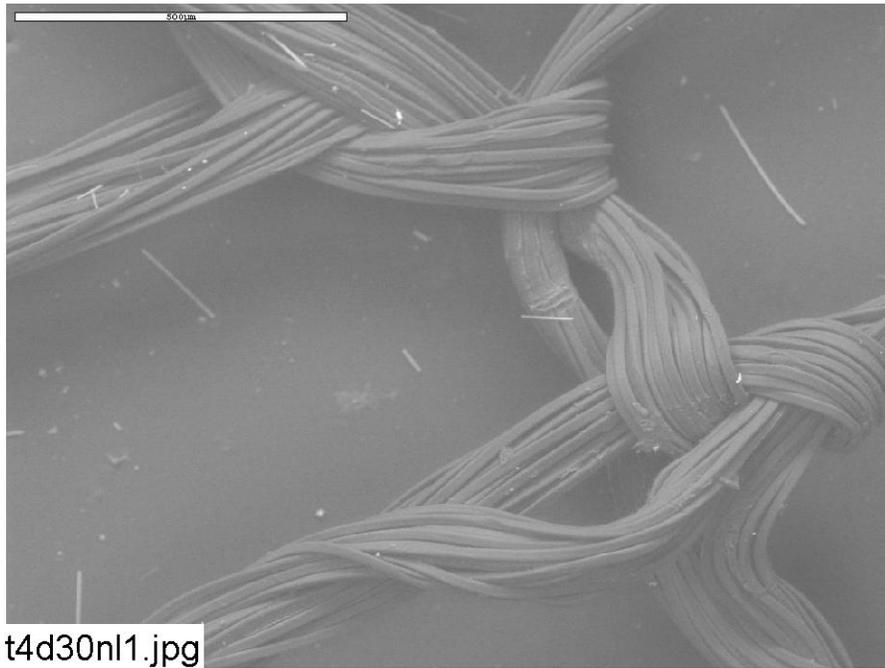
Figure 3-44. Environmental SEM image magnified 100 times for a Test #4 Day 30 nylon mesh submerged in low-flow area (inserted on Day 4). (t4d30nl1.jpg)

A 5 g fiberglass sample was enclosed in a nylon mesh and submerged in a low-flow zone of the tank on Day 3, to provide a comparison to all other fiberglass samples, which were enclosed in stainless steel mesh and placed in the tank on Day 0. The purpose of using a nylon mesh was to see if the mesh material (i.e., stainless steel or nylon) affects the deposits on the fiberglass samples. Comparing these results to Day 30 low-flow fiberglass samples, no significant difference was observed. The film was still the dominant deposit on both of the exterior and the interior samples. There were no particulate deposits found on the fiberglass. This result suggests that the mesh material did not significantly affect the deposits on fiberglass. In addition, ESEM images show that the nylon fiber was relatively clean and without significant deposits on it. The nylon mesh sample was put in the tank on Day 3, and no significant difference was found compared to the low-flow fiberglass samples put in the tank at the start of the test. Figures 3-44 through 3-49 show the Day 30 nylon-enclosed fiberglass results.

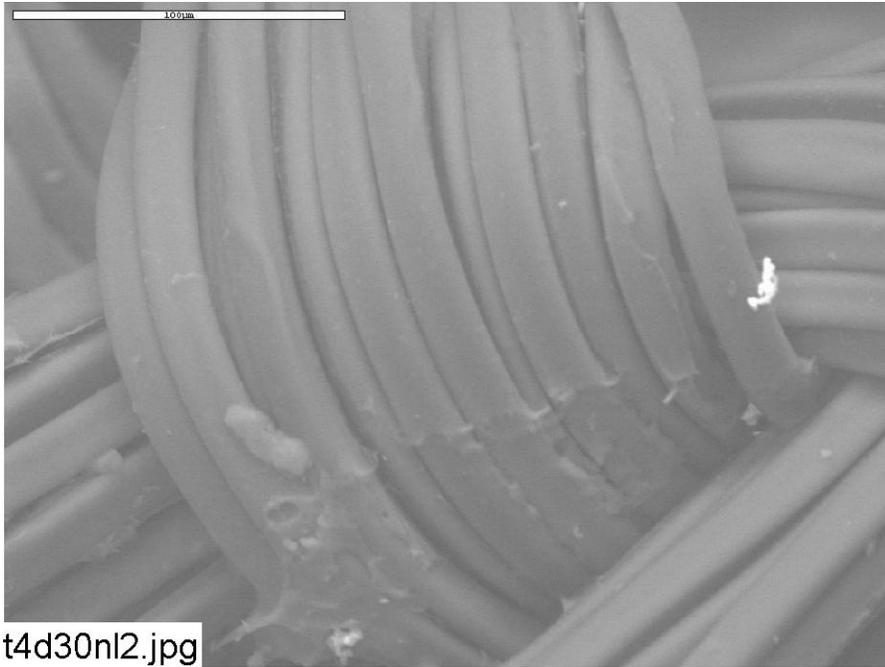
Figure 3-45. Environmental SEM image magnified 500 times for a Test #4 Day 30 nylon mesh submerged in low-flow area (inserted on Day 4). (t4d30nl2.jpg)

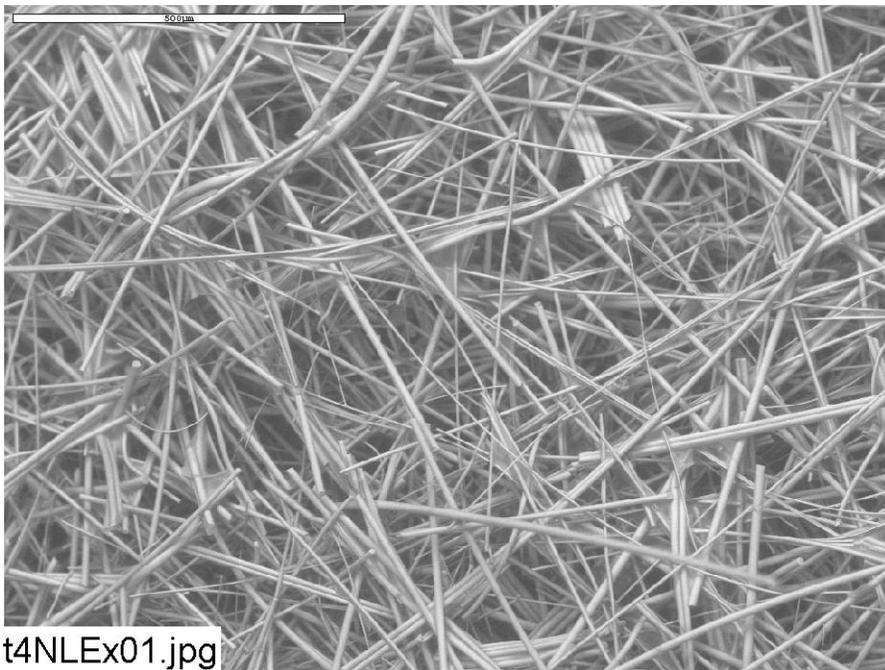
Figure 3-46. Environmental SEM image magnified 100 times for a Test #4 Day 30 exterior low-flow fiberglass sample contained in a nylon mesh (inserted on Day 4). (t4NLEx01.jpg)

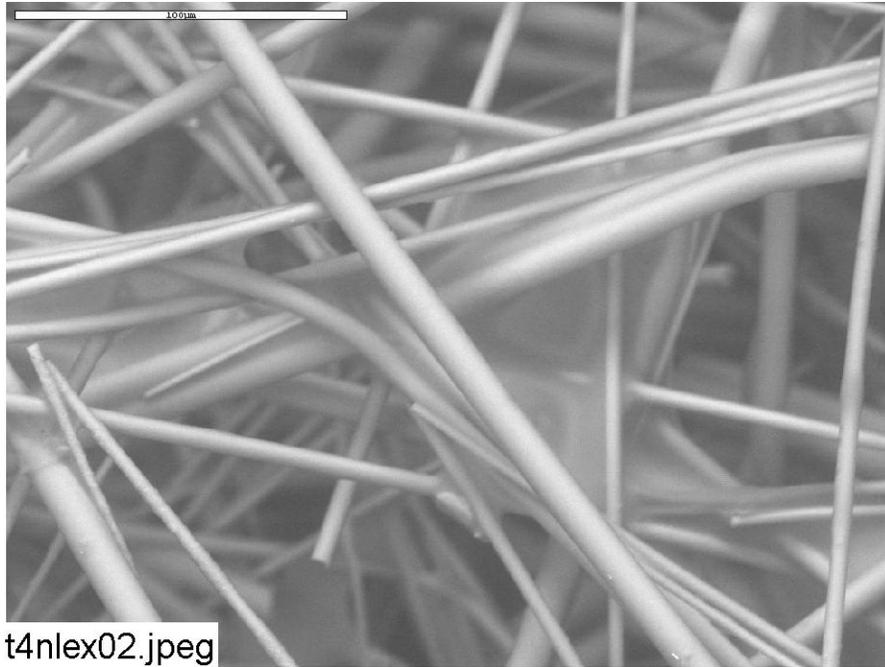
Figure 3-47. Environmental SEM image magnified 500 times for a Test #4 Day 30 exterior low-flow fiberglass sample contained in a nylon mesh (inserted on Day 4). (t4nlex02.jpeg)

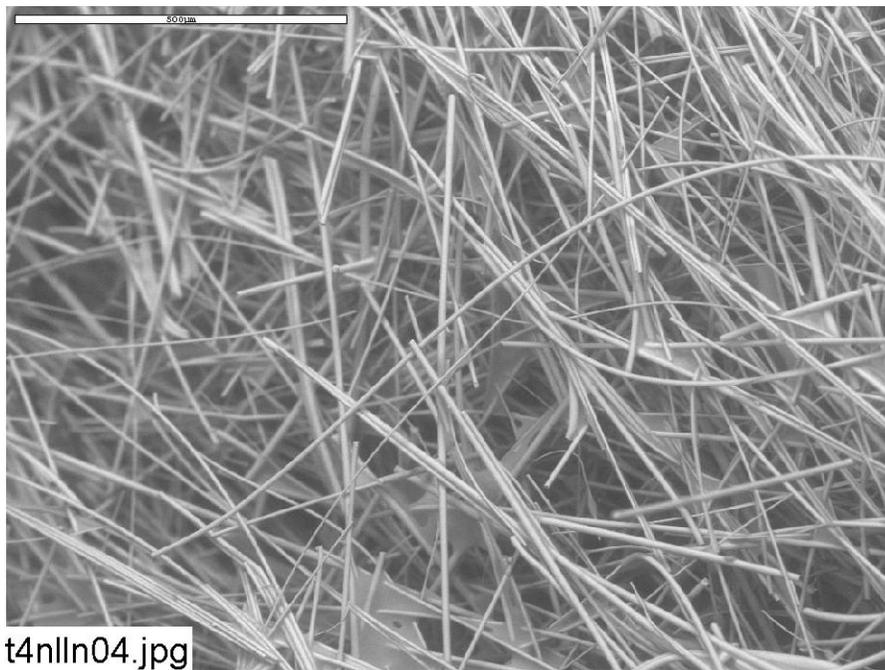
Figure 3-48. Environmental SEM image magnified 100 times for a Test #4 Day 30 interior low-flow fiberglass sample contained in a nylon mesh (inserted on Day 4). (t4nlln04.jpg)

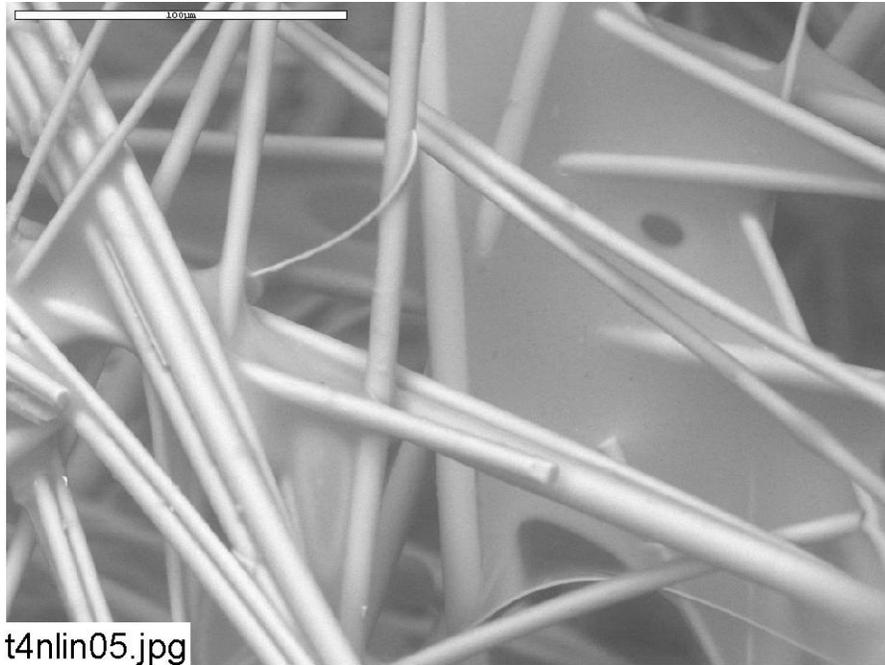
Figure 3-49. Environmental SEM image magnified 500 times for a Test #4 Day 30 interior low-flow fiberglass sample contained in a nylon mesh (inserted on Day 4). (t4nlin05.jpg)

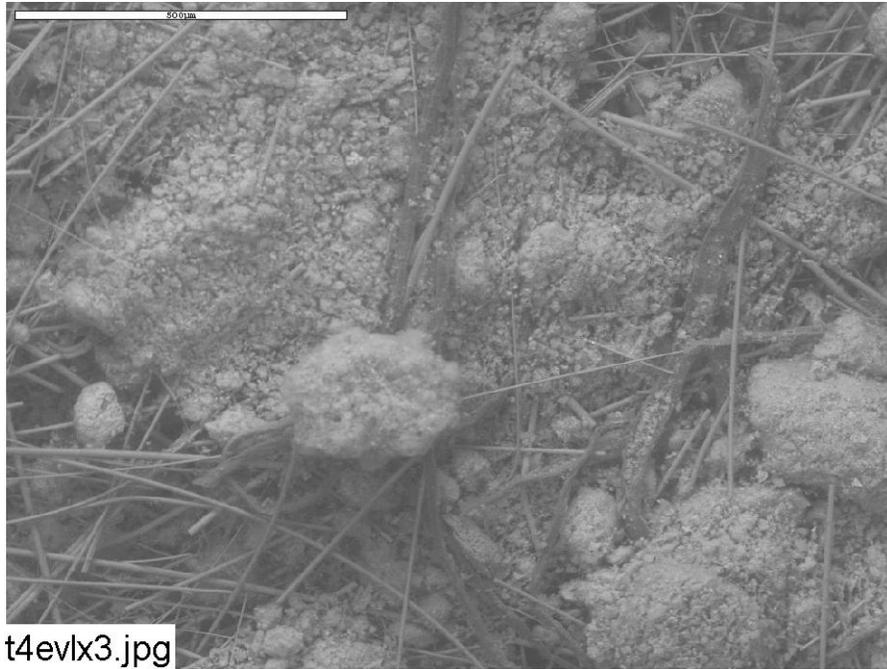
Figure 3-50. Environmental SEM image magnified 100 times for a Test #4 Day 30 exterior low-flow fiberglass sample in a big envelope. (t4evlx3.jpg).

Compared to other Day 30 low-flow fiberglass samples, a significant amount of particulate deposits was observed on the exterior of the Day 30 low-flow samples in the big envelope. The big envelope sat on the tank bottom and was in contact with the test sediment on the bottom of the envelope. Figure 3-120 shows the sediment after the samples were lifted out of the tank. However, no particulate deposits were observed on the fiberglass interior. In addition, some large flat fibers were found on the exterior fiberglass samples (see Figure 3-51). These large flat fibers were likely from cal-sil (see Appendix D). It is possible that the particulate deposits and cal-sil fibers were physically attached/retained on the exterior of the fiberglass samples. Figures 3-50 through 3-53 show the results from the Day 30 low-flow fiberglass enclosed in the big envelope. In contrast to other samples, these samples were gently rinsed with RO water and no film was found on either the exterior or the interior of the fiberglass. The disappearance of the film is likely caused by the rinse of RO water to keep the sample moist before ESEM analysis. Based on the control experiment noted earlier (See Appendix C4), the film is soluble.

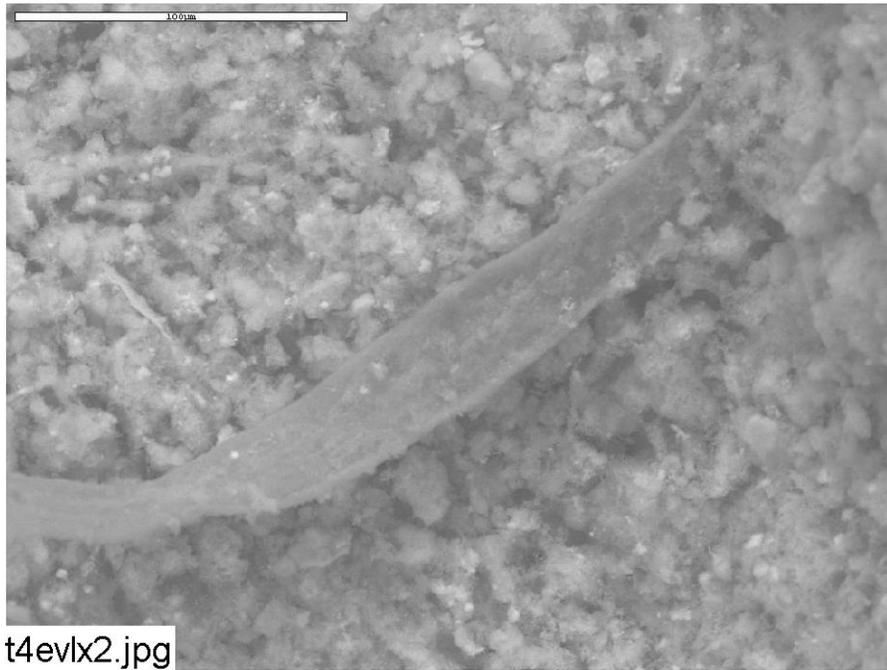
Figure 3-51. Environmental SEM image magnified 500 times for a Test #4 Day 30 exterior low-flow fiberglass sample in a big envelope. (t4evlx2.jpg)

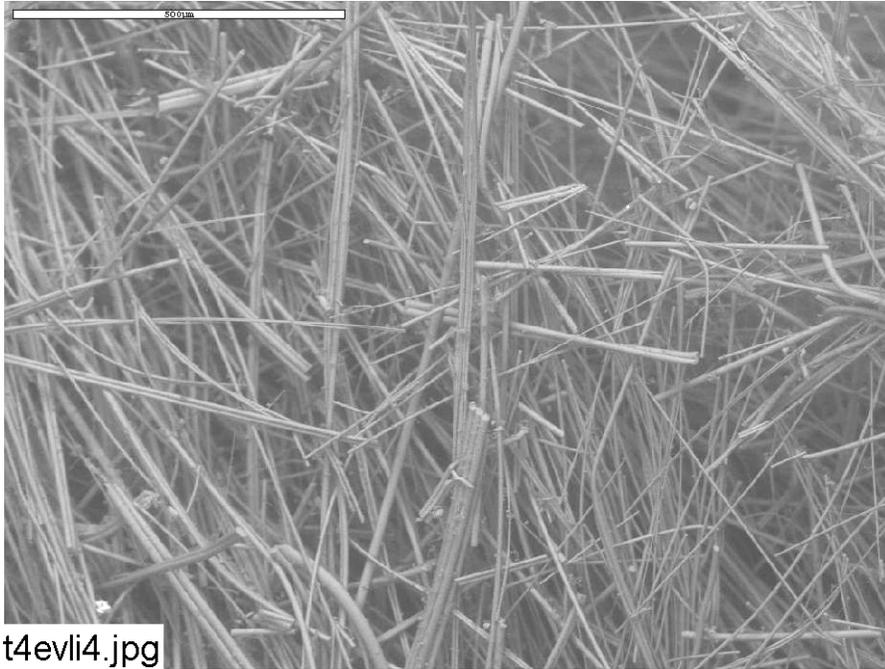
Figure 3-52. Environmental SEM image magnified 100 times for a Test #4 Day 30 interior low-flow fiberglass sample in a big envelope. (t4evli4.jpg)

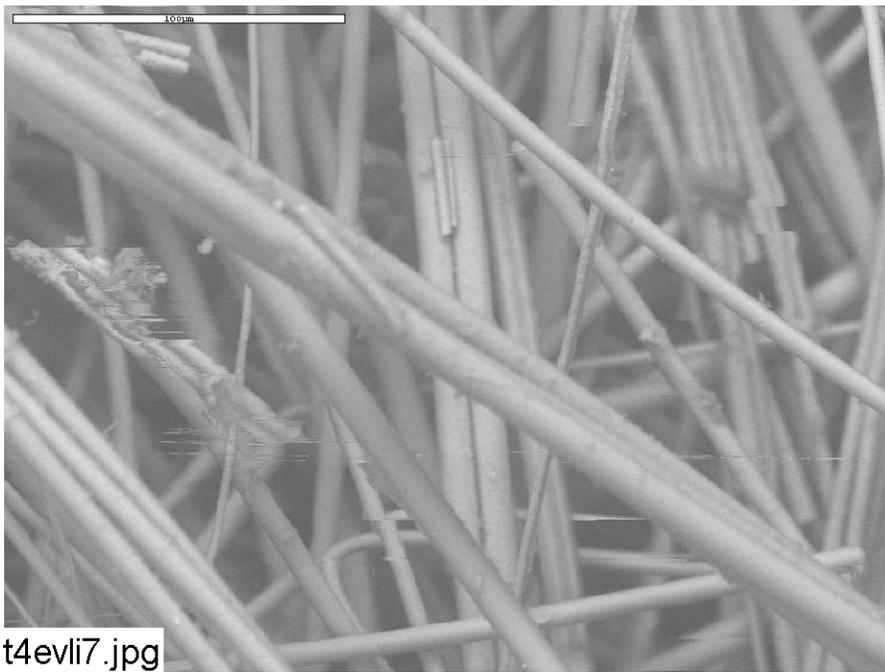
Figure 3-53. Environmental SEM image magnified 500 times for a Test #4 Day 30 interior low-flow fiberglass sample in a big envelope. (t4evli7.jpg)

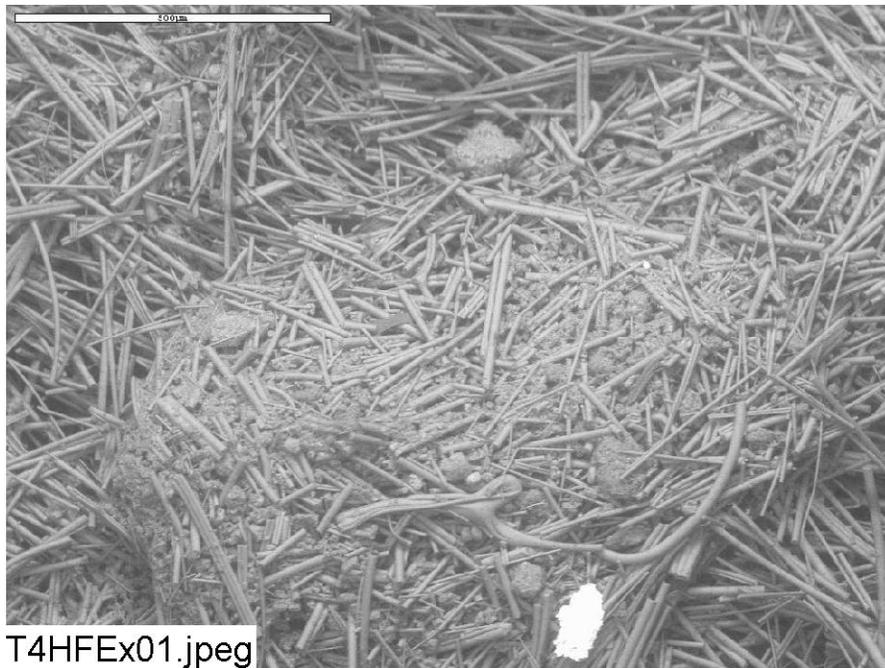
Figure 3-54. Environmental SEM image magnified 100 times for a Test #4 Day 30 exterior high-flow fiberglass sample. (T4HFEx01.jpg)

Compared to Day 30 low-flow fiberglass samples, a significant amount of particulate deposits and fiberglass debris were found on high-flow exterior samples. However, no particulate deposits were found on the interior. This result suggests that these particulate deposits were physically attached/retained on the fiberglass exterior. However, similar film deposits were found on both of the fiberglass exterior and the interior. The EDS result shows the film was composed of O, Na, Ca, C, Mg, Al, K, and possibly Si, which is similar to other EDS results. Figures 3-54 through 3-61 show the Day 30 high-flow fiberglass results. Figures 3-60 and 3-61 show fiberglass after it was rinsed with RO water.

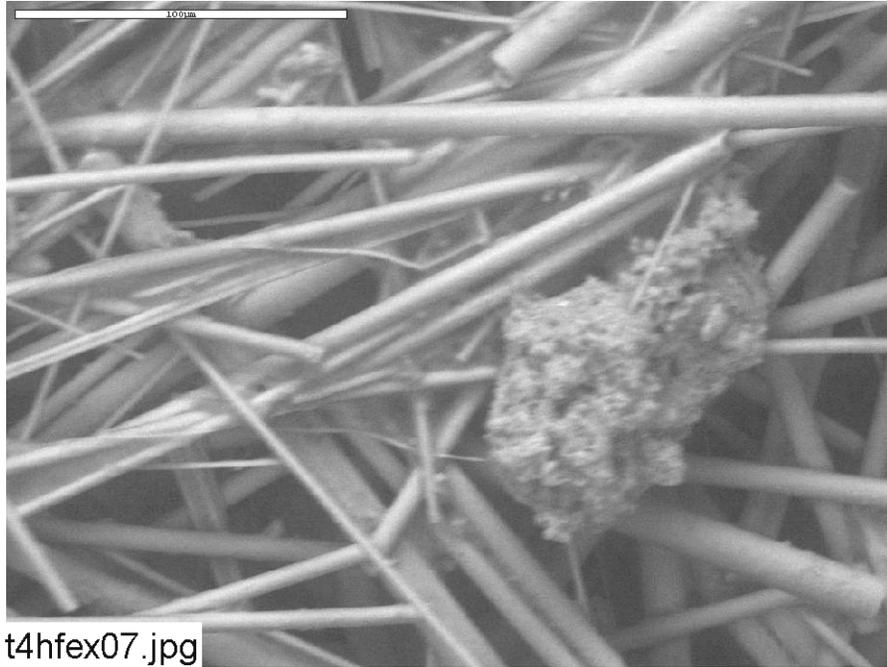
Figure 3-55. E Environmental SEM image magnified 500 times for a Test #4 Day 30 exterior high-flow fiberglass sample. (t4hfex07.jpg)

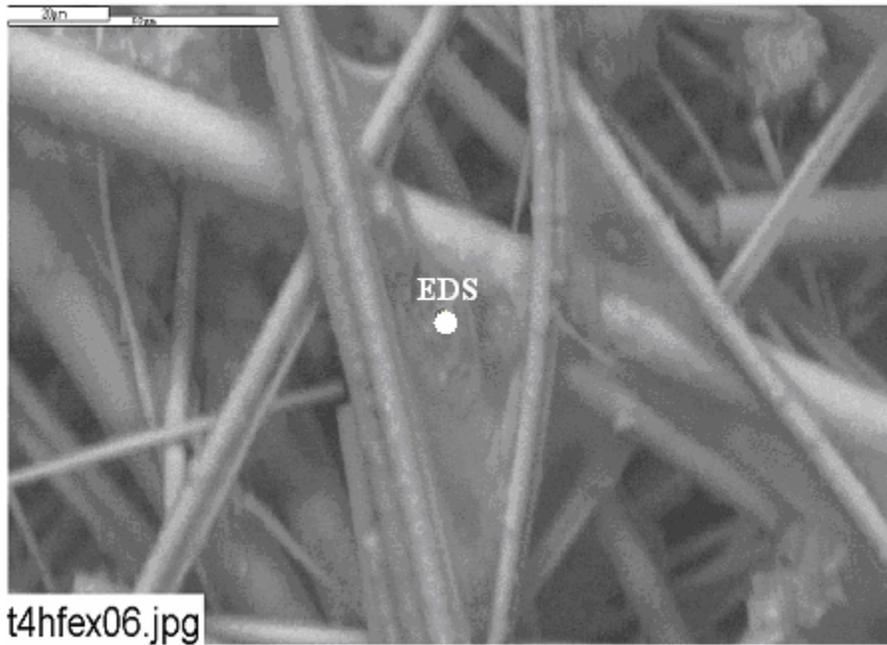
Figure 3-56. Environmental SEM image magnified 800 times for a Test #4 Day 30 exterior high-flow fiberglass sample. (t4hfex06.jpg)

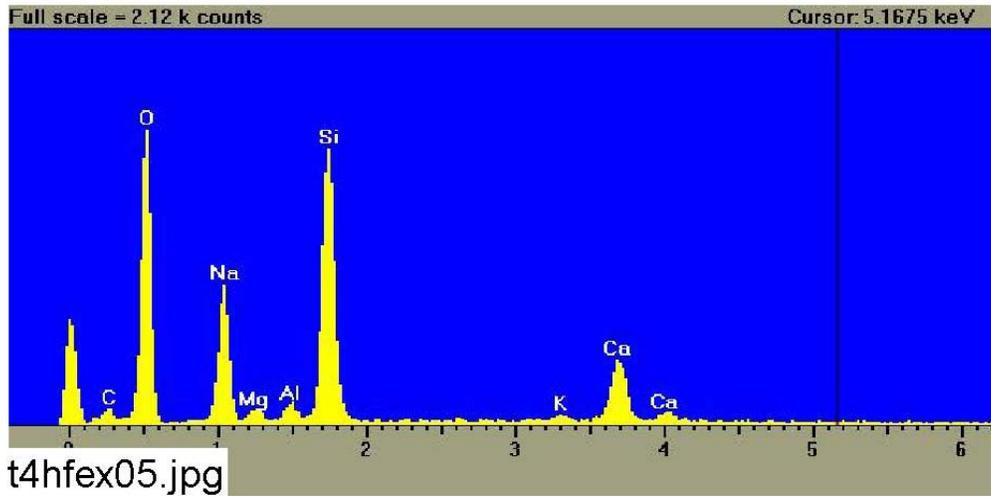
Figure 3-57. EDS counting spectrum for the spot of film on the fiberglass shown in Figure 3-56. (t4hfex05.jpg)

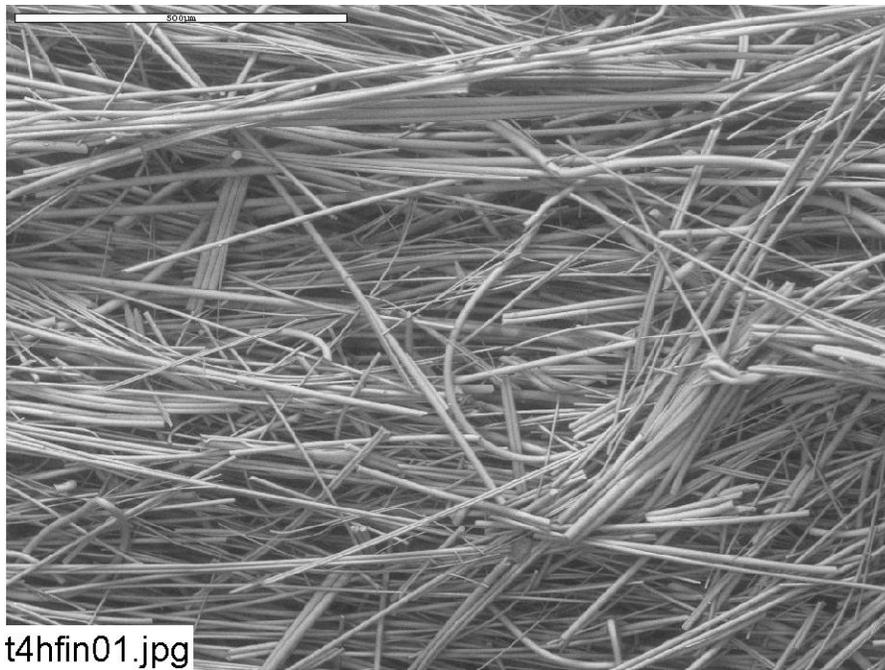
Figure 3-58. Environmental SEM image magnified 100 times for a Test #4 Day 30 interior high-flow fiberglass sample. (t4hfin01.jpg)
