Integrated Chemical Effects Test Project: Test #4 Data Report

Los Alamos National Laboratory

**U.S. Nuclear Regulatory Commission
Office of Nuclear Regulatory Research
Washington, DC 20555-0001**

A 30-day test was conducted in the Integrated Chemical Effects Test (ICET) project test apparatus. The test simulated the chemical environment present inside a pressurized water reactor containment water pool after a loss-of-coolant accident. The initial chemical environment contained 15.41 kg of boric acid, 8.47 kg of sodium hydroxide, 0.663 g of lithium hydroxide, and 212 mL of hydrochloric acid. An additional amount of sodium hydroxide (614 g) was added with the spray beginning at time zero and lasting until 30 minutes into the test. The test was conducted for 30 days at a constant temperature of 60°C (140°F). The materials tested within this environment included representative amounts of submerged and unsubmerged aluminum, copper, concrete, zinc, carbon steel, and insulation samples (80% calcium silicate and 20% fiberglass). Representative amounts of concrete dust and latent debris were also added to the test solution. Water was circulated through the bottom portion of the test cham

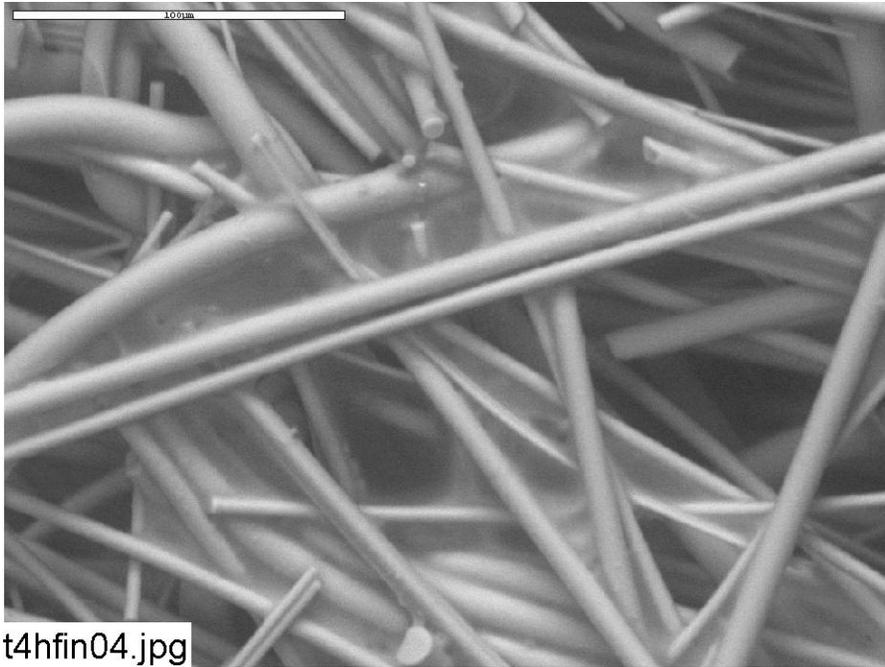
Figure 3-59. Environmental SEM image magnified 500 times for a Test #4 Day 30 interior high-flow fiberglass sample. (t4hfin04.jpg)

Compared to Day 30 low-flow fiberglass samples, a significant amount of particulate deposits and fiberglass debris were found on high-flow exterior samples. However, no particulate deposits were found on the interior. This result suggests that these particulate deposits were physically attached/retained on the fiberglass exterior. However, similar film deposits were found on both of the fiberglass exterior and the interior. The EDS result shows the film was composed of O, Na, Ca, C, Mg, Al, K, and possibly Si, which is similar to other EDS results. Figures 3-54 through 3-61 show the Day 30 high-flow fiberglass results. Figures 3-60 and 3-61 show fiberglass after it was rinsed with RO water.

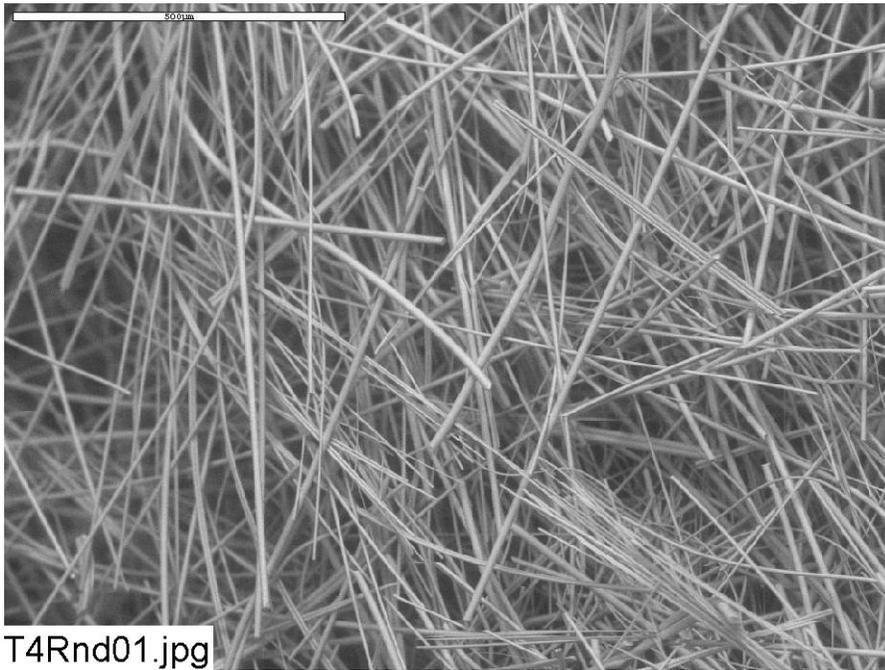
Figure 3-60. Environmental SEM image magnified 100 times for a Test #4 Day 30 interior high-flow fiberglass sample. The sample was gently pre-rinsed with RO water. (T4Rnd01.jpg)

To understand the formation of the film deposits, control experiments were performed by gently rinsing the interior fiberglass samples with several drops of RO water before ESEM analysis. The results show that after being rinsed with RO water, the film deposits disappeared from the fiberglass samples. This fact suggests that the film is actually soluble, which is consistent with the explanation that the film was formed by chemical precipitation during the drying process of fiberglass. In other words, although the ESEM analysis maintains samples in a moister state than conventional SEM, the partial drying that took place during ESEM analysis was sufficient for some chemicals to precipitate and form the film deposits that were observed. Sections 3.3.1.6 and 3.3.1.7 contain results from rinsed fiberglass samples.

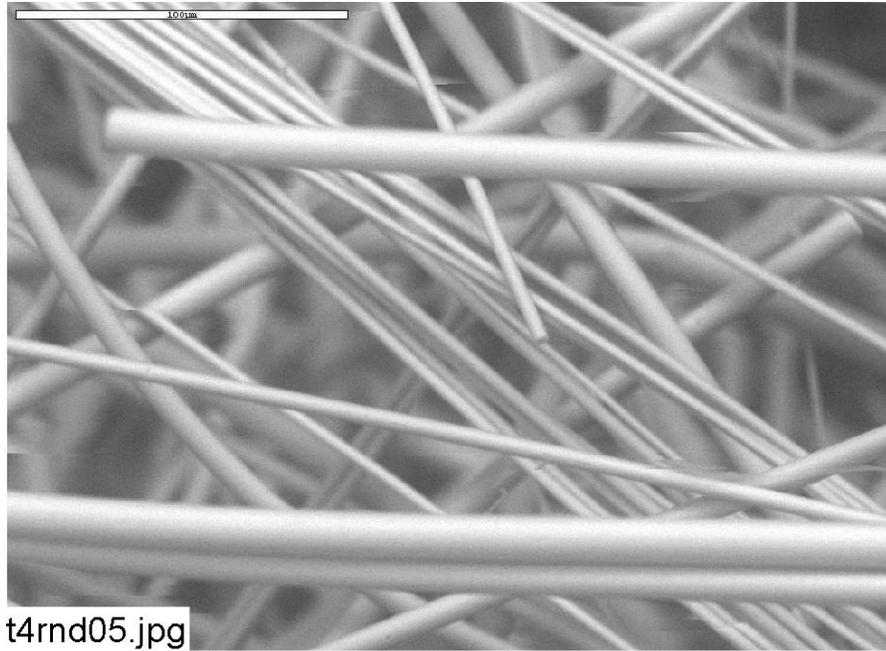
Figure 3-61. Environmental SEM image magnified 500 times for a Test #4 Day 30 interior high-flow fiberglass sample. The sample was gently pre-rinsed with RO water. (t4rnd05.jpg)

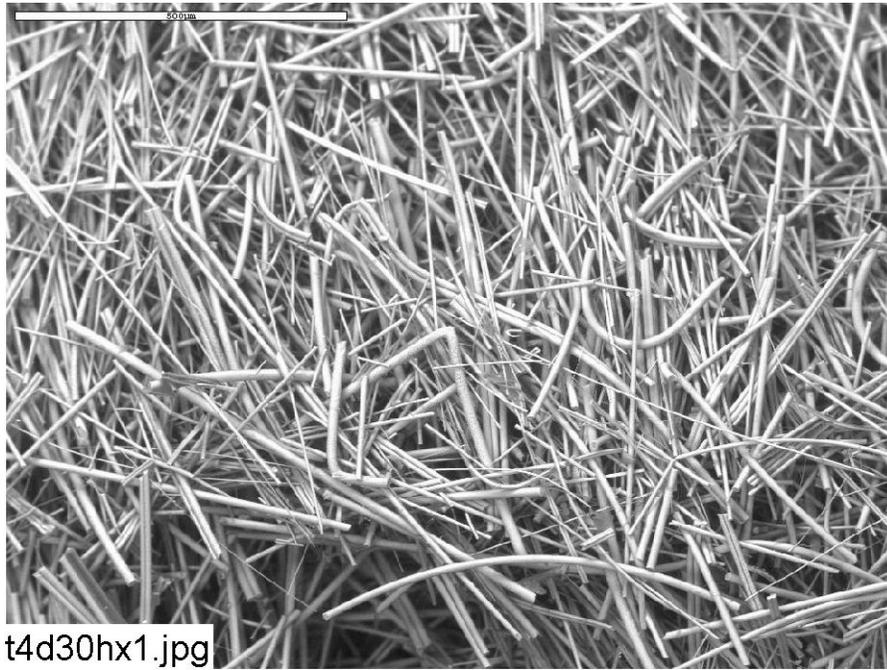
Figure 3-62: Environmental SEM image magnified 100 times for a Test #4 Day 30 exterior high-flow fiberglass sample in front of a header (inserted on Day 4). (t4d30hx1.jpg)

The images of the fiberglass in front of a header are different from the conventional high-flow fiberglass samples in Section 3.3.1.7. The header sample was put in the tank on Day 2 to compare with samples placed in the tank on Day 0. Due to settling of suspended particles and decrease in turbidity during the first two days of the test, no significant particulate deposits were found on the header fiberglass exterior, as shown by ESEM images. This suggests that the deposits observed on the exterior of the high-flow samples put in the tank on Day 0 are due to the higher suspended solids and turbidity present in the system during the first several days. However, the coating and film deposits were found on both the exterior and the interior of the header samples. Consistent with earlier observations, the coating and the film were composed of O, Na, Ca, Mg, Al, C, K, and possibly Si. As mentioned before, coating and film deposits are likely caused by chemical precipitation when the samples were partially dehydrated. Figures 3-62 through 3-68 show the results from the Day 30 high-flow fiberglass in front of a header.

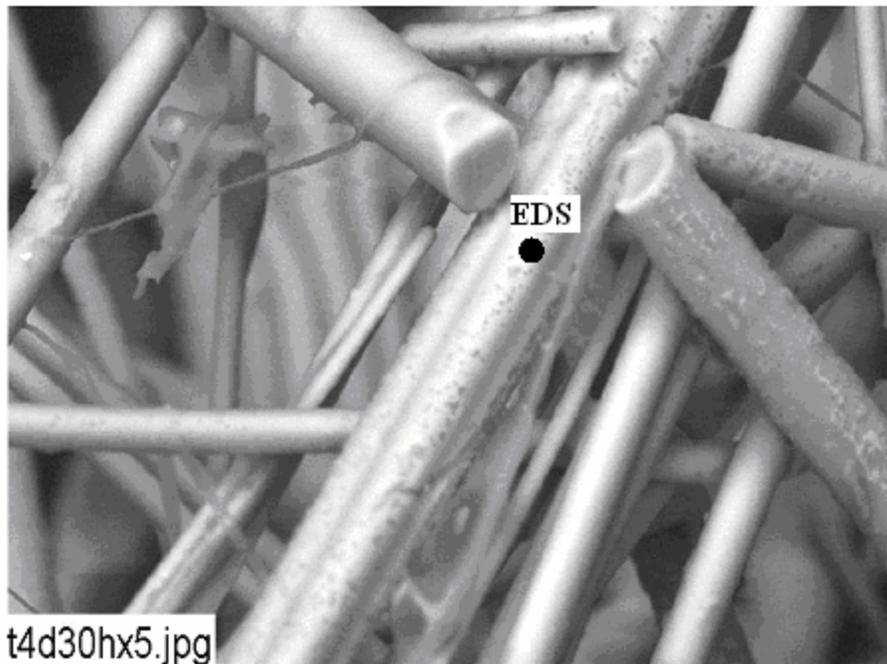
Figure 3-63: Environmental SEM image magnified 1000 times for a Test #4 Day 30 exterior high-flow fiberglass sample in front of a header (inserted on Day 4). (t4d30hx5.jpg)

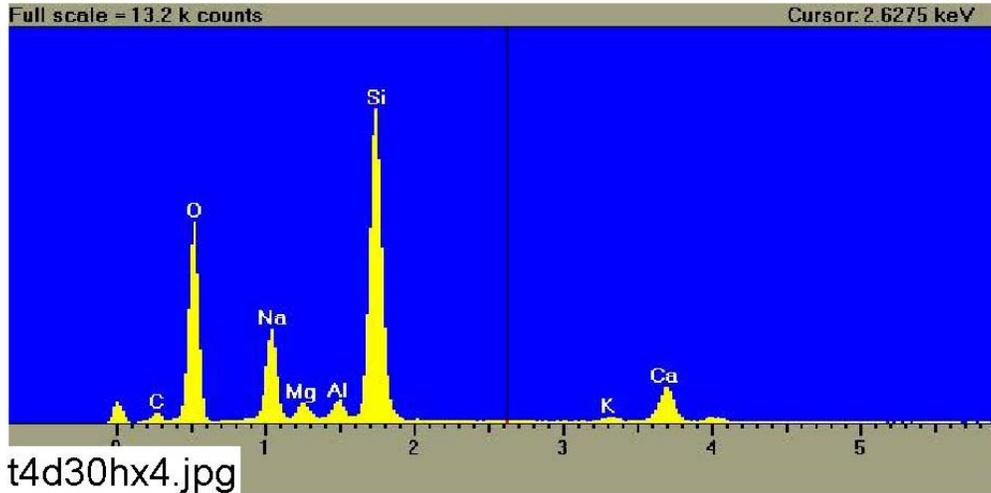
Figure 3-64: EDS counting spectrum for the spot of coating substance on fiberglass shown in Figure 3-63. (t4d30hx4.jpg)

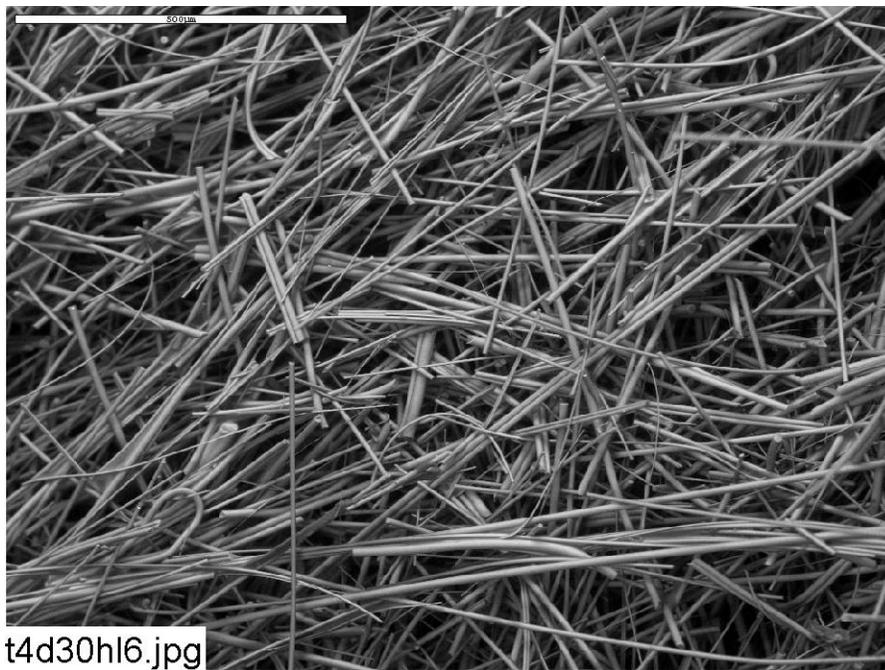
Figure 3-65: Environmental SEM image magnified 100 times for a Test #4 Day 30 interior high-flow fiberglass sample in front of a header (inserted on Day 4). (t4d30hI6.jpg)

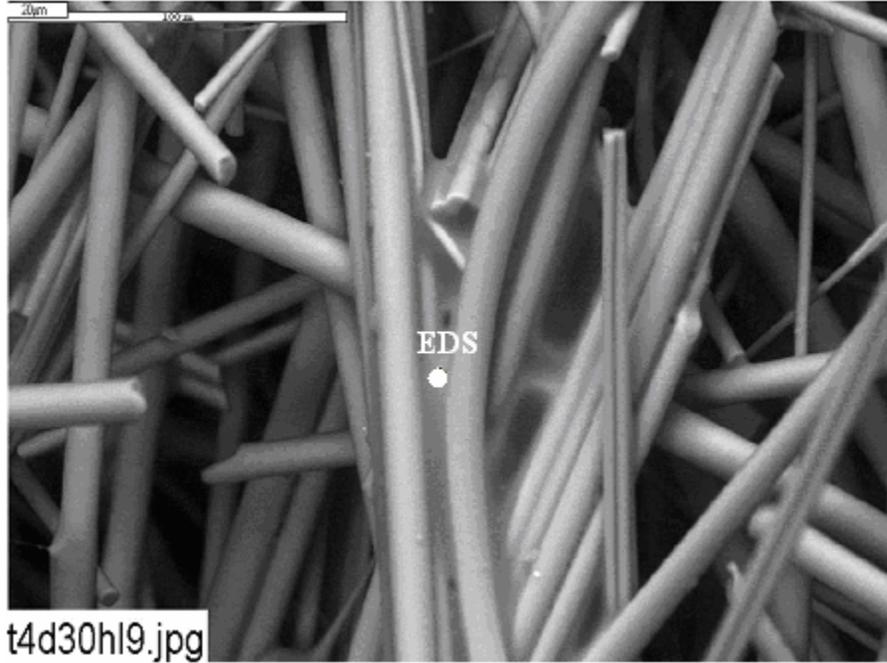
Figure 3-66: Environmental SEM image magnified 500 times for a Test #4 Day 30 interior high-flow fiberglass sample in front of a header (inserted on Day 4). (t4d30h19.jpg)

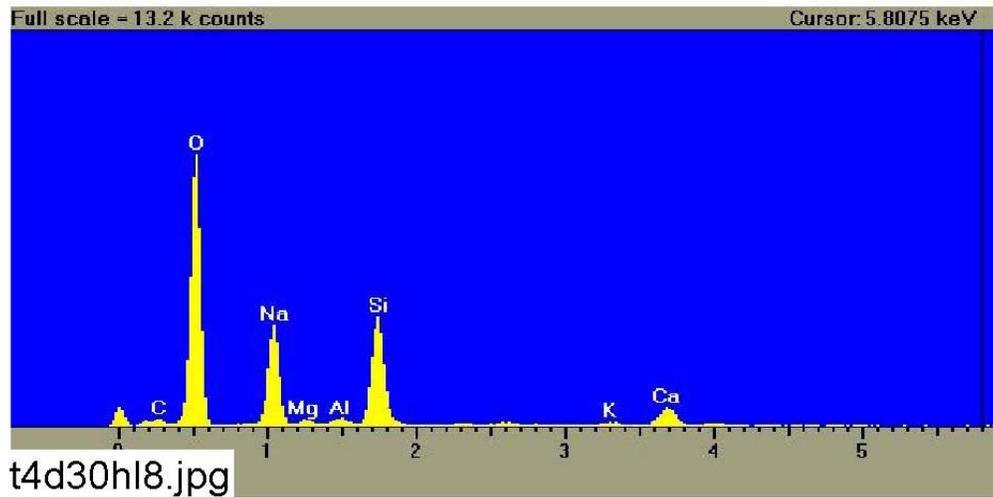
Figure 3-67: EDS counting spectrum for the spot of substance attached on fiberglass shown in Figure 3-66. (t4d30h18.jpg)

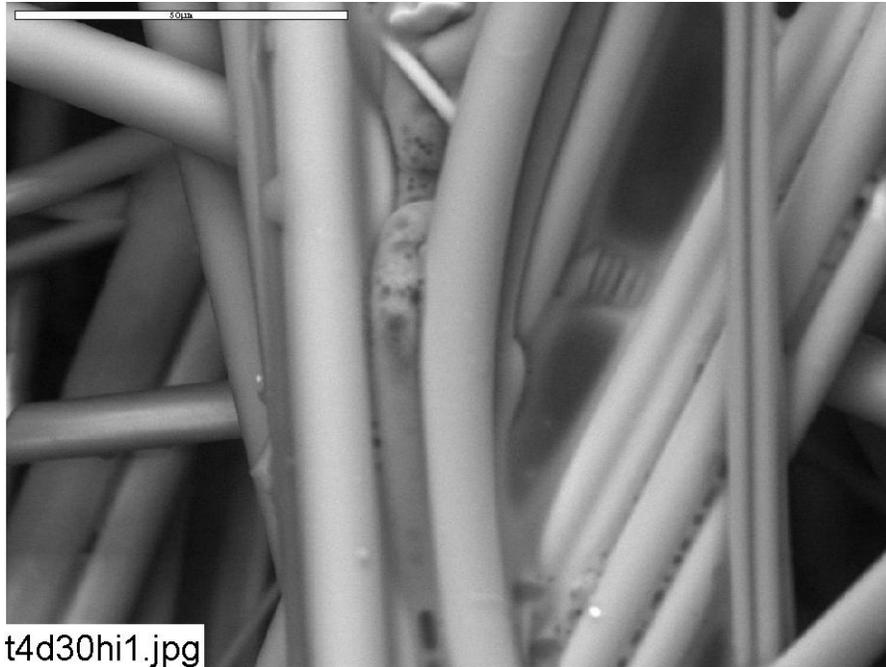
Figure 3-68: Environmental SEM image magnified 1000 times for a Test #4 Day 30 interior high-flow fiberglass sample in front of a header (inserted on Day 4). (t4d30hi1.jpg)

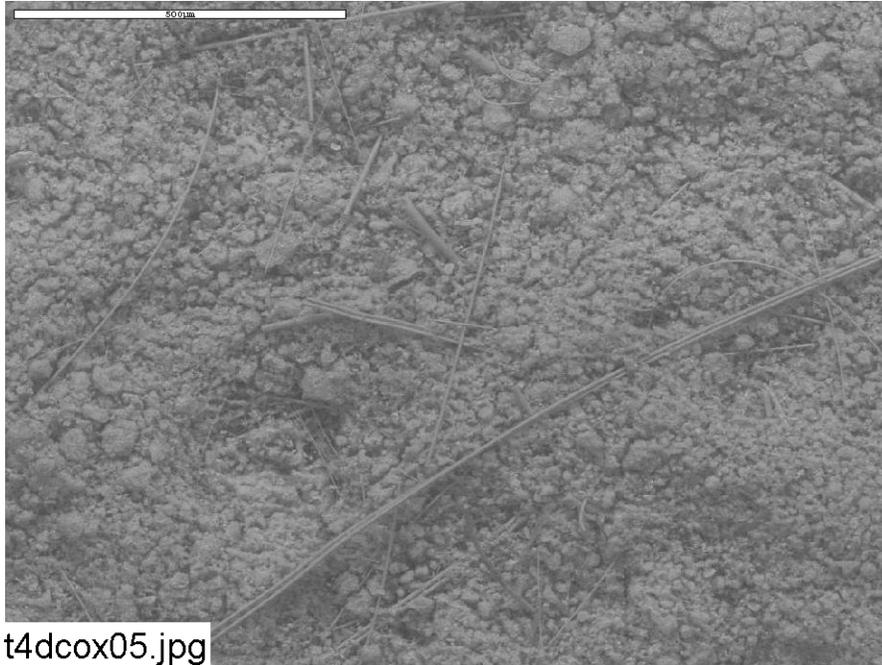
Figure 3-69: Environmental SEM image magnified 100 times for a Test #4 Day 30 exterior fiberglass sample on the drain collar (away from the drain screen). (t4dcox05.jpg)

When the tank was drained, the drain collar was totally surrounded by sediment. Figure 3-121 shows the drain collar after the tank was drained. Both the exterior fiberglass sample that was farthest from the drain screen and the exterior sample that was next to the drain screen have significant amounts of particulate deposits. Inspection revealed the development of a continuous coating on the drain collar exterior, including particulate deposits that were likely physically retained or attached. The amount of deposits on the drain collar exterior was greater than on high- and low-flow fiberglass samples. EDS results indicate that the particulate deposits were mainly composed of O, Si, Ca, Na, Al, and C, regardless of whether the drain collar exterior was farthest from the drain screen or next to the drain screen. The high content of Si and Ca in the particulate deposits suggests that they were probably from cal-sil debris. In contrast to the exterior, no significant particulate deposits were found in the drain collar interior sample, and only film-like deposits were found (see Figure 3-75). The drain collar interior appears similar to the other high- and low- flow fiberglass interior samples. This result suggests that almost all of the particulate deposits were physically retained at the fiberglass exterior, which is consistent with Day 30 high-flow fiberglass samples. Figures 3-69 through 3-79 show the drain collar fiberglass results.

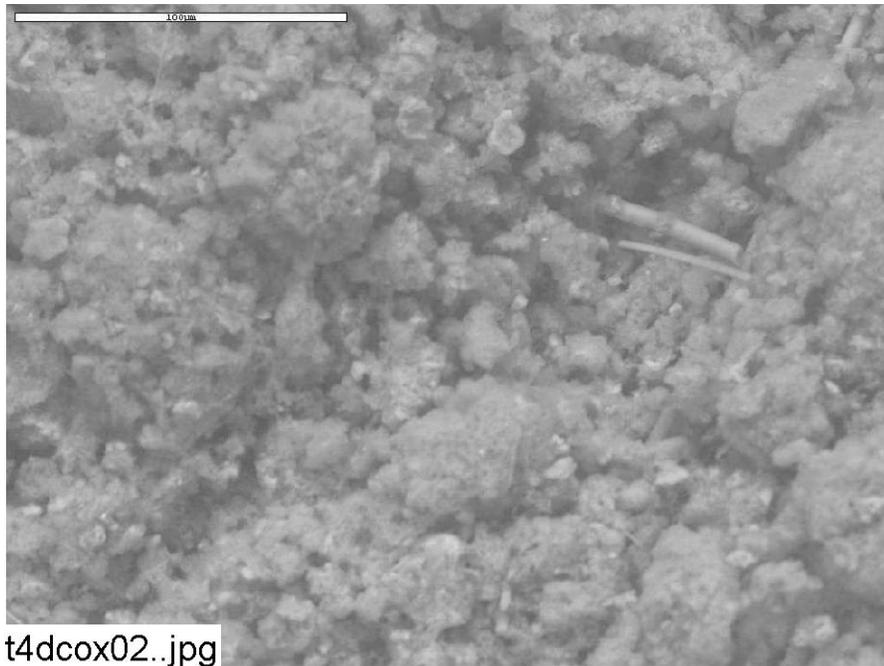
Figure 3-70: Environmental SEM image magnified 500 times for a Test #4 Day 30 exterior fiberglass sample on the drain collar (away from the drain screen). (t4dcox02.jpg)

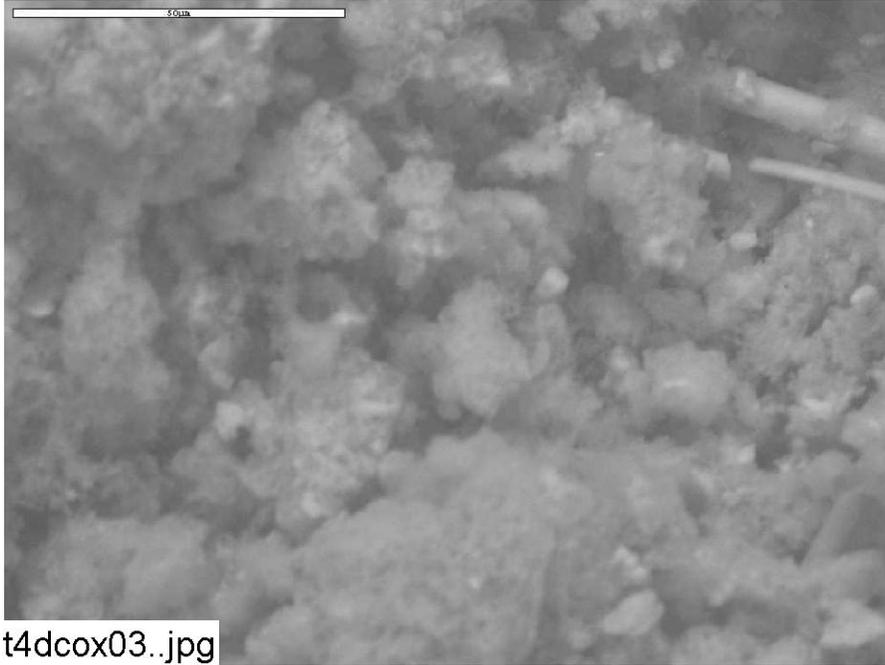
Figure 3-71: Environmental SEM image magnified 1000 times for a Test #4 Day 30 exterior fiberglass sample on the drain collar (away from the drain screen). (t4dcox03.jpg)

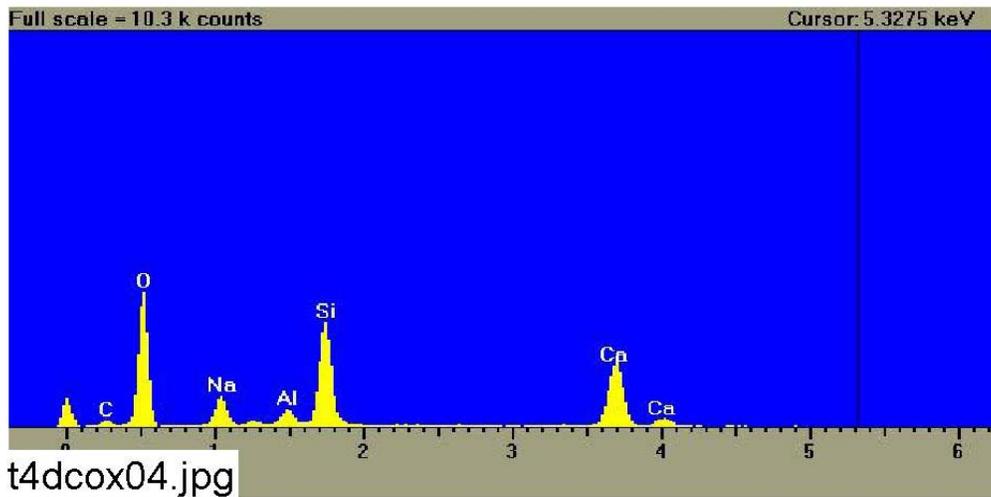
Figure 3-72: EDS counting spectrum for the large mass of particulate deposits on fiberglass shown in Figure 3-71. (t4dcox04.jpg)

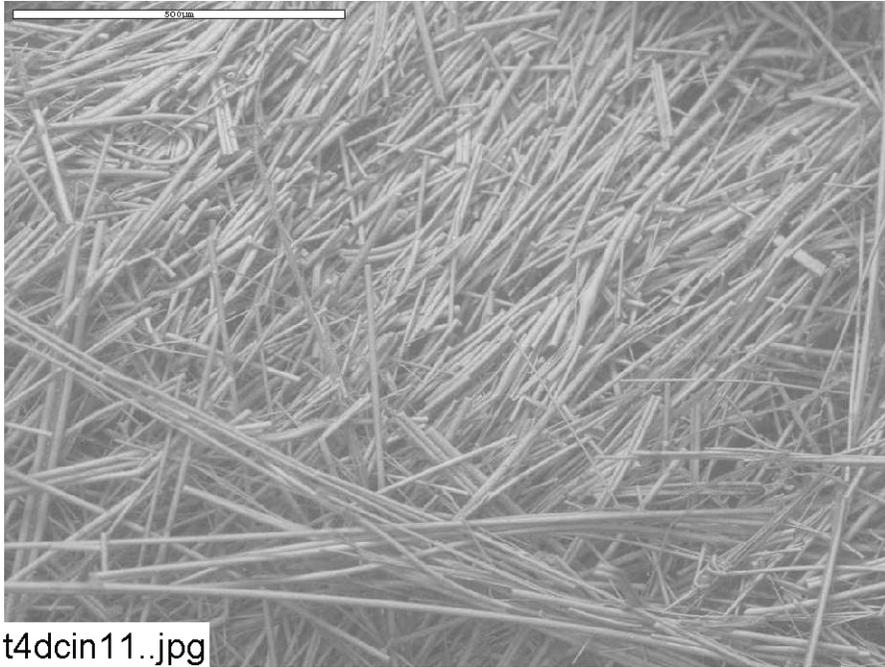
Figure 3-73: Environmental SEM image magnified 100 times for a Test #4 Day 30 interior fiberglass sample on the drain collar. (t4dcin11.jpg)

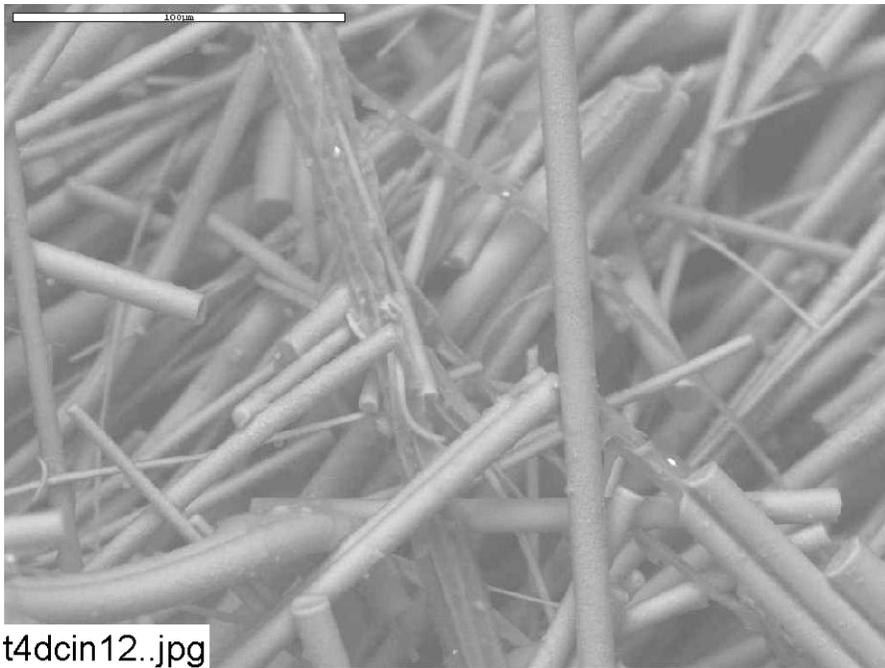
Figure 3-74: Environmental SEM image magnified 500 times for a Test #4 Day 30 interior fiberglass sample on the drain collar. (t4dcin12.jpg)

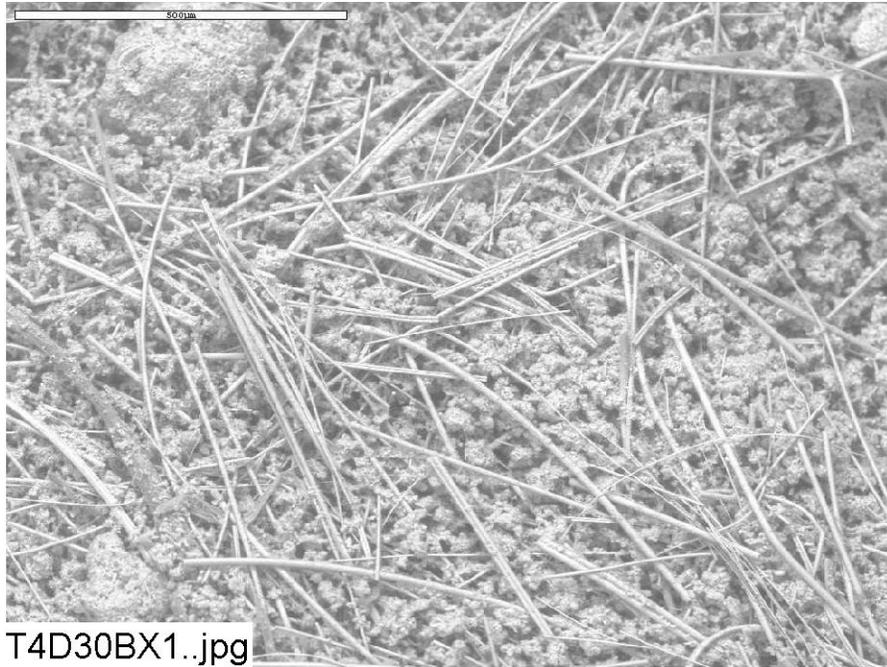
Figure 3-80: Environmental SEM image magnified 100 times for a Test #4 Day 30 exterior fiberglass sample within the birdcage. (T4D30BX1.jpg)

For the Day 30 fiberglass sample within the birdcage, the SEM images indicate a significant amount of particulate deposits (see Figure 3-80) on the exterior of the fiberglass. The location of the birdcage was on top of a large cal-sil sample that sat on the bottom of the tank and was in direct contact with the sediment. The birdcage, however, was not in direct contact with the sediment. The amount of particulate deposits was greater than the amounts on the high- and low-flow fiberglass samples, but less than the drain collar exterior. The EDS result shows that the particulate deposits were composed of O, Si, Ca, Na, Al, and C, which is consistent with the drain collar exterior. Again, the high content of Si and Ca suggests these particulate deposits were from cal-sil debris. Compared to the exterior, the interior sample was relatively clean. Only film deposits were found. These film deposits were similar to the observed high- and low-flow fiberglass samples, which were likely caused by chemical precipitation during the drying process. Again, this result suggests that almost all of the particulate deposits were physically retained at the fiberglass exterior, consistent with Day 30 high-flow and drain collar fiberglass samples. Figures 3-80 through 3-85 show the birdcage fiberglass results.

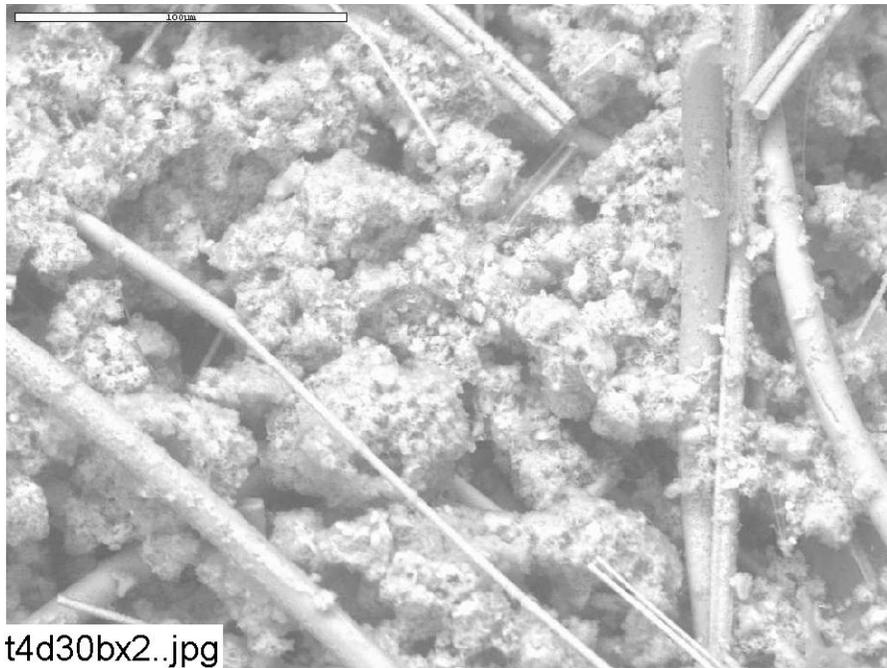
Figure 3-81: Environmental SEM image magnified 500 times for a Test #4 Day 30 exterior fiberglass sample within the birdcage. (T4D30bx2.jpg)

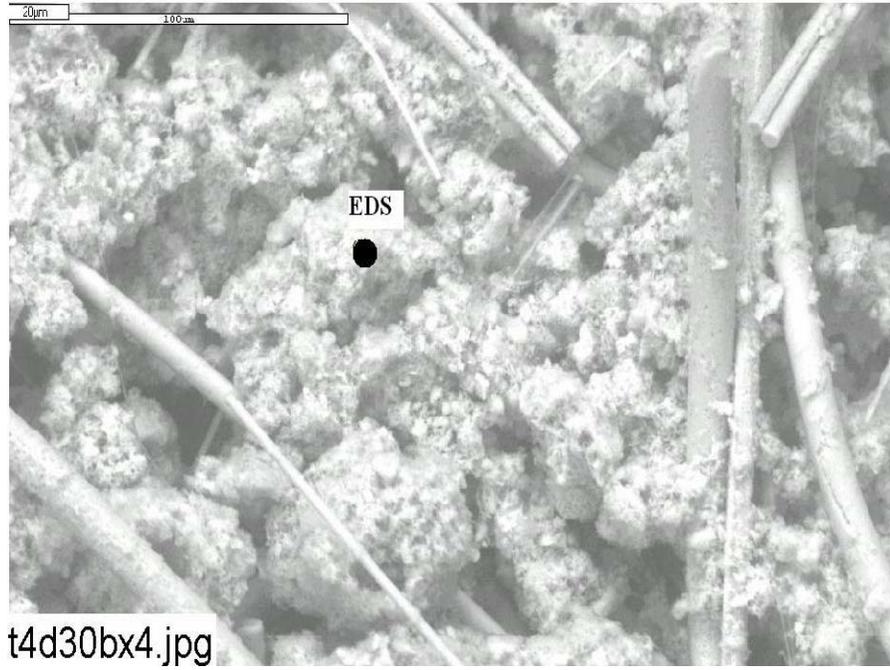
Figure 3-82: Annotated environmental SEM image magnified 500 times for a Test #4 Day 30 exterior fiberglass sample within the birdcage. (t4d30bx4.jpg)

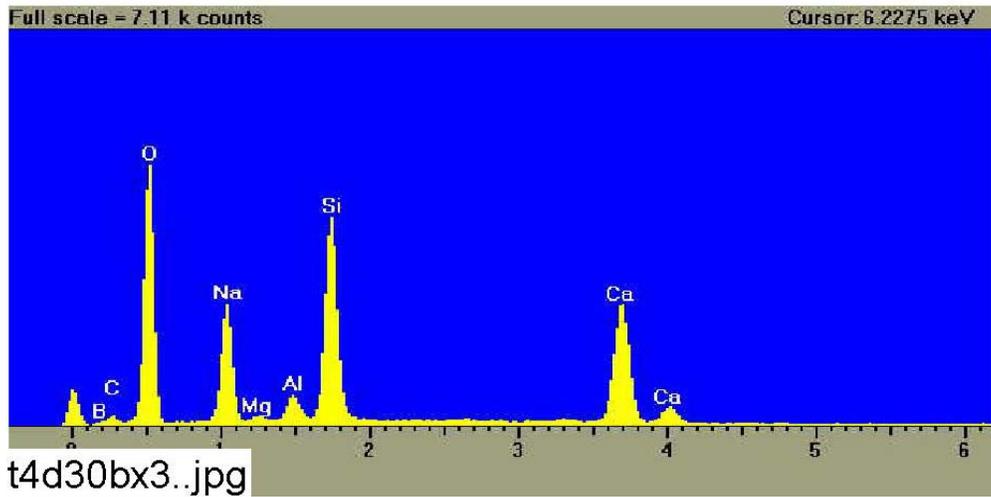
Figure 3-83: EDS counting spectrum for the particulate deposits on fiberglass shown in Figure 3-82. (T4D30bx3.jpg)

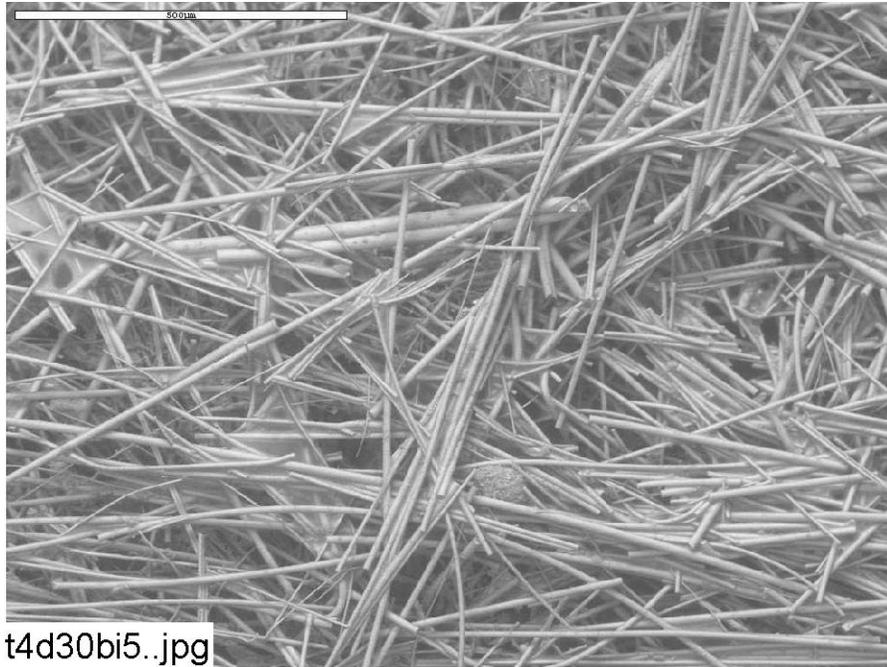
Figure 3-84: Environmental SEM image magnified 100 times for a Test #4 Day 30 interior fiberglass sample within the birdcage. (t4d30bi5.jpg)

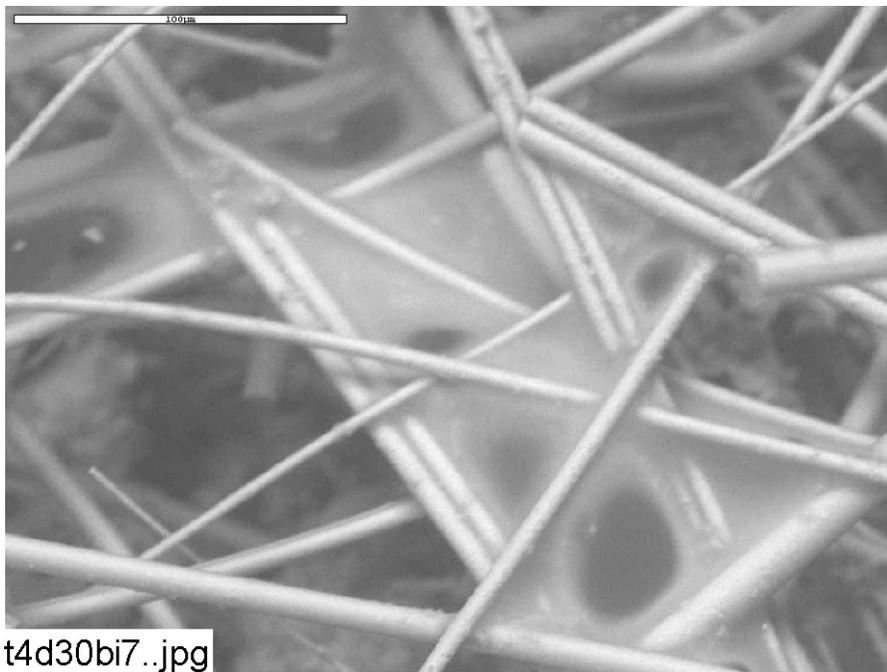
Figure 3-85: Environmental SEM image magnified 500 times for a Test #4 Day 30 interior fiberglass sample within the birdcage. (t4d30bi7.jpg)

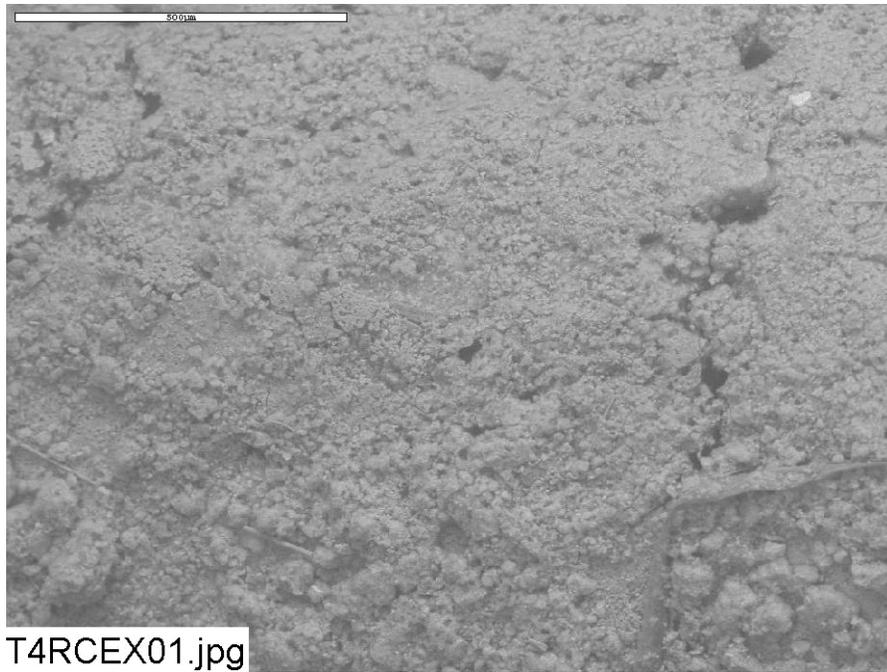
Figure 3-86: Environmental SEM image magnified 100 times for a Test #4 Day 30 low-flow exterior raw cal-sil sample. (T4RCEX01.jpg)

Both raw and baked cal-sil samples were submerged in the tank throughout the test. No significant differences were found between the raw and baked cal-sil, or between the exterior and the interior. EDS results show that both raw and baked cal-sil were composed primarily of O, Si, Ca, Na, Al, C, Mg, and Fe. Due to the granular shape of cal-sil particles, it is difficult to distinguish whether the particles are foreign deposits or they are the cal-sil particles themselves. Figures 3-86 through 3-97 show cal-sil results.

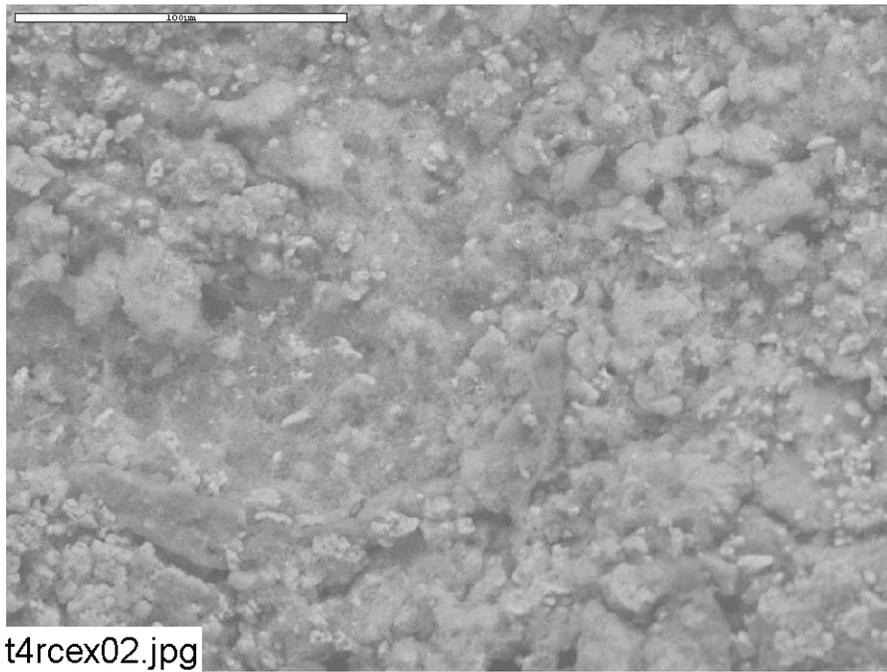
Figure 3-87: Environmental SEM image magnified 500 times for a Test #4 Day 30 low-flow exterior raw cal-sil sample. (t4rcex02.jpg)

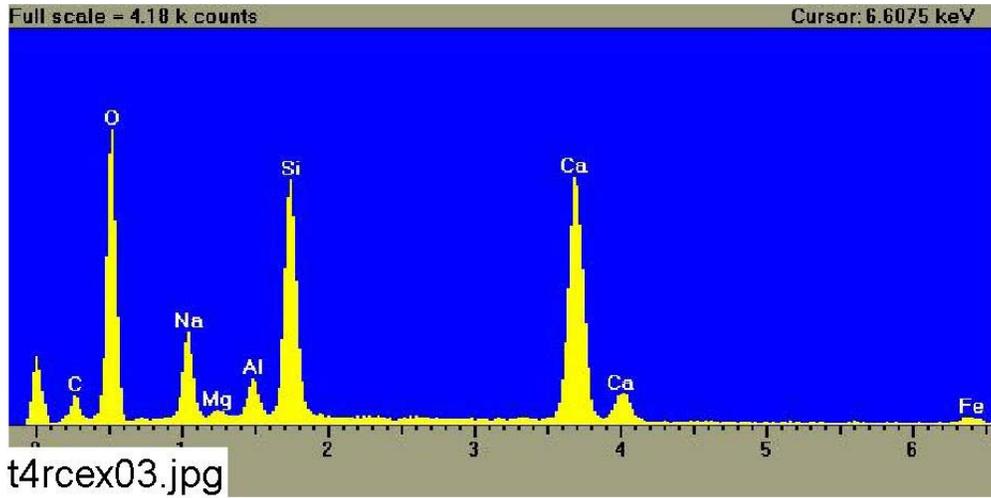
Figure 3-88: EDS counting spectrum for the whole image shown in Figure 3-87. (t4rcex03.jpg)

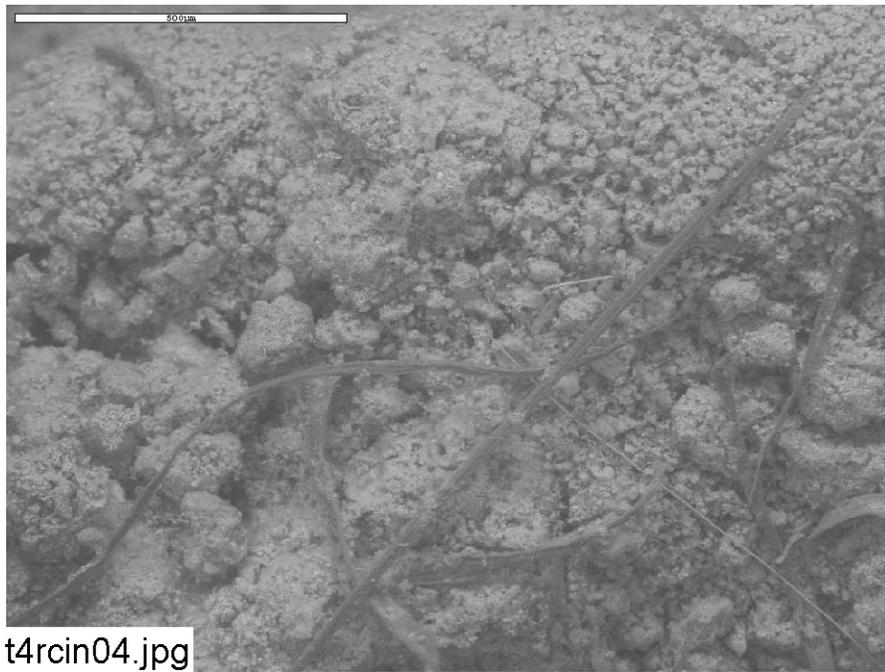
Figure 3-89: Environmental SEM image magnified 100 times for a Test #4 Day 30 low-flow interior raw cal-sil sample. (t4rcin04.jpg)

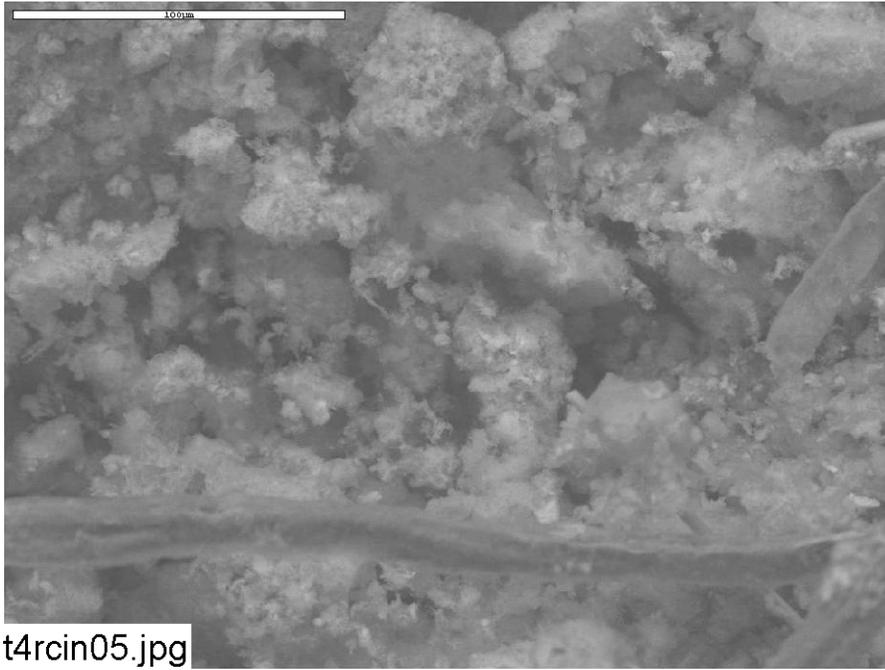
Figure 3-90: Environmental SEM image magnified 500 times for a Test #4 Day 30 low-flow interior raw cal-sil sample. (t4rcin05.jpg)

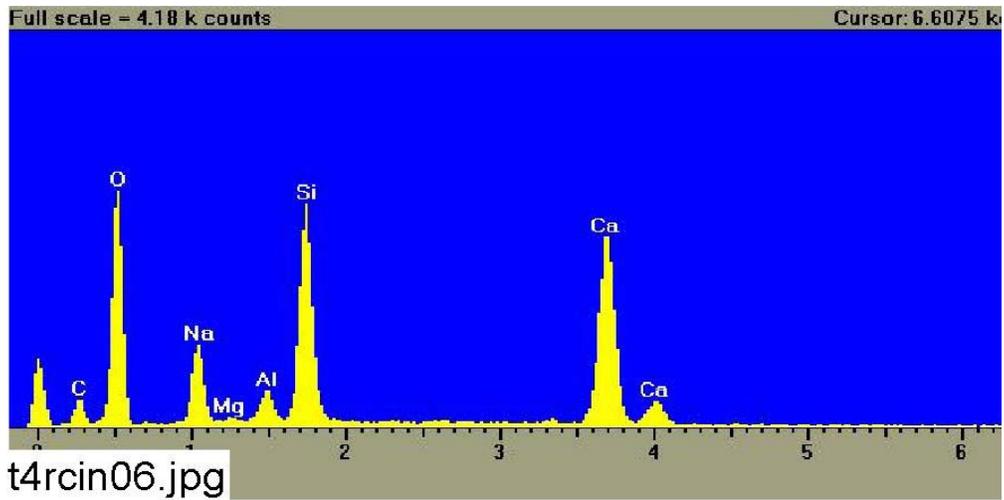
Figure 3-91: EDS counting spectrum for the whole image shown in Figure 3-90. (t4rcin06.jpg)

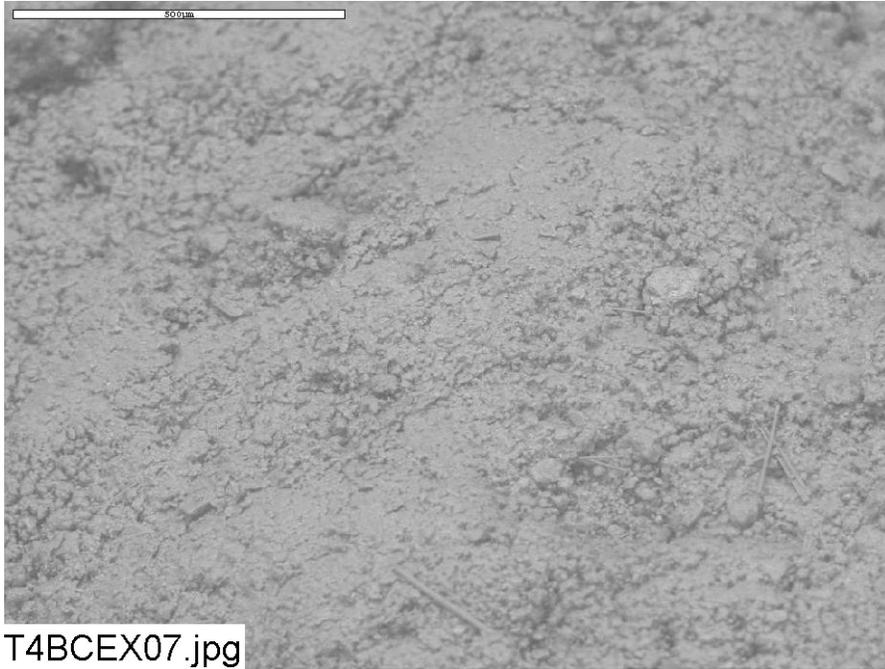
Figure 3-92: Environmental SEM image magnified 100 times for a Test #4 Day 30 low-flow exterior baked cal-sil sample. (T4BCEX07.jpg)

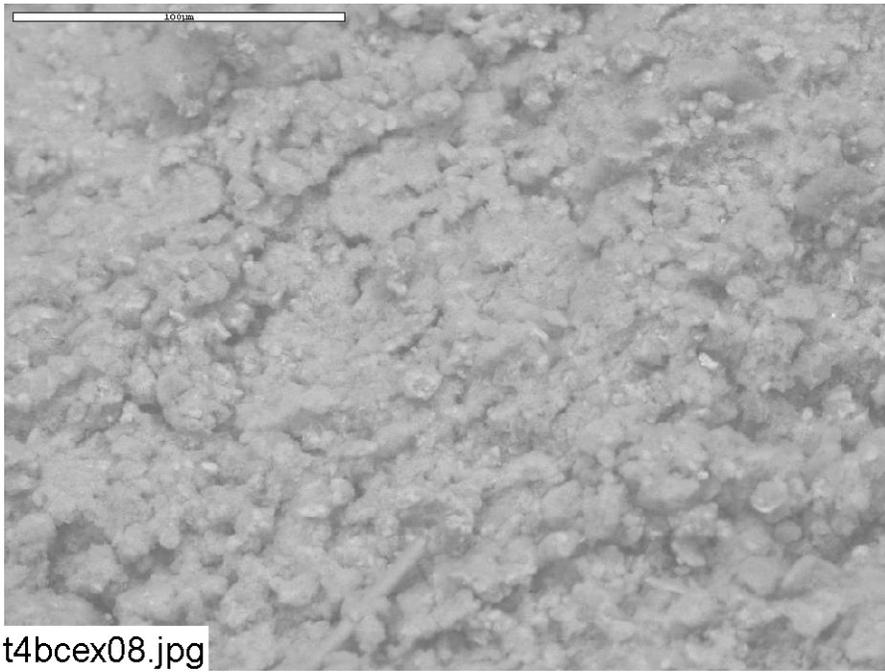
Figure 3-93: Environmental SEM image magnified 500 times for a Test #4 Day 30 low-flow exterior baked cal-sil sample. (t4bcex08.jpg)

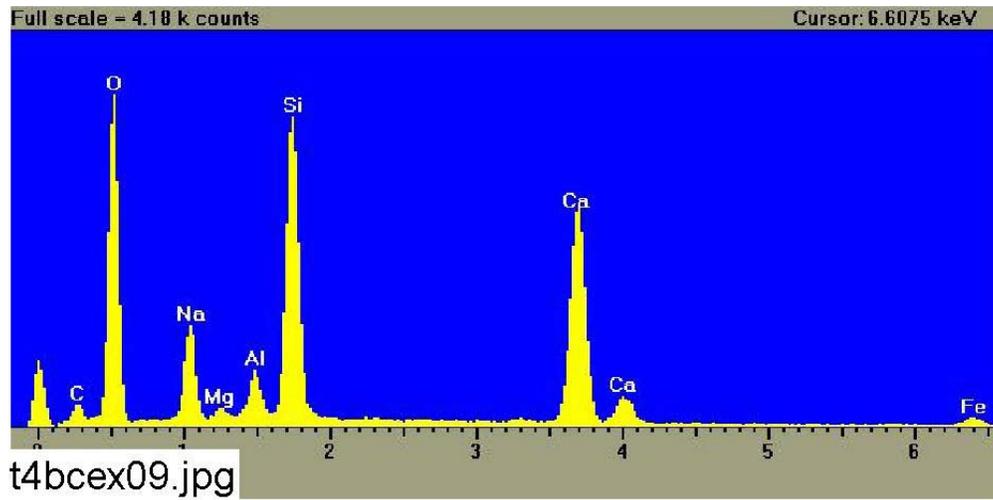
Figure 3-94: EDS counting spectrum for the whole image shown in Figure 3-93. (t4bcex09.jpg)

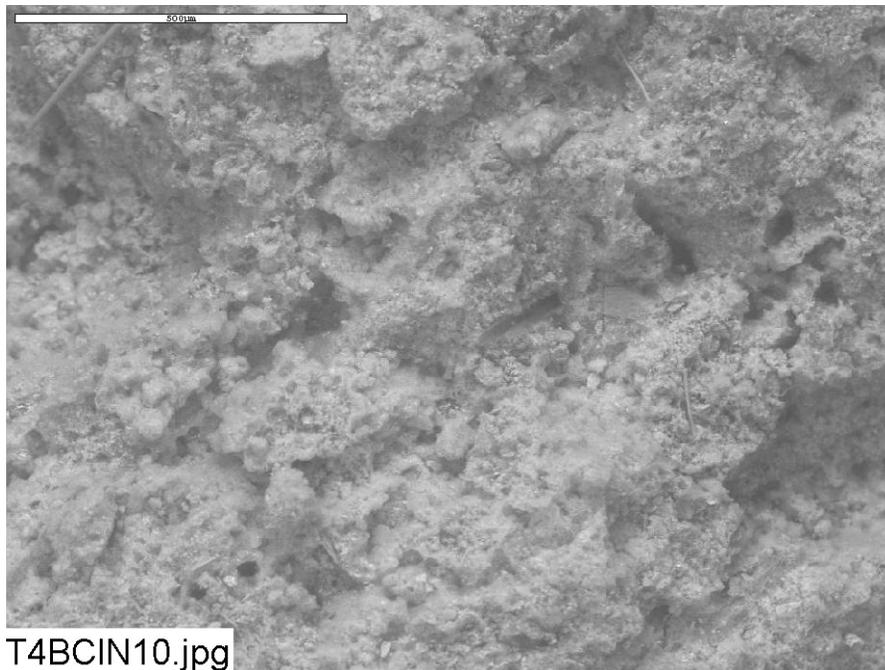
Figure 3-95: Environmental SEM image magnified 100 times for a Test #4 Day 30 low-flow interior baked cal-sil sample. (T4BCIN10.jpg)

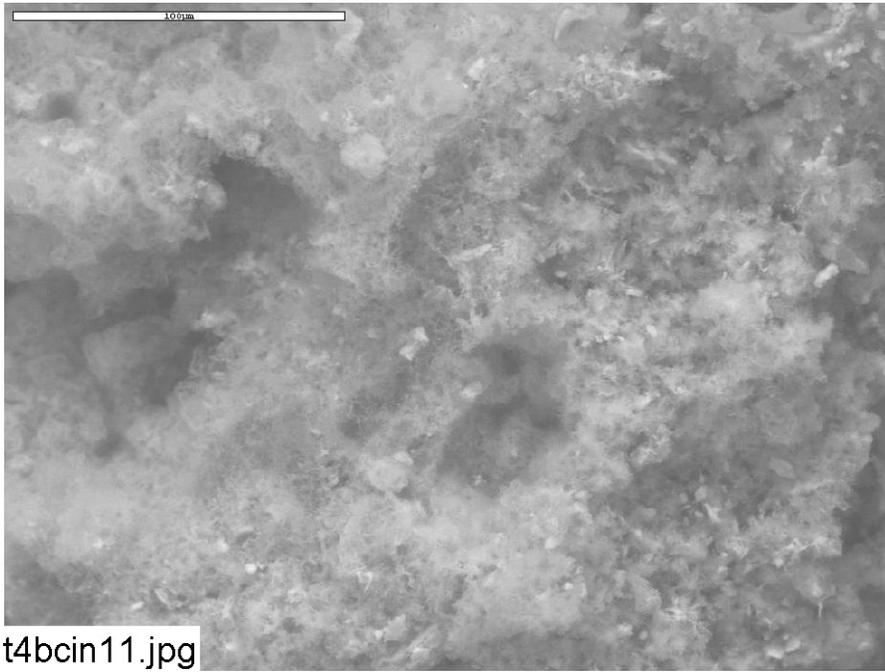
Figure 3-96: Environmental SEM image magnified 500 times for a Test #4 Day 30 low-flow interior baked cal-sil sample. (t4bcin11.jpg)

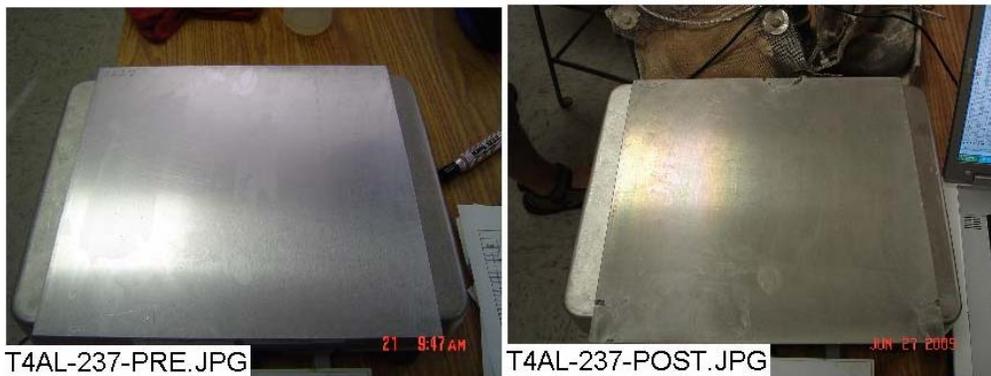
Figure 3-98: Al-237 submerged, pre-test (left) and post-test (right).

There are three submerged aluminum coupons in each test. Figures 3-98 through 3-100 display the pre- and post-test pictures of those coupons that were in Test #4. The relative locations of the aluminum coupons from east to west of the tank are: Al-239, Al-238, and Al-237. Al-239 and Al-238 were the two aluminum coupons that were isolated next to the concrete coupon. There were no visual differences between the three coupons after they were removed from the tank. The overall appearance of the aluminum coupons did not significantly change from their pre-test appearance. The post-test coupons appeared to have a light film on them and had lost their pre-test shiny appearance.
