Integrated Chemical Effects Test Project: Test #4 Data Report

Los Alamos National Laboratory

**U.S. Nuclear Regulatory Commission
Office of Nuclear Regulatory Research
Washington, DC 20555-0001**

A 30-day test was conducted in the Integrated Chemical Effects Test (ICET) project test apparatus. The test simulated the chemical environment present inside a pressurized water reactor containment water pool after a loss-of-coolant accident. The initial chemical environment contained 15.41 kg of boric acid, 8.47 kg of sodium hydroxide, 0.663 g of lithium hydroxide, and 212 mL of hydrochloric acid. An additional amount of sodium hydroxide (614 g) was added with the spray beginning at time zero and lasting until 30 minutes into the test. The test was conducted for 30 days at a constant temperature of 60°C (140°F). The materials tested within this environment included representative amounts of submerged and unsubmerged aluminum, copper, concrete, zinc, carbon steel, and insulation samples (80% calcium silicate and 20% fiberglass). Representative amounts of concrete dust and latent debris were also added to the test solution. Water was circulated through the bottom portion of the test cham

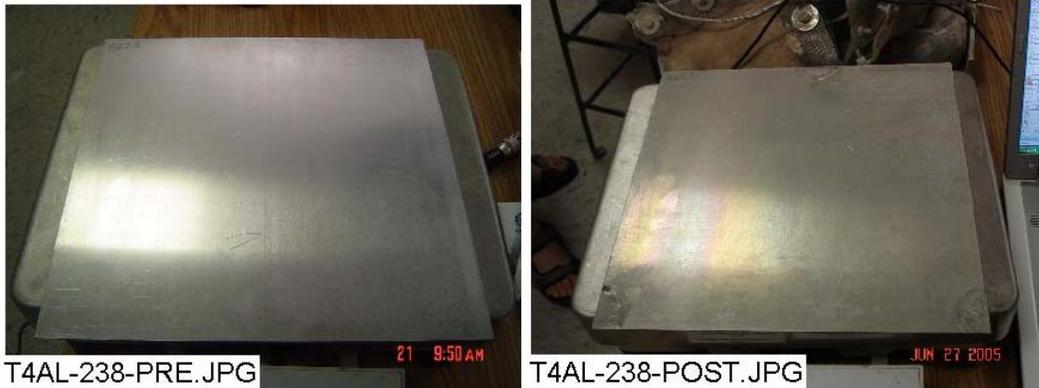
Figure 3-99: Al-238 submerged, pre-test (left) and post-test (right).

There are three submerged aluminum coupons in each test. Figures 3-98 through 3-100 display the pre- and post-test pictures of those coupons that were in Test #4. The relative locations of the aluminum coupons from east to west of the tank are: Al-239, Al-238, and Al-237. Al-239 and Al-238 were the two aluminum coupons that were isolated next to the concrete coupon. There were no visual differences between the three coupons after they were removed from the tank. The overall appearance of the aluminum coupons did not significantly change from their pre-test appearance. The post-test coupons appeared to have a light film on them and had lost their pre-test shiny appearance.

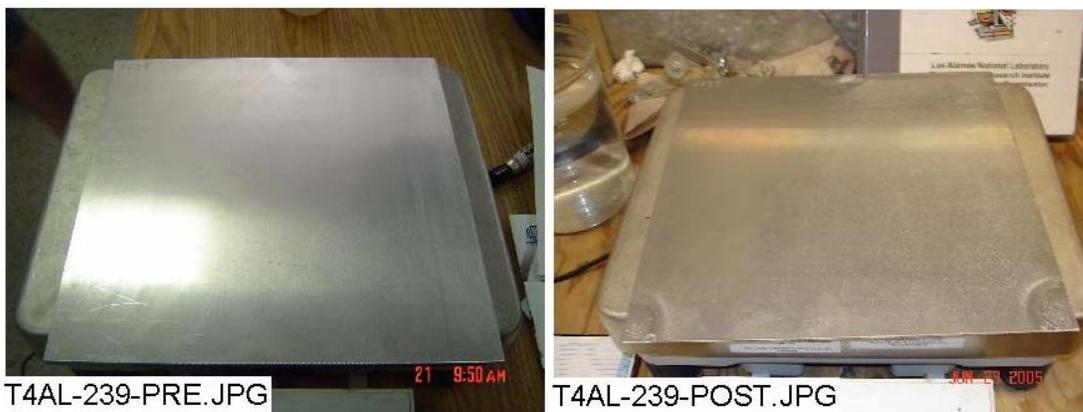
Figure 3-100: Al-239 submerged, pre-test (left) and post-test (right).

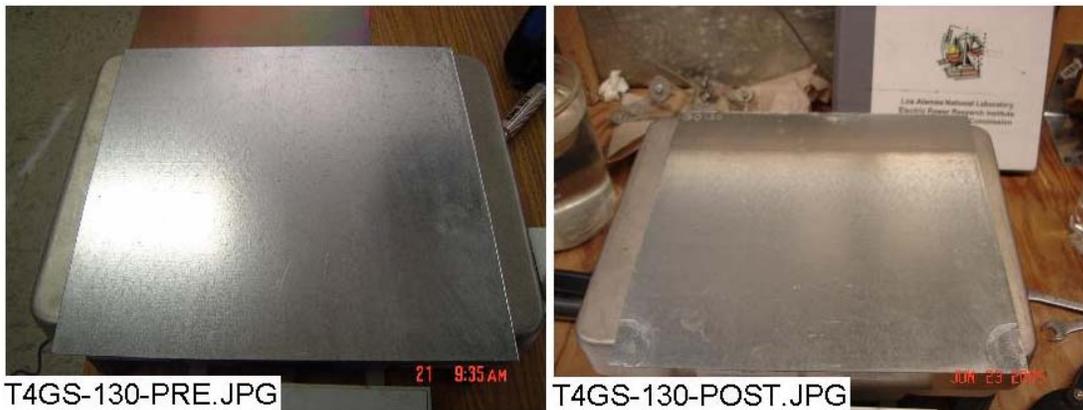
Figure 3-101: GS-130 submerged, pre-test (left) and post-test (right).

Figures 3-101 through 3-103 present the pre- and post-test pictures of three submerged galvanized steel coupons. The galvanized steel coupons did not experience any significant observable change. The coupons appeared to be relatively clean and the only noticeable marks of any sort are the circular marks caused by the racks that they are mounted in. GS-130 does appear to have some particle deposition that is concentrated mainly on the bottom corners and on the top where the coupon resides in the rack.

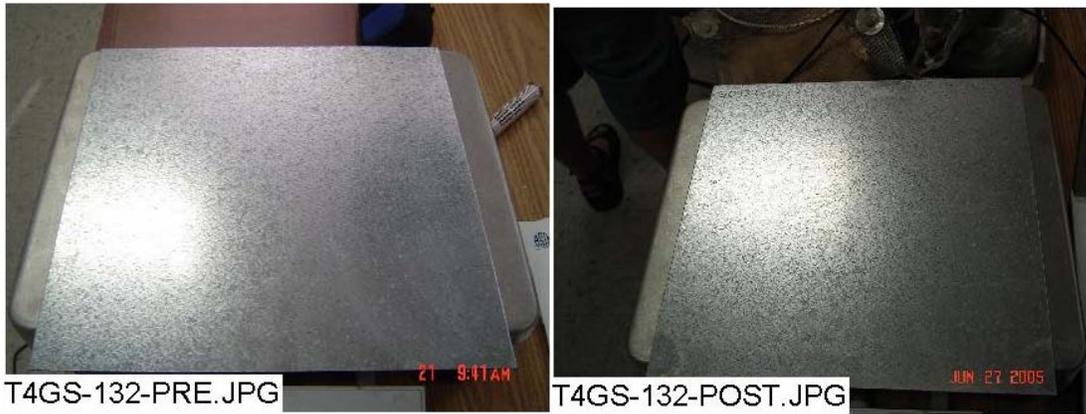
Figure 3-102: GS-132 submerged, pre-test (left) and post-test (right).

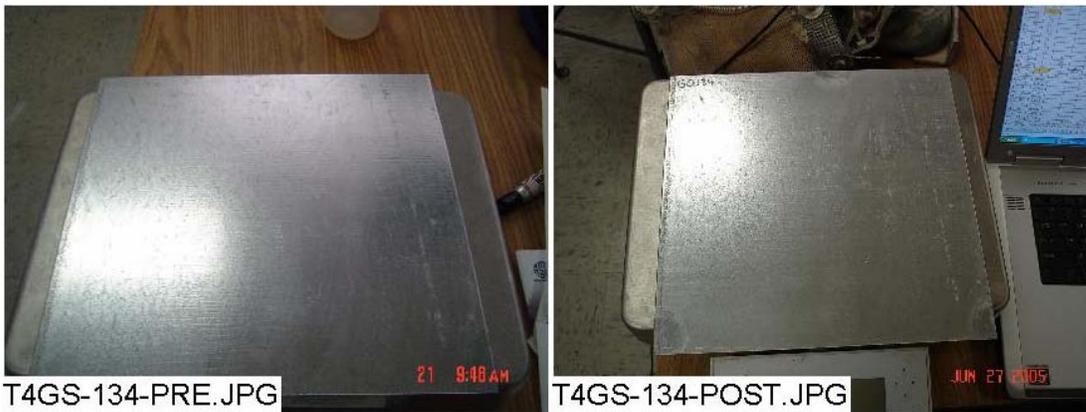
Figure 3-103: GS-134 submerged, pre-test (left) and post-test (right).

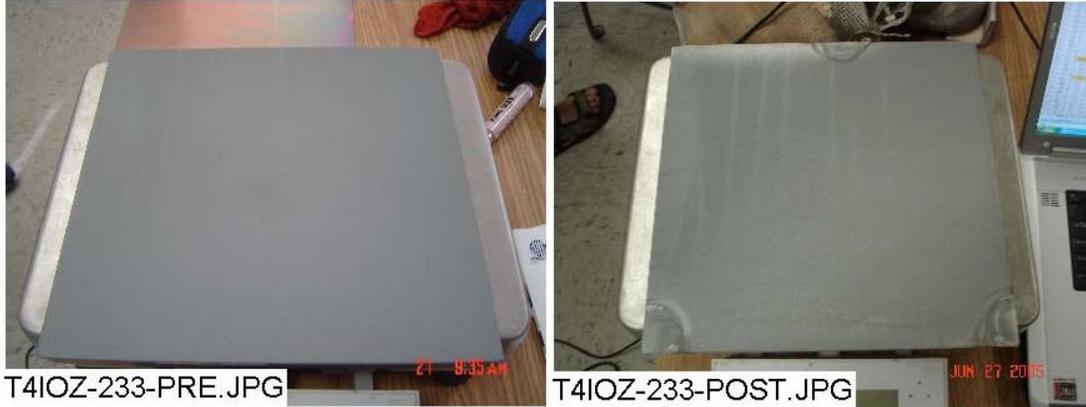
Figure 3-104: IOZ-233 submerged, pre-test (left) and post-test (right).

Figures 3-104 and 3-105 present the pre- and post-test pictures of two submerged inorganic zinc (IOZ) coated steel coupons. Both submerged IOZ coated steel coupons have similar, light particle depositions. There is a small accumulation of a white precipitate that originates mostly from the points of contact with the racks. However on IOZ-233, the particles seem to be distributed over the majority of the surface of the coupon. This coupon was the westernmost IOZ coupon in the rack in relation to the others.

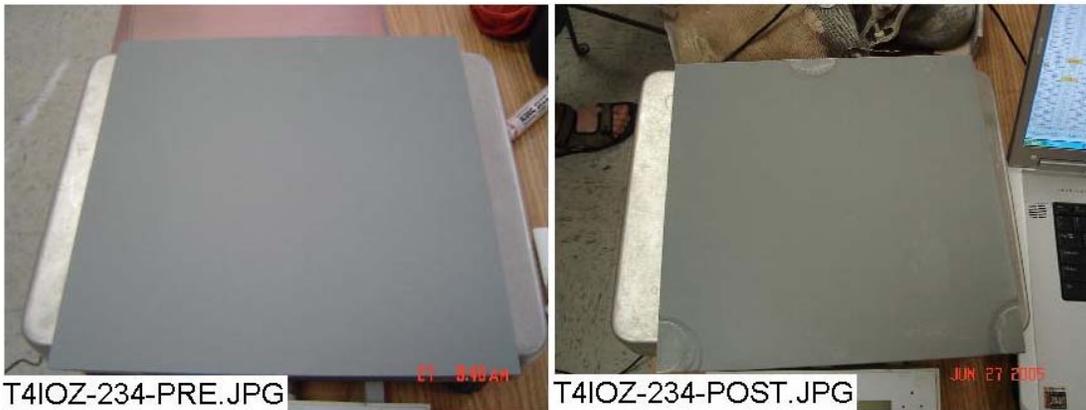
Figure 3-105: IOZ-234 submerged, pre-test (left) and post-test (right).

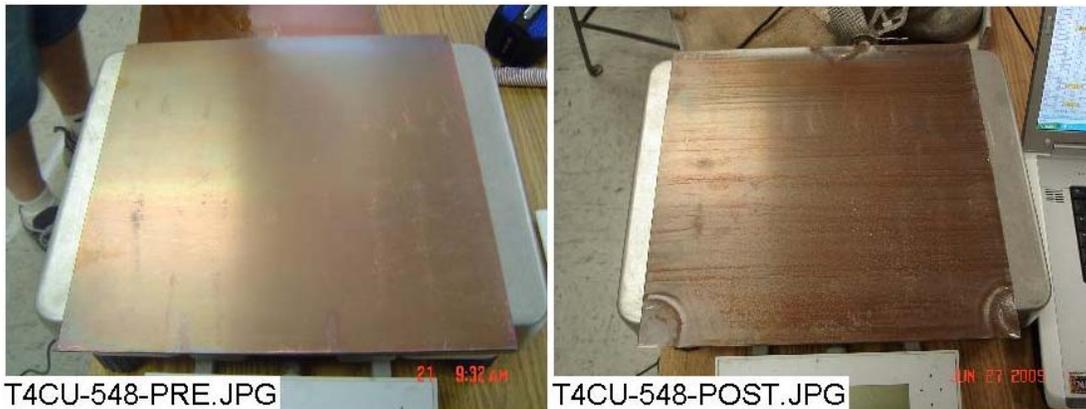
Figure 3-106: CU-548 submerged, pre-test (left) and post-test (right).

Figures 3-106 and 3-107 present the pre- and post-test pictures of two submerged copper coupons. The copper coupons were mainly unchanged. Like the other coupons, there is a very light concentration of particulate deposits in the areas where the coupons contact the rack.

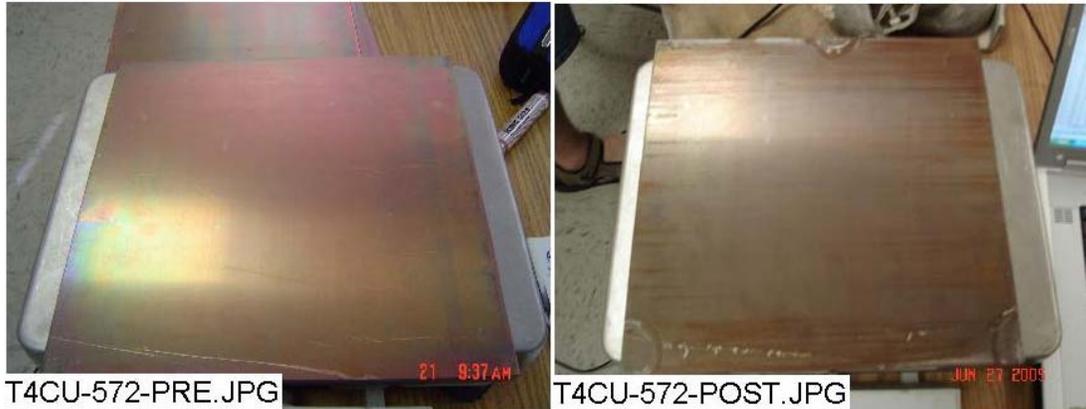
Figure 3-107: CU-572 submerged, pre-test (left) and post-test (right).

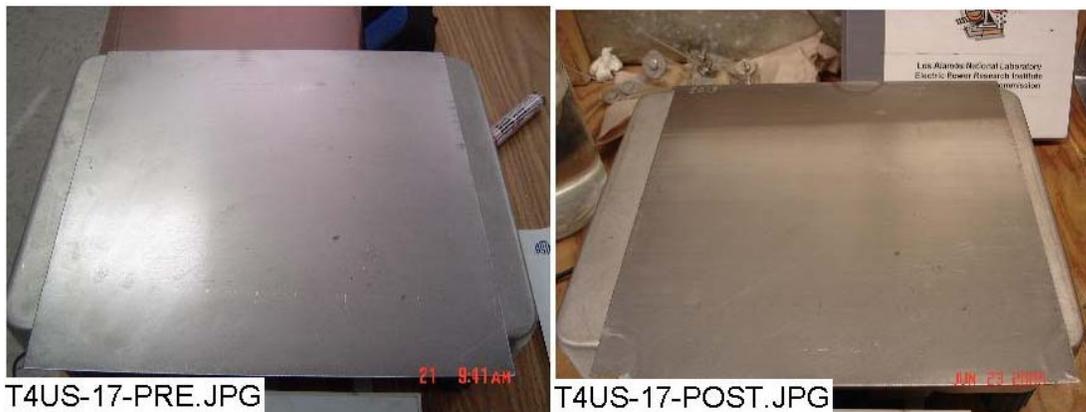
Figure 3-108 presents the pre- and post-test pictures of the submerged carbon steel coupon. Other than some discoloration, there was no change. There was a small amount of rust on the bottom corners.

Figure 3-108: US-17 submerged, pre-test (left) and post-test (right).

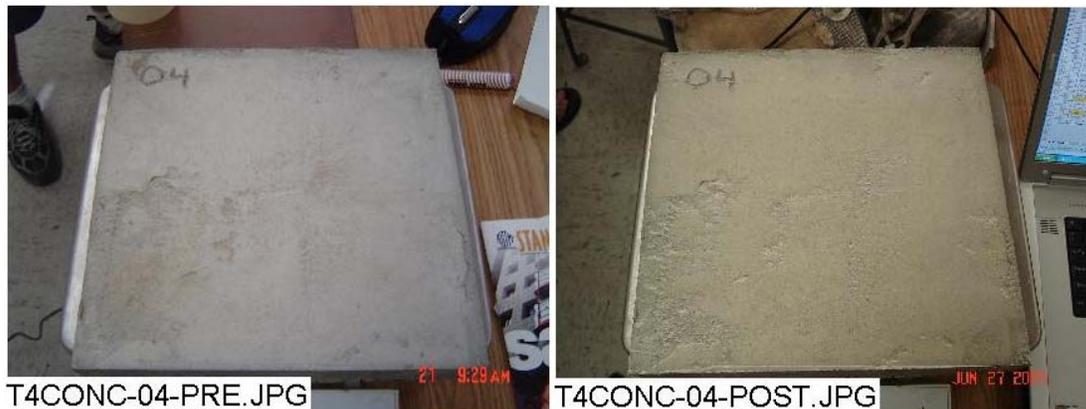
Figure 3-109 presents the pre- and post-test pictures of the submerged concrete coupon. The post-test concrete coupon exhibits a brownish color.

Figure 3-109: Conc-004 submerged, pre-test (left) and post-test (right).

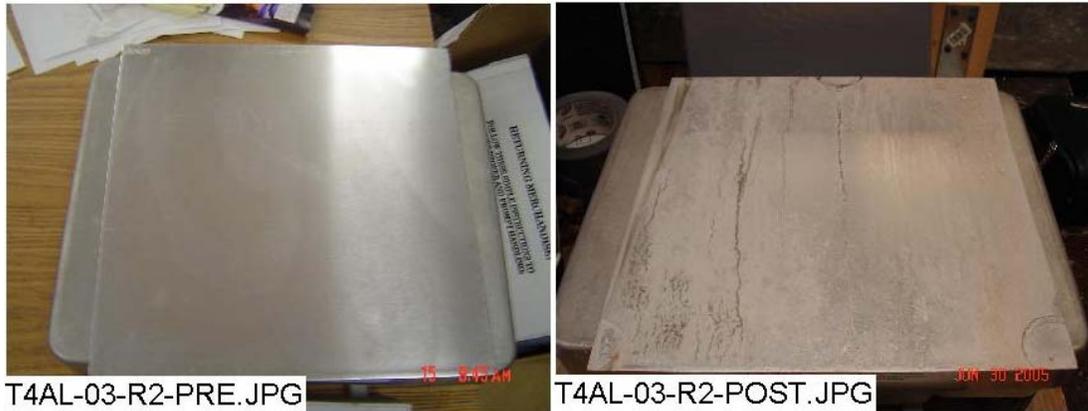
Figure 3-110: Al-003 unsubmerged, pre-test (left) and post-test (right).

Figures 3-110 and 3-111 show the pre- and post-test pictures of two unsubmerged aluminum coupons. Each unsubmerged aluminum coupon accumulated a white particle deposition along with some areas of a brownish color. This coating caused the surface of the aluminum coupons to become coarse and rough. The photo of Al-229 shows that most of the surface is coated with the particle deposition, however, in the upper right hand corner the surface is relatively smooth with a color change observable. This is likely caused by uneven spray on the coupons. Even though the four spray nozzles were set to spray uniformly across their spray radius, the spray was not a perfect mist. There were some non-uniform areas, and the positions of the six coupon racks also interfered with the sprays. Al-003 was loaded in Rack 2 (bottom tier, southernmost) and Al-229 was loaded in Rack 7 (upper tier, northernmost)

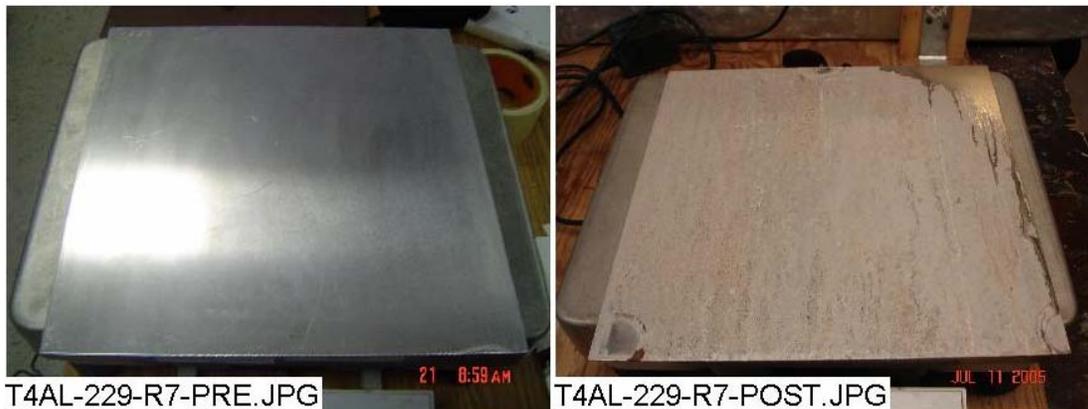
Figure 3-111: Al-229 unsubmerged, pre-test (left) and post-test (right).

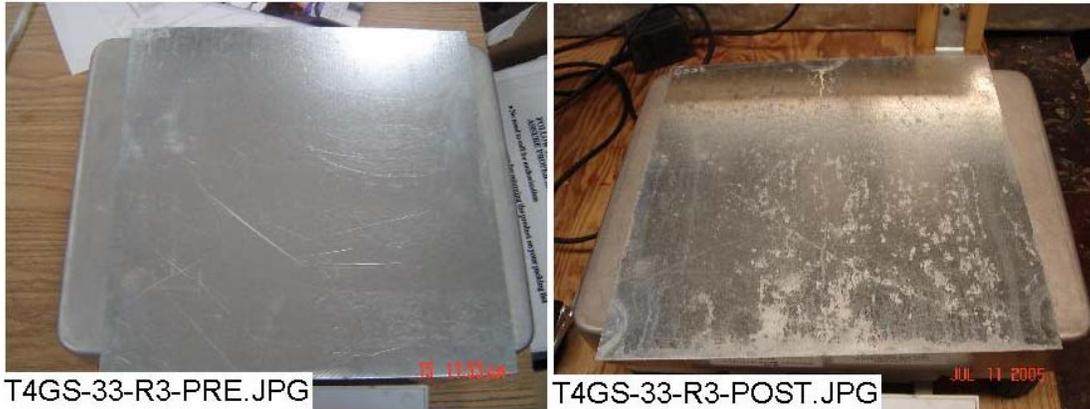
Figure 3-112: GS-33 unsubmerged, pre-test (left) and post-test (right).

Figures 3-112 and 3-113 show the pre- and post-test pictures of two unsubmerged galvanized steel coupons. There was some white deposition on the surface of these coupons although it was in small amounts. The post-test coupons were relatively clean,

with little change. GS-33 was mounted in Rack 3 (bottom tier, middle rack) and GS-91 was mounted in Rack 6 (upper tier, middle rack).

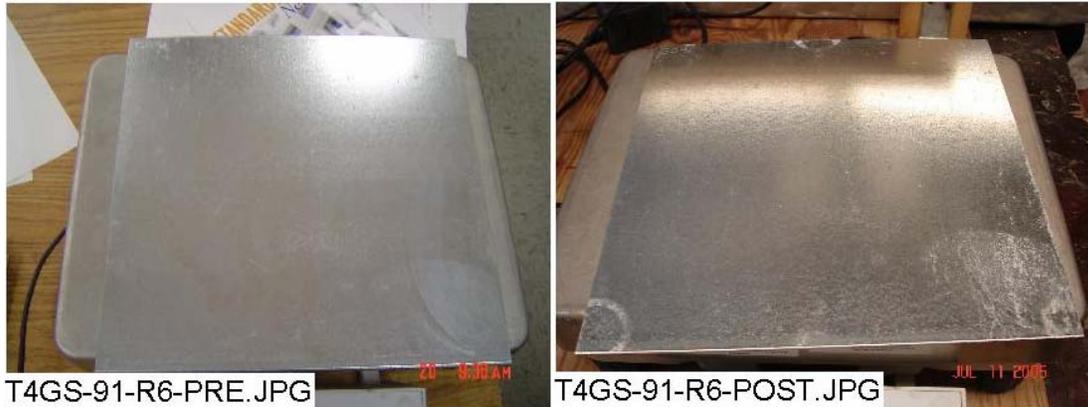
Figure 3-113: GS-91 unsubmerged, pre-test (left) and post-test (right).

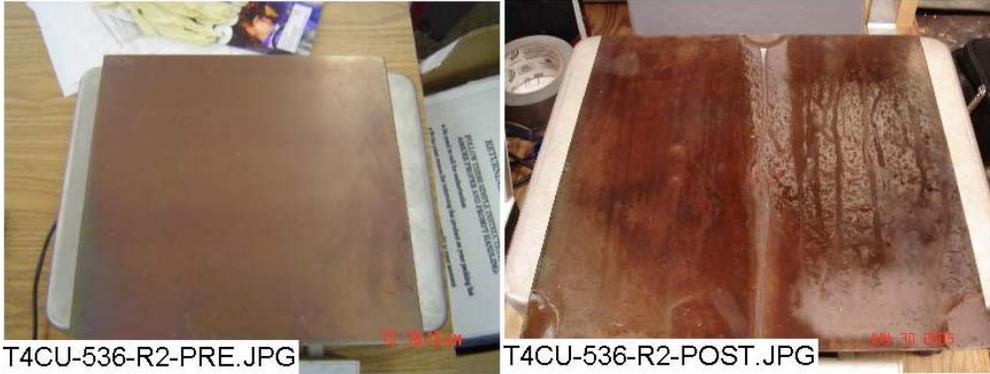
Figure 3-114: CU-536 unsubmerged, pre-test (left) and post-test (right).

Figures 3-114 and 3-115 present the pre- and post-test pictures of two unsubmerged copper coupons. All of the copper coupons had vertical water marks that were caused by water flowing downward on the coupon surface during the spray portion of the test. The copper coupons did not appear to accumulate any particle deposition. CU-536 was mounted in Rack 2 (bottom tier, southernmost) and CU-584 was mounted in Rack 7 (upper tier, northernmost).

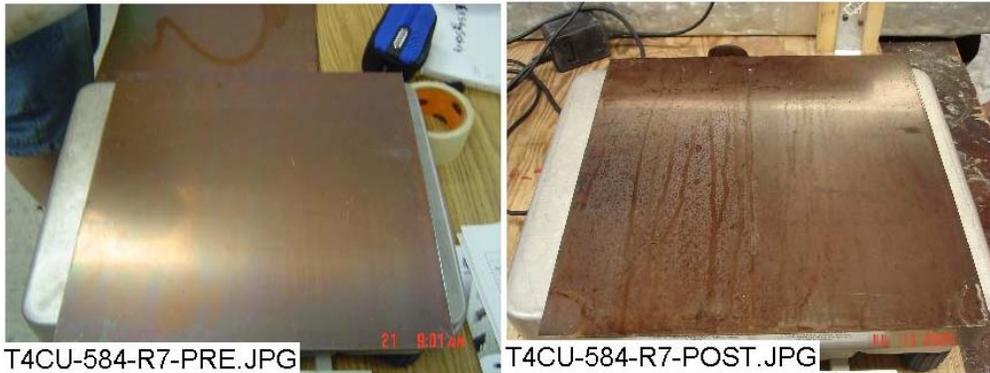
Figure 3-115: CU-584 unsubmerged, pre-test (left) and post-test (right).

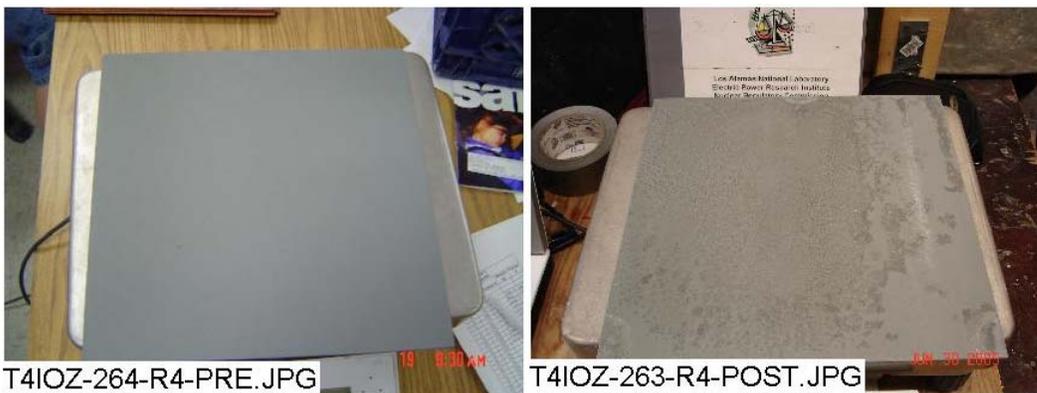
Figures 3-116 and 3-117 present the pre- and post-test pictures of two unsubmerged inorganic zinc coated steel coupons. IOZ-263 was mounted in Rack 4 (bottom tier, northernmost) and IOZ-275 was mounted in Rack 5 (upper tier, northernmost).

Figure 3-116: IOZ-263 unsubmerged, pre-test (left) and post-test (left).

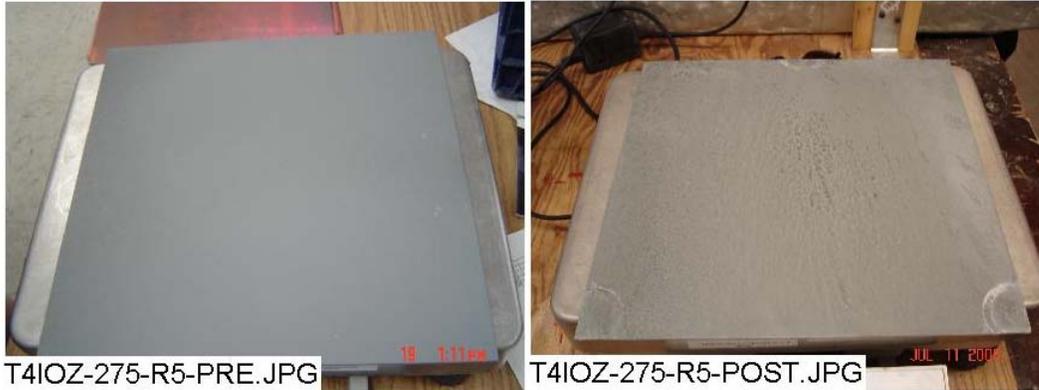
Figure 3-117: IOZ-275 unsubmerged, pre-test (left) and post-test (right).

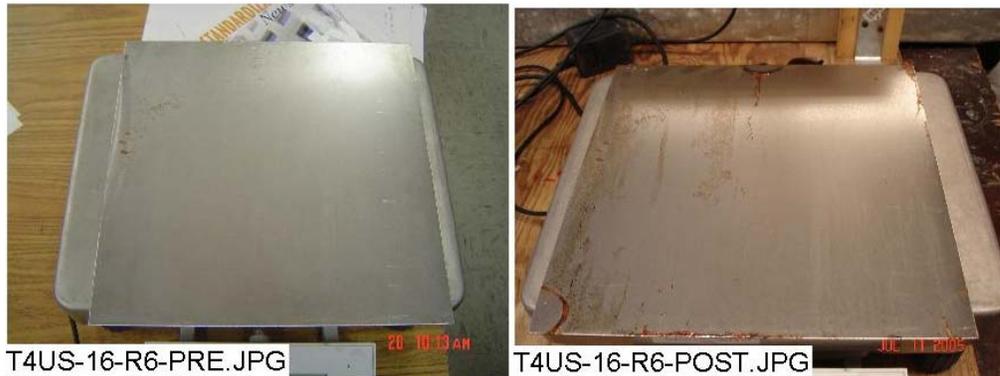
Figure 3-118 presents the pre- and post-test pictures of one unsubmerged carbon steel coupon. US-16 was mounted in Rack 6 (upper tier, middle rack).

Figure 3-118: US-16 unsubmerged, pre-test (left) and post-test (right).

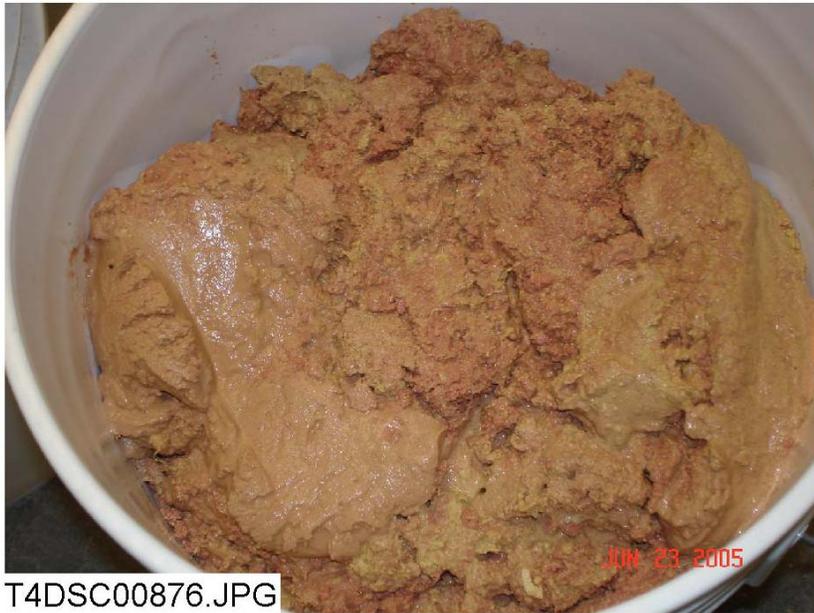
Figure 3-119. Sediment removed from the tank.

Sediment was collected from the tank bottom after the test solution was drained. It consisted of a particulate sediment that covered the entire tank bottom. Figure 3-119 shows some of this sediment. In addition, Figure 3-120 shows the tank bottom with the sediment, after the samples were removed. Figure 3-121 shows the top of the drain screen with the drain collar surrounded by sediment, and Figure 3-122 shows the drain screen and drain collar after removal from the tank. Figure 3-123 shows the birdcage sitting on top of a basket of cal-sil after the tank was drained. The cal-sil baskets sat on top of the sediment, and thus, the birdcage was not in direct contact with the sediment.

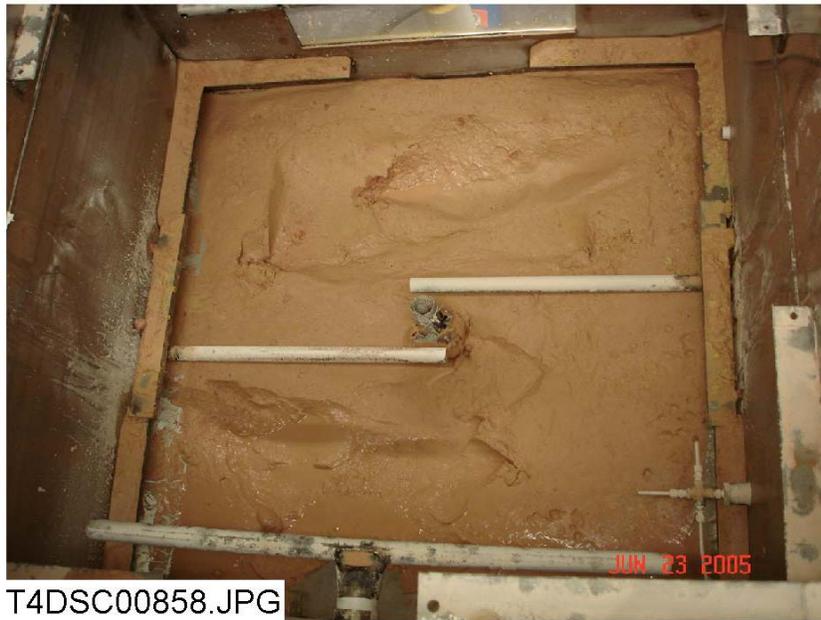
Figure 3-120. Sediment on the tank bottom.

Compared to other Day 30 low-flow fiberglass samples, a significant amount of particulate deposits was observed on the exterior of the Day 30 low-flow samples in the big envelope. The big envelope sat on the tank bottom and was in contact with the test sediment on the bottom of the envelope. Figure 3-120 shows the sediment after the samples were lifted out of the tank. However, no particulate deposits were observed on the fiberglass interior. In addition, some large flat fibers were found on the exterior fiberglass samples (see Figure 3-51). These large flat fibers were likely from cal-sil (see Appendix D). It is possible that the particulate deposits and cal-sil fibers were physically attached/retained on the exterior of the fiberglass samples. Figures 3-50 through 3-53 show the results from the Day 30 low-flow fiberglass enclosed in the big envelope. In contrast to other samples, these samples were gently rinsed with RO water and no film was found on either the exterior or the interior of the fiberglass. The disappearance of the film is likely caused by the rinse of RO water to keep the sample moist before ESEM analysis. Based on the control experiment noted earlier (See Appendix C4), the film is soluble.

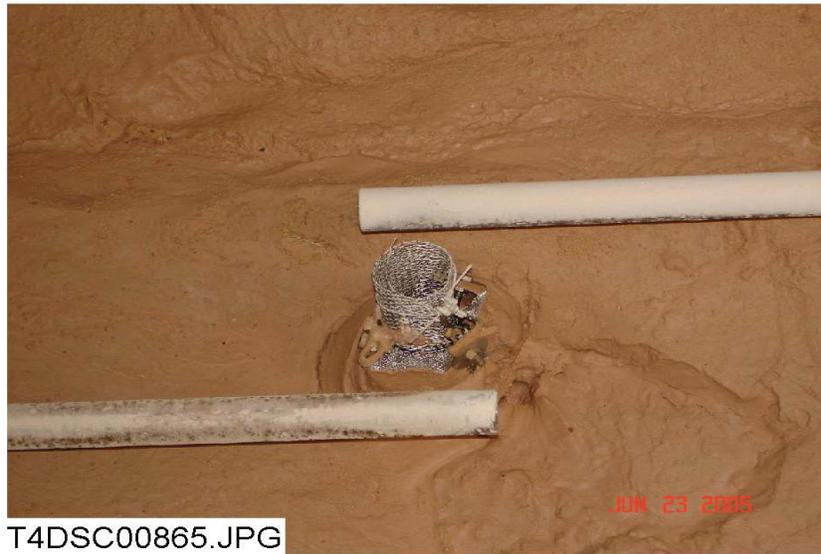
Figure 3-121. Drain collar surrounded by sediment on the tank bottom.

When the tank was drained, the drain collar was totally surrounded by sediment. Figure 3-121 shows the drain collar after the tank was drained. Both the exterior fiberglass sample that was farthest from the drain screen and the exterior sample that was next to the drain screen have significant amounts of particulate deposits. Inspection revealed the development of a continuous coating on the drain collar exterior, including particulate deposits that were likely physically retained or attached. The amount of deposits on the drain collar exterior was greater than on high- and low-flow fiberglass samples. EDS results indicate that the particulate deposits were mainly composed of O, Si, Ca, Na, Al, and C, regardless of whether the drain collar exterior was farthest from the drain screen or next to the drain screen. The high content of Si and Ca in the particulate deposits suggests that they were probably from cal-sil debris. In contrast to the exterior, no significant particulate deposits were found in the drain collar interior sample, and only film-like deposits were found (see Figure 3-75). The drain collar interior appears similar to the other high- and low- flow fiberglass interior samples. This result suggests that almost all of the particulate deposits were physically retained at the fiberglass exterior, which is consistent with Day 30 high-flow fiberglass samples. Figures 3-69 through 3-79 show the drain collar fiberglass results.

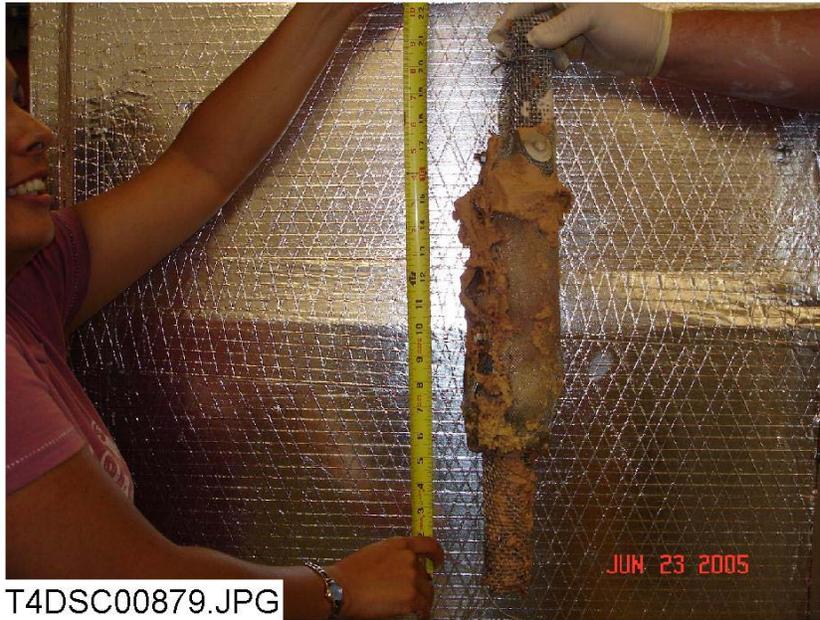
Figure 3-122. Drain collar and drain screen removed from the tank.

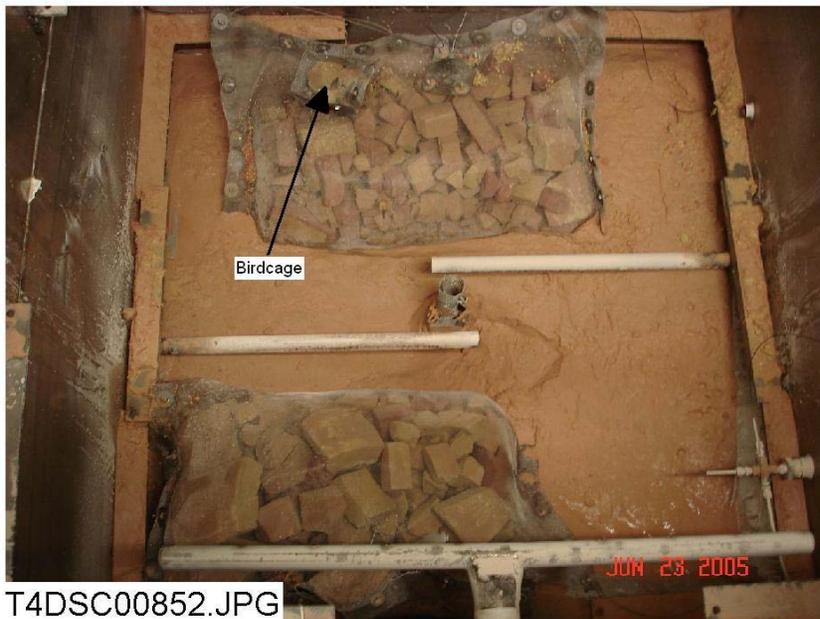
Figure 3-123. Birdcage and cal-sil baskets after the tank was drained.

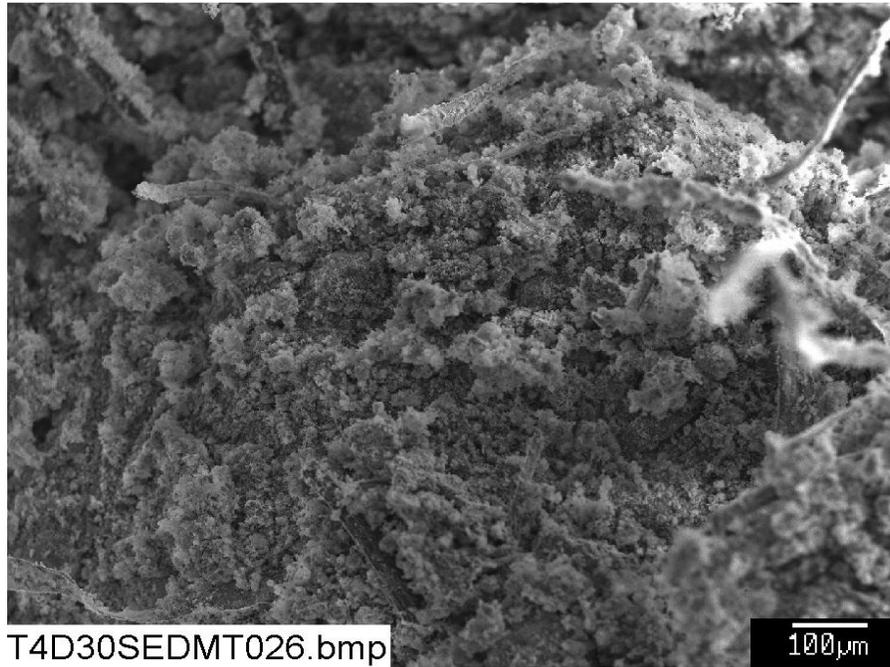
Figure 3-124: SEM image magnified 100 times for a Test #4 Day 30 sediment sample at the bottom of the tank. (T4D30SEDMT026.bmp)

Figures 3-124 through 3-129 and Table 3-6 provide ESEM/EDS and XRD/XRF analysis results. The complete Day 30 sediment analyses are given in Appendix G.

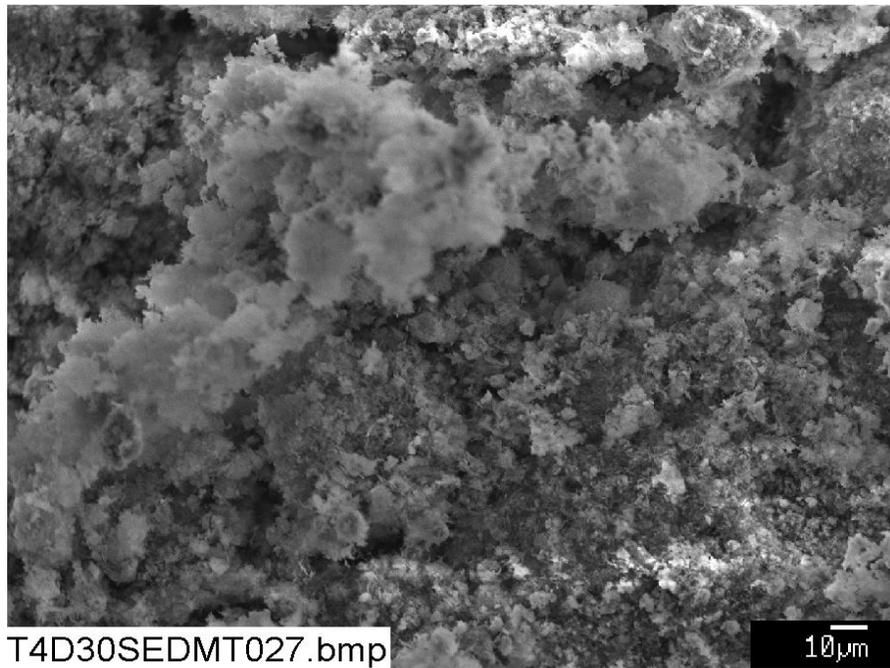
Figure 3-125: SEM image magnified 500 times for a Test #4 Day 30 sediment sample at the bottom of the tank. (T4D30SEDMT027.bmp)

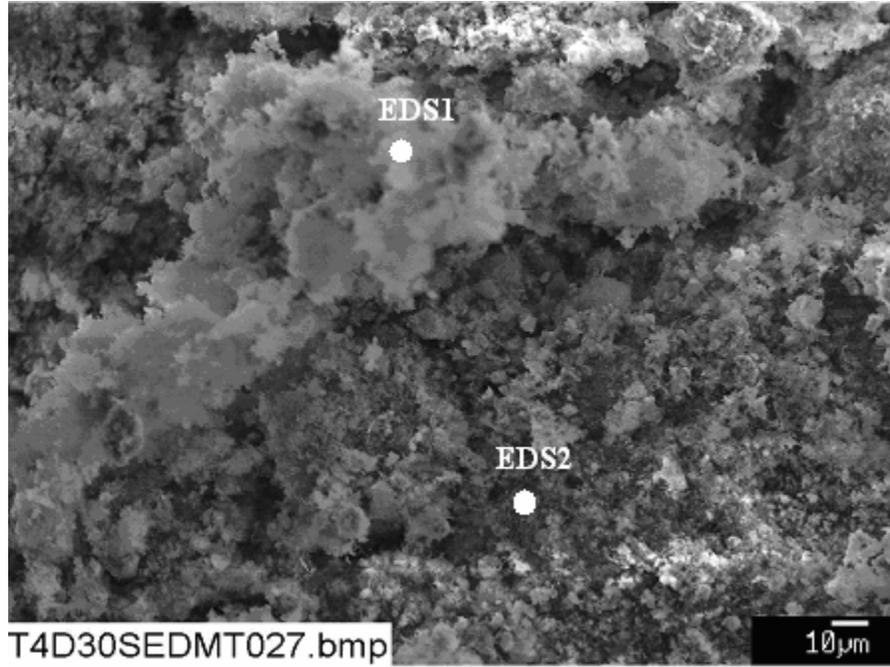
Figure 3-126: Annotated SEM image magnified 500 times for a Test #4 Day 30 sediment sample at the bottom of the tank. (T4D30SEDMT027.bmp)

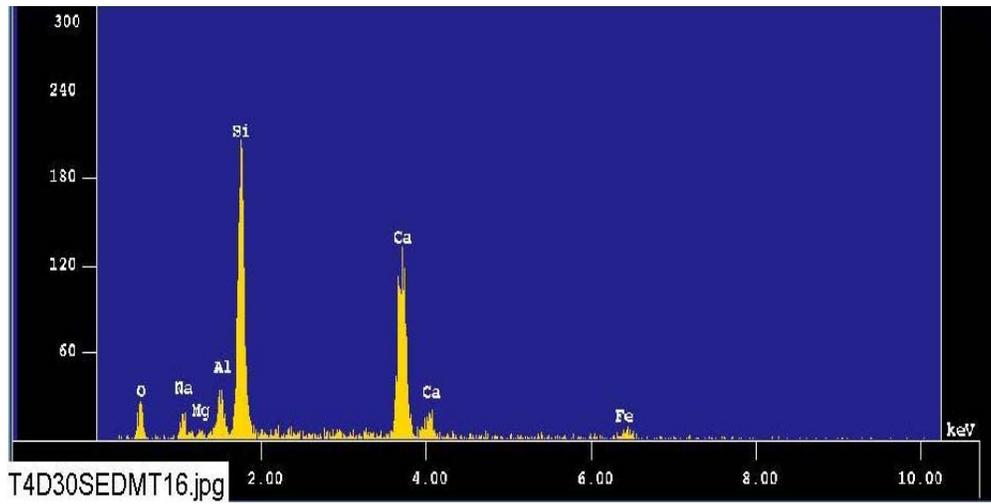
Figure 3-127: EDS counting spectrum for the white snow like deposits (EDS1) shown in Figure 3-126. (T4D30SEDMT16.jpg)

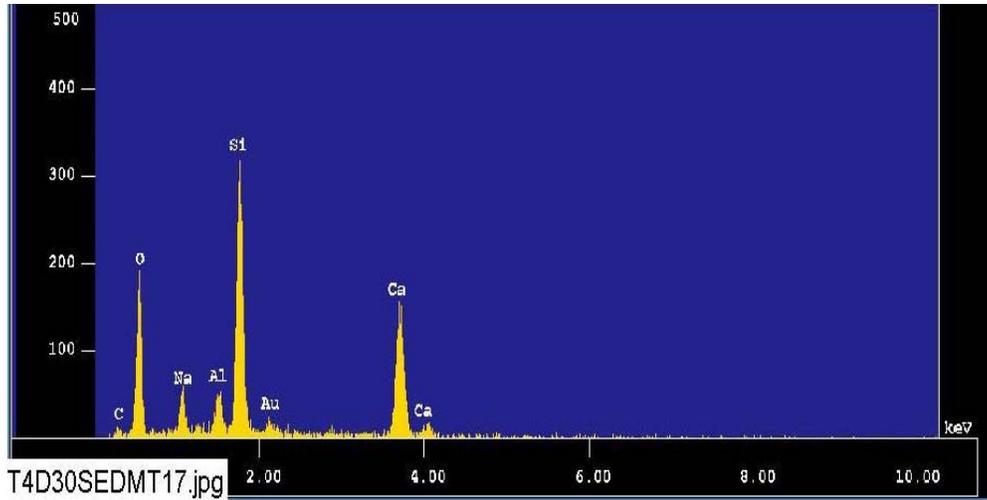
Figure 3-128: EDS counting spectrum for the dark deposits (EDS2) shown in Figure 3-126. (T4D30SEDMT17.jpg)

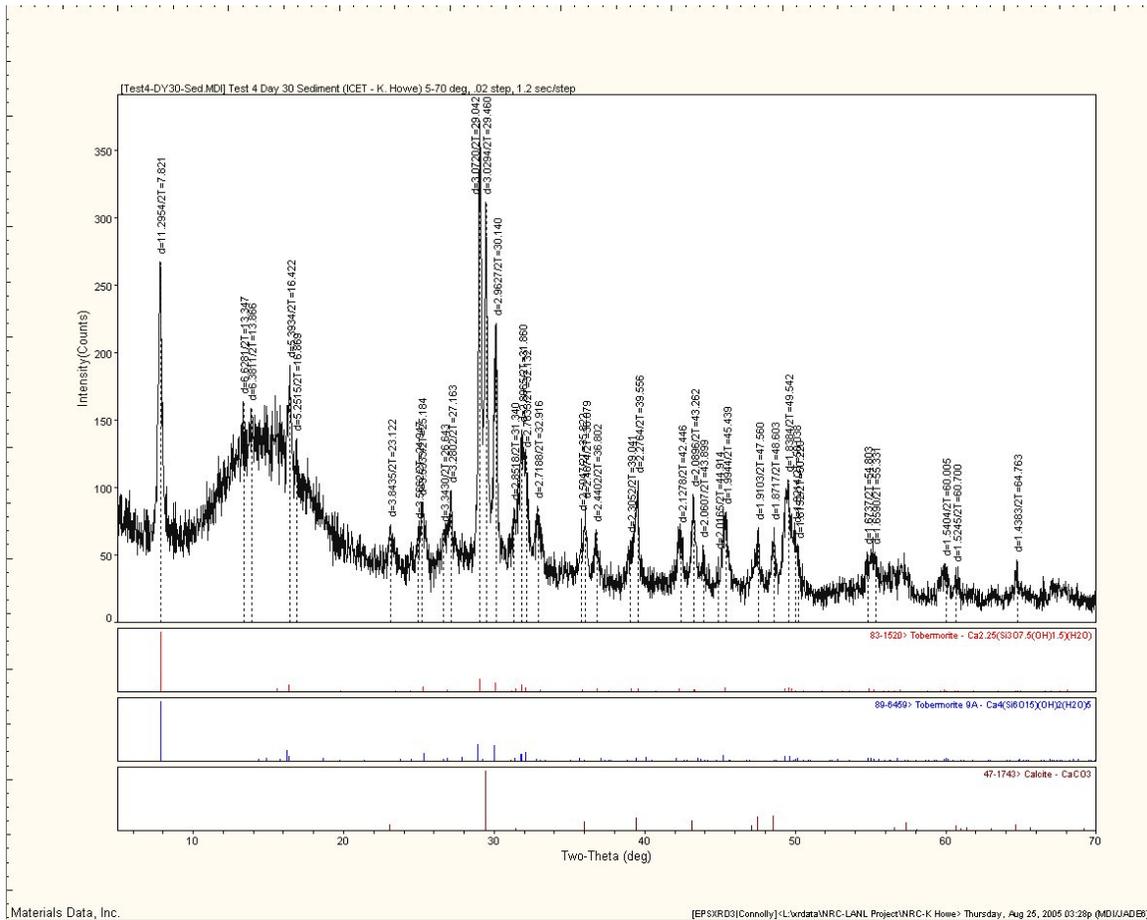
Figure 3-129: XRD result of the possible matching crystalline substances in Test #4 Day 30 sediment.

Based on XRD results, the sediment sample contained crystalline substances of tobermorite ($\text{Ca}_{2.25}(\text{Si}_3\text{O}_{7.5}(\text{OH})_{1.5})(\text{H}_2\text{O})$) and $\text{Ca}_4(\text{Si}_6\text{O}_{15}(\text{OH})_2)(\text{H}_2\text{O})_5$) as well as calcite (CaCO_3), which are the same as unused raw or unused baked cal-sil samples. Considering the collective evidence from the EDS, XRF, and XRD analyses, it is likely that the sediment was composed of a significant amount of cal-sil debris, including both raw and baked cal-sil. It should be noted that other deposits such as fiberglass debris and corrosion products may also contribute to the sediments and can not be ruled out.

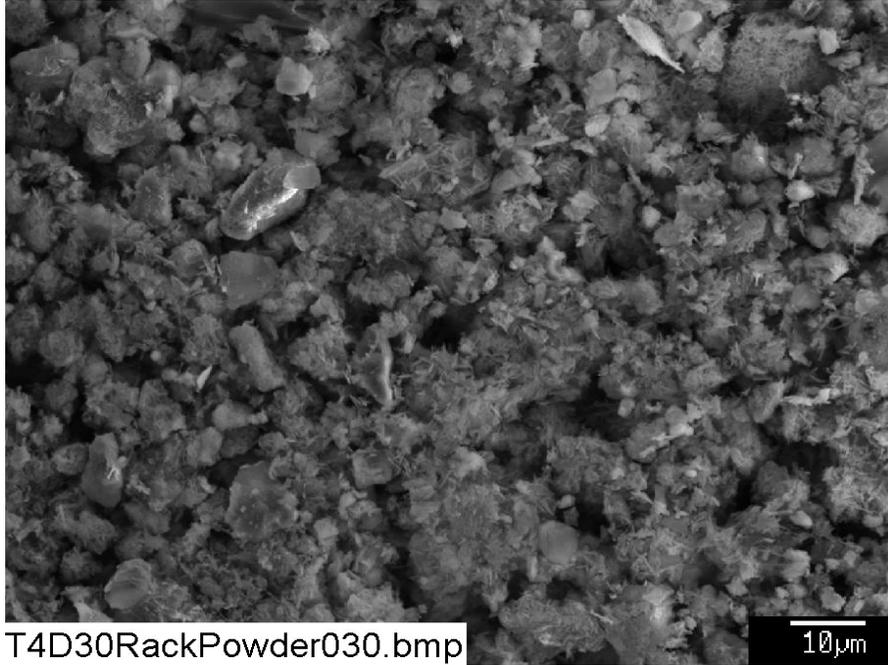
Figure 3-130: SEM image magnified 1000 times for a Test #4 Day 30 fine powder on the submerged rack. (T4D30RackPowder030.bmp)

The deposition of debris/corrosion products in the tank after it was drained was observed on the submerged objects in the tank. These corrosion/deposition products, which looked like a fine powder, were collected for analysis. Those collected were from the submerged CPVC coupon rack. SEM/ EDS results indicated that these fine powders were mainly composed of O, Ca, Si, Na, Al, and C. The high content of Ca and Si suggests that the powders were likely from cal-sil and fiberglass debris.

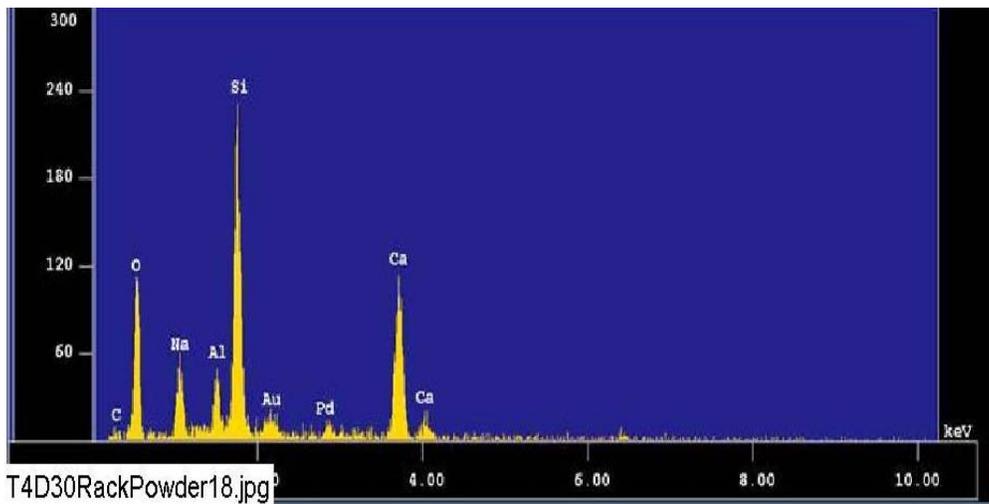
Figure 3-131: EDS counting spectrum for the particles (whole image) shown in Figure 3-130. (T4D30Rackpowder18.jpg)
