## Appendix B1

# ESEM/EDS Data for Test #4 Day-15 Fiberglass in Low-Flow Zones

This appendix shows the ESEM/EDS results on ICET Test #4 Day-15 low-flow zone fiberglass samples. The samples were obtained on June 8, 2005 (15th date for Test #4). Both exterior and interior locations of the fiberglass samples were examined. ESEM/EDS data presented here were obtained on June 23, 2005. The hydrated fiberglass samples without any coating were examined by ESEM under a low vacuum condition (i.e., 80 Pa). EDS results provide a semi-quantitative elemental analysis of the debris attached on fiberglass.

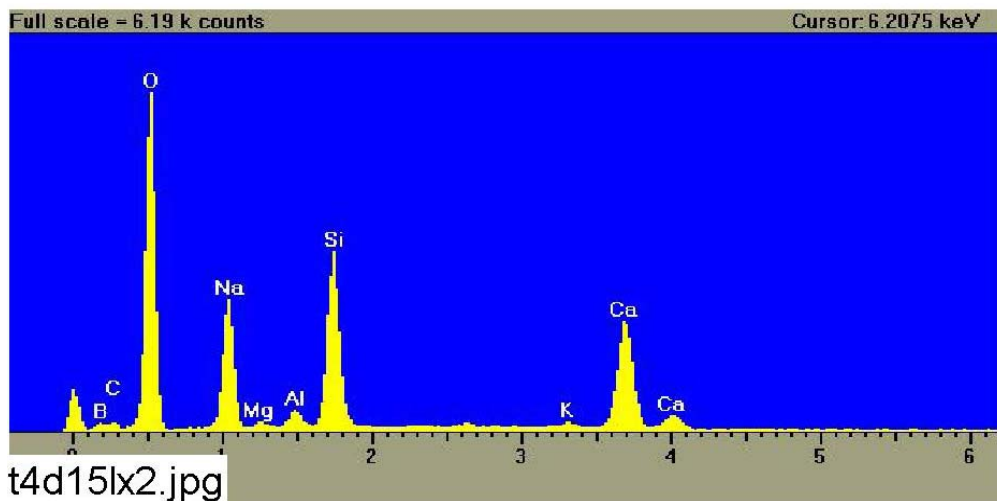
Figure B1-2: EDS counting spectrum for the particulate deposit on fiberglass shown in Figure B1-1. (t4d15lx2.jpg)

Image:	t4d15lx3	100 ×	ESEM annotated image	Figure B1-1
EDS:	t4d15lx2		EDS image on particles in t4d15lx3	Figure B1-2
Image:	t4d15lx4	500 ×	ESEM image of fiberglass	Figure B1-3
	t4d15lx5	1000 ×	ESEM image at higher magnification	Figure B1-4
